U. S. FOREST SERVICE  
RESEARCH PAPER NC-4  
JUNE 1966

# Effect of Initial Moisture Content on Performance of HARDWOOD PALLET

# The Effect of Initial Moisture Content On Performance of Hardwood Pallets

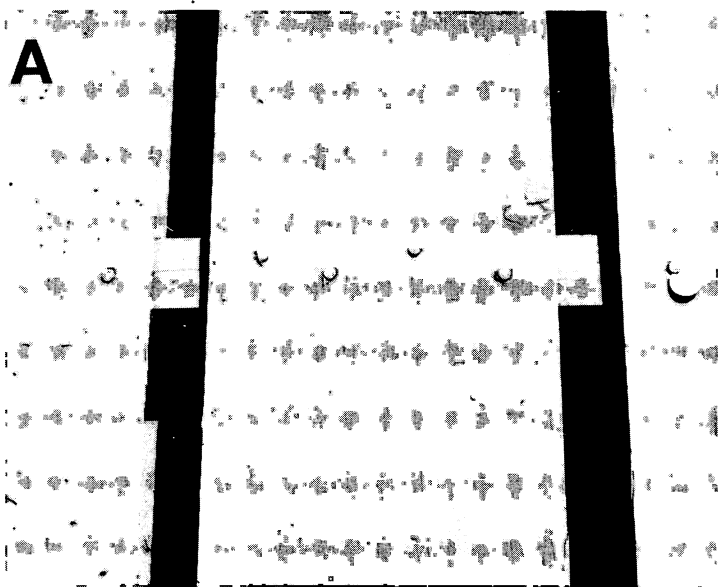
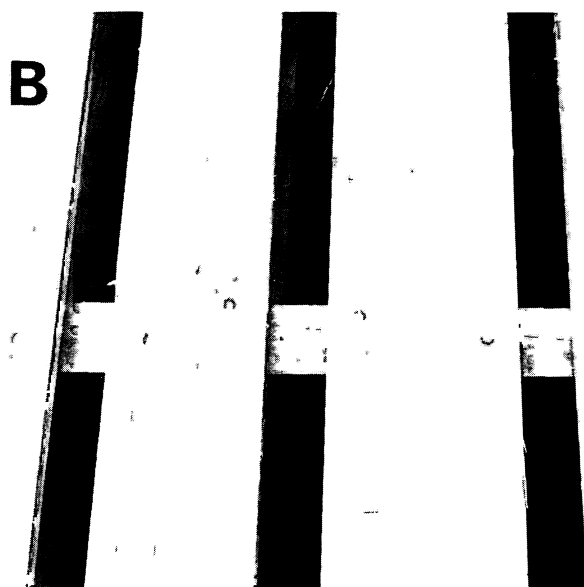
Nail-popping, the projection of nailheads above the surface of the deckboards due to shrinking of stringers, was prevalent in pallets made with green stringers. It did not occur in the pallets made with dry stringers (fig. 2). Nail-popping developed during the early stages of the test while the green stringers were drying. Most nail-popping was slight and it was not regarded as a serious defect in this study.

FIGURE 2.— (A) Nail-popping in an all-green pallet because of stringer shrinkage; (B) no nail-popping in an all-dry pallet because stringer did not shrink.

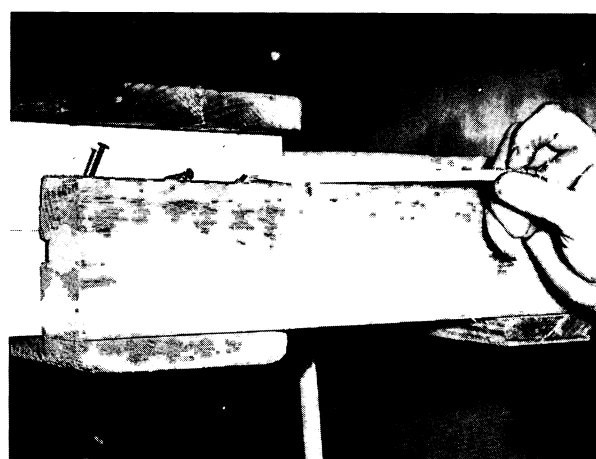
Most often, particularly in the early stages of the test, edgeboards failed by coming loose from one or more stringers. When an edgeboard split at the nails, the nails usually pulled through the board. If the edgeboard was not split, the failure was usually because the nails sheared off between the stringer and the deckboard. Those nails closest to the leading or outside edge of the edgeboard most often pulled

FIGURE 3.— Edgeboard separated from stringer. Leading nail (left) pulled through the deckboard. Pencil points at nail on inside edge of deckboard that sheared off.

through, while those nearest the trailing or inside edge usually sheared off (fig. 3). Failure of the nails at the center of the joint was about equally divided between pullthrough and shearing.

When splits were present at the nails in edgeboards, the prying action of lift-truck forks caused the leading-edge nails to begin pulling through the deckboard. This increased the load on trailing-edge nails

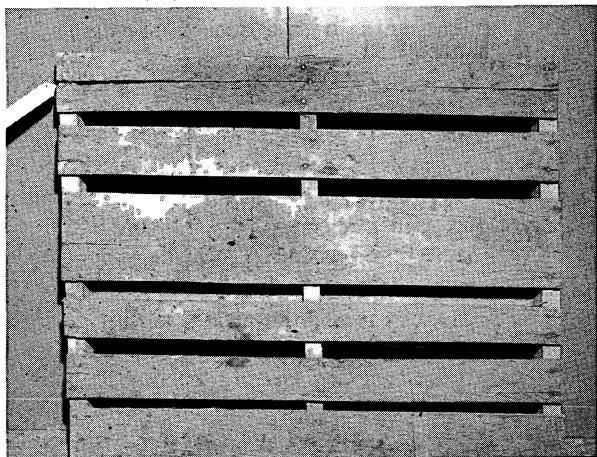
In some cases edgeboards split from end to end and one or both halves of the edgeboard broke away from the stringers (fig. 4). These end-to-end splits developed gradually from short splits at the nails after repeated bumping and pushing by lift-truck forks. When splits (following cross grain) extended to the leading or trailing edge of the board, a wedge-shaped piece often broke off (fig. 5). After 4 years the number of wedges broken off the edgeboards

FIGURE 4.—Lengthened split causing edgeboard to split into two parts.

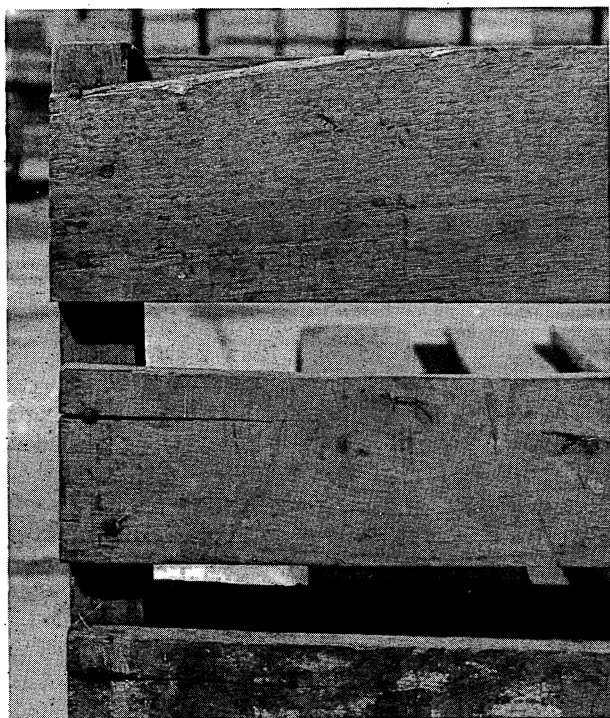
averaged 3.1 per pallet for all-green pallets, 1.5 per pallet for all-dry pallets, and 1.9 per pallet for dry-green pallets. Wedge breakout did not cause edgeboards to be rejected or necessitate repair of the pallet.

FIGURE 5.—Wedge breakout at leading (outside) corner of top edgeboard.

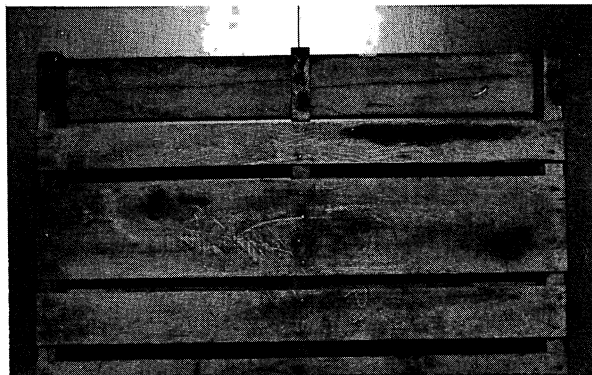
Another type of splitting started in checks that developed in the bottom deckboards during the third year of the test. Long, deep, continuous checks developed on the upper face of many bottom edgeboards and wide interior deckboards (fig. 6). These checks sometimes extended the full length of the board. After the fourth year they were equally frequent and severe in all pallets regardless of original moisture content. In all-dry and dry-green pallets,

We believe this defect was caused by tension stresses in bottom deckboards that absorbed moisture from the floor causing the bottom face of the boards to swell while the upper face remained dry due to airflow across it. Cupping of the boards did not occur especially in all-dry pallets, because the boards

FIGURE 6.—Long, deep, continuous checking on upper surface of bottom edgeboard.

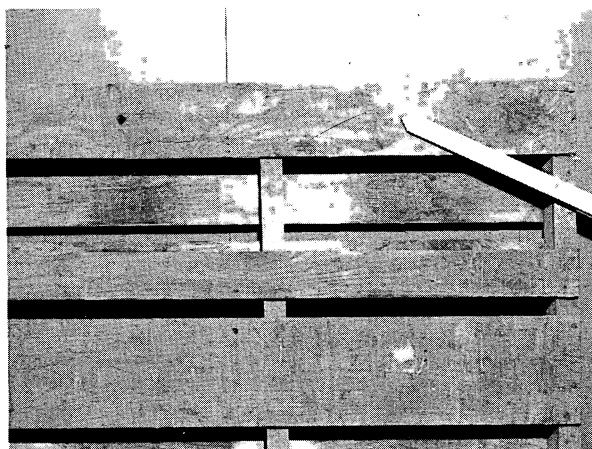
these checks averaged 34 inches in length, while in all-green pallets they averaged 37 inches in length. Oftentimes these checks extended through the board and developed into splits (fig. 7).

FIGURE 7.—Deep checking on upper face of bottom edgeboard has developed into a split on the bottom face. From left to right pointer indicates length of split.

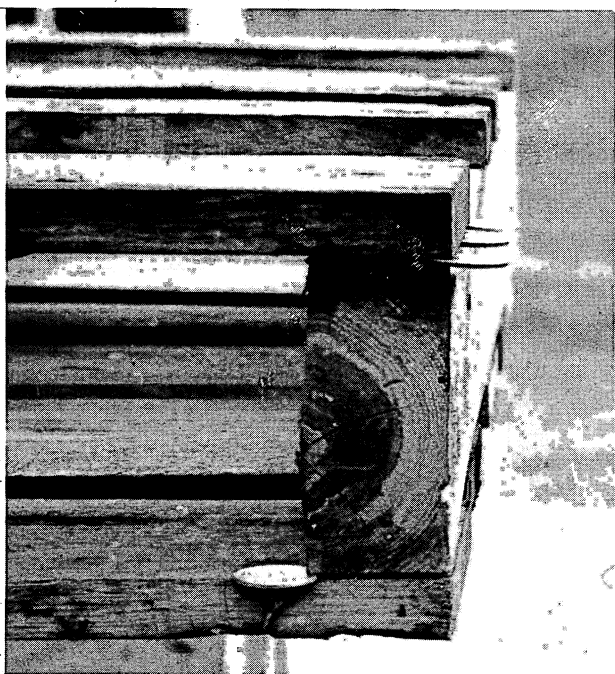
Green stringers shrank during the first few months of use and, as a result, joints between deckboards and stringers were loosened. When stringers shrank uniformly, the nailheads projected slightly above the surface of the deckboards. When stringers shrank into a diamond shape, the deckboards rested on the high side of the stringer and a gap opened between the deckboards and the low side of the stringer (fig. 8). We think the nails in these loosened joints yielded on impact of the lift-truck forks and absorbed much of the impact shock on the edgeboards of the dry-green pallets.

FIGURE 8.—Stringer diamonding in an all-green pallet because of uneven shrinkage.

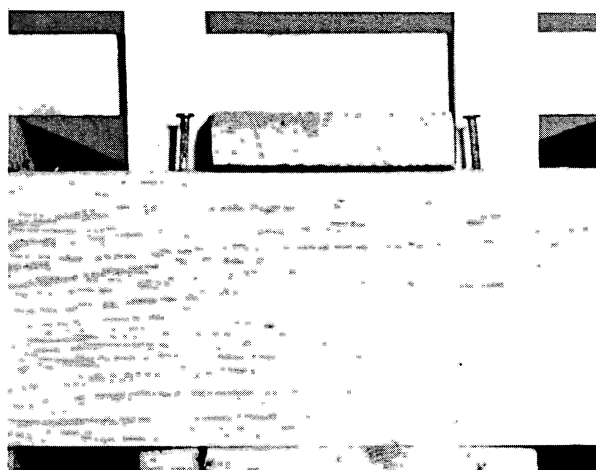
FIGURE 9.—Outer nails leaning 3 degrees toward board center in pallet that has not been moved by a fork truck. Lean is due to board shrinkage.

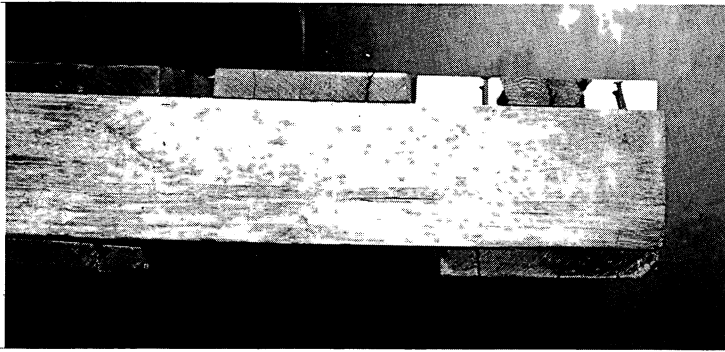
The pattern of nail bending in pallets in use was altered by repeated impacts from fork trucks. This was indicated by the difference of nail bending in the pallets that were service tested. In some pallets the leading nail bent about 5 to 6 degrees towards the center nail in a 3-nail edgeboard joint (fig. 10), but the trailing nail remained almost erect. The increased bending of the leading nail was evidence that the fork truck pushed the edgeboard back slightly, therefore increasing stresses at the leading nail and causing splits. When the grain sloped towards the leading edge, wedge breakout occurred. In pallets with dry deckboards most nails remained almost erect, thus indicating there were no serious stresses at nails.

FIGURE 10.—Leading nail bending 6 degrees toward board center in pallet that has been moved about 277 times by fork trucks. Lean is due to impact loading and board shrinkage. Trailing nail is almost erect.
