U. S. FOREST SERVICE  
RESEARCH PAPER NC-16  
AUGUST 1967

# HARDWOOD SIDING PERFORMANCE

GLENN A. COOPER

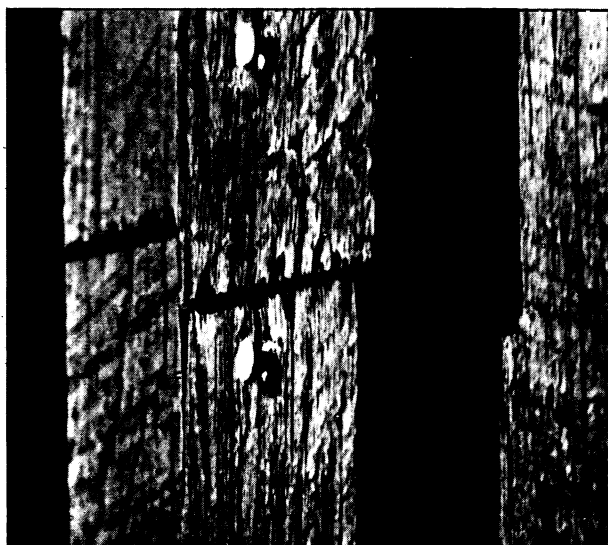
F-516581

Hickory was intermediate in performance. Thirteen percent of the total joint length in the panels leaked. These leaks were chiefly due to warping of the battens. Six percent of the hickory siding parts had splits, slightly more of them in the battens than in the boards. Three percent of the nails popped, most of them in battens (fig. 2). Eighty percent of the panel surface area was checked, and the checks were longer and deeper than in red oak.

Figure 2.—Popped nails in hickory battens. Most popped nails were not this far out.

Joint leaks on the south wall, initially much more numerous than on the north wall, are now only slightly more numerous but noticeably longer. The longer leaks are due primarily to more nail loosening, warp, and shrinkage (figs. 2 and 4). This is true regardless of species or treatment, but it is more evident in beech and sycamore than in the other species. Furthermore, water stain on the inside was first noticed on the south wall, and it continues to be more extensive there than on the north wall.

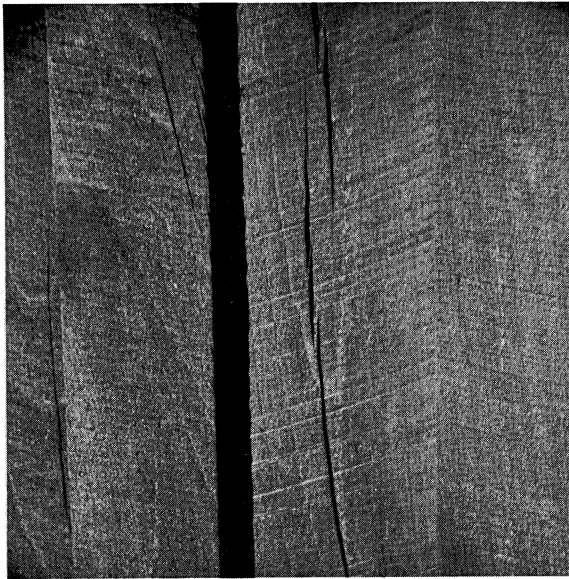
F-516582

Sycamore performed noticeably poorer than any species except beech. The untreated sycamore joints leaked along 30 percent of their total length, partly because of considerable warp of the battens. Nail popping (6 percent) and checking (60 percent) were about the same as for soft maple. Splitting (20 percent) occurred mainly as a few long splits (fig. 3).

Figure 3.—Sycamore board-and-batten siding, untreated, south wall, with long mid-board splits.

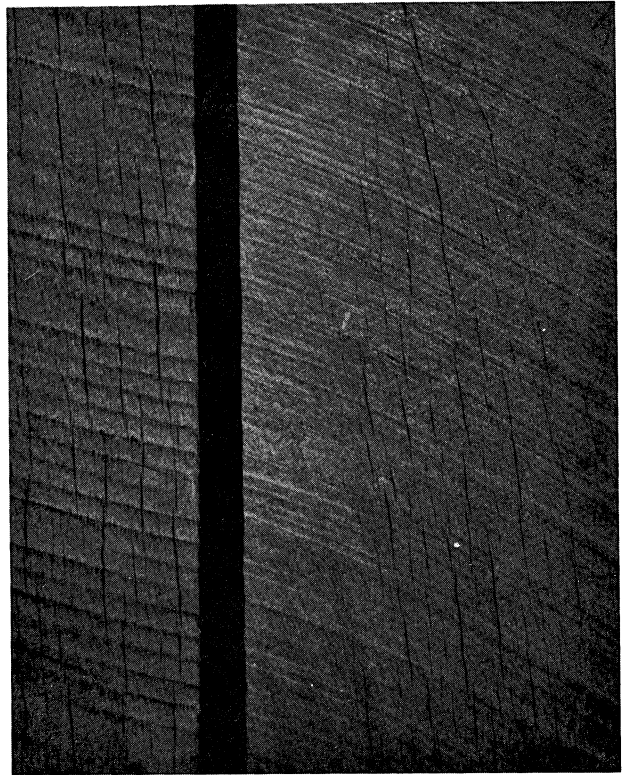
F-516584

Beech performed poorest of the six species by all test criteria except splitting where it ranked fourth. Leaks occurred along 40 percent of total joint length and were larger than in the other woods due to greater warpage of the boards and battens (fig. 4). Checks were of moderate size compared to the other species, but 90 percent of the test surface had many closely spaced checks (fig. 5).

Figure 5.—Checking in beech board - and - batten siding was extensive but did not reduce the utility of the siding.

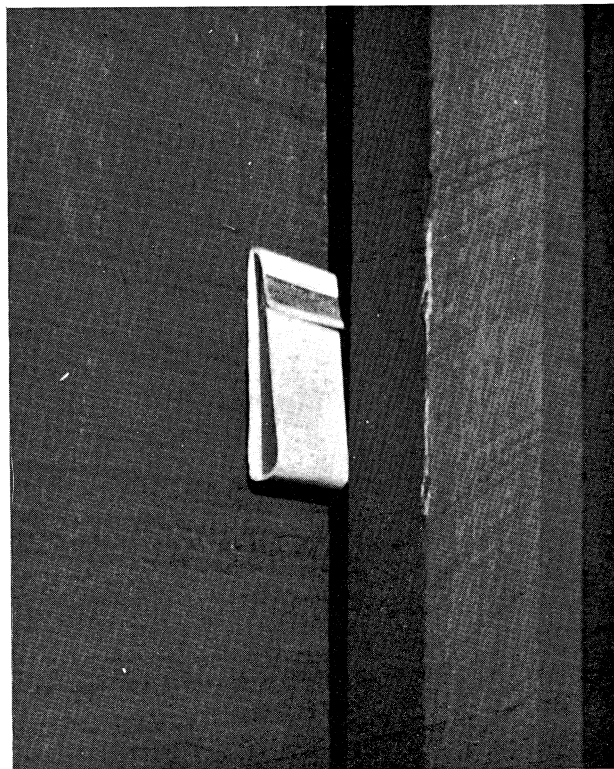
F-516583

Figure 4.—This beech batten bowed over  $\frac{1}{4}$  inch away from the adjacent boards.

Board-and-batten siding did not perform nearly as well as the tongue - and - groove siding. Battens that warped or were loosened by nail pops did not remain flush to the boards (see fig. 4); and because nails were at 3-foot intervals, any warp caused a leak. Boards in the board-and-batten siding were not held in place as tightly as tongue-and-groove boards and therefore warped more. Furthermore, after the boards and battens were dressed on one side and installed on the girts, the sawn faces of adjacent boards were not always in the same plane. Thus, a batten might be tight to one board but not to the other, and a leak would result.

3. Where vertical siding is installed on horizontal nailing girts, the girts should be closer than 3 feet on centers, particularly with board-and-batten siding. We recommend placing girts on 2-foot centers.

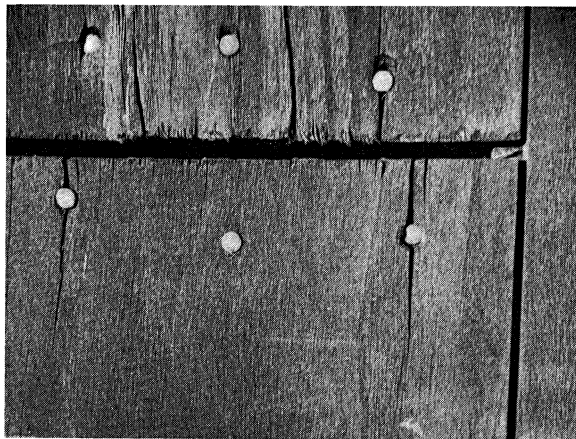
F-516585

The cottonwood was inferior to the ash because it warped badly. In two instances tongue-and-groove joints in cottonwood panels became disengaged, causing a leak. Furthermore, the cottonwood had more splits and nail pops than the ash. Longitudinal shrinkage (probably due to concentrations of tension wood) was apparent at the butt joints in the cottonwood but not in the ash (figs. 6 and 7). This longitudinal shrinkage

Figure 6.—This 1/4-inch butt joint gap in cottonwood tongue-and-groove siding resulted from excessive longitudinal shrinkage, particularly in the upper board. The indentation of the nail at upper right, and the splitting at nails is further evidence of longitudinal change.

caused splits at the nails. The cottonwood also was more cupped than the ash.

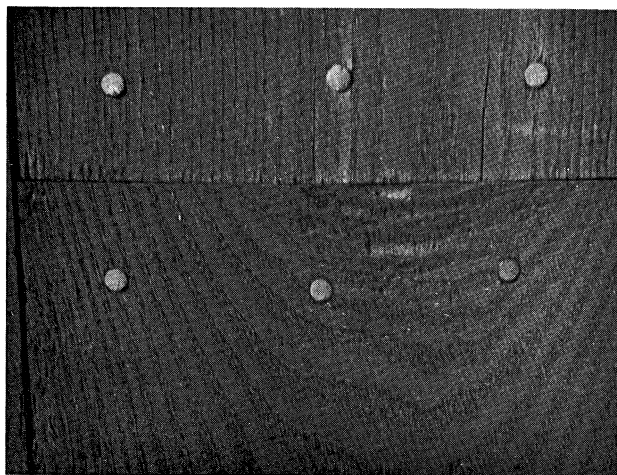
F-516586

Figure 7.—Tight butt joints in ash with the same treatment and exposure as the cottonwood in figure 6. Note the absence of end splits at the nails.

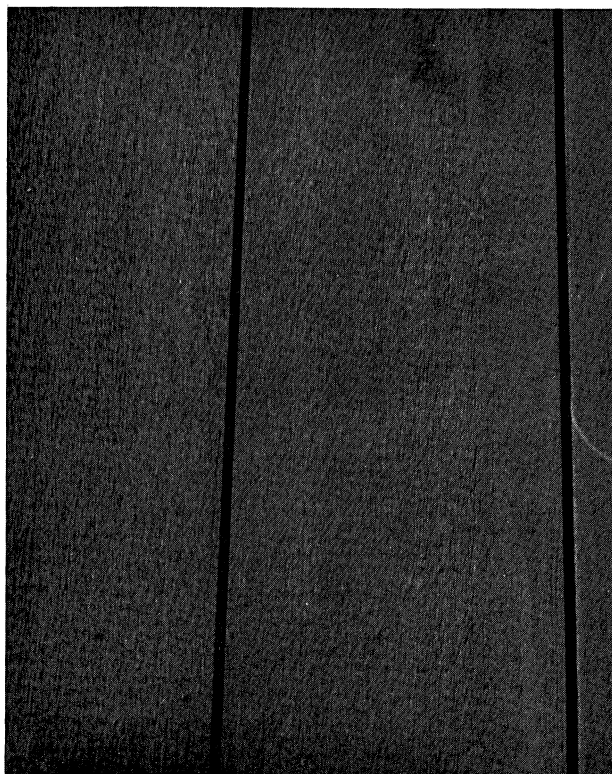
F-516587

Differences in the red oak and yellow-poplar siding styles were clearly evident. Tongue-and-groove siding was the most watertight (figs. 8 and 9). Only one leak in the 16 test panels occurred, and this was due to tongue breakage during installation. There was less water staining on the inside of these panels than in the other styles because the

Figure 8.—Yellow-poplar tongue-and-groove siding, water repellent treatment on the south wall. The boards have shrunk exposing 3/16 inch of tongue, but the joint is tight.

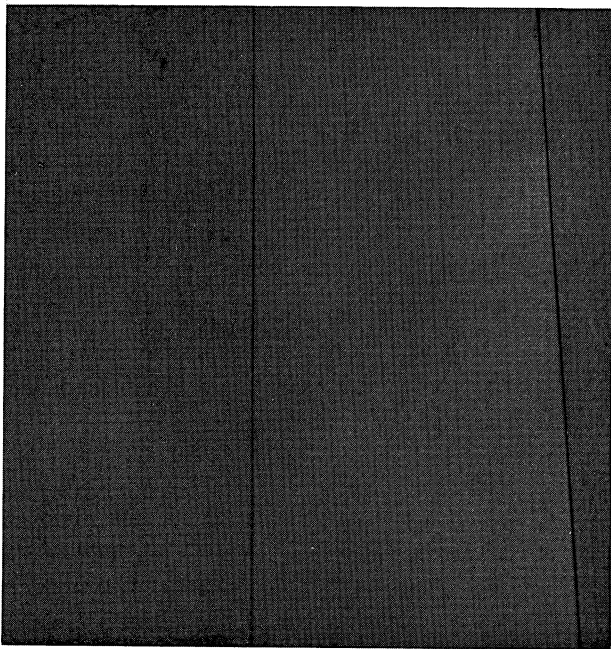
F-516588

Figure 9.—Yellow-poplar tongue-and-groove siding, water repellent treatment on the north wall. Shrinkage has exposed less than 1/16 inch of tongue, joints are tight, and checking is almost invisible.

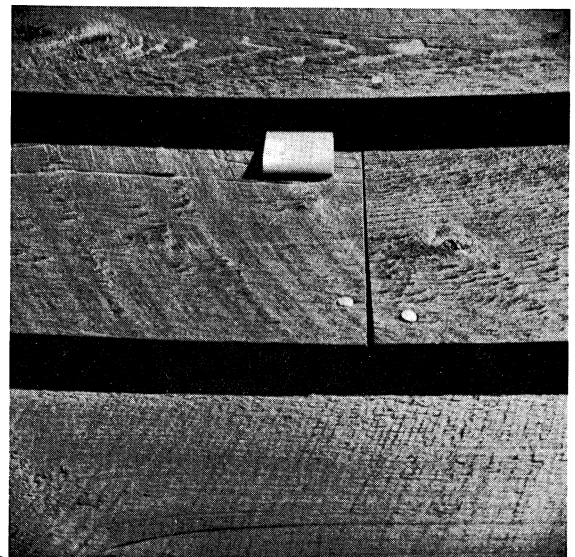
F-516590

board-and-batten siding. Every joint showed light between the rough exterior face of one board and the dressed interior face of the board above in both the red oak and yellow-poplar panels (fig. 10), and wetting was evident on the inner faces after rains.

Figure 10.—This yellow-poplar horizontal clapboard siding joint was open about 1/8 inch.

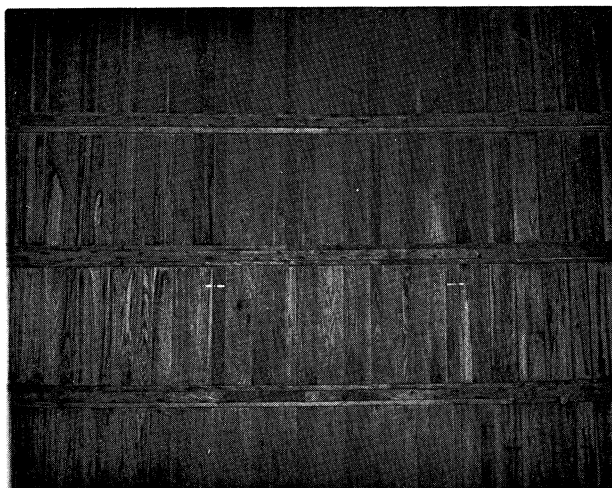
F-516589

An outstanding difference due to treatments was the amount of water stain on the inside of the panels (see fig. 11). In all siding the water repellent-penta treated boards were almost free of stain, whereas all the untreated and penta treated panels had considerable stain on the inner faces.

Figure 11.—Water has stained the inner faces of the penta-treated (left) and untreated (right) portions of this red oak mixed-length tongue-and-groove siding. The water-repellent penta-treated portion (center) has no stain. Free water was not observed on any of the portions after rains. Stain is therefore attributed to moisture wicking through butt and edge joints.

water-repellent preservative, and installed bark side out.
