## RESEARCH NOTE NC-27

NORTH CENTRAL FOREST EXPERIMENT STATION, FOREST SERVICE—U.S. DEPARTMENT OF AGRICULTURE

### Wetland Road Crossings: Drainage Problems and Timber Damage

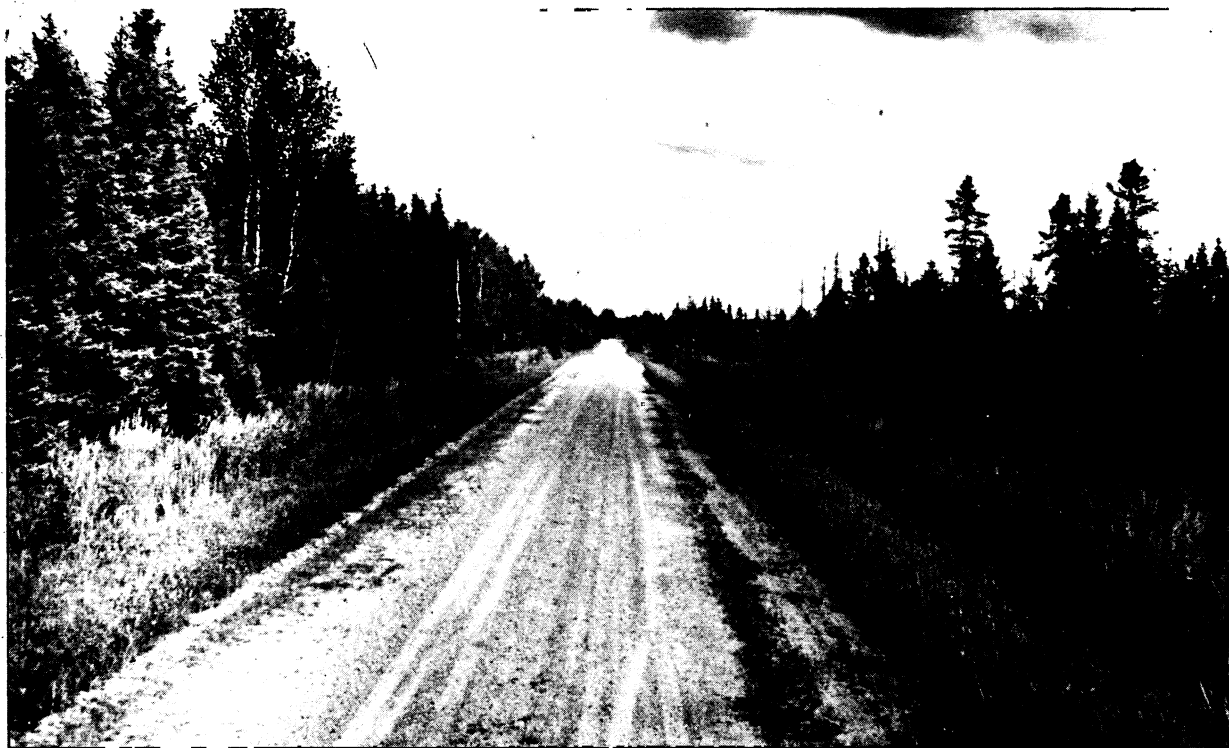
A common sight in the Lake States and parts of Eastern Canada is dead or dying timber in patches or strips along one side of a wetland forest road (fig. 1). Cause is failure to provide adequate cross drainage. Such damage is especially prevalent on peatland.

Figure 1.—Trees at the right on the “uphill” side of this road crossing a black spruce swamp show depressed growth and poor vigor compared with the normal trees at left on the “downhill” side. Because no culvert was used here the water table was raised about 10 inches. Cattails predominate on the flooded side of the crossing showing site retrogression. Alder, fern, and willow make up the ground cover on the other side.

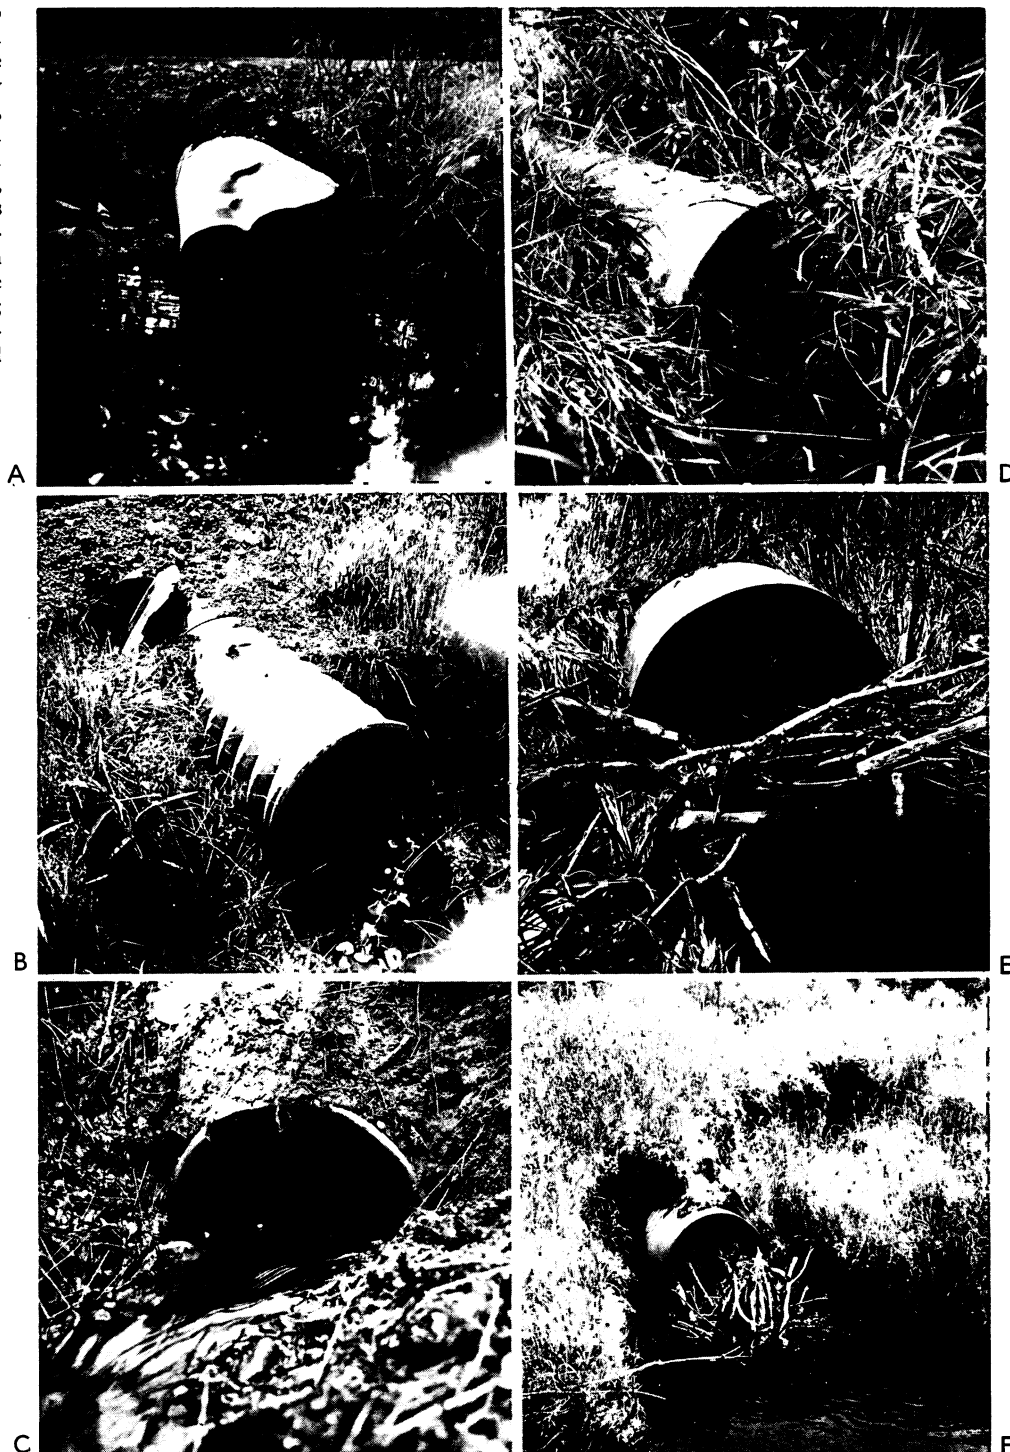
The chief problems were absence of culverts or other cross drainage, culverts set too high, no collector ditch, no discharge ditch, inadequate collector or discharge ditches, and low culvert capacity (table 3, fig. 2). Many sites had a combination of two or three of these deficiencies.

One of the crucial cross-drainage problems is the shallow placement of culverts. When small-diameter culverts are only a few inches below the surface of the road, they invariably fail to adequately drain the area on the higher side of the road; hence, pools of water form and timber may be flooded for prolonged periods and killed. The "high" culverts are

sometimes damaged by road-grader blades or snow-plows. Capacity of such culverts is reduced and potential life span shortened.

Other problems are lack of stability of ditch slopes or road shoulder, sloughing of soil, and subsequent siltation of culverts. Sometimes dry sticks or other debris may plug up the inlet or outlet of culverts. Vegetation such as willow and tall grass or weeds may also reduce culvert capacity.

Figure 2.—A, culvert set too high, damaged by road grader; B, culvert intake capacity reduced probably by snowplow damage; C, culvert outlet half filled with gravel that sloughed off the road shoulder; D, grass, willow, and chunks of sod constrict culvert entrance; E, a culvert with about half its intake plugged with dry sticks; F, discharge end of a culvert partially plugged with sticks by beavers.

The remedy for the culvert problem is to set the bottoms of the culverts in most Lake States wetlands

about 1½ to 3 feet below the general level of the swamp surface (depending on swamp gradient, drainage area, and culvert size). Also, there should be provided an adequate collector ditch parallel to the road on its "upstream" side, and beyond any zone of spoil deposit or compaction. An adequate discharge ditch, where necessary, should be carried out at about right angles to the road for several hundred feet or more on the "downstream" side of the road, or a sufficient distance to cross two 1-foot contours and thus avoid any backwater effect. If a naturally incised stream channel is already present, the dis-

charge ditch may not be required; and, if the "valley" slopes on both sides toward the stream or drainageway at about a right angle, the collector ditch is probably not necessary.
