## Quincy Mine Blacksmith Shop Condition Assessment of Timbers

By Robert J Ross and Xiping Wang

### Scanning Timbers for Deterioration

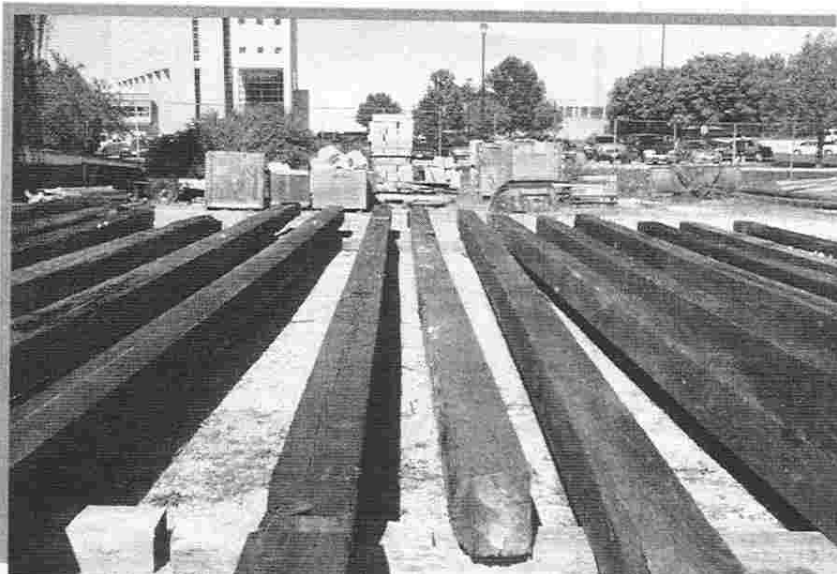
Fifteen 12- by 12-inch white pine timbers removed from the Quincy Mine Blacksmith Shop were transported to the USDA Forest Service, Forest Products Laboratory (FPL) in Madison, Wisconsin on August 2, 2001 (Figure 1). The timber specimens ranged from 25.5 feet to 50 feet in length; 13 of the specimens were about 50 feet long (originally used as tension members in the roof trusses) and 3 of the specimens were from 26 feet to 34 feet long (probably used as pitched chord or web materials). These timbers were part of the original roof structures and had been exposed to weather for several years. Surface decay, splits, mechanical damage, and notches were the major defects observed (Appendix A: Major Defects Observed in 12- by 12-inch White Pine Timbers).

Figure 1: Fifteen 12-by 12-inch white pine timbers removed from the Quincy Mine Blacksmith Shop

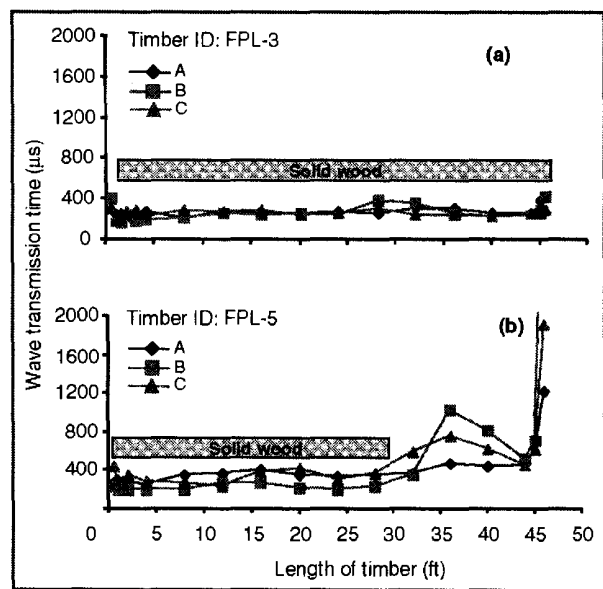
Results obtained from stress wave scans are shown in two graphs in Figure 3. The stress wave transmission time measured, perpendicular to grain, was in microseconds. Given the same width of 12 inches for all timbers, the stress wave data expressed in y-axis can also be deemed as values in a unit of microsecond per foot ( $\mu\text{s}/\text{ft}$ ). Therefore, the scan results for all 15 timbers can be conveniently compared with the baseline data given in previous publications (Ross and Pellerin 1994; Ross et al. 1998, 2001; FPL 2000; Clausen et al. 2001).

Figure 3: Typical scan results from 12-by 12-inch white pine timbers

As shown in wave transmission-time/length-of-timber graphs, these white pine timbers are in various conditions, from solid, slightly to severely deteriorated, to almost fully deteriorated. As previously mentioned, the deterioration was mainly caused by decay (surface and internal), splits, and mechanical damage. From scans shown in Figure 3, it is possible to distinguish whether deterioration occurs in surface areas or inside of timber as stress wave transmission times obtained from three scan lines (A, B, and C) are plotted on the same graph for each timber.

The solid wood in each timber was determined by comparing scan results with the baseline data of stress wave transmission times for solid wood. The approximate length of solid wood for each timber that could have potential structural uses was also determined and indicated below each scan graph. A summary of potential recovery of the solid wood from all tested white pine timbers is detailed in Table 1.

From the scans and Table 1, it is evident that a substantial amount of solid wood could be recovered from these timbers except for one short timber, FPL-12, which was almost fully deteriorated. The potential recovery rate could be as low as 16 to 17 percent due to severe deterioration found in timbers (such as FPL-4 and FPL-8); it could
