Forest  
Products  
Laboratory

Research  
Paper  
FPL 344  
**1979**

# California Black Oak Drying Problems and The Bacterial Factor

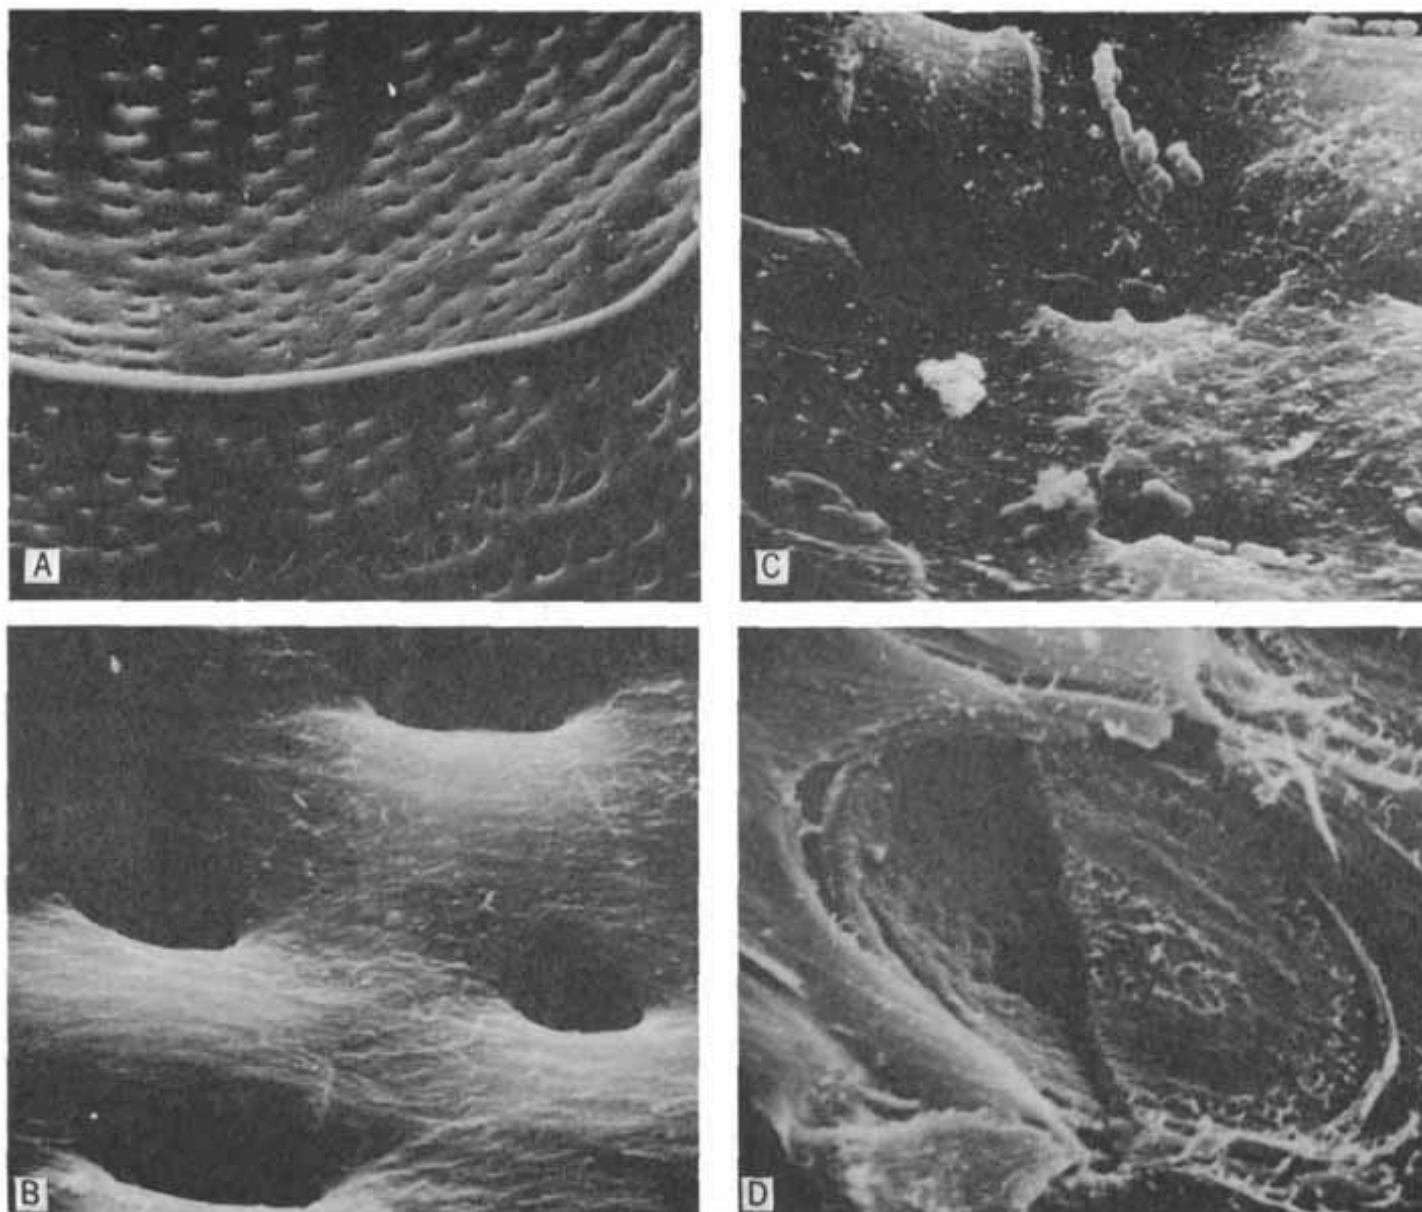
Figure 1.—Scanning electron micrographs of noninfected sapwood (A-E) and bacterially infected heartwood (C-D) from living California black oak trees. Spore of *Clostridium* sp. within the bordered pit in D. (M 147 430, M 147 428, M 147 429, M 147 428)

California black oak trees can be infected by anaerobic bacteria in a manner similar to that reported for eastern red and black oaks (Ward 1972, Ward *et al.* 1972). Results from both the large-scale mill study and the FPL laboratory study indicate that the bacterially infected heartwood can be related to the unexpected occurrence of drying degrade from honeycomb, ring failure, and collapse.

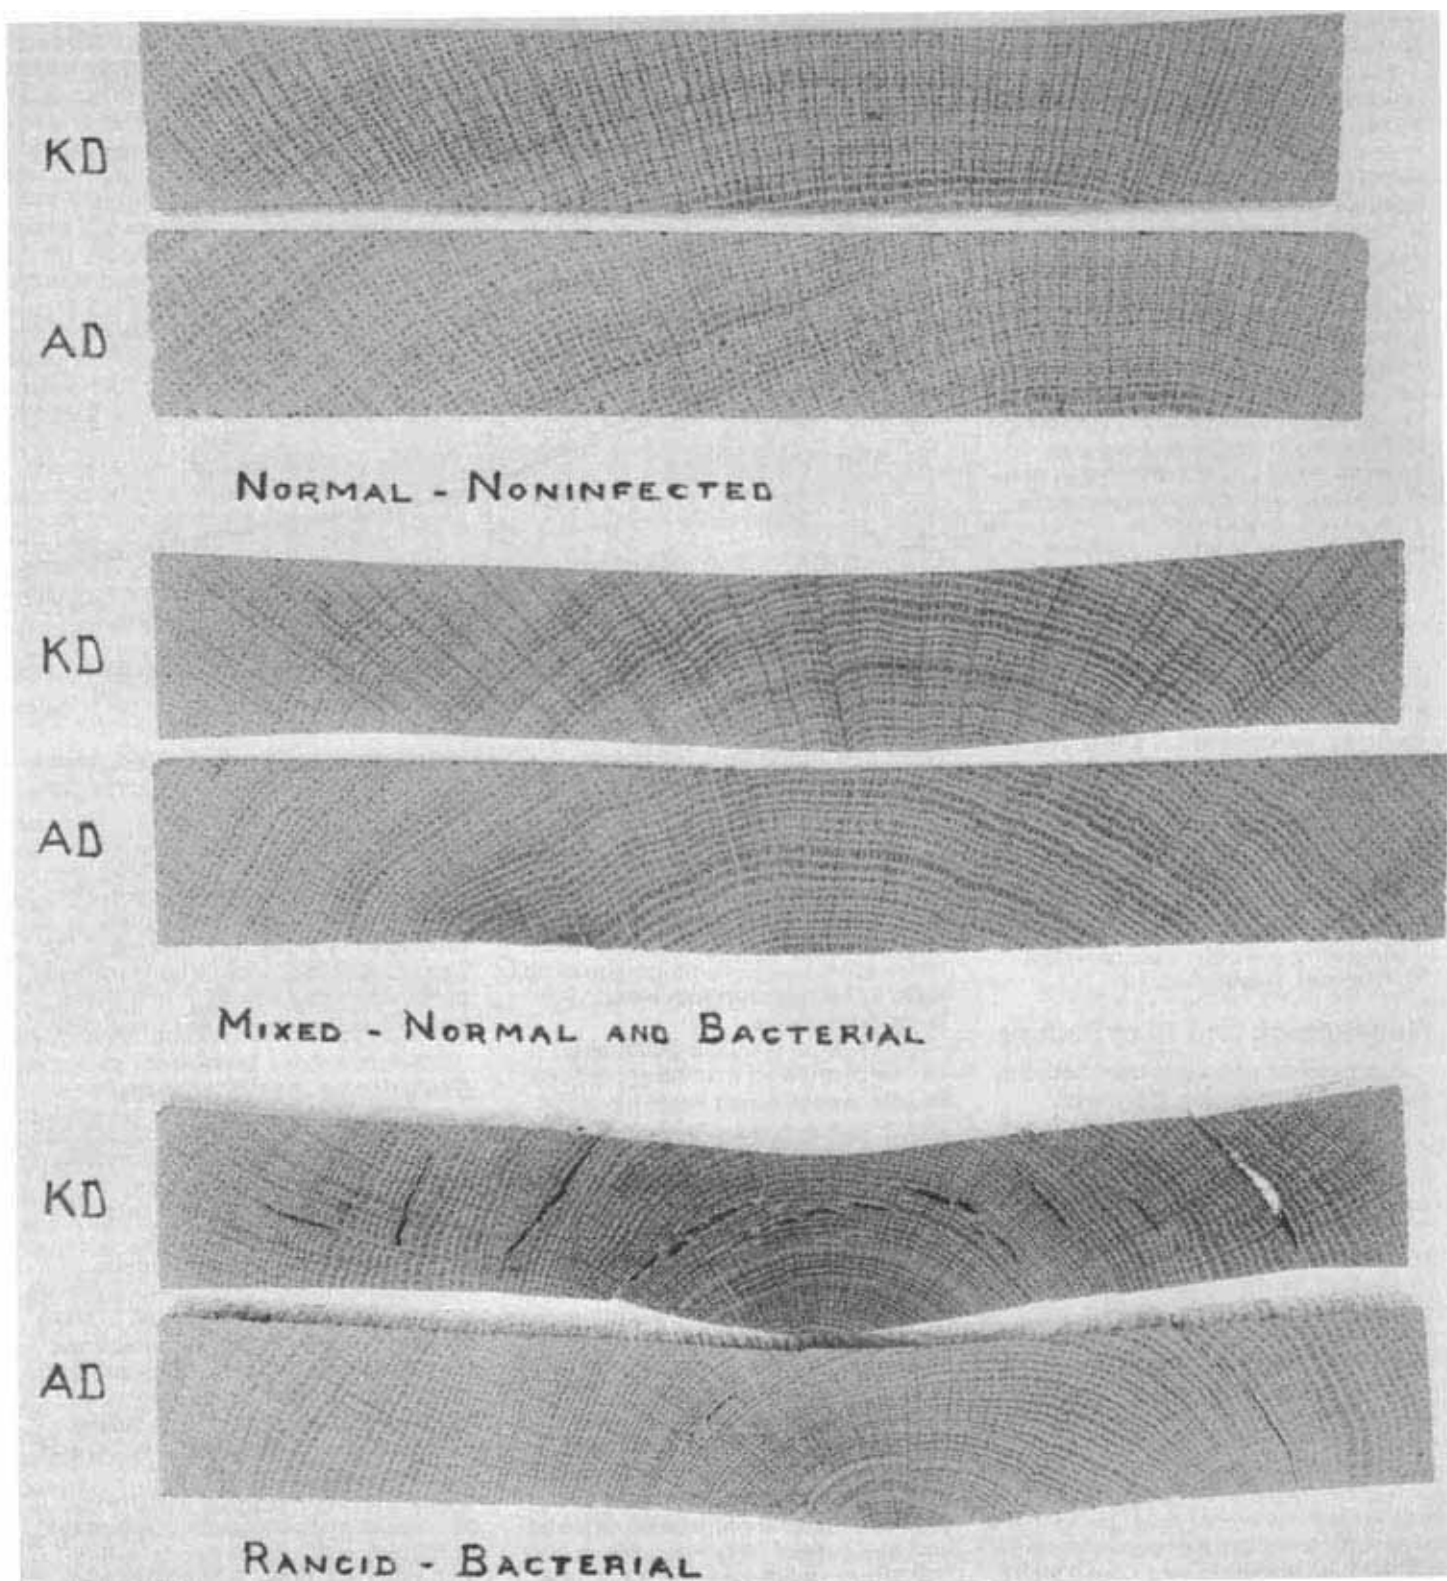
Ring failure was present in cross sections cut from both the kiln- and air-dried samples of the rancid board, but ring failure was more severe under kiln-drying conditions (fig. 4). Ring failure did not develop in normal, noninfected heartwood or in the infected heartwood of the mixed sample. Honeycomb developed in the kiln-dried rancid sample, but could not be detected in the air-dried sample. The mixed heartwood sample developed a few internal hairline checks in the bacterial heartwood under kiln drying but not air drying. Neither the surface checks which closed during the final drying stages nor the hairline internal checks are visible in

Collapse or excessive shrinkage in thickness is evident in all samples containing bacterial heartwood when compared with cross sections from normal, noninfected heartwood samples.

Figure 4.—Cross sections from matched sample boards of 4/4 California black oak—dried under laboratory conditions from green to 6 percent moisture content. KD = kiln dried, AD = air dried.  
(M 147 113)

The absence of honeycomb in air-dried boards containing bacterial heartwood substantiates Smith's (1961) recommendations that California black oak in general should be predried under temperatures that do not exceed 100° F. However, our laboratory experiments also indicate that some bacterially infected heartwood, particularly the rancid-odor type, cannot be dried defect-free even under the mildest commercial conditions. This is substantiated by the third test of the mill study where over half of the kiln charge was degraded from checking and collapse, even though drying was done in the winter with initial temperatures that did not exceed 100° F.

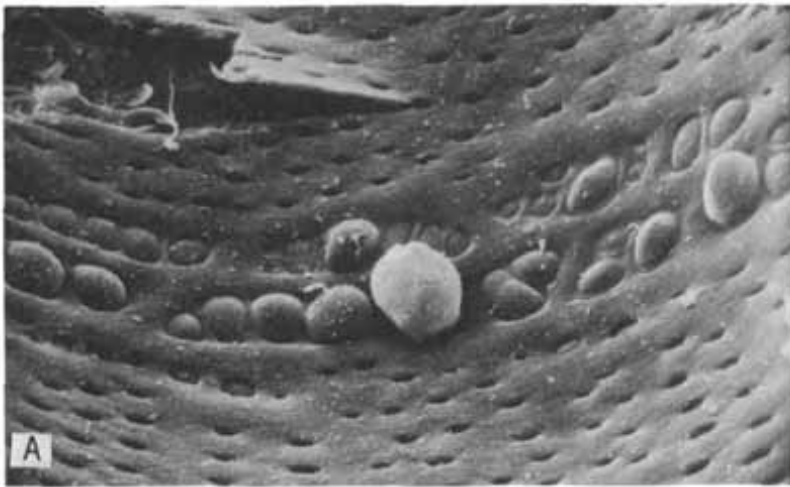
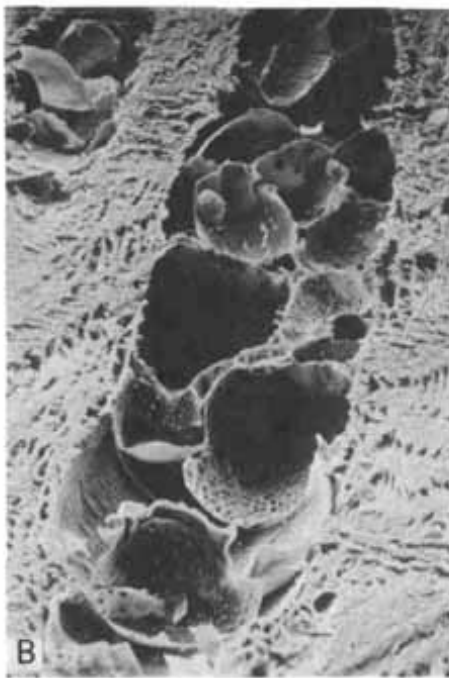
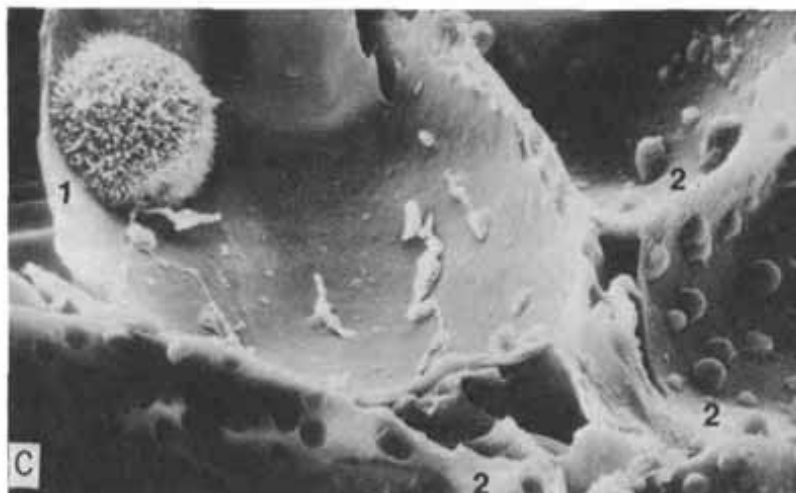
California black oak than in most of the eastern red and black oaks. The deep collapse zones in California black oak can be attributed to relatively severe drying conditions, bacterially weakened wood, and plugging of the vessels or pores with tyloses. Moisture movement through the vessels is retarded by the tyloses and bacterial debris. Tensile stresses that are set up are sufficient to cause collapse of the weakened wood tissue.

The presence of tyloses is generally considered a diagnostic characteristic of white oaks rather than the red and black oaks. But California black oak is an exception. All heartwood, both normal and infected, that was examined in this study contained an abundance of tyloses. Furthermore, a comprehensive study Of the anatomy of American oaks by Williams (1942) found that tyloses are the rule rather than the exception in California black oak.

Figure 5.—Scanning electron micrographs of tyloses in living California black oak. A. Vessel from sapwood to heartwood transition zone showing initial tyloses development from ray pits. B. Vessel from noninfected heartwood showing abundant tyloses growth. C. Closeup of tyloses in B showing: (1) Crystal inclusion inside one tyloses and (2) Secondary burgeoning from membranes within adjacent tyloses. (M 147 433, M 147 431, M 147 434)

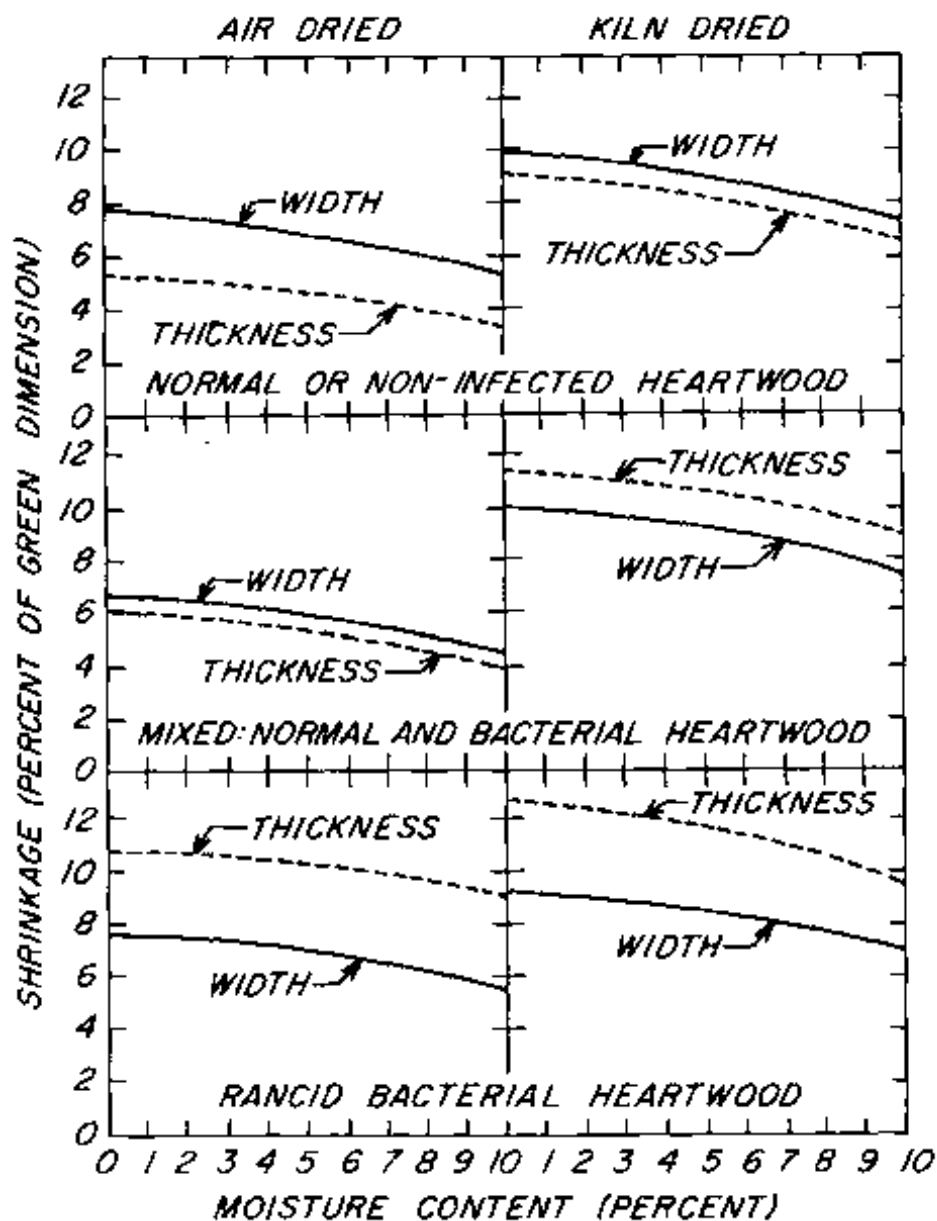
The influences of bacterial weakening of the wood and of drying conditions on the dimensional shrinkage of California black oak are illustrated in figure 6.

Figure 6.—Effect of drying conditions and bacterial tree infections on the dimensional shrinkage of flatsawn 4/4 California black oak boards. All heartwood contained tyloses.
