# ***REPAIR, MAINTENANCE AND EVALUATION***

## **ASSESSMENT AND MAINTENANCE OF A 15 YEAR OLD STRESS-LAMINATED TIMBER BRIDGE**

T. Russell Gentry, Karl N. Brohammer  
Georgia Institute of Technology, USA

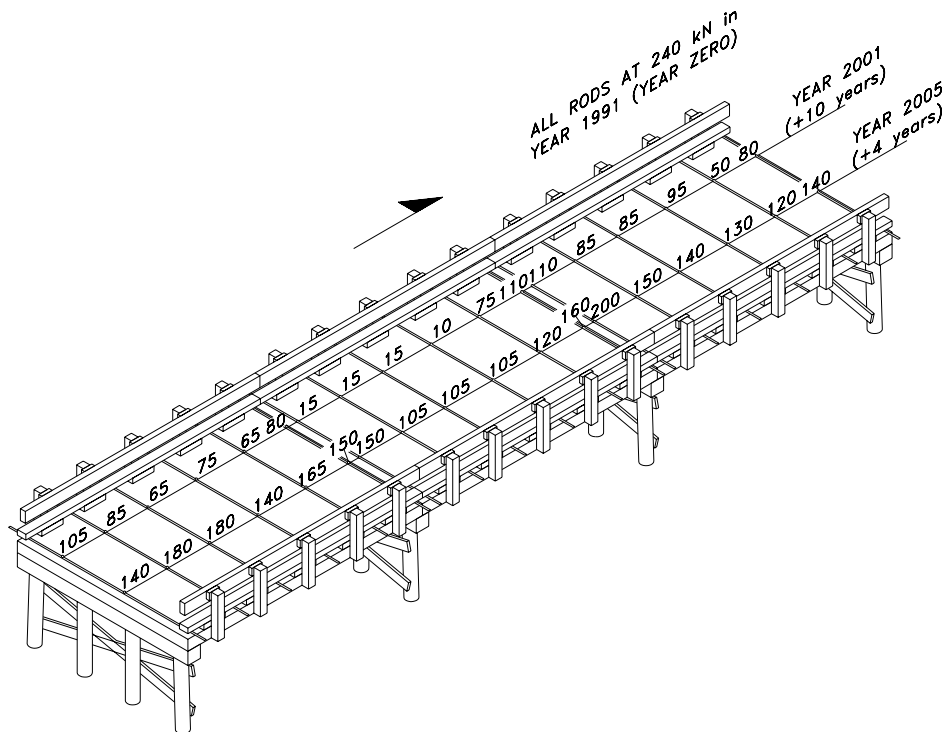
Figure 2: Residual post-tensioning forces in DWYDAG bars, 2001 and 2005 (in kN).

These residual forces as measured in 2001 and 2005 are shown in Figure 2. Bar forces are reported to the nearest 5 kN, as this is considered a reasonable degree of confidence in the measurement given the method and equipment used for checking the bars. In 2001, 10 years after the bridge was constructed, the average force in the bars was 70 kN, or about 30% of the original design force. A number of the bars at the central span had forces as low as 10 kN, indicating that these bars were essentially loose. At the high end, some bars had residual forces of 110 kN, almost 50% of the original force. Ritter indicates that a drop of interlaminar stress to 0.15 MPa (approximately 25% of the original stress) is necessary to allow the laminations to slip relative to one another (1).

In the 2005 assessment, the force in the bars was measured again, using the same procedure. The average force in the bars was 145 kN (60% of the 2001 re-tensioning force), with the low being 105 kN (45% of the 2001 re-tensioning force). Once again, the lowest residual forces were found in three bars in the central span of the bridge.

Loss of post-tensioning forces in bars in the period from 1991 to 2001 was excessive. Though no transverse slippage of the laminations was noted in the 2001 inspection, this may have been due to lack of heavy vehicle loading. Post-tensioning losses over the four-year period from 2001-2005 are in the acceptable range (assuming that 50% loss is expected as per the 1983 Ontario Bridge Code), indicating that a four-year period between re-tensioning is acceptable.

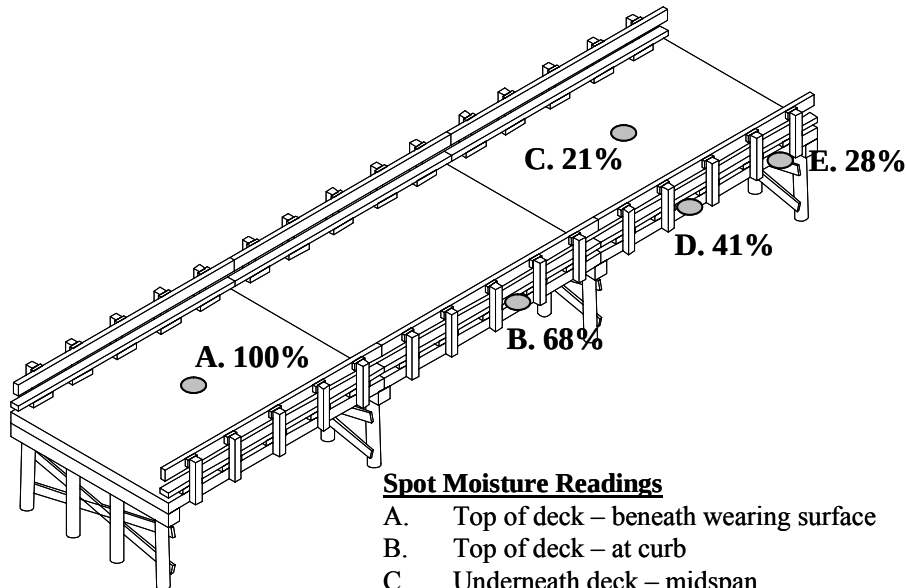
**Spot Moisture Readings**

- A. Top of deck – beneath wearing surface
- B. Top of deck – at curb
- C. Underneath deck – midspan
- D. Side of deck – at curb
- E. Side of deck – at curb

At location “A”, approximately 150 mm of asphalt was removed to reveal the top portion of the wood deck. There was no moisture barrier between the asphalt at the deck at this location. The wood at surface of the deck in this location was essentially saturated, and was found to be soft. The moisture reading from the meter was 100%.

At location “B”, which was on the deck beneath the guardrail, there was approximately 50 mm of dirt and debris. The moisture content here was 68%. At locations “C” and “D”, taken adjacent to the post-tensioning bar bearing plates, the moisture contents were 41% and 28%.

In all locations, the moisture contents were considered to be high, and it may be that moisture contents are correlated with the loss in post-tensioning force observed. Yazdani et al. completed a parametric study of stress-laminated wood decks, and included considerations of moisture in this study (6). Both this work and earlier work by others (Oliva, Batchelor) indicate that moisture cycling leads to loss of post-tensioning force. What is not clear is whether high moisture contents lead to increased transverse compressive creep of the wood – which would then lead to subsequent post-tensioning losses. This phenomenon is not described in the stress-laminated deck literature. Pellicane and colleagues describe a model for the transverse compression of wood (7).

High moisture contents observed in the laminations at the top of the deck and at the side laminations may be contributing to premature loss of post-tensioning forces in the bars. Data acquired to date is insufficient to confirm this suspicion. Future assessment protocols will be modified to probe the correlation between moisture content and level of residual bar force.

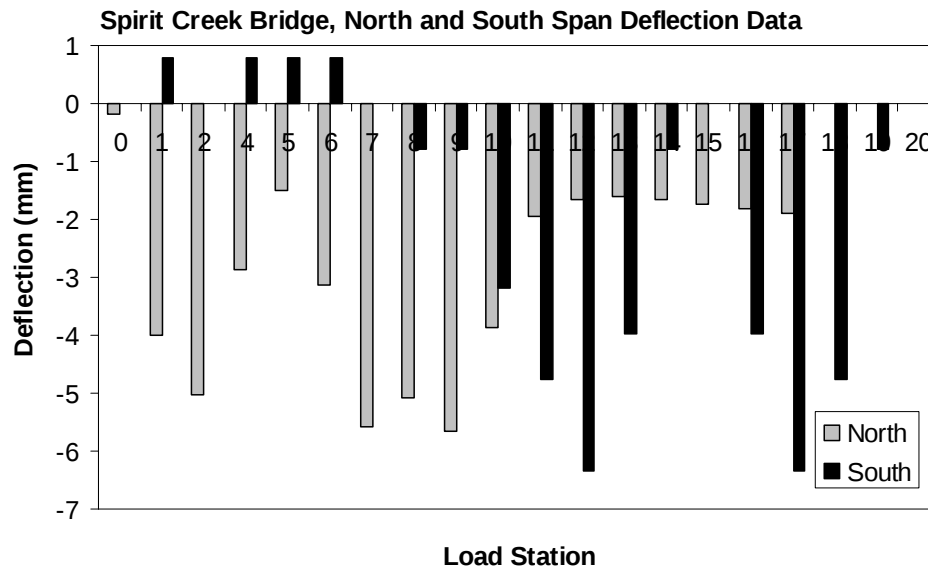
Figure 4: Deflection under Moving Truck Load.

Deflections were measured at mid-span of the North and South spans with a string potentiometer (North span) and laser distometer (South span) with an accuracy of  $\pm 0.1$  mm. The maximum absolute deflection observed was 6.4 mm. This equates to a deflection ratio of  $L/960$  of the clear span, which is only one-third of the design allowable deflection of  $L/360$ . This might be considered surprising given that the  $2 \times 12$  deck is at the upper bound suggested by AASHTO given the span (4). In many instances however, it is the limit on transverse flexural stresses, and not deflection or longitudinal stresses that controls the design of stress-laminated bridge decks. In laboratory testing, Olivia showed that deflections in decks with butt joints show substantially more deflection than decks with full-length laminations (5). The load test on the Spirit Creek Bridge, which has butt joints in all three spans, demonstrates that this additional deflection is probably not significant in a full-scale structure.

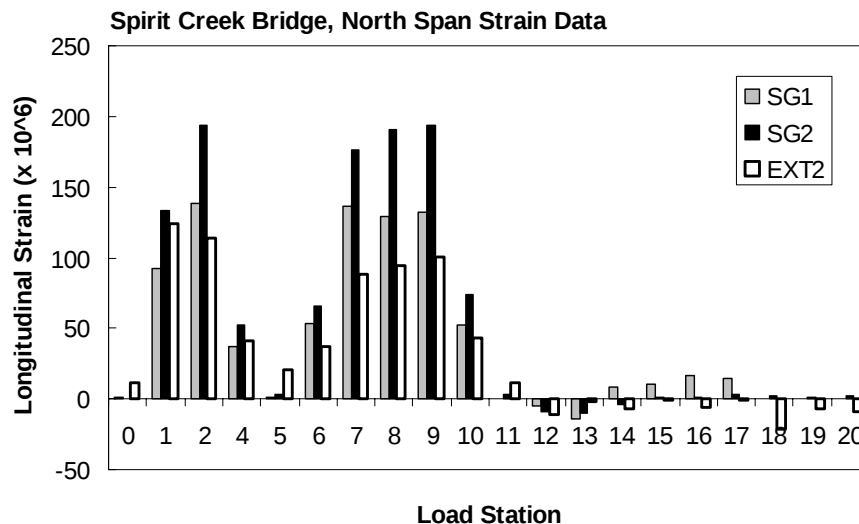
Figure 5: Observed strains in deck under moving truck load (2005).

Longitudinal strains were taken only on the North span (Fig. 5). Three gages were used to record strain. Gage SG1 was located at the centerline of the bridge, at midspan. Gage SG2 was located at the edge of the bridge, directly under the loaded tire, at midspan. Gage EXT2 was adjacent to gage SG2. The SG gages were bonded resistance strain gages with a 100 mm gage length. Gage EXT2 was a screw-on extensometer that was joined to the wood lamination using wood screws. Initial readings of EXT2 appear to be quite close to SG2, but subsequent readings lead to conclusion that EXT2 may have slipped relative to SG2 and thus provides a low-biased reading.

The maximum strain read in any of the gages was 194  $\mu\epsilon$ , recorded in gage SG2 at load station 9 when the rear axle of the trailer was directly at the mid-span of the North span. At this point, the centerline gage read 132  $\mu\epsilon$ . Though there is an obvious strain lag across the bridge deck, it can be concluded that the centerline gages are participating substantially in the flexural capacity of the bridge.

Assuming a modulus of elasticity of around 10 GPa for No. 2 Southern Pine, and a peak strain of 200  $\mu\epsilon$ , this equates to a flexural stress in the wood of approximately 2 MPa in the wood under the load of trailer.
