# Buckland's Crossing Firefighter Burnover— A Case Study of Fire Behaviour and Firefighter Safety Implications

**Abstract**—On March 24, 1998, a crew of eight rural firefighters were burned over while attempting to suppress a backburning sector of the Bucklands Crossing Fire in North Otago, New Zealand. The fire demonstrates how factors typical of the New Zealand fire environment – steep slopes, highly flammable shrub fuels, and a strong foehn wind effect – combined to produce extreme fire behaviour. Several firefighters sustained varying degrees of injury. They were hit by a blowup that was most likely caused by a rapid reburn through previously underburned shrub fuels. The exact trigger for upslope spread and transition to a crown fire was not definitively identified; however, it was most likely the result of strong winds and localised turbulence, combining with steep topography and highly flammable, preheated shrub fuels. The case study report prepared on this burnover describes the activities of personnel leading up to and during the incident in relation to the fire environment and fire behaviour. Possible causes of the blowup are reviewed, and observed fire behaviour compared

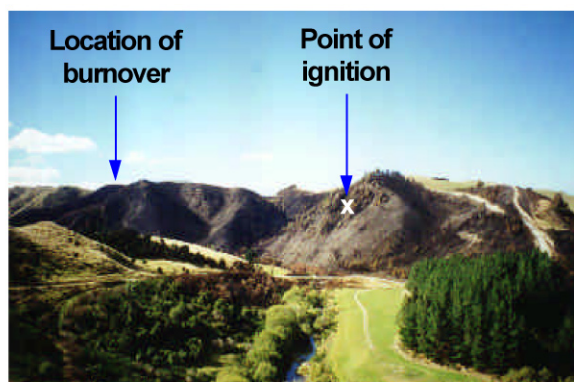
At 07:47 a.m. on Tuesday, 24 March 1998, a fire was reported by a local musterer on his way to work near Bucklands Crossing, some 40 km (25 miles) north of Dunedin (fig. 1). The fire is believed to have been ignited by sparks resulting from powerlines contacting adjacent vegetation in high winds (see fig. 2). Initially, NZ Fire Service structural firefighters from Waikouaiti and Palmerston responded. They were later supported by rural fire crews from Dunedin City Council, local forestry companies and the Department of Conservation. Two helicopters were also used, although the strong, gusty winds initially prevented effective aerial fire suppression.

**Figure 2**—General view of the Bucklands Crossing Fire looking northeast to the fire's point of ignition and burnover location.

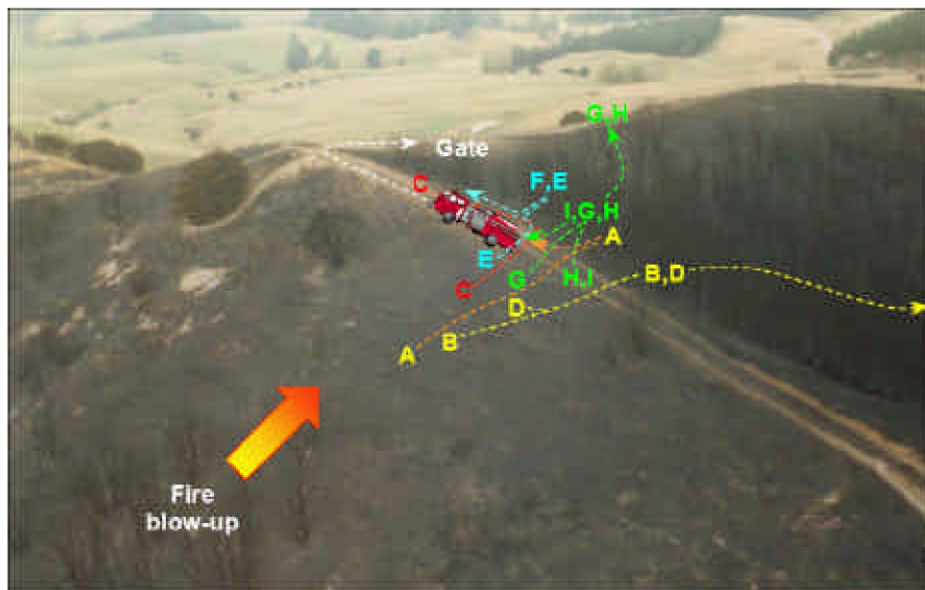
At around 11:25 a.m., a crew of eight rural firefighters were burned over while attempting to suppress a backing sector of the fire. The crew had parked their fire appliance on the crest of a steep ridge in a burnt out sector of the fire, and were deploying a hoseline downhill toward a fire edge burning slowly downslope (see fig. 3). The fire had already burnt out the catchment on one side of this ridge and was backing downhill beneath manuka (*Leptospermum scoparium*) shrub fuels down into the adjacent catchment where the crew were deploying the hoseline. Before being able to charge this hoseline, the crew were overrun by a “fireball” exploding from the gorse-filled (*Ulex europaeus*) gully beneath them (see fig. 4). Three firefighters sustained burn injuries, one serious, while a fourth crew member received minor injuries whilst evacuating. The driver and another crew member took shelter behind the appliance and, along with the remaining two crew members, were uninjured. (Fire shelters are not used in New Zealand, so their use was not an option available to firefighters in this situation. However, it is unlikely that crew members would have had sufficient time to properly deploy shelters due to the rapid approach

**Figure 3**—Locations and escape paths taken by the fire crew members during the burnover (letters denote individual firefighters).

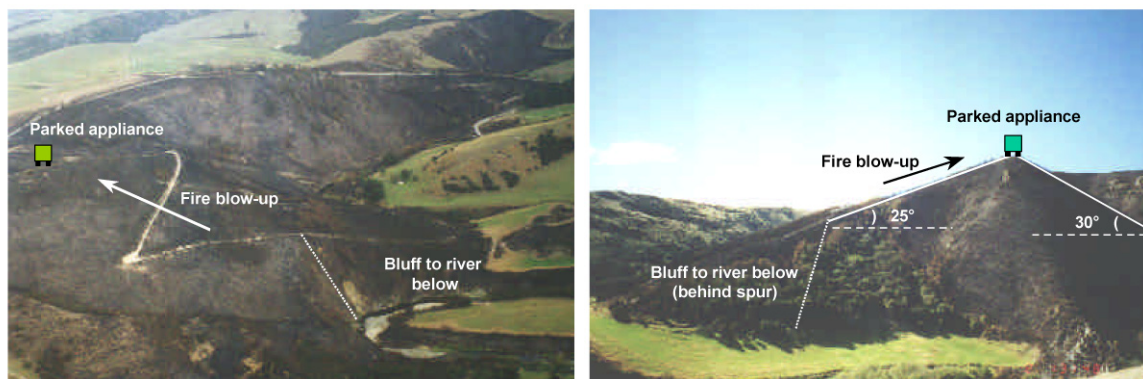
**Figure 4**—Topography in the area of the ridge where the burnover incident occurred.

The fire occurred in rugged terrain comprising steep slopes that drop sharply to the meandering course of the Waikouaiti River below. Slopes of 30 to 40° (55 to 85 percent) are common, and many rock outcrops occur throughout the fire area. Several side gullies drain into the main river course with steep, narrow ridges in between. The burnover occurred on one of these ridges (fig. 4; also see fig. 6), which consisted of a 30° (58 percent) slope on the lee side which had been burned over earlier, a narrow ridge crest some 4 to 5 m (13 to 16 ft) wide, and a 25° (47 percent) slope on the upwind side leading down to the shrub fuels under which the fire was backing downhill.

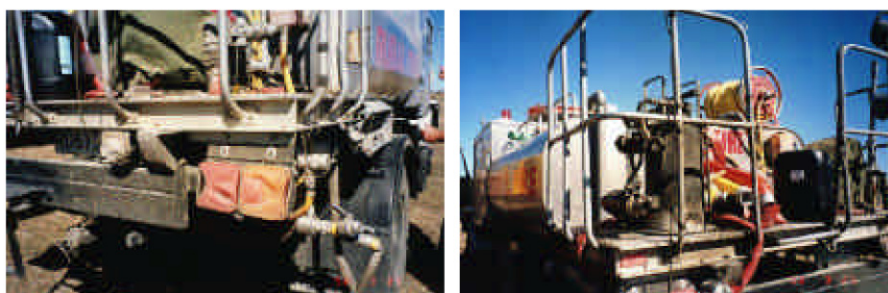
of the fire and strong, gusty wind conditions.) Damage to the fire appliance as a result of the burnover was also significant (see fig. 5).

**Figure 5**—Damage to the fire appliance, including tail lights, foam proportioner, pump cover and rubber hose fittings.

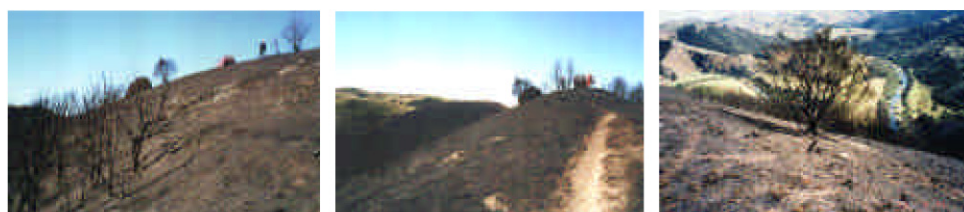
**Figure 6**—Views of the ridge on which the burnover incident occurred, illustrating the steepness of the slope in the direction from which the flame front came, the burnt out grass fuels along the ridge crest, and the distance between the vegetation and the site where the fire appliance was parked (as indicated by the utility).

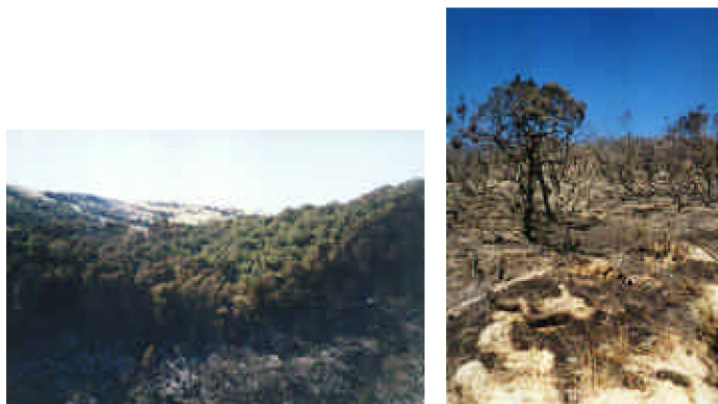
Fuels in the broader fire area consisted of radiata pine woodlots, manuka, and gorse shrubs, and grazed pasture, some with scattered tussock grasses. Dense 2 to 3 m (6 to 10 ft) tall manuka shrubs covered the lee side of the ridge on which the incident occurred. This had been burnt out earlier in a rapid uphill fire run. Grass fuels with scattered short tussocks covered the open ridgetop where the appliance was parked (see fig. 6), and this too had been burnt out prior to the crew arriving. These grass fuels extended some 30 to 40 m (100 to 130 ft) down the upwind slope to 3 to 4 m (10 to 13 ft) tall manuka shrubs (fig. 7 left). This shrub vegetation was initially only underburnt, but burned out completely at a later time. The manuka stand extended some 30 to 50 m (100 to 165 ft) to the gorse-filled gully bottom below (fig. 7 right).

**Figure 7**—Fuels in the burnover area, including (left) partially burned manuka shrub fuels on the ridge adjacent to where the burnover occurred, and (right) burnt gorse fuels below the location of the burnover, in the area where the blowup is believed to have originated.

The firefighters involved in the Bucklands Crossing Fire burnover reported being hit by a “fireball” originating from the gully below them. This may have been the result of a collapsing fire whirl or convection column, flash-over, or even a carbon dust explosion. However, the most likely cause was a flame extension or “rollover” associated with an uphill run and reburn through the preheated shrub canopy. The collapse of the fire front as such a run reached the end of the shrub stand (see fig. 9) would push flames along the ground and, together with the pulsing of the flame front as volatile gases are burned, would create an effect similar to that of a fireball or flashover observed by the firefighters. It would also produce extreme flame lengths capable of reaching the 30 to 50 m (100 to 165 ft) to the ridge where the fire appliance was parked.

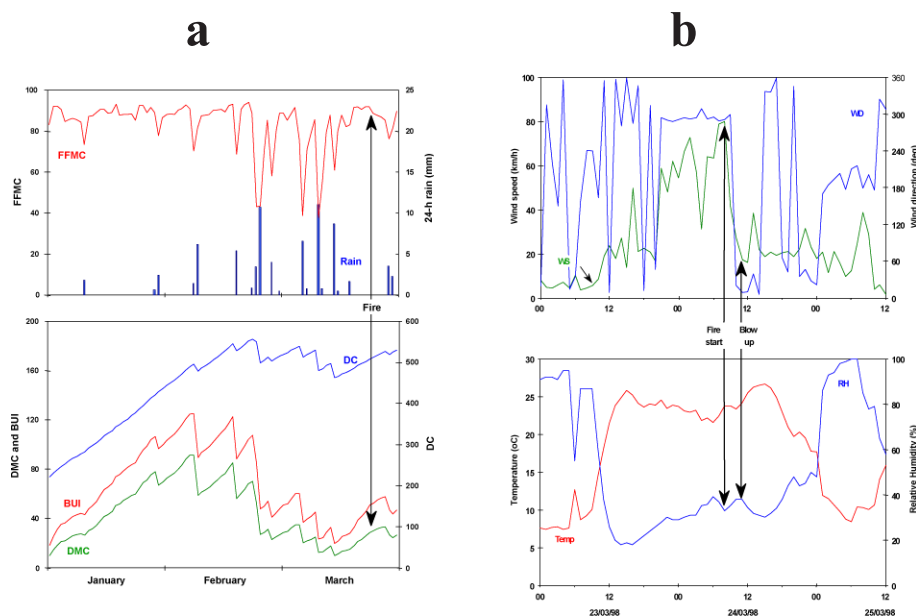
The fire occurred during warm, windy conditions in a period of extended dryness. Weather and Fire Weather Index (FWI) System (Van Wagner 1987) values (see fig. 8a) for midday on March 24 were: temperature 25.5 °C (78 °F), relative humidity 35 percent, wind speed 16 km/h (10 mph), 6 days since >0.6 mm (0.02 inches) rain, Fine Fuel Moisture Code (FFMC) 92.0, Duff Moisture Code (DMC) 41, Drought Code (DC) 569, Initial Spread Index (ISI) 12.9, Buildup Index (BUI) 70, and Fire Weather Index (FWI) 31. Recorded temperatures on the day of the fire reached 27 °C (81 °F) and higher values were reported at the fire site (fig. 8b); however, these values of temperature and relative humidity were not unusually high or low, respectively, for this area. Gale force northwesterly winds that exceeded 80 km/h (50 mph) initially restricted aerial suppression operations and, although they dropped off during the day, the erratic strength and direction of the wind contributed to unpredictable fire behaviour.

**Figure 8—**(a) Wetting and drying cycles for the FWI System moisture codes leading up to ignition of the Bucklands Crossing Fire on 24 March 1998; and (b) diurnal weather patterns recorded before, during, and after the initial run of the Bucklands Crossing Fire.

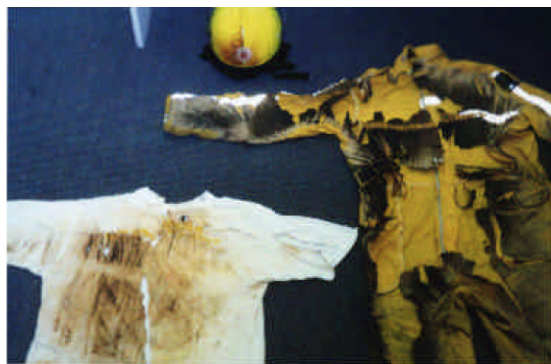
The firefighters involved in the burnover incident were saved from more severe injuries by the short duration of their exposure to heat and flame, the

fact that they were correctly attired in their protective clothing (fig. 10), and that they received immediate attention from onsite medical services. While these were positive outcomes, there were also a number of other safety issues that were identified as a result of the incident that are addressed in the case study. In addition to the performance of personal protective equipment (PPE), these include:

**Figure 10**—Damage to personal protective clothing from Firefighter C (who received the most serious burn injuries), including Nomex coveralls, cotton T-shirt and fibreglass helmet.
