# Moisture Performance of a Contemporary Wood-Frame House Operated at Design Indoor Humidity Levels

Charles Carll

Anton TenWolde  
Member ASHRAE

Robert Munson

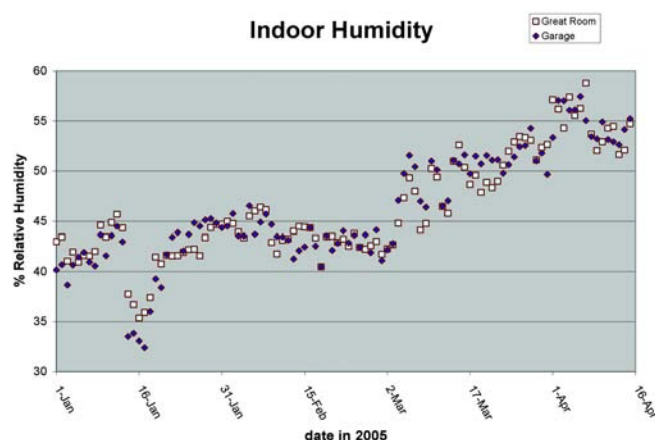
Actual indoor relative humidity levels during the mid and later parts of the fourth and fifth heating seasons are shown in Figures 2 and 3 respectively. The figures indicate that conditions were usually close to targeted values. In January of 2006,

**Figure 2** Indoor humidity in the living room and garage over the period of Jan. 1—Apr. 15, 2005 (garage and house as single zone). The dip in relative humidity between Jan. 13—18 occurred when a humidifier malfunctioned, and, (after more than one attempted repair), it was replaced.

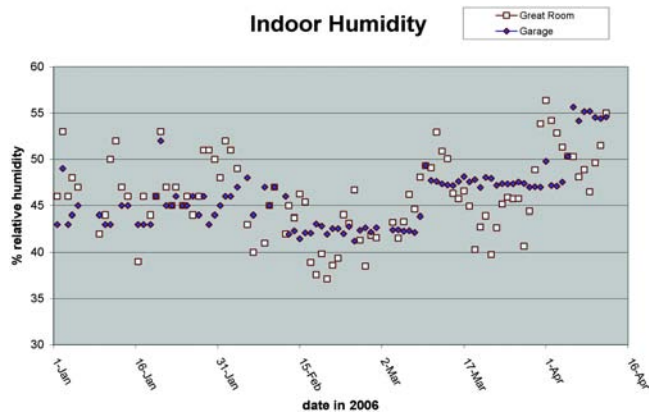
**Figure 3** Indoor humidity in the living room and garage over the period of Jan. 1—Apr. 12, 2006 (garage and house as separate zones). Humidity values in garage are stable at very close to set-points after Feb 15. Humidity levels in the living room vary inasmuch as humidifiers in the house were controlled for daily moisture release, rather than for humidity set-point.

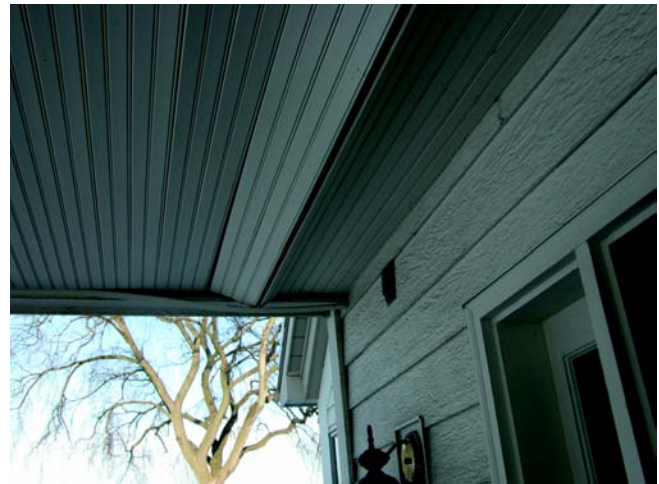
rior porch ceiling was however seasonally wetted, causing buckling and permanent distortion (Figure 4). The pattern lumber was not back-primed. It was nailed to the lower flanges of wood I-joists that cantilevered beyond first story walls; the I-joists supported a second-story bedroom floor that cantilevered beyond the first-story walls. There was no blocking between I-joists where they rested on the top plate of the first-story wall. Outside of the first-story walls and below the second-story bedroom floor, the spaces between I-joists had been packed full of dry-blown cellulose insulation, (using netting to hold the insulation in place). The porch ceiling extended outward beyond the second story bedroom floor to a ventilated soffit. Buckling was restricted to that portion of the ceiling below the bedroom floor (the portion packed with insulation — and not ventilated). Buckling was most extreme near the first story wall. The buckled lumber was of pine sapwood, which has limited mold resistance, but it showed no mold or mildew growth, suggesting that moisture accumulated during the winter was dissipated by the time temperature conditions were conducive to fungal growth<sup>11</sup>.

**Figure 4** Buckled flat-grain pine pattern lumber on porch ceiling in late December of 2005. In contrast to lumber on ceiling, OSB lap siding on adjacent wall is not buckled. Buckled lumber is not defaced by mold or mildew.

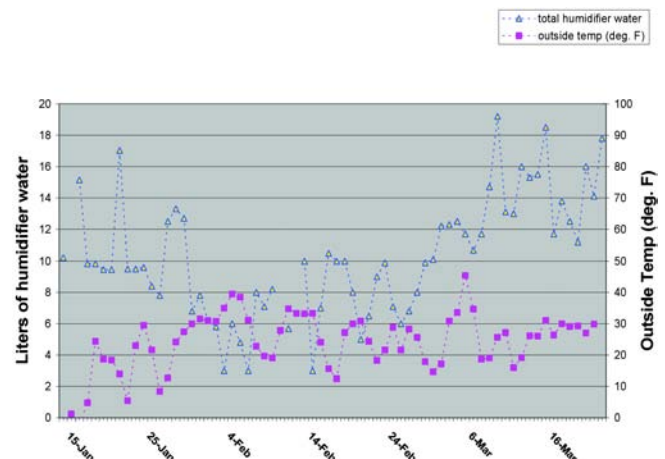
**Figure 5** Daily consumption of humidifier water, plotted with outdoor daily average on-site temperature over the period of mid January through late March of 2005.

Over the later half of the 4th heating season, (when water consumption of the humidifiers was carefully measured), the combined consumption (in the house and the garage) was, on most days, considerably less than 15 liters per day (Figure 5). Humidification at very close to design levels was thus being attained, usually at much less than the anticipated moisture release rate, despite the fact that the house ACH<sub>50</sub> value was not particularly low, and, as indicated previously, the house, garage and basement were being operated as a single zone with respect to air exchange. The low measured water consumption by humidifiers was consistent with the crude

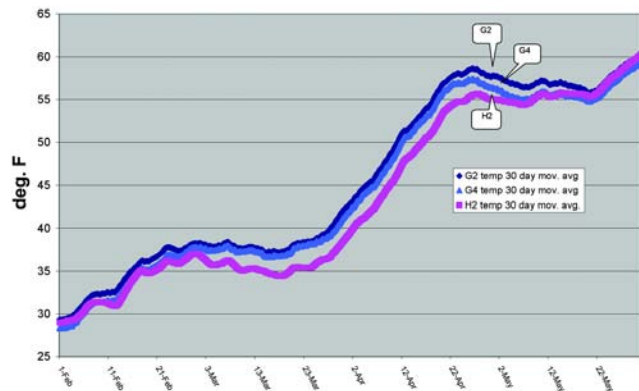
**Figure 6** Temperature near the sheathing in three selected wall cavities during the winter/spring of 2005.

Despite the consistently higher outer-cavity temperatures seen in Figure 6 in the walls facing ESE or SSW (walls G-2 and G-4) than in the wall facing NNE (wall H-2), the wall facing NNE showed less sheathing moisture accumulation, and (at least until early-spring) tended to show lower RH in the insulated cavity (Table 4). The primary reason for superior moisture performance of the walls clad with brick veneer or lap siding is probably air exchange between the exterior and the space(s) behind the cladding. Our observations concur with those of Murray and Tichy (2006), who observed drier conditions in walls clad with fiber cement lap siding than in walls clad with stucco<sup>14</sup>. By algebraic calculation, Straube and Burnett (1998) evaluated the theoretical benefit of cladding ventilation, and concluded that the benefit was likely substantial even when ventilation rates were modest.
