# Decay Detection in Red Oak Trees Using a Combination of Visual Inspection, Acoustic Testing, and Resistance Microdrilling

Xiping Wang and R. Bruce Allison

**Abstract.** Arborists are often challenged to identify internal structural defects hidden from view within tree trunks. This article reports the results of a study using a trunk inspection protocol combining visual observation, single-path stress wave testing, acoustic tomography, and resistance microdrilling to detect internal defects. Two century-old red oak (*Quercus rubra*) trees located in Capitol Park, Madison, Wisconsin, U.S., were visually inspected and then evaluated using a single-path stress wave timer, an acoustic tomography, and a resistance measuring drill. The trees were subsequently felled, and a disk at each test location was obtained and examined. It was found that the visual inspection and single-path stress wave tests correctly identified a general problem but without specificity; the tomograph accurately revealed the general location and magnitude of the defect within the cross-sections tested but required resistance microdrilling to precisely locate defects and differentiate between decay and crack-ind

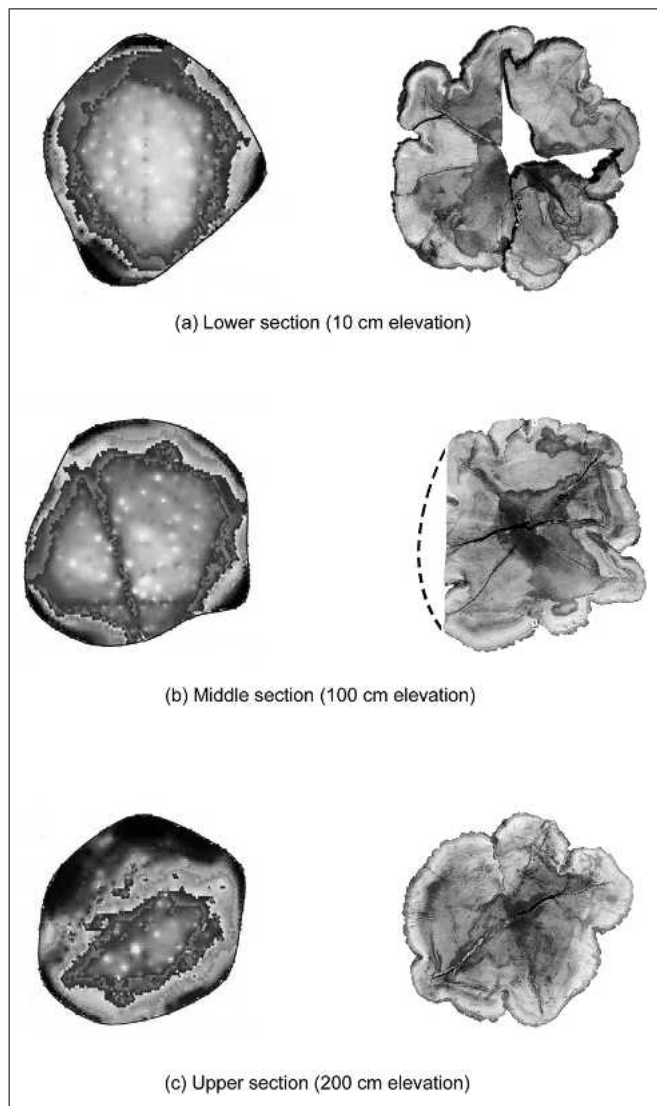
For red oak No. 307, the visual inspection revealed trunk seams, *Ganoderma applanatum* fungal conks, and lack of root flare. The single-path stress wave tests revealed stress wave transmission times ranging from 1640 to 3248  $\mu\text{s/m}$  (500 to 990  $\mu\text{s/ft}$ ). These values were significantly higher than the anticipated transmission times for intact oak of 621 to 724  $\mu\text{s/m}$  (189 to 221  $\mu\text{s/ft}$ ) (Wang et al. 2004). The tomographs indicated a large area of defect at all three elevations. The Resistograph drilling revealed that some areas displayed in the tomographs as potential decay or cavity were actually sound wood and that large cracks were creating an acoustic shadow display in the tomograph.

After being cut down, tree No. 307 was found to have heartwood decay at all three elevations. Laboratory examination confirmed the presence of white rot decaying fungus. The decay was less severe in the upper cross-section (200 cm [80 in] elevation), but it increased in size as the elevation dropped.

In addition to decay, major internal cracks were present in the cross-sections of tree No. 307. The combination of extensive decay and large lateral cracks caused the base disk to fall into several pieces during transportation. The photographs of the disks show that lower and middle cross-sections had multiple lateral cracks and the upper cross-section had one large lateral crack.

Figure 1 shows the comparisons of acoustic tomographs and photographs of the cross-sections at three elevations for red oak No. 307. The dark-colored zones (brown if it is in color print) in the tomograms represent solid wood, and the light-colored zones represent potentially decayed wood (if displayed in color, the tomograms use green, violet, and blue to represent increasing degradation by decay). It is clear that the tomographs show a strong correspondence to the images of the disks. Extensive decay and radiating lateral cracks in the lower and middle cross-sections were reflected by large light-color zones in the tomographs. The tomograph of the upper cross-section accurately located the position and orientation of the big lateral crack and heartwood decay.

**Figure 1. Comparison of acoustic tomographs and photographs of corresponding cross-sections for red oak tree No. 307.**

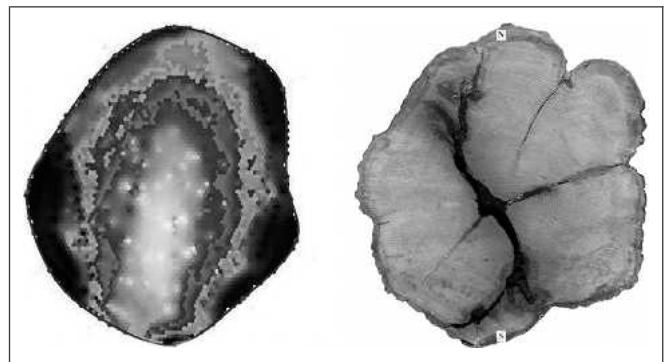
For red oak No. 123, the visual inspection revealed trunk seams and cracks with cankering on the south side with associated *Ustulina deusta* fungus. The single-path stress wave tests revealed a stress wave transmission time ranging from 1908 to 2320  $\mu\text{s/m}$  (581 to 707  $\mu\text{s/ft}$ ). The tomography revealed a large area of defect. The Resistograph drilling revealed a large snake-shaped crack. Figure 2 shows the comparison of the acoustic tomograph and photograph of the cross-section for red oak No. 123.

**Figure 2. Comparison of acoustic tomograph and photograph of the cross-section for red oak tree No. 123.**
