# In Situ Materials and Structural Assessment of Stress-Laminated Deck Bridge Treated with Chromate Copper Arsenate

T. Russell Gentry, James P. Wacker, Karl N. Brohammer, and John Wells

A bridge consisting of three 6.7-m spans with a stress-laminated deck was constructed in 1991 in the Spirit Creek State Forest near Augusta, Georgia. The bridge was constructed by the Georgia Forestry Commission, with guidance from the U.S. Department of Agriculture, Forest Service, Forest Products Laboratory (FPL). Water-borne chromated copper arsenate lumber was used for the deck, instead of the oil-borne preservatives recommended by AASHTO. The bridge was initially monitored by FPL and remained in service from 1994 to 2001 with no maintenance, at which time the bridge was inspected and load tested and the posttensioning bars were restressed. In 2005 the bridge was again inspected and load tested, and the bars were retensioned. The results of the inspection and load tests are presented. The overall condition of the bridge is reported, along with details on the moisture condition, overall deck deflection, and timber strains under load. Details on the loss of posttensioning forces in the bars, and

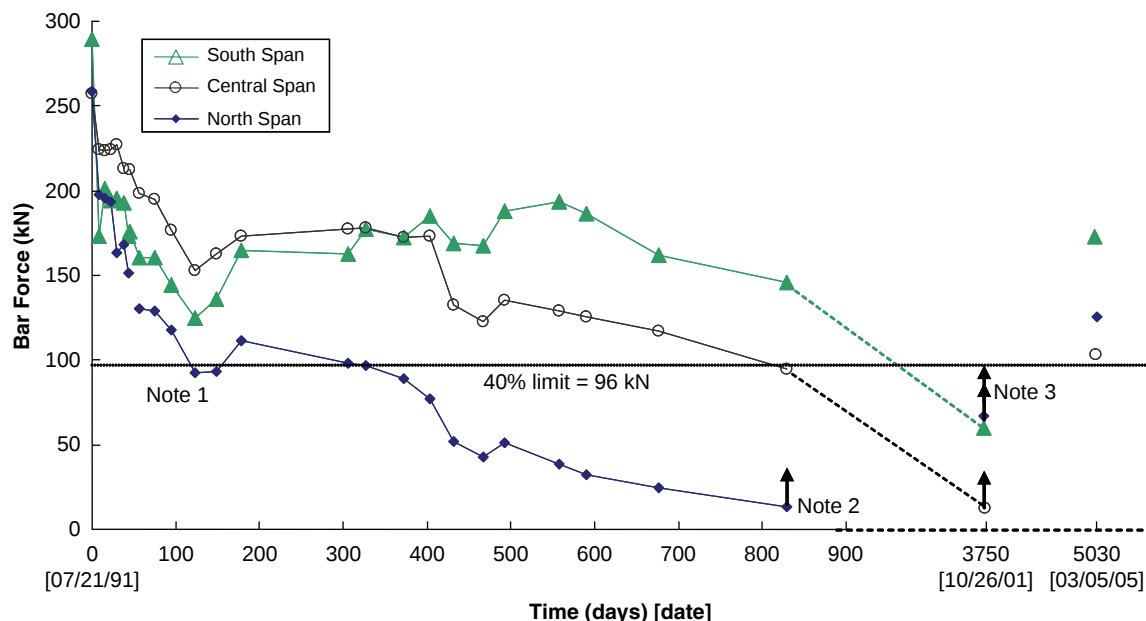
In early 1994, monitoring of the bar stress level was discontinued. At this time, the six bars in the north span were retensioned, as the force in the bars in this level had uniformly fallen to below 40% of their initial value. Ritter and Hilbrich Lee recommend that restressing take place when bar forces drop to 40% of the design levels (2). The bars in the two adjacent spans were not retensioned at this time, and the bridge received no additional maintenance until 2001.

FIGURE 2 Loss of posttensioning in six bars (1991–2005). North span data use only one load cell after 75 days because of failure of one cell. North span was retensioned at 829 days, and all bars were retensioned at 3,750 days.

the USDA Forest Products Laboratory (FPL) recommendations for jacking of bars was followed when the bridge was installed. The forces in 6 of the 18 bars were measured, as shown in Figure 2.

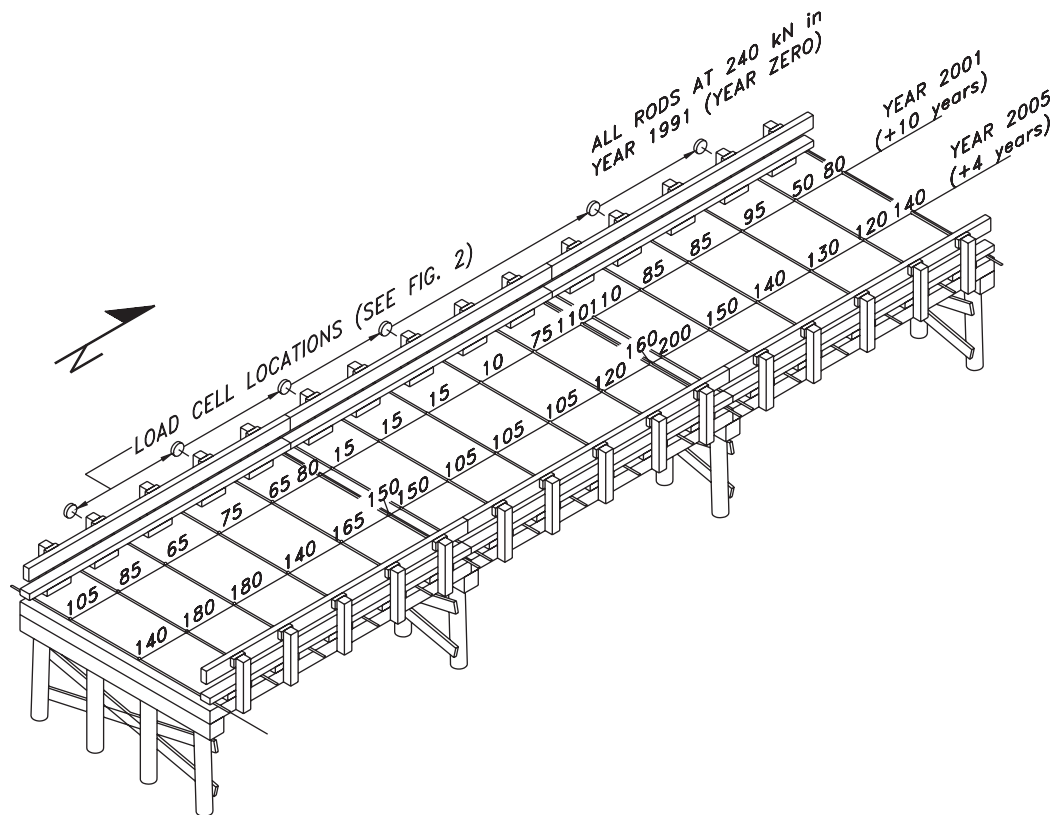
FIGURE 3 Residual posttensioning forces in Dywidag bars, 2001 and 2005 (kN).

These residual forces as measured in 2001 and 2005 are shown in Figure 3. Bar forces are reported to the nearest 5 kN, as this is considered a reasonable degree of confidence in the measurement given the method and equipment used for checking the bars. In 2001, 10 years after the bridge was constructed, the average force in the bars was 70 kN, or about 30% of the original design force. A number of the bars at the central span had forces as low as 10 kN, indicating that these bars were essentially loose. At the high end, some bars had residual forces of 110 kN, almost 50% of the original force. Ritter et al. indicate that a drop of interlaminar stress to 0.15 MPa (approximately 25% of the original stress) is necessary to allow the laminations to slip relative to one another (1).

the level of posttensioning losses as compared with the central span. As noted previously, the bars in the north span were retensioned in 1994, and this may account for the reduced losses in the north span.

In the 2005 assessment, the force in the bars was measured again by using the same procedure. The average force in the bars was 145 kN (60% of the 2001 retensioning force), with the low being 105 kN (45% of the 2001 retensioning force). Once again, the lowest residual forces were found in three bars in the central span of the bridge. In 2005, none of the bars had dropped to the level recommended as the minimum (40% of initial or 96 kN) before retensioning is required.

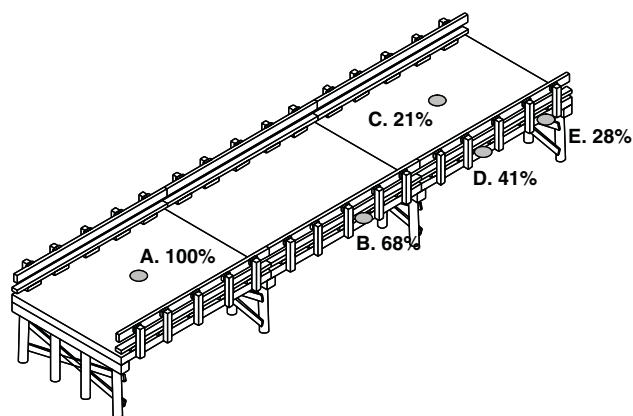
In 2001 and 2005, moisture contents in readily accessible elements of the bridge were taken by using a Lignomat G1000 moisture meter with an E12 electrode and 50-mm pins. Representative moisture contents observed in 2005 are shown in Figure 4. At locations along the side of the deck, moistures contents were taken just adjacent to the posttension bar bearing plates. At the top of the deck, the moisture contents were taken underneath the asphalt wearing surface at the centerline of the roadway and at the curb (where no asphalt was present).

At Location A, approximately 150 mm asphalt was removed to reveal the top portion of the wood deck. There was no moisture barrier between the asphalt at the deck at this location. The wood at surface of the deck in this location was essentially saturated and was found to be soft. The moisture reading from the meter was 100%.

At Location B, which was on the deck beneath the guardrail, approximately 50 mm dirt and debris was present. The moisture content here was 68%. At Locations C and D, taken adjacent to the posttensioning bar bearing plates, the moisture contents were 41% and 28%.

In all locations, the moisture contents were considered to be high, and it may be that moisture contents are correlated with the loss in

FIGURE 4 Moisture contents from 2005 assessment. Spot moisture readings: A, top of deck, beneath wearing surface; B, top of deck, at curb; C, underneath deck, at midspan; D, side of deck, at curb; and E, side of deck, at curb.

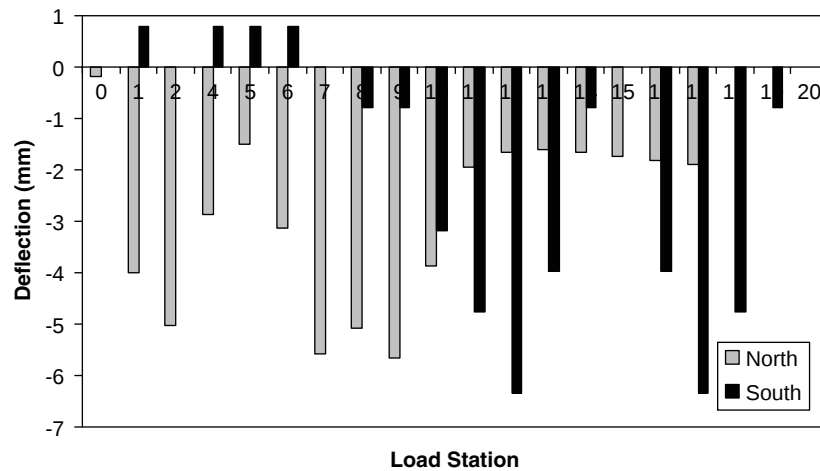
Deflections were measured at midspan of the north and south spans with a string potentiometer (north span) and laser distometer (south span) with an accuracy of  $\pm 0.1$  mm. The maximum absolute deflection observed was 6.4 mm. This equates to a deflection ratio of  $L/960$  of the clear span, which is only one-third the design-allowable deflection of  $L/360$ . This might be considered surprising given that the  $2 \times 12$  deck is at the upper bound suggested by AASHTO given the span (6). In many instances, however, it is the limit on transverse flexural stresses and not deflection or longitudinal stresses that controls the design of stress-laminated bridge decks. In laboratory testing, Oliva et al. showed that deflections in decks with butt joints show substantially more deflection than decks with full-length laminations (8). The load test on the Spirit Creek Bridge, which has butt joints in all three spans, demonstrates that this additional deflection is probably not significant in a full-scale structure.

FIGURE 5 Deflection under moving truck load (mm), Spirit Creek Bridge.

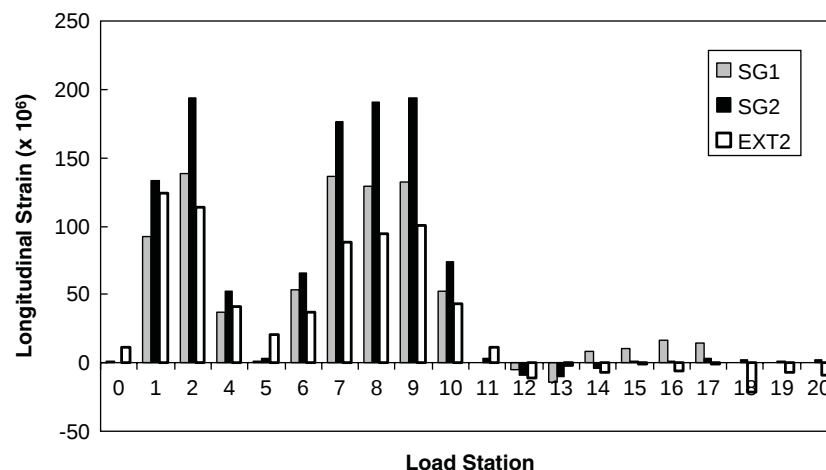
Longitudinal strains were taken only on the north span (Figure 5). Three gauges were used to record strain. Gauge SG1 was located at the centerline of the bridge, at midspan. Gauge SG2 was located at the edge of the bridge, directly under the loaded tire, at midspan. Gauge EXT2 was adjacent to Gauge SG2. The SG gauges were bonded resistance strain gauges with a 100-m gauge length. Gauge EXT2 was a screw-on extensometer that was joined to the wood lamination

The maximum strain read in any of the gauges was  $194 \mu\epsilon$ , recorded in Gauge SG2 at Load Station 9 when the rear axle of the trailer was directly at the midspan of the north span. At this point, the centerline gauge read  $132 \mu\epsilon$ . Although there is an obvious strain lag across the bridge deck, it can be concluded that the centerline gauges are participating substantially in the flexural capacity of the bridge.

FIGURE 6 Observed strains in deck under moving truck load (2005), Spirit Creek Bridge, north span.
