# **Development of Flexural Vibration Inspection Techniques to Rapidly Assess the Structural Health of Rural Bridge Systems**

## **Final Report**

CTS 08-22

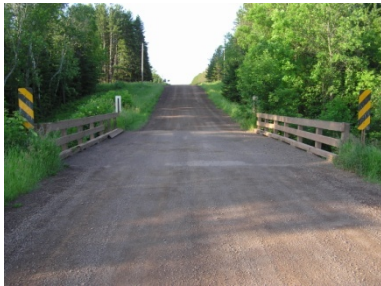
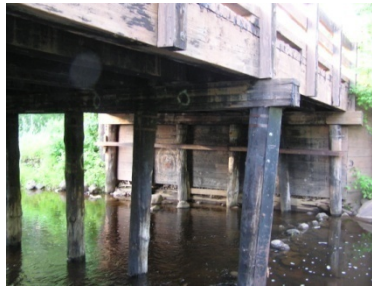
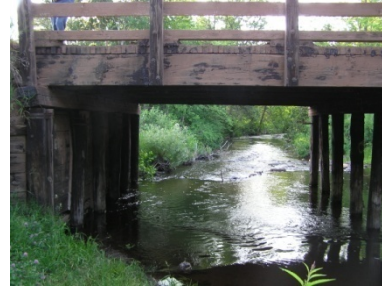
The pilings were in fair condition with numerous splits that have been strapped for added support; the timing data shows no major concerns with the exception of the bottom of piles 3, 7 and 9.

The pile caps were not solid timber but laminated lumber. Therefore, timing data was not performed due to the timbers not being solid timber. Visual inspection noted that pile cap A and C are out of plum due to the abutments pushing inward.

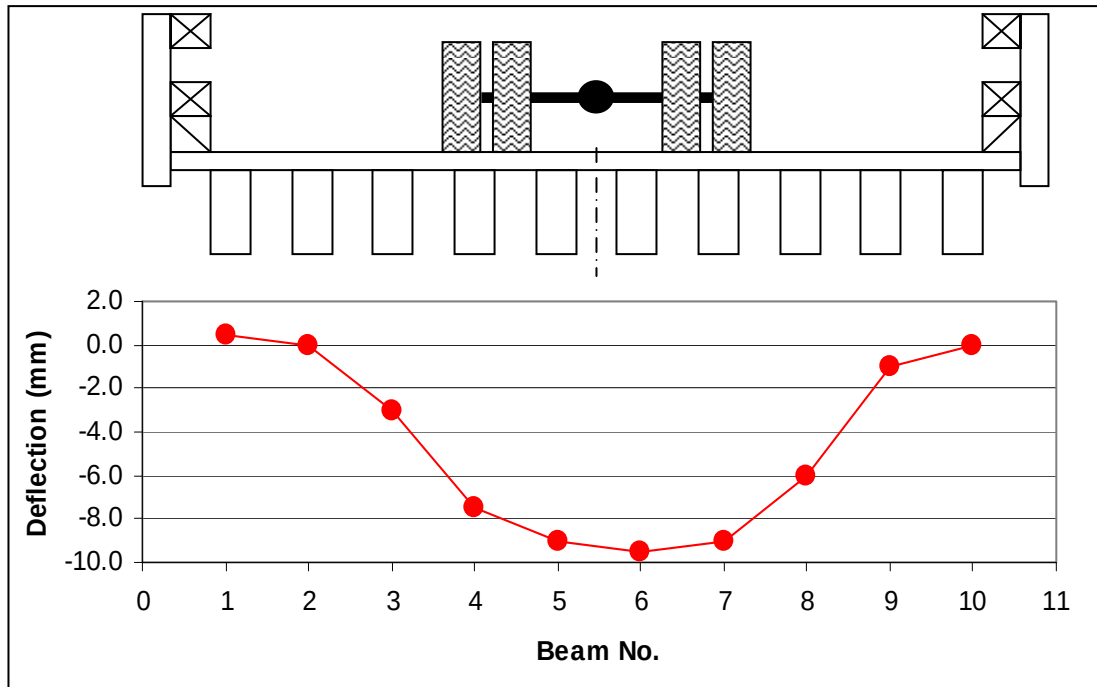
**Figure 4.4.** Deflection of span 1 of Bridge 85 for center loading.

Figures 4.4 and 4.5 show the deflections of spans 1 and 2 of Bridge 85 for center loading.

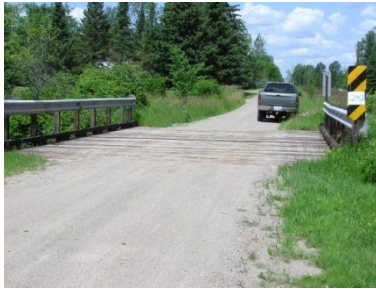
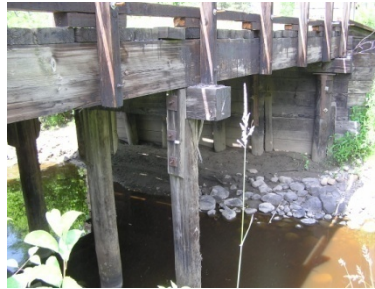
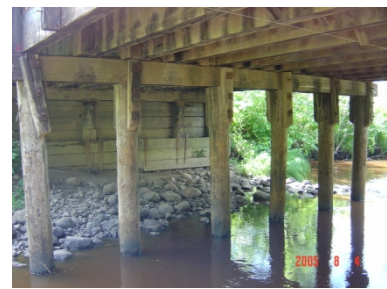
Pile numbers 5 and 6 showed presence of substantial decay as noted by stress wave timing data. Piling number 6 was visually broken. Pile numbers 7, 8, 10, and 11 appear to have significant decay present at the top of the pile in contact with the pile cap. They should be further investigated on site if the pile cap is removed or repaired.

Pile cap A shows the presence of decay at a distance between 8 and 18 ft from the upstream end. Pile cap B (at bridge center pile support) showed significant decay along the entire length and should be considered for replacement. Resistance drilling data shows that there is severe internal decay present in the pile cap. At the upstream end, there is an internal void present of 4 inches, increasing to 11 inches at 17 ft. At the downstream end, the pile cap is in good condition.

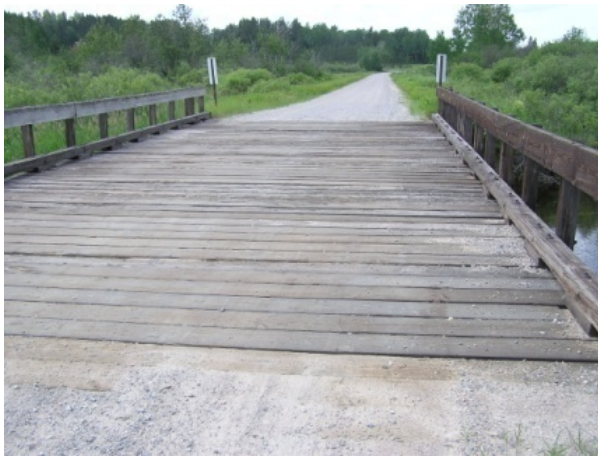
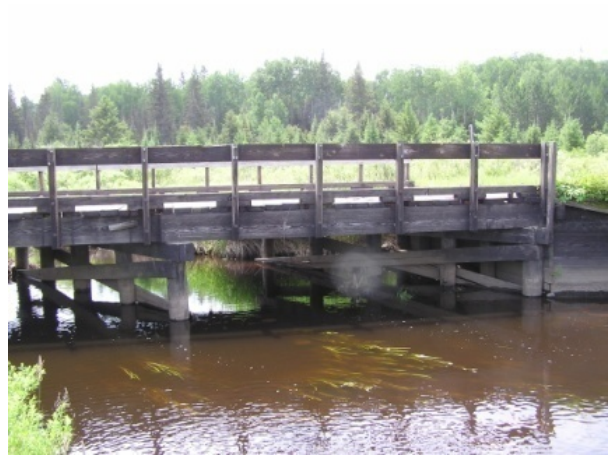
The pilings all showed high microsecond time data with pile numbers 1 and 2 being severely decayed; cross bracing of the pilings have deteriorated to the point where it has no function. Several of the pilings should be further investigated to determine replacement.

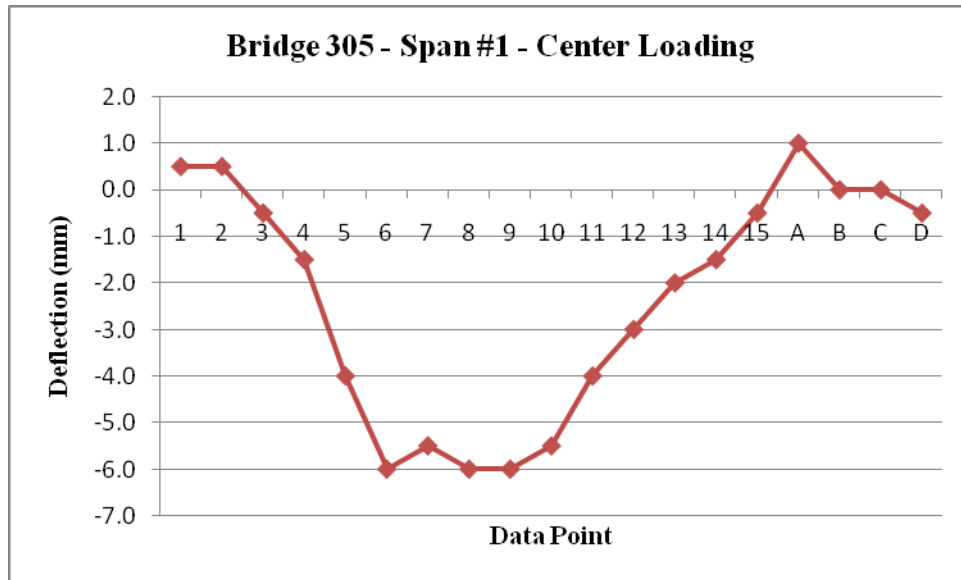
**Figure 4.17.** Deflection of span 1 of Bridge 305 for center loading.

Figures 4.17 and 4.18 show the deflections of spans 1 and 2 of Bridge 305 for center loading.

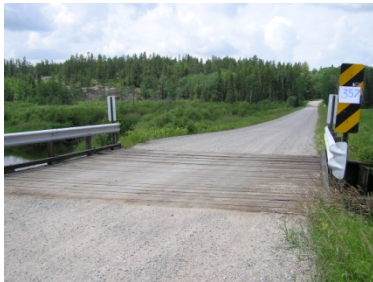
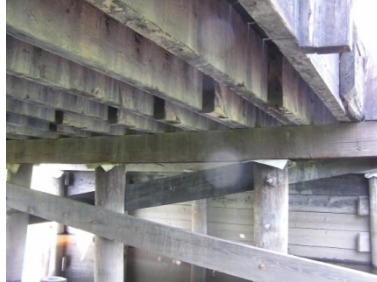
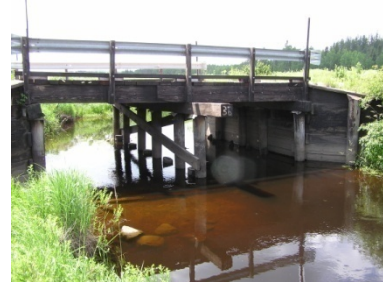
Piles number 6, 7, 8, and 10 showed the presence of decay as noted by stress wave timing data. Piling number 7 shows very high timing data and should be further investigated.

Pile cap A showed the presence of decay at a distance between 4 and 20 ft from the upstream end. Pile cap B (at bridge center support) showed decay and insect damage in the center section of the pile cap. Pile cap C timing data showed the timber in good condition.

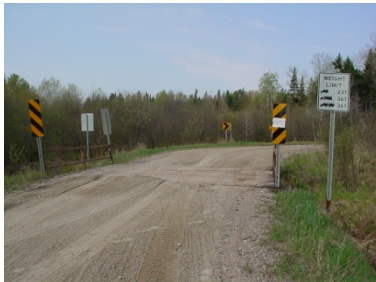
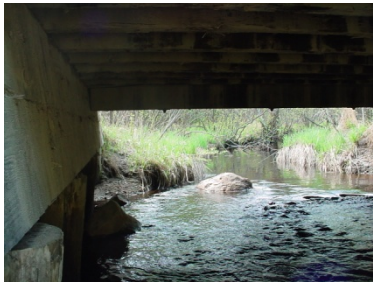
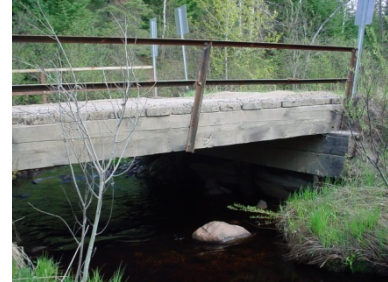
Due to the high water at the time of testing, pilings # 1, 2, 3 and 4 were not tested with the microsecond timer but were visually inspected. There is decay and shell damage visible, and pilings 4 through 8 are considered partially decayed with microsecond time readings in the 500 to 600 µs range.

Girders 4 and 5 are 24 inches in depth and are notched for proper top side alignment, and are in good condition. Girder # 1 (upstream) has a split along its entire length and decay is present on both ends. Girders 7, 8, and 12 showed high timing data on one end

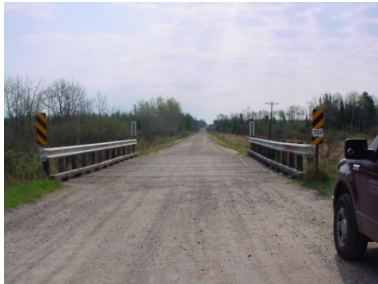
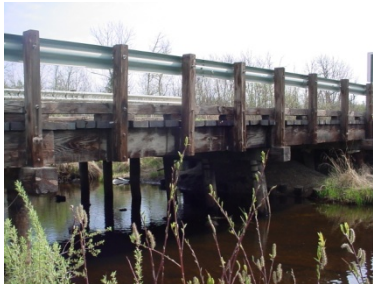
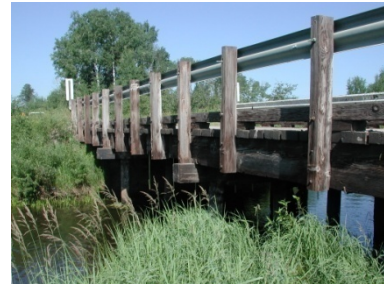
Piles number 5 and 6 showed presence of substantial decay as noted by stress wave timing data. Piling number 6 is visually broken. Piles number 7, 8, 10, and 11 appear to have significant decay present at the top of the pile in contact with the pile cap. They should be further investigated on site if the pile cap is removed or repaired.

Pile cap A shows the presence of decay at a distance between 8 and 18 ft from the upstream end. Pile cap B (at bridge center pile support) showed significant decay along the entire length. Resistance drilling data shows that there was severe internal decay present in the pile cap. At the upstream end, there is an internal void present of 4 inches, increasing to 11 inches at 17 ft. At the downstream end, the pile cap is in good condition.
