# FIELD INVESTIGATION OF A 100-YEAR-OLD TIMBER CRIB FOUNDATION AT A HISTORIC COPPER MINE

James P. Wacker<sup>1</sup>, Xiping Wang<sup>2</sup>, Douglas R. Rammer<sup>3</sup>

**ABSTRACT:** In June 2009, the authors conducted a comprehensive on-site evaluation of the timber crib foundation at Alaska's Historic Kennecott Mine Concentration Mill Building. The primary goal of the 6-day inspection was to assess the physical conditions of the existing timber crib foundation and identify timber members and areas that have structural deficiencies. The inspection process included visual assessment, species identification/confirmation, moisture content determination, stress wave scanning test, resistance micro-drilling, and core-drilling. Extensive deterioration was noted in the timber crib foundation members at the lower floors of the mill building. The upper levels of the timber crib foundation exhibited less deterioration, especially in areas where the timber crib cells were not filled with soil. Current efforts are focusing on a comprehensive structural evaluation of the Concentration Mill building with the goal of stabilizing and preserving this historical mining building important to t

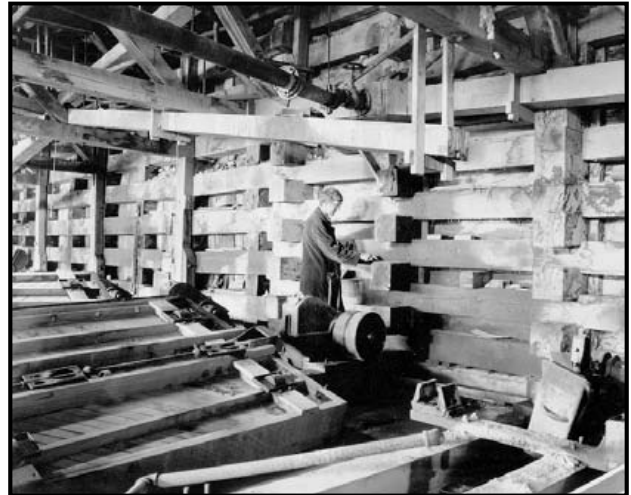
The Concentration Mill foundation walls at level 3 are shown in Figure 3 and are open-cell type consisting of square timbers measuring  $25 \times 25\text{cm}$  or  $30 \times 30\text{cm}$  interconnected with saddle notching. The “headers” are

notched members (designated as “E” members) that are aligned perpendicular to the face of the wall. The “stretchers” (designated as “S” members) have no notching and are aligned parallel to the face of the wall. Timber planking is attached at the backside of the stretchers at most locations to contain the soil fill material inside the timber crib cells.

**Figure 3:** Timber crib foundation wall at level 3 of the Concentration Mill Building during 1976 inspection.

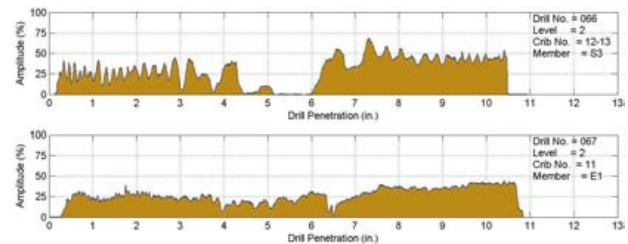
Sample plots of the resistance micro-drilling data are provided in Figure 5 with a complete set of drill-resistance plots provided in [3]. The sample resistance micro-drilling plots show the internal relative drilling resistance of the member versus the depth of penetration in inches. Short distances of zero resistance are usually indicative of splits or checks in the member. Zero resistance lasting approximately 1-inch and longer is usually indicative of internal decay pockets.

**Figure 5:** Typical plots showing relative density profile from the resistance micro-drilling tool (1in. = 25.4mm).

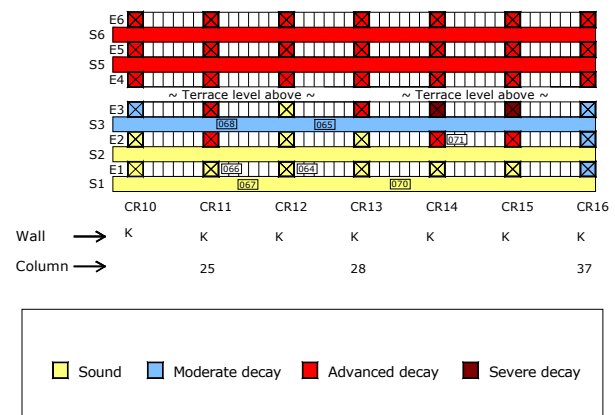
The overall condition of the timber crib foundation is detailed in [3]. Examples of the physical conditions of the timber crib foundation walls in the Concentration Mill Building are provided in Figure 6 (Level 2) and Figure 7 (Level 6). Many areas of the timber crib foundation walls contained timbers with advanced to severe deterioration.

**Figure 6:** Mapping of the physical conditions of the timber crib foundation wall at level two.

- The timber crib foundation walls in the poorest condition, characterized by widespread severe deterioration and multiple failed members and wall sections, were found at level 2 (crib 10-16 terrace level), level 2A (crib 1-6), level 3 (crib 12-22), level 3B (all exposed sections), level 6 (crib 8-12), and level 6B (crib 8-12). The timber crib foundation walls in the best condition, characterized by many sound members with sporadic moderately decayed members, were found at level 1 (crib 2-15) and level 4 (all exposed sections).

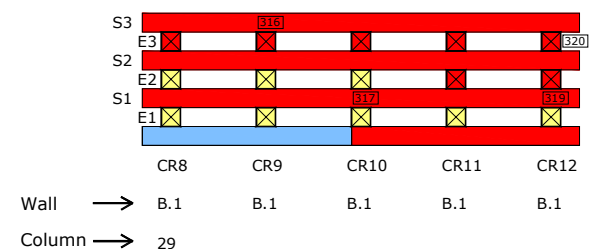
**Figure 7:** Mapping of the physical conditions of the timber crib foundation wall at level six.
