General  
Technical  
Report  
FPL-GTR-198

# Evaluation of Fleet Management Techniques for Timber Highway Bridges

Brent M. Phares  
Travis K. Hosteng  
Justin Dahlberg  
Michael A. Ritter

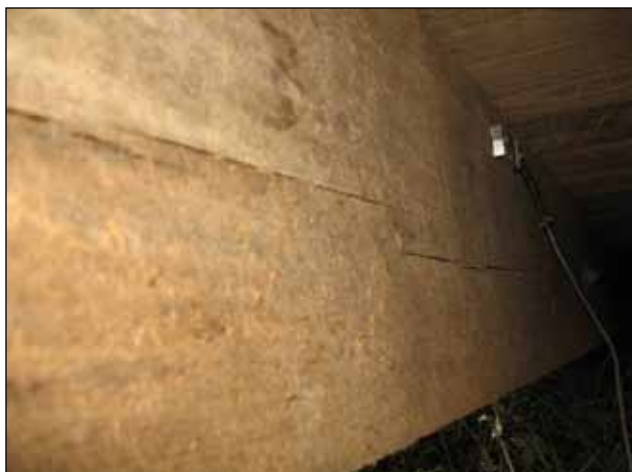
**Figure E15. Observed checking in girders.**

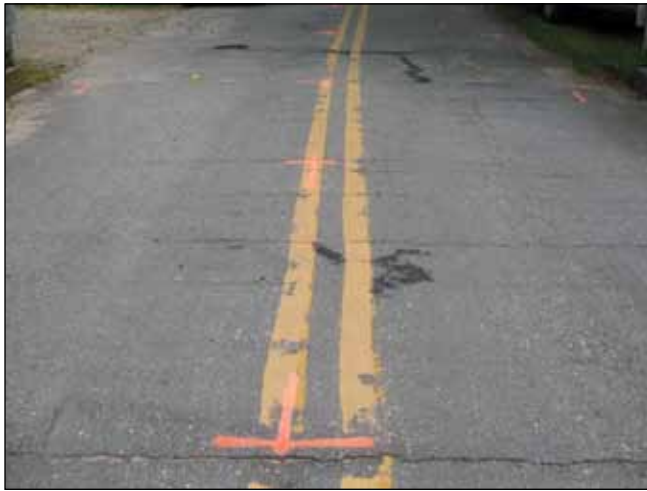
Figure F13. Presence of transverse cracks.

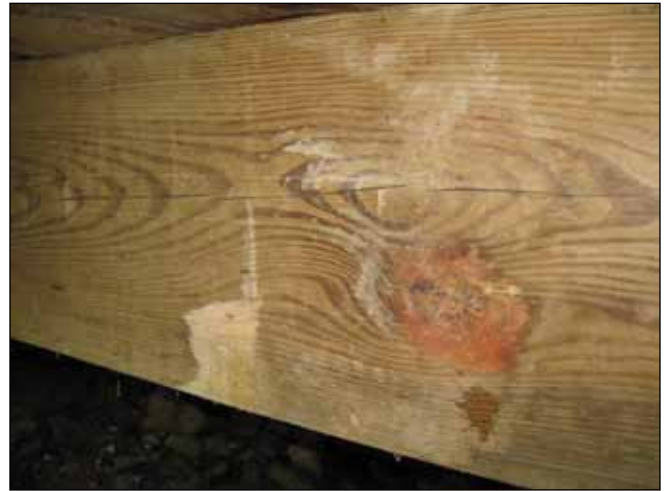
Figure F16. Checking at girder centerline.

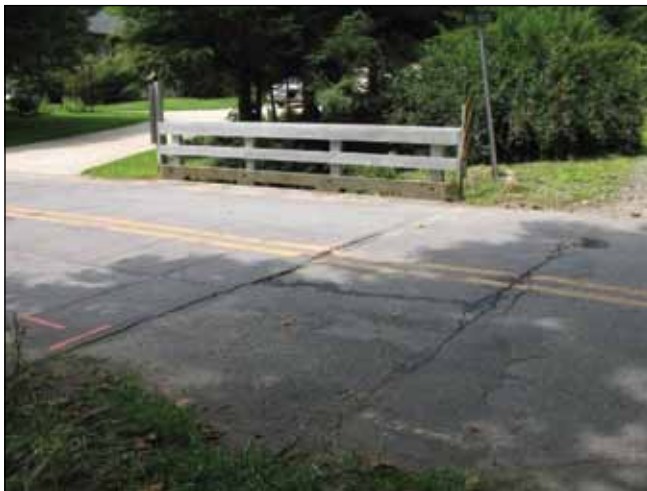
Figure F14. Transverse cracks at bridge approach.

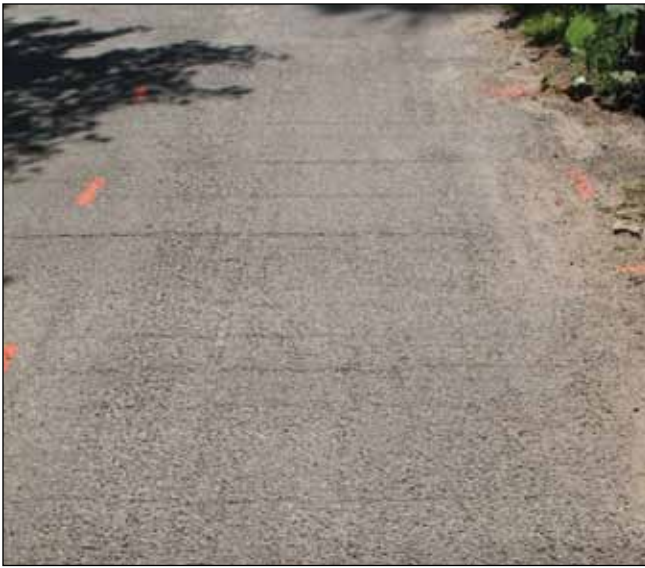
Transverse cracks were observed in the asphalt pavement at the floor board seams and are shown in Figure G13. Though determined to be relatively minor, these cracks should be noted. Overall, the asphalt pavement generally looked to be in satisfactory condition. At the transitions between the approach and the bridge wearing surface, transverse cracking begins, though the transition between the roadway and asphalt does not appear to be problematic for the bridge. An uneven transition could subject the bridge to unnecessary effects from dynamic loads, although slow vehicle speeds on this roadway make this unlikely. In addition, a significant amount of debris had collected on top of the bridge near the curbs, which could hinder drainage and promote seepage through the wearing surface to the decking and superstructure.

**Figure G13. Transverse cracks in the wearing surface.**

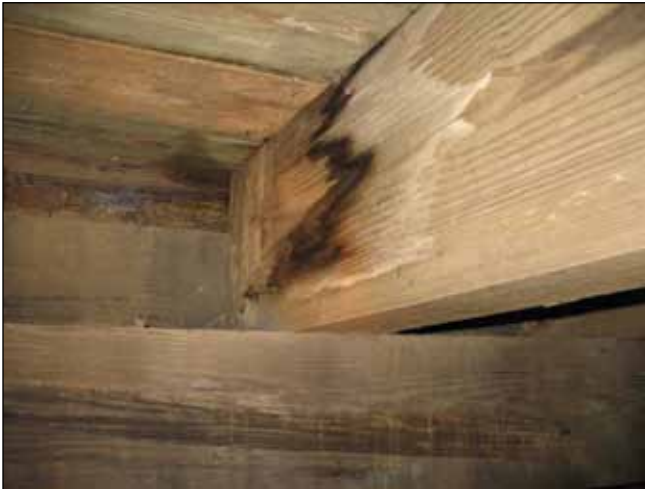
**Figure G14. Girder end conditions.**

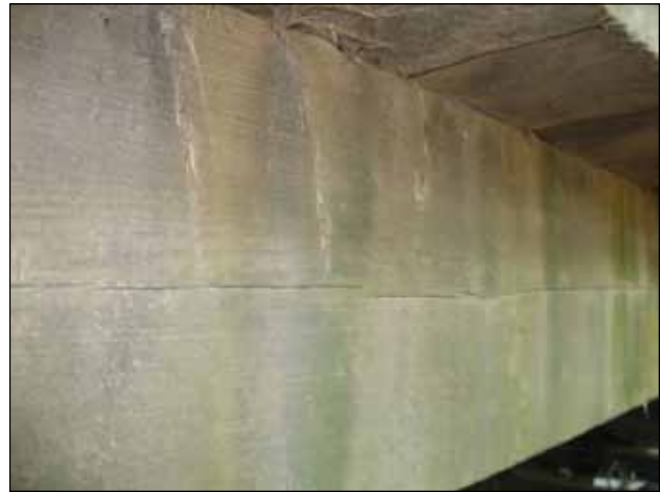
**Figure G15. Checking at girder centerline.**

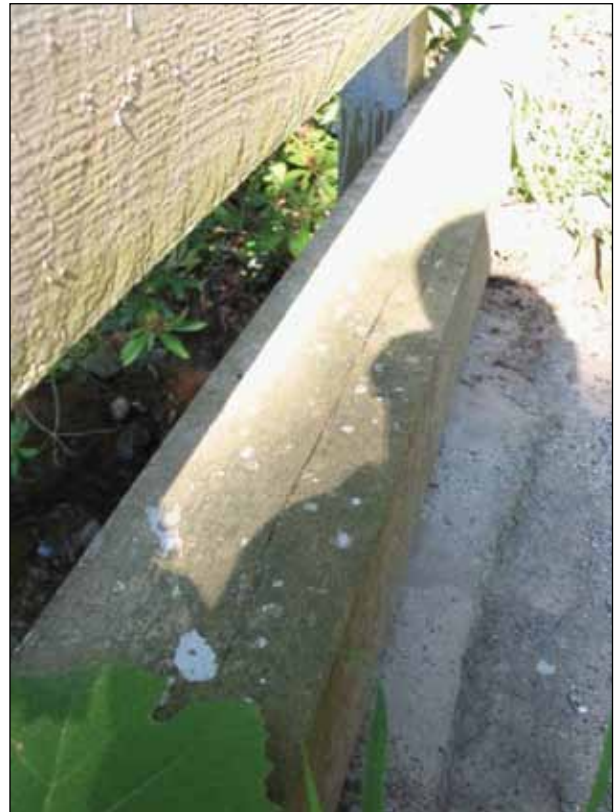
**Figure G16. Parapet condition.**

wintergreen signifying fungal growth was present. There was no evidence of insect, mechanical, or ultraviolet degradation. Minor issues of concern include the presence of filtering at the abutments, where various locations on the sill and backwalls were very wet. There were minor checks in the parapet and parapet curb (see Fig. G16).

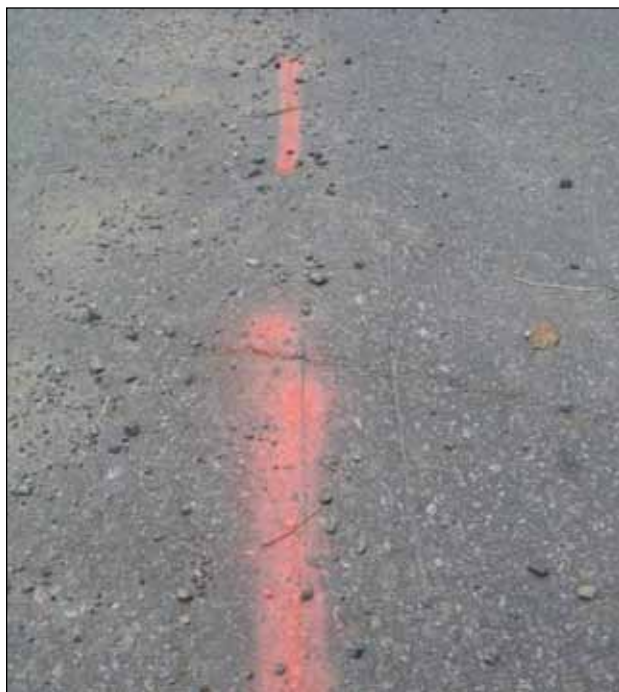
**Figure H13. Minor transverse cracks.**

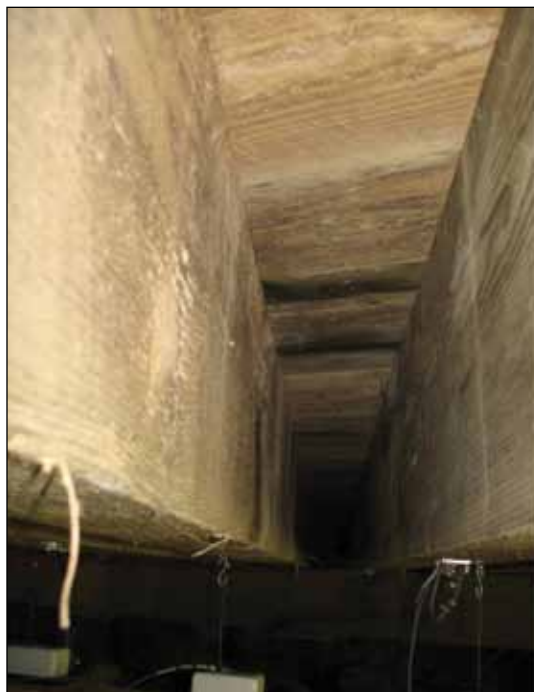
**Figure H14. Typical superstructure condition.**

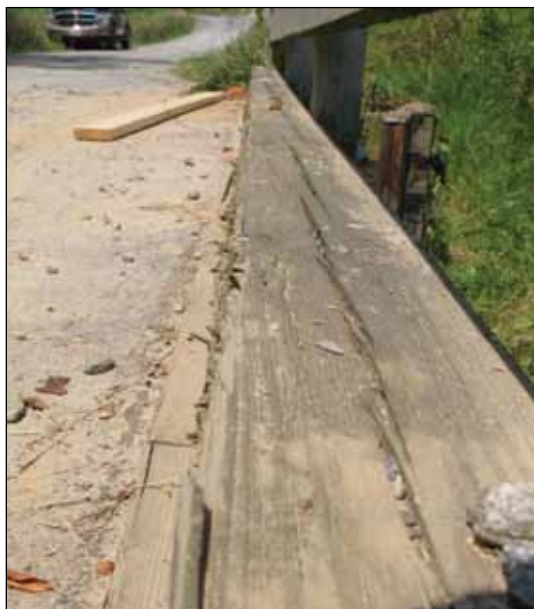
**Figure H15. Advanced degradation throughout curbs.**

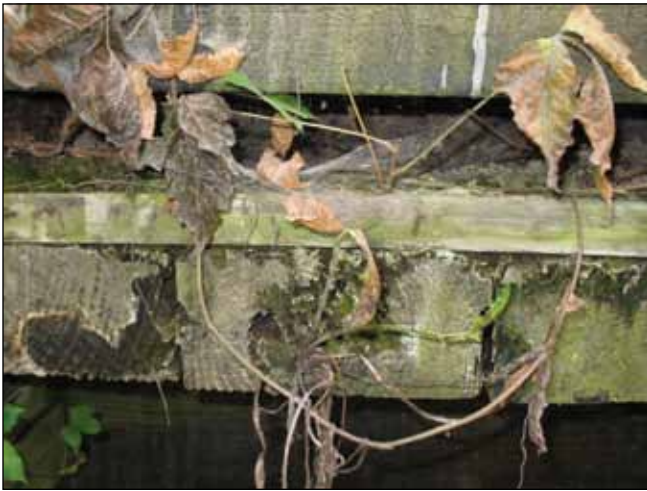
Figure I13. Decay in the ends of the deck boards.

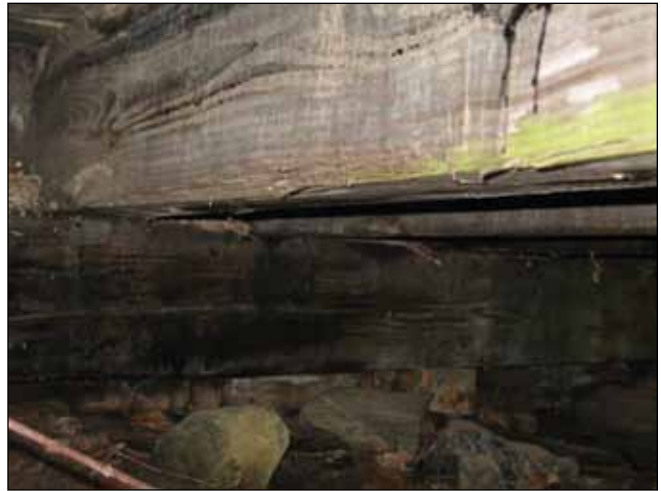
Figure I16. Mechanical damage to girder.

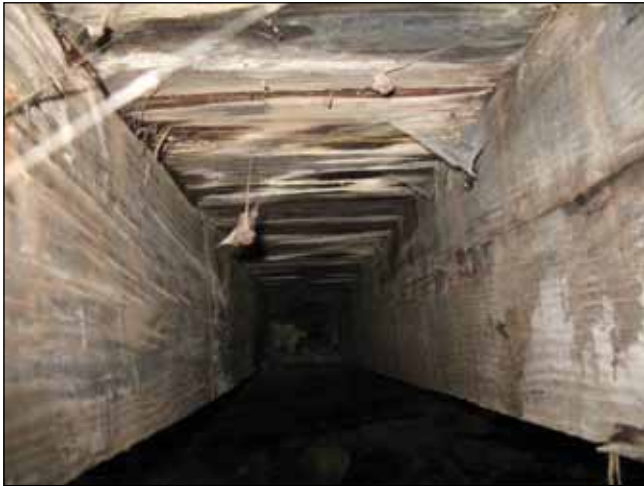
Figure I14. Girder and deck condition.

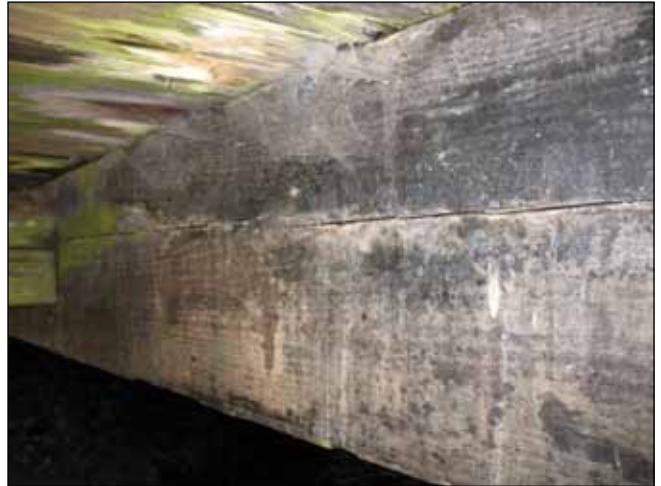
Figure I17. Checking in the girders.

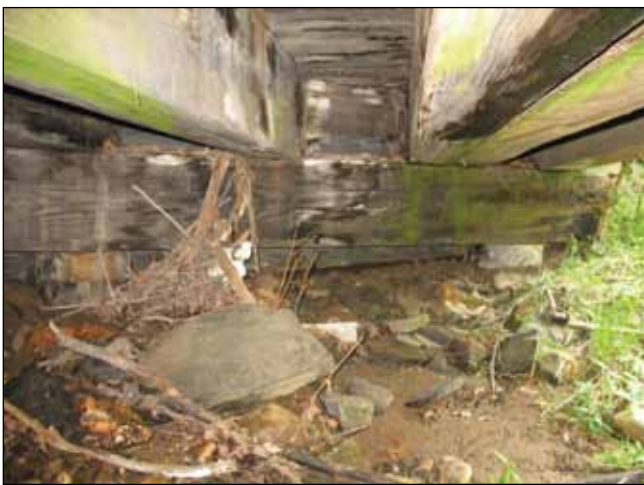
Figure I15. Fungal growth throughout superstructure.

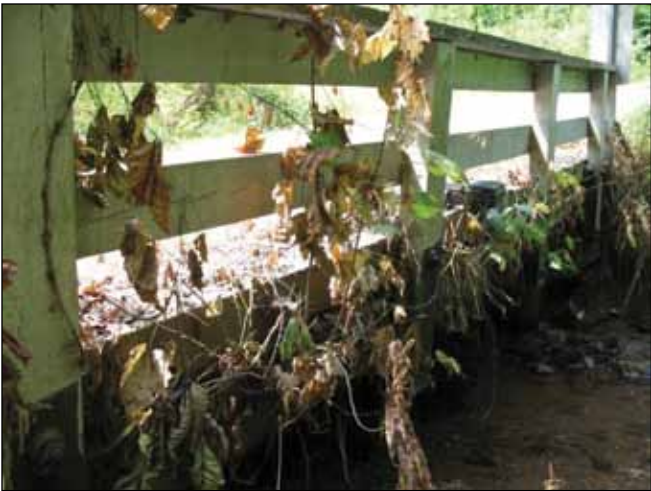
Figure I18. Foliage overgrowth.

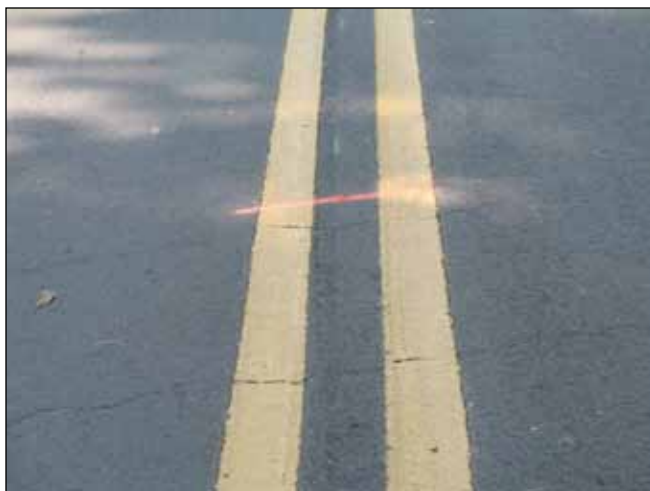
Figure J13. Observed transverse cracks.

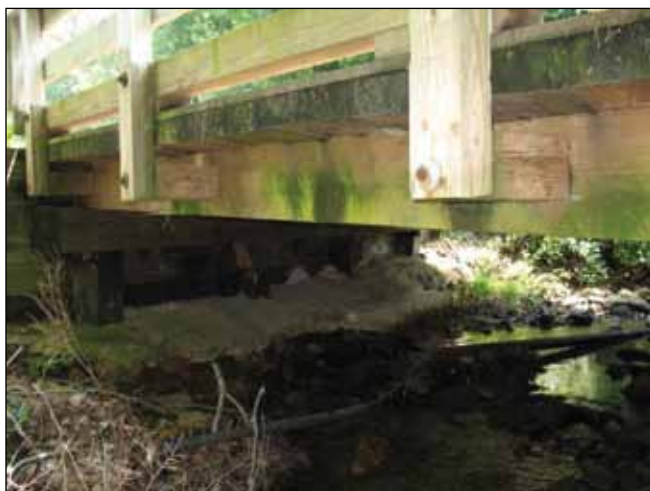
Figure J14. Moss growth on girder 19.

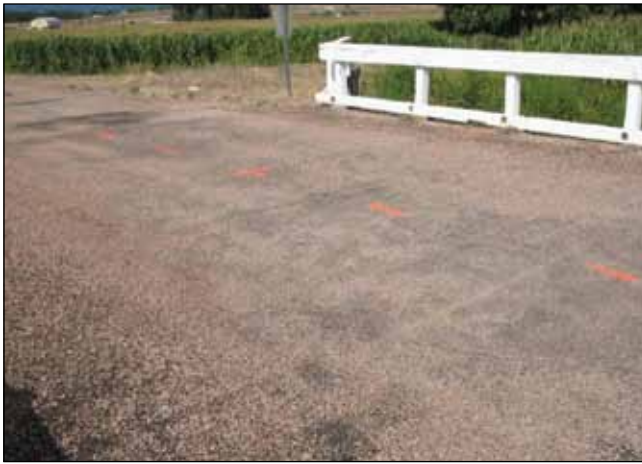
Figure K13. Transverse wearing surface cracking.

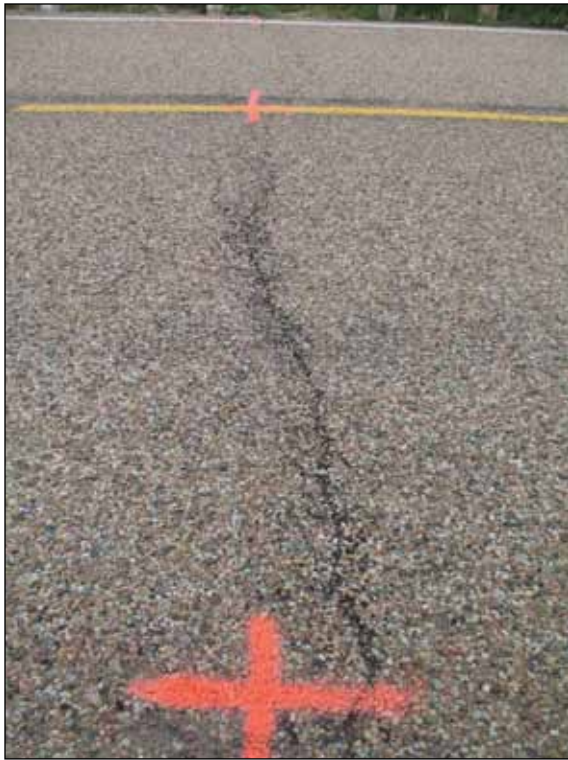
**Figure L13. Transverse wearing surface cracking.**

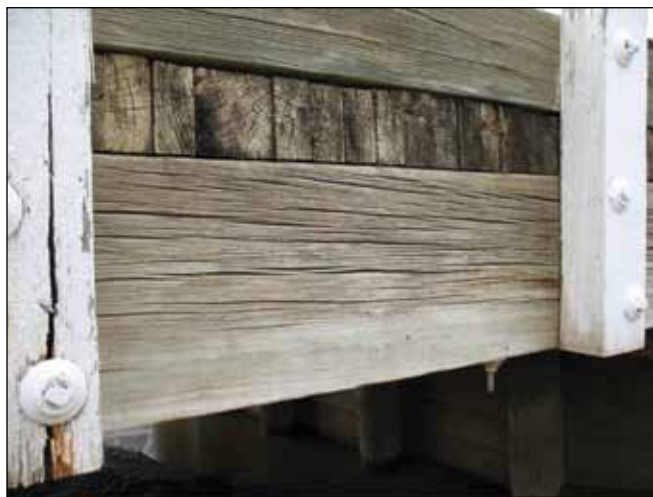
**Figure M14. Checking in exterior girders.**

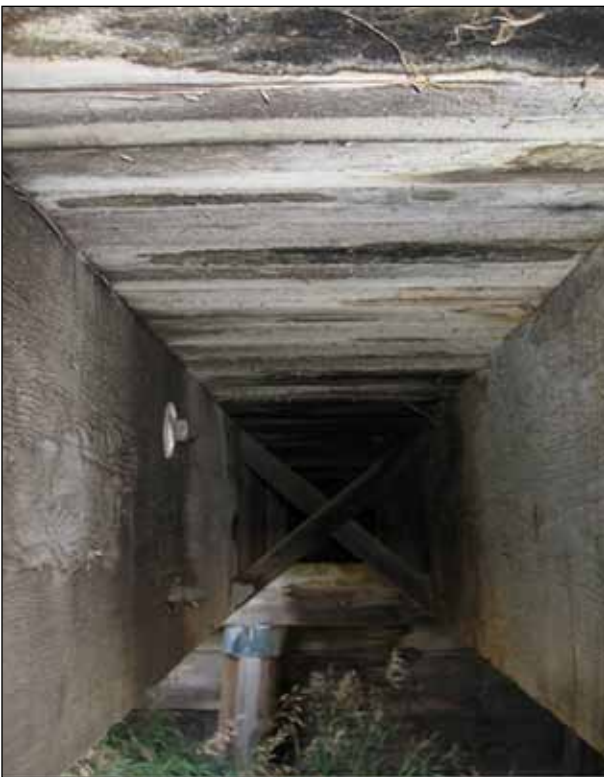
Figure N14. White residue formation on deck.

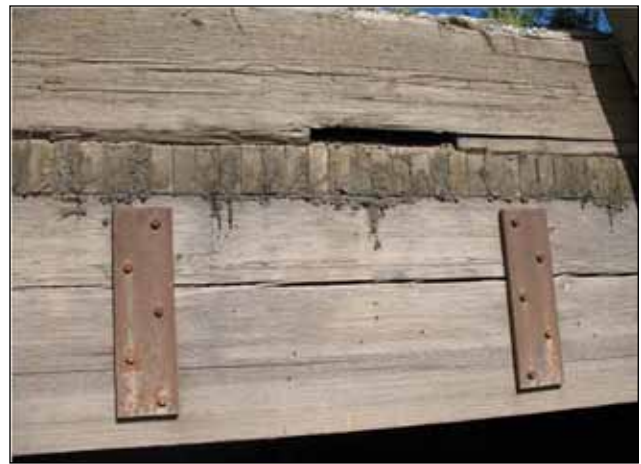
Figure N15. Checking in exterior girders.

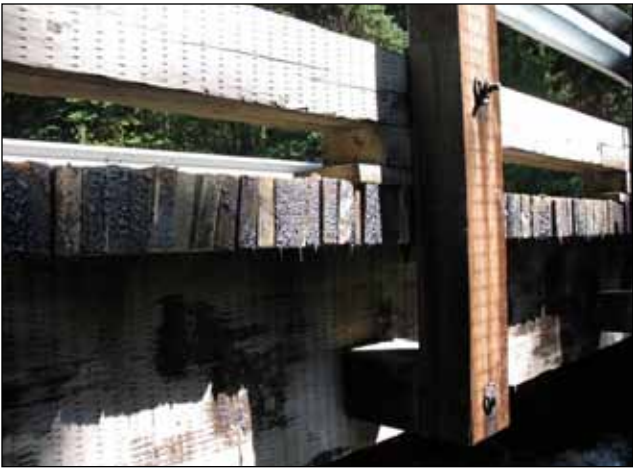
Figure P14. Twisting of deck boards.
