# **Rock Gabion, Rip-Rap and Culvert Treatments: Successes and Failures in Post-Fire Erosion Mitigation, Schultz Fire 2010**

Daniel G. Neary and Karen A. Koestner

USDA Forest Service, Rocky Mountain Research Station, 2500 Pine Knoll Drive, Flagstaff, Arizona 86001

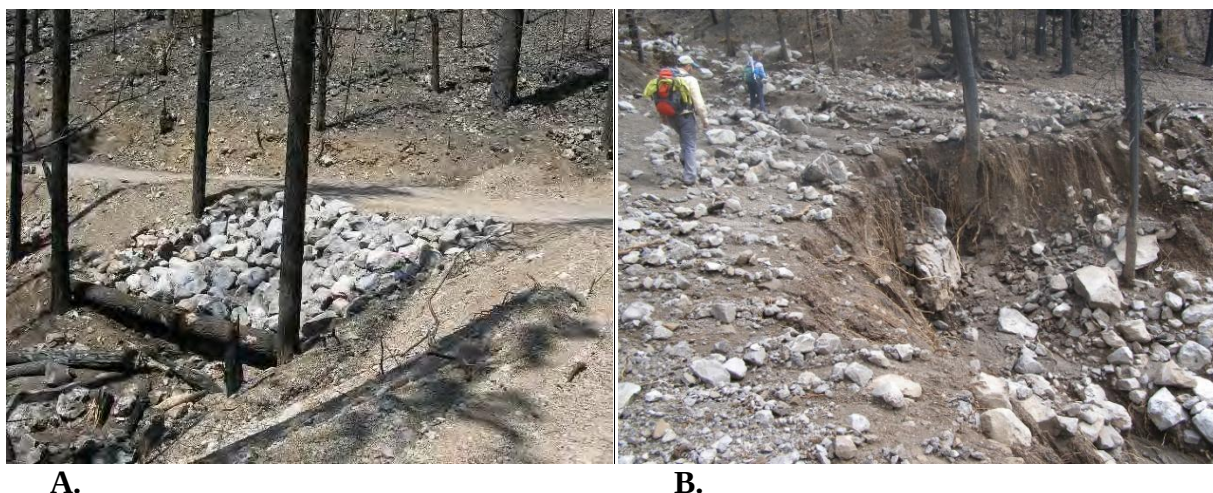
*Rock Armoring:* This treatment was done on the Waterline Road after the fire at 17 drainage crossings (Figure 1A). It consisted of placing 294 m<sup>3</sup> of large rocks (30 to 60 cm diameter) below the road on potential water flow paths. The downhill end of each rock armoring array was anchored to the ground by large logs.

*Rock Armoring:* The large rock armoring on the slopes below the upper elevation Waterline Road failed completely in the storm of July 20<sup>th</sup> (Figure 1B). All of it was washed away by the high water flows and deep gully incisions in that storm and subsequent storms. At most of the armored crossings, debris flows and runoff carrying much larger rocks than the armoring rocks (30 – 60 cm diameter) crossed the road and washed out the armored sections. The erosion control treatments were simply overwhelmed by the magnitude of the flood events. The size of the armoring pad rocks was too small to process high velocity flows coming off steep, 100%+ slopes. Flood flows lower on the mountain were powerful enough to knock over 13 Mg Jersey barriers. Larger rocks (1+ m in diameter) should have been used but there was probably not enough time to organize delivery of resources of that size. This erosion control technique contributed to the post-fire erosion and did nothing to reduce it. Therefore, this treatment is not recommended in steep terrain unless adequately sized rock material can be obtained.

**Figure 1.** Rock armoring along the Waterline Road before (A) and after (B) the July 20<sup>th</sup> flood.

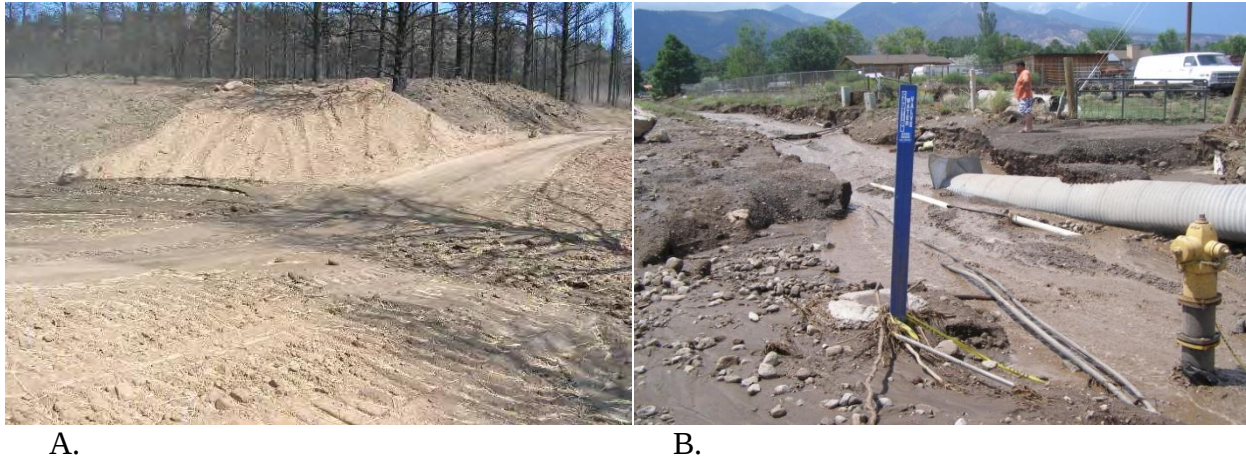
*Culvert Removal:* The low-water channel crossings on Forest Road 420 where culverts were removed functioned satisfactorily (Table 1) and prevented addition of road fill and fill-breach surges to the stormflow (Figure 2A). Some minor maintenance is required to keep the crossings trafficable after floods.

Road culverts in the urban area were grossly under capacity and most were either buried, breached, or bypassed, thus increasing the amount of sediment transported to lower elevations

(Table 1, Figure 2B). In some instances, home owners replaced storm-damaged or poorly functioning culverts with larger diameter culverts only to have the same failure rate. Of the two that were successful in the private ownership area, one was designed as a concrete surfaced low-water crossing. The other had a set of four 1-m wide culverts located in a depression that followed the gradient of the alluvial fan. This set of culverts was actually installed by Coconino County on a county road. The majority of the roads in the Timberline residential area are private, thus culvert sizing has not been standardized.

Culvert removal on National Forest lands facilitated passage of flood flows from the upper slopes of the San Francisco Peaks. This treatment did not contribute to increased erosion and actually reduced potential erosion and flooding by eliminating the risk of road fill breaches. The culvert removal and low-water channel crossings treatment is recommended as a relatively inexpensive and effective means of coping with post-fire flood flows. Culverts on some private land would have performed better had been larger in diameter. However, others would have failed regardless of size due to excessive rock and woody debris. The best approach in most cases is culvert removal and construction of low-water crossings. Maintenance needs to be carried out on an as-needed basis after stormflow.

**Figure 2.** An example of (A) successful culvert removal and construction of low-water crossings on National Forest lands; and (B) a bypassed and breached, undersized culvert on private property, Schultz Fire, Arizona.

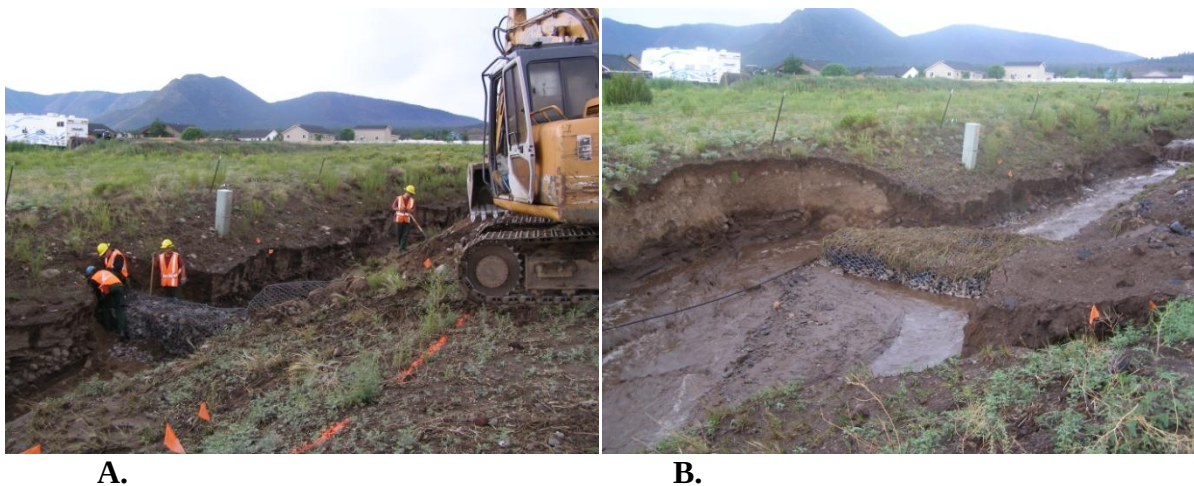
*Rock Gabions:* The gabions in the drainage ditch functioned for a short time but were then bypassed by flood flows, causing significant channel widening and transport of additional sediment (Figure 3). All of the gabions accumulated sediment on their upstream sides early in the storm event and then failed. Left side failures accounted for 56% (10). Only 11% (2) of the gabion failures occurred on the right side of the channel where the construction machinery was located (Figure 3A). An additional 33% (6) of the failures involved both sides of the gabion. The single factor contributing to the gabion failure was incomplete extension of the gabion wings into the left and right banks of the drainage ditch. The presence of phone, electricity, gas, water, and cable TV lines on both sides of the ditch restricted placement of the gabions.

**Figure 3.** Gabion construction along Campbell Avenue prior to the July 30, 2010, storm (A); and results during the storm event showing gabion failure and channel widening (B).

Figure 3B shows a phone line (black pipe downstream of a junction box) that was exposed by lateral widening of the Campbell ditch at a gabion. All the gabions had to be removed after the July 20<sup>th</sup> storm to reduce further channel widening and to make room for channel armoring with concrete. One section of the channel surface that was armored with concrete functioned successfully during the July 20th event.

Gabion wire baskets can be used to reduce erosion from post-fire flood flows, but they need to be constructed correctly. Proper construction must include adequate gabion wing walls securely tied in 2 to 3 m beyond the channel slope breaks to prevent water from working around the wings. The center of the gabion should be at mid-channel and the lowest part of the structure. Channel flow velocities must also be considered. The Campbell Avenue channel has a slope of 4% so the average flow velocity was over 1 m s<sup>-1</sup> with enough velocity to maintain hyperconcentrated streamflow. High flow velocities and the potential for structure failure were reasons why the Burned Area Emergency Response team (Robichaud et al. 2000) decided to not use channel structures like gabions above the Timberline area.
