# Coal Canyon Fire

August 11, 2011

## Serious Accident Investigation Report

Hell Canyon Ranger District  
Black Hills National Forest  
South Dakota

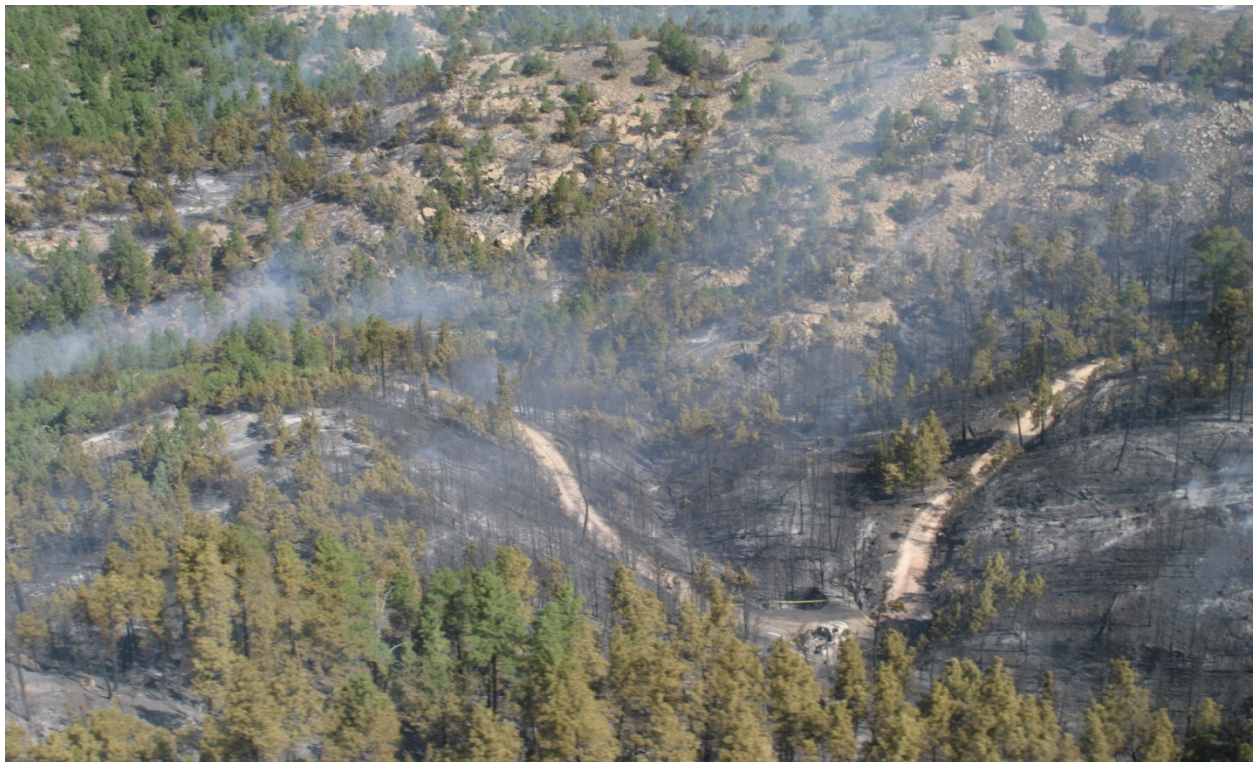
*Figure 2. Photo showing the location of E2 stuck on the road in the draw at the apex of the sharp curve.*

As E2 works on the spot fire, (b) hikes back up the road toward the draw. He sees at least two more spots above the road and thinks, *"This canyon's going to go."* (See figures 2 & 3) He hikes back toward

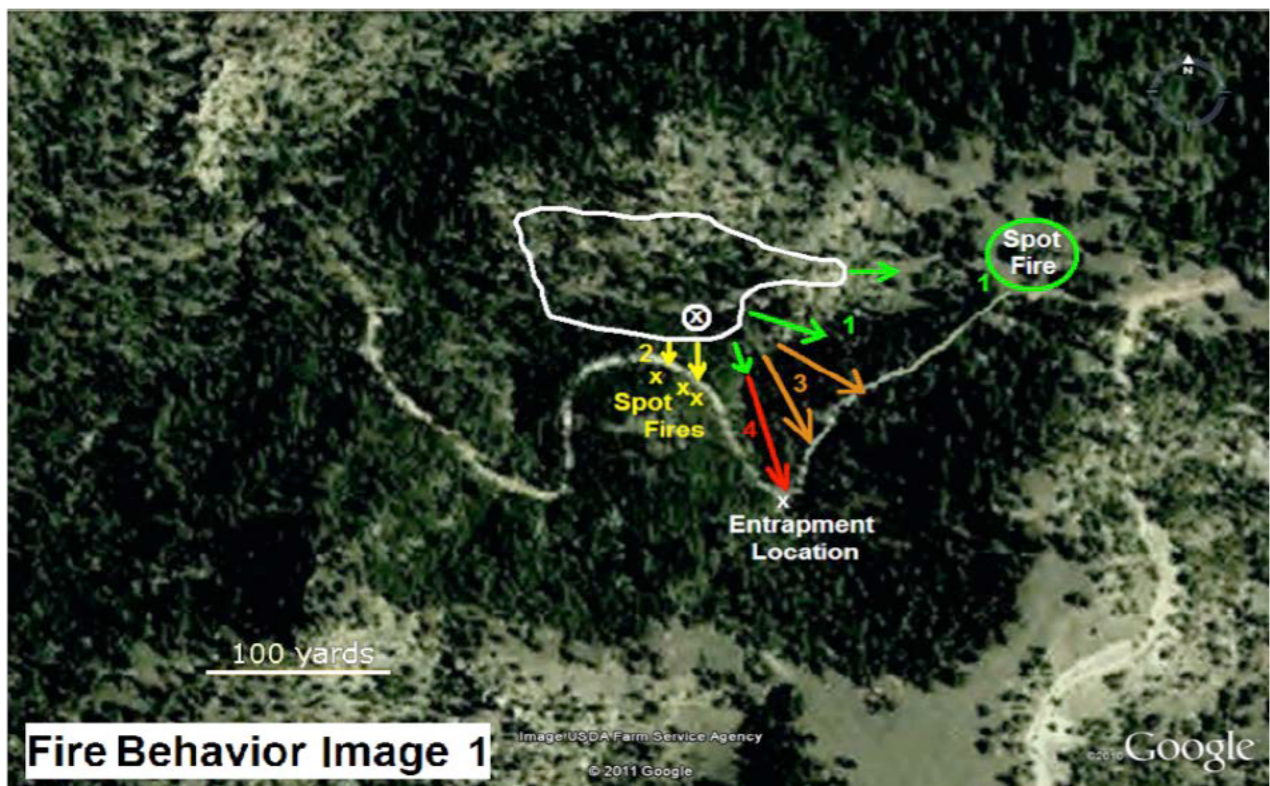
Figure 3. Fire progression on the right flank (from Fire Behavior Analysis, Appendix B): The spotting at (1) blocks (b) progress up the road. Then, at (2), he finds spots above the road near the western edge of the fire. E2 works these spots and later drives forward from here. Their escape is cut off by fire over the road (3), so they pull back. The vehicle gets stuck in the turnaround spot in the draw, and fire runs through the draw (4).

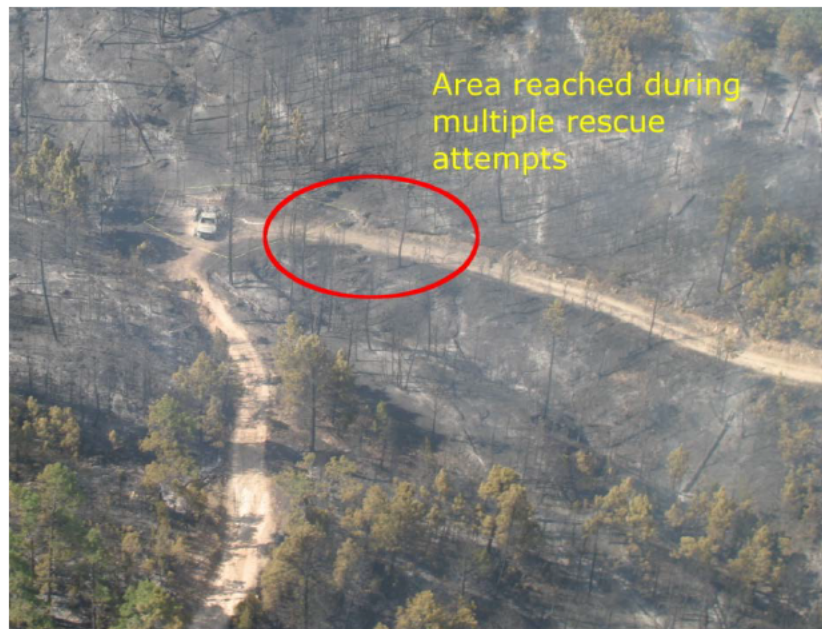
*Figure 4. Aerial view showing how far rescue attempts reached while trying to come to E2's aid.*

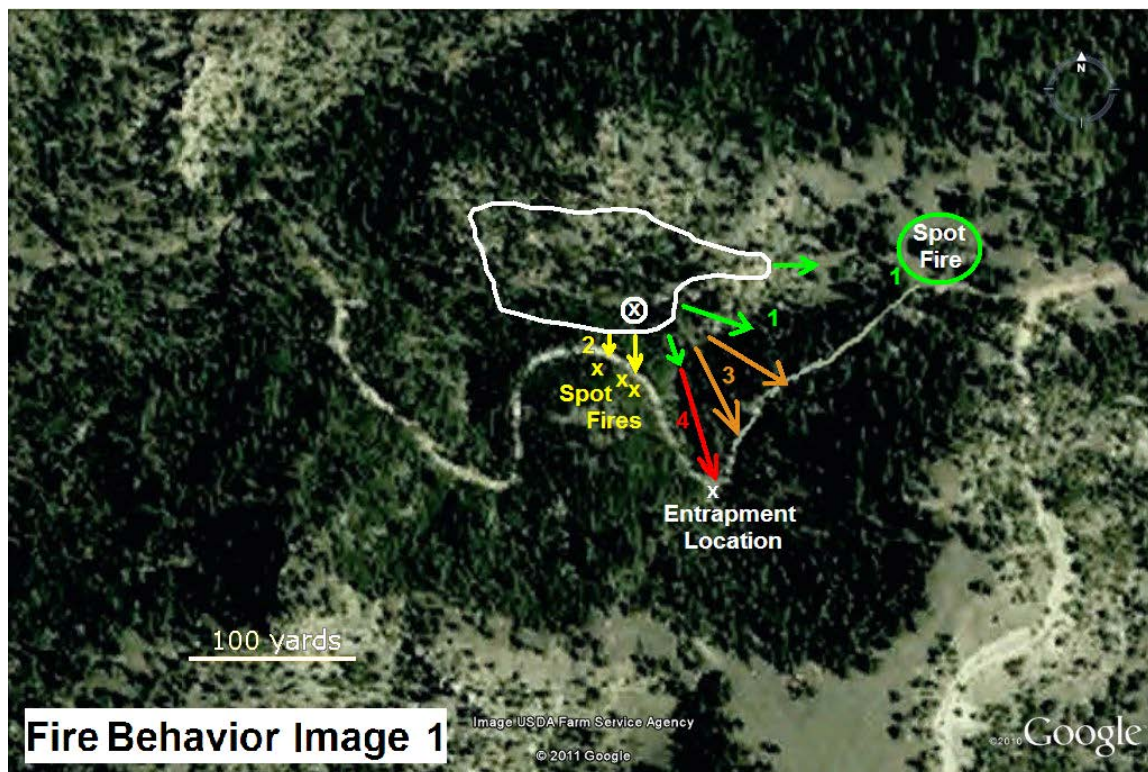
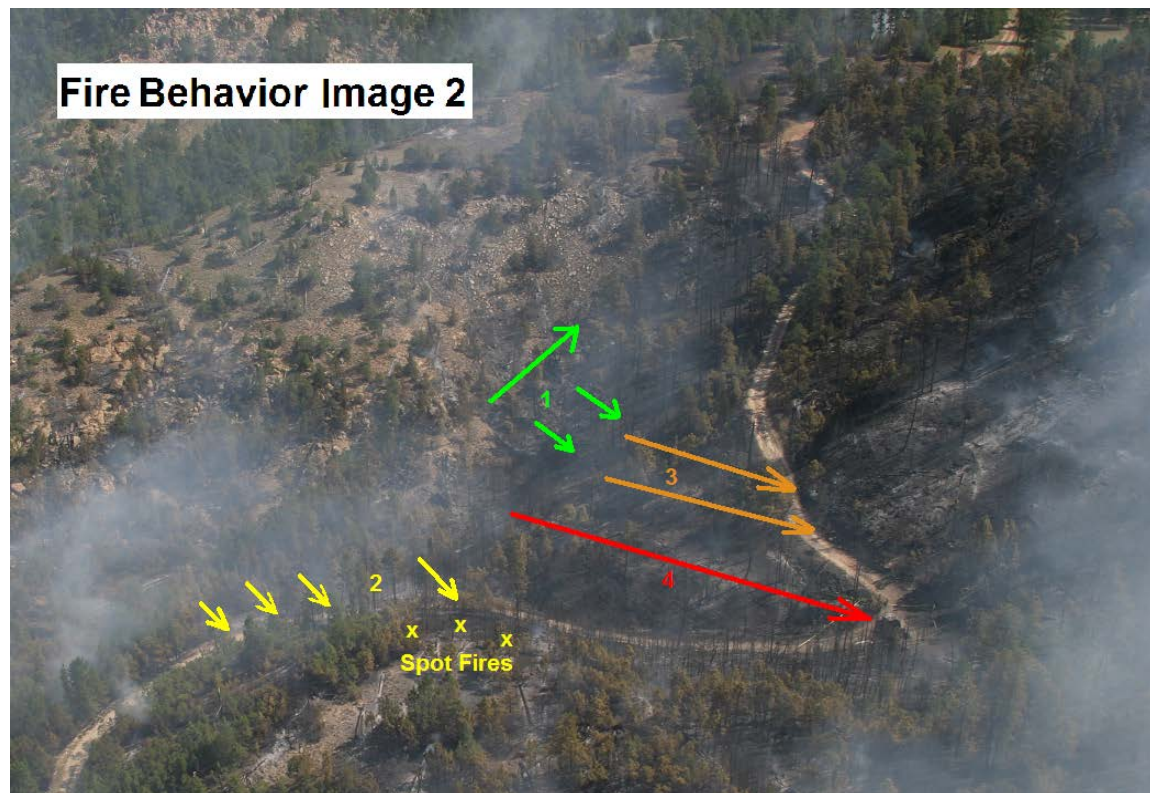
The following two images illustrate the progression of fire spread on the right flank. The white outline represents the estimated perimeter during the arrival of the initial attack units. Initially the fire was reported to be primarily creeping with 1- to 3-foot flames. Following is the estimated timeline for following fire behavior images:

- 1440** Fire activity increases in the bottom of the canyon, and a spot fire develops east of the fire.
- 1450** The fire becomes active near the road on the south end of the fire. Several spot fires occur near the road. At the same time, the fire progresses northward along the drainage bottom.
- 1503** The fire flares up below the road at the bottom of the steep pitch, making the road unusable as an egress.
- 1505** The fire in the bottom of the chimney moves into the crown and crosses the road at the location of the entrapment.

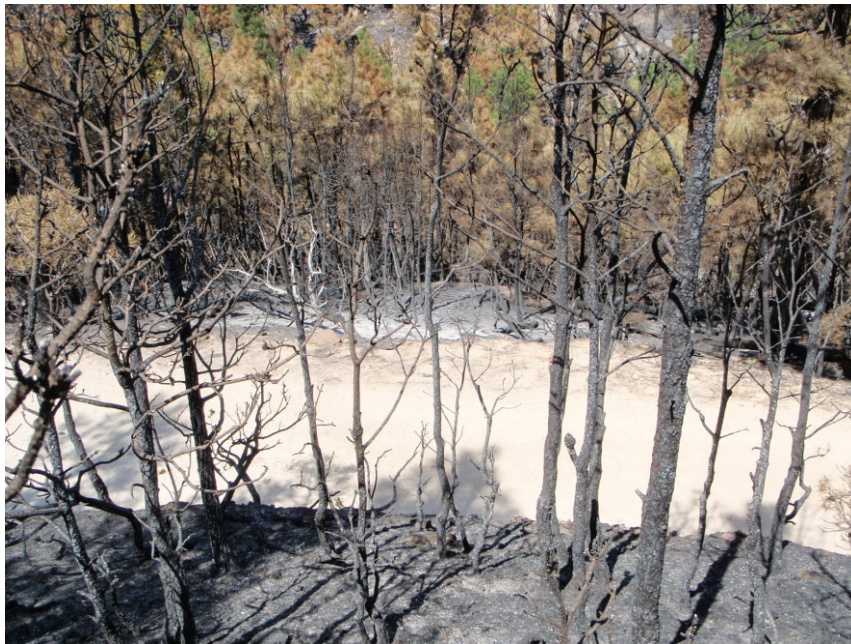
The third E2 crewmember was lying across the road at a 45° angle with his head facing the draw and his feet towards the road cut bank. This roadbed site was exposed to mostly high intensity radiant heat. Directly below and above the spot where the crewmember lay for 3 to 4 minutes without deploying his fire shelter, tree crowns of short ponderosa pine were consumed by fire.

*Area where the third E2 crewmember laid face down on the roadbed. Notice the torched trees both below and above the road.*

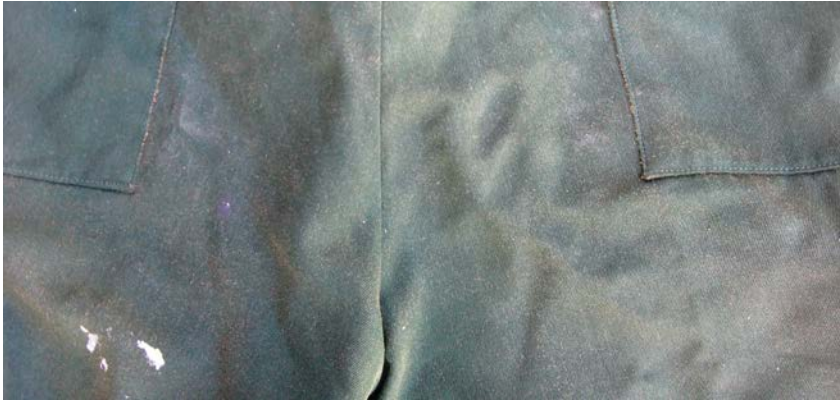
- Date of manufacture: Not legible
- Size 36 – 40 X 30
- Condition: ½-inch and ¼-inch spots of dye sublimation on the lower right leg, exposed thread ends, exposed thread ends of a blown seam, fabric fuzz from waistband to knees, and medial edges of rear pocket showed dye sublimation—condition of the pants is estimated as similar to what might result from a one-second flash fire

*Dye sublimation (orange color) of the fabric fuzz and edges of rear pockets.*

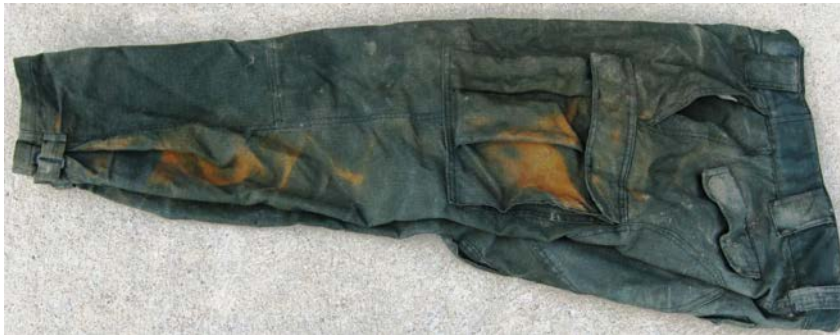
- Manufacturer: Barrier Wear, Inc.
- Date of manufacture: 08/2007
- Material: Kevlar/Nomex (Aramid) blend, rip-stop weave
- Size: Medium/32
- Condition: Lateral lower left pants leg showed a 24-square-inch area of dye sublimation; lateral thigh of left pants leg showed 28 square inches of dye sublimation

*Dye sublimation (orange color) on the left side of pants.*

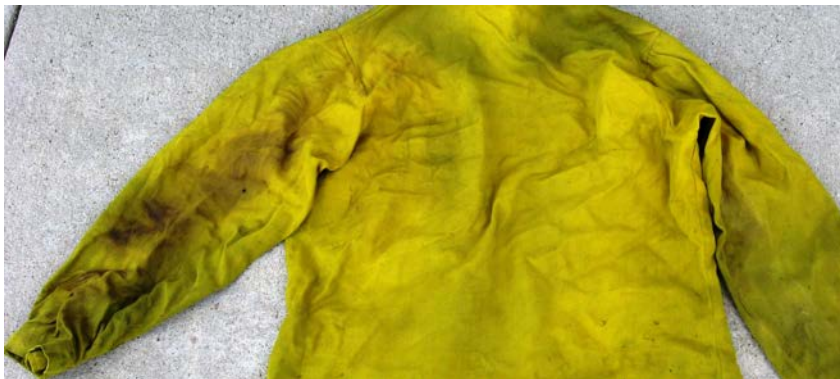
- Date of manufacture: Not legible
- Material: 98% Aramid blend, 2% anti-stat
- Size: Medium
- Condition: Material of the back of the left arm from the cuff to the shoulder showed areas of dye sublimation and scorch; material on the right elbow showed dye sublimation

*Dye sublimation and scorch on the back of the entire left arm and right elbow of shirt.*

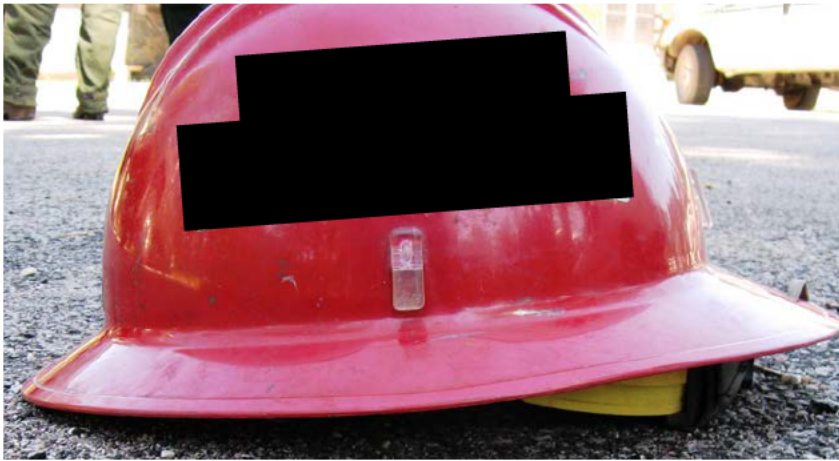
- Compliant and certified to NFPA 1977
- Condition: Showed signs of heat—left side of the hardhat brim received enough heat to soften and droop slightly

*There is a slight droop of the brim of (b) (6) hardhat caused by the high heat environment of the rescue attempts.*
