## Condition Assessment of the Timber Structures of a Century-Old Industrial Building Using a Nondestructive Inspection Procedure

**Abstract.** This paper reports an in situ inspection project conducted on heavy timber structures of a century-old industrial building at a paper manufacturing facility. A nondestructive inspection procedure was employed to evaluate the true condition of the heavy timbers that serve as the main framing structure of the building. The on-site investigation involved monitoring of the microclimate environment resulting from the paper machine operations, wood species identification, wood moisture content measurements, and internal decay detection using sounding, stress wave timing, and resistance micro-drilling methods. The testing results revealed that numerous locations were in poor condition indicated by widespread internal and external deterioration, reduced cross-sections from fire damages, and multiple failed members. Many timber members in the first floor exhibited a very high level of moisture condition (23 to 55%) as a result of high humidity air created by the paper making operations. This paper also showcases a new way of interpreting the evalua

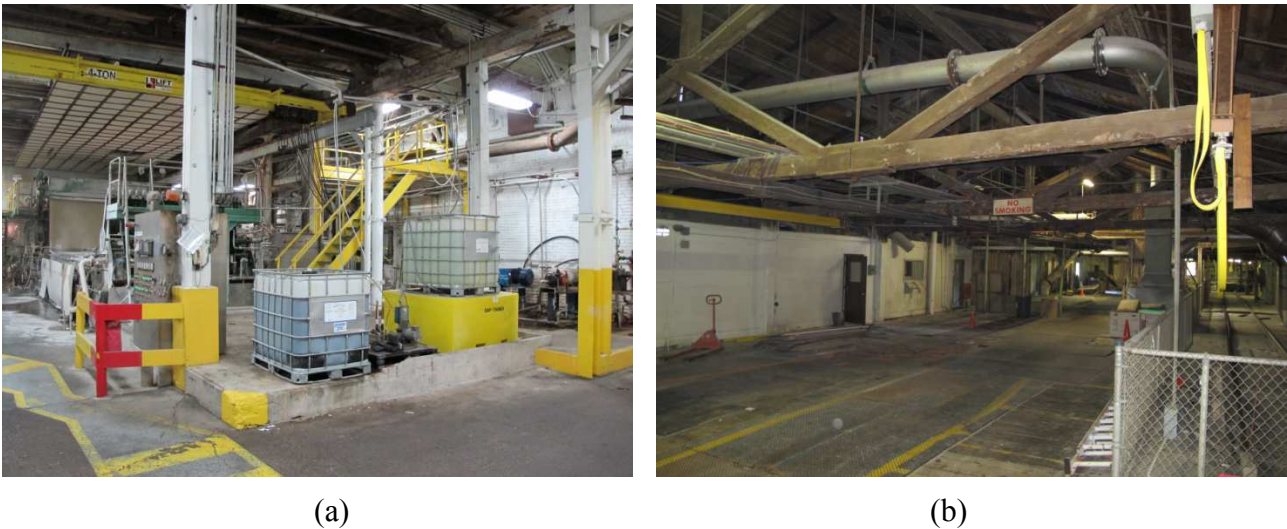
Figure 1. Heavy timber structures of a century-old industrial building. (a) Interior view of the first floor in the building showing a paper machine operation; (b) Interior view of the second floor in the building showing roof trusses and the floor.

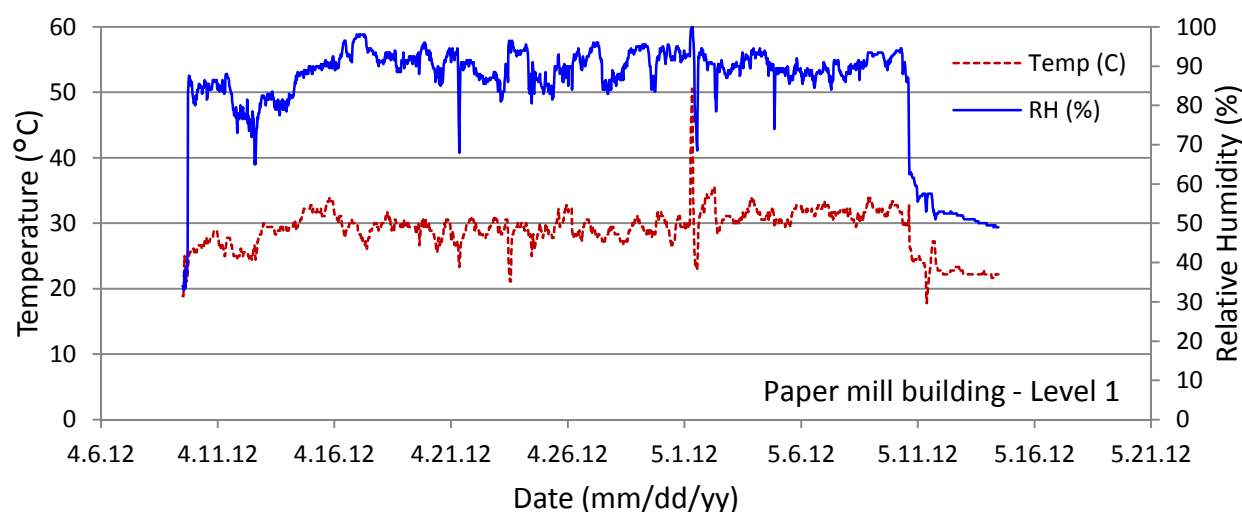
**Wood Moisture Content and Microclimate.** All timber columns in the first floor were generally in a dry condition (8 to 12.8% MC) except the columns in row A, which were from 26% to 28% MC, indicating possible moisture or water intrusion. Almost all the longitudinal beams and transverse beams in the first floor exhibited very high levels of moisture condition (23 to 55% MC). Most longitudinal beams were around fiber saturation point (30% MC), whereas all the transverse beams were almost fully saturated (30 to 55% MC). This high moisture level in the timbers was presumably caused by the high humidity and wet air condition created by the paper making operations. Note that the paper machinery is located between rows A and B and below the beams No. 6 to No. 9. The temperature and relative humidity of the air monitored at this location was shown in Figure 3. The monitoring record shows that the air temperature fluctuated between 22.2 °C and 34.4°C most of the time, and the relative humidity ranged from 83% to 96%, indicating an extremely wet condition resulting from the paper making operations. This constant high humidity environment is considered very detrimental to the physical conditions of the timber members in this area. This has been proved by the subsequent stress wave timing and resistance micro-drilling tests. The timber columns and bottom chords of the trusses in the second floor were in a good dry condition (8 to 11% MC).

Figure 3. Indoor air temperature and relative humidity inside the paper mill building monitored over a period of one month.

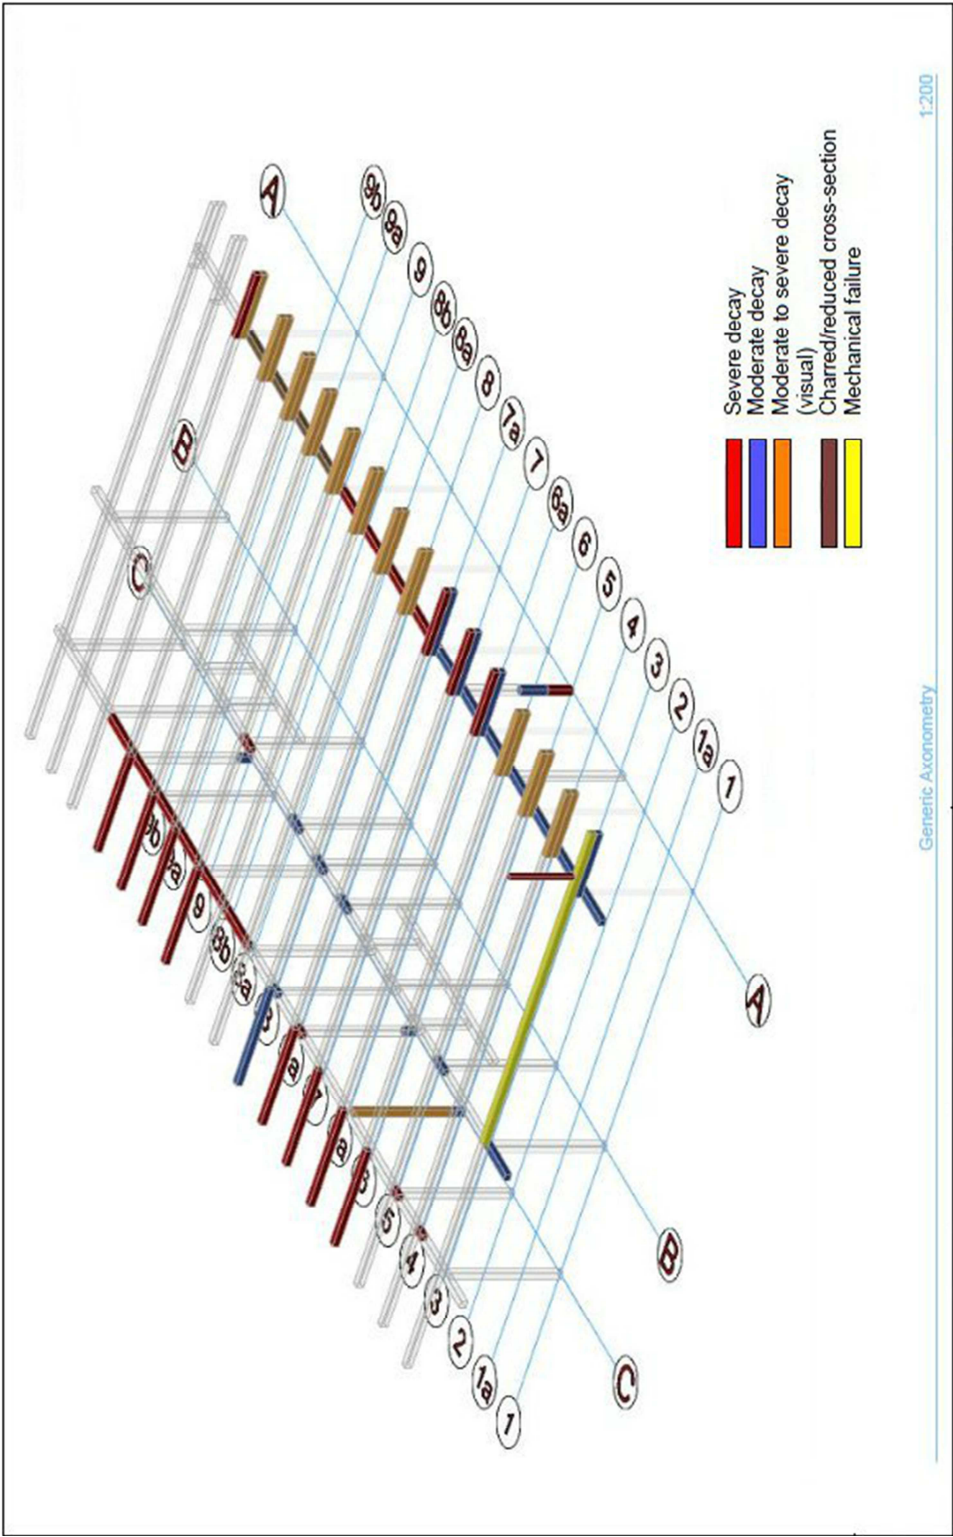
**Physical Conditions of the Structural Timbers.** The physical conditions of the heavy timber structures in the paper mill building are summarized and presented in color-coded maps as shown in Figure 4 and 5. The condition maps are 3D model-drawings created by using an ArchiCAD software and reflect the inspection results made by the team using a combination of visual, sounding, stress wave timing, micro-resistance drilling, and moisture content checking techniques. Only members with deterioration or mechanical failures were color painted using a color scheme defined for different levels of deterioration. Although not every timber member or every location were physically tested due to limited accessibility, these condition maps represent the best assessment of the true conditions of the timber structures in this building through the implementation of a nondestructive testing based inspection procedure.

The longitudinal beams in row A and the transverse beams between column A and the east wall, including corbels, are in poorest condition exhibited by widespread severe deterioration, reduced cross-sections by fire damage, and multiple failed members. Resistograph tests in these areas show little resistance or no resistance – an indication of severe internal deterioration (Figure 6). High moisture coming from the paper making operation is the leading cause of the severe deterioration in this area. Most members in this area are saturated or show signs of past wetness. As an example, Figure 7 shows the longitudinal beam between A8 and A9a exhibiting fire damage.

The transverse beams No. 3 – 6, and No. 8 – 9 between row C and the west wall also exhibited extensive deterioration as a result of water leaks from the water sink in the second floor. Resistograph tests on these beams show almost zero resistance. The longitudinal beams in row C No. 7 – No. 9 appear to have failed in the past and are currently reinforced by a steel beam. Moderate deterioration was also found in the beam connection areas where two longitudinal beams meet and sit on a timber column.

Transverse beams between row A and row B were found in relatively good condition exhibited by higher relative resistance and less deterioration, except beam No. 1 has extensive mechanical failures and can be deemed as a failed member. Most transverse beams in this area exhibited high level of moisture condition ( $>30\%MC$ ). This condition has two implications: 1) a significant strength reduction comparing with normal dry condition; 2) potential of decay development.

Minor to moderate deteriorations were found in some columns in row C near the concrete supporting pier. Column C4 was found leaning to west, an indication of stability problem. The transverse beam (between C4 and the west wall) above column C4 exhibits severe deterioration, and moderate decay was found in the lower portion of column C4.

Figure 4. Condition map of the timber structures in level 1 of the paper mill building (3D view)

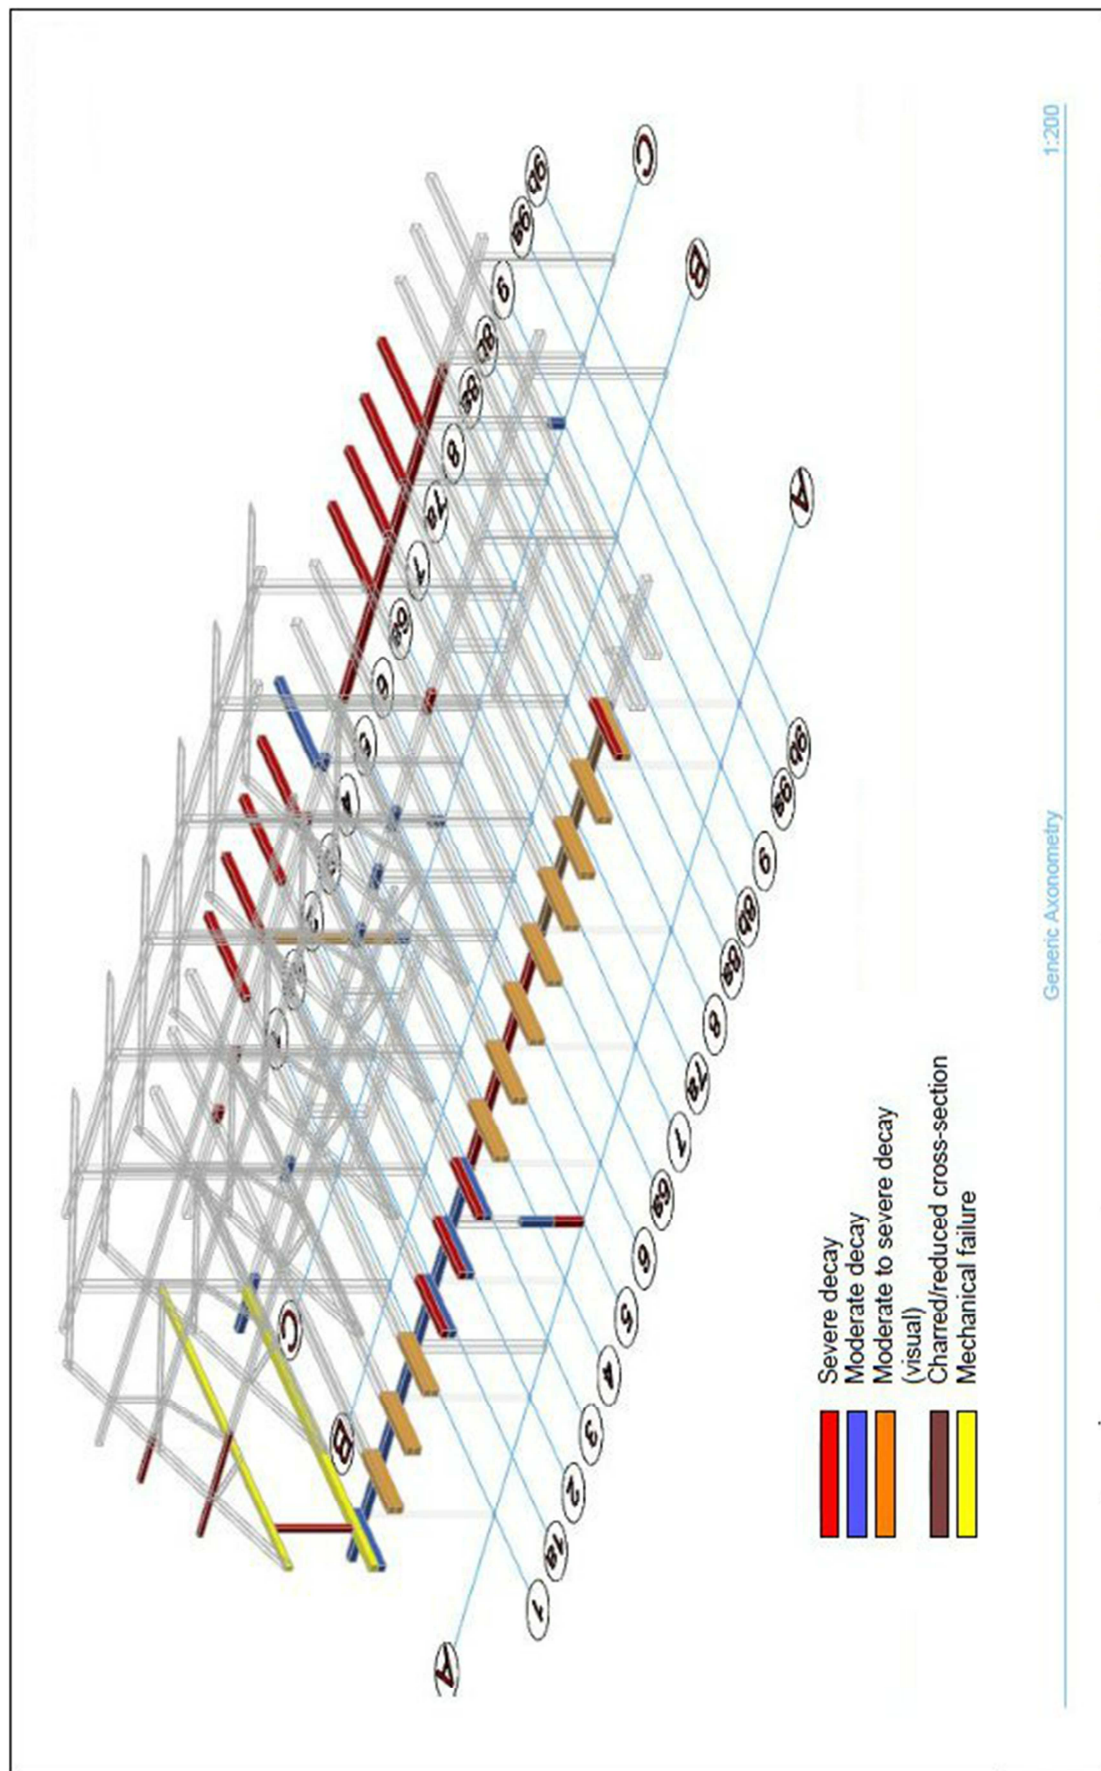
In the second story, Truss No. 1 has extensive mechanical failures and decay damage as evidenced by large deflection and shear failure on the bottom chord, failed steel bar connection, end decay, and delamination on the top chord. The roof beams under the top chord exhibit severe decay and delamination. The lower roof beam is actually broken at the location connecting to the top chord. The column supporting the Truss No. 1 next to the east wall also shows significant deterioration and delamination.

The bottom chords of Truss No. 3 and 4 have mechanical failures at the center connection area where two chords meet together and connected through a steel bar and two steel plates. All the bottom chords show minor to moderate deteriorations at the ends. The steel bar connections at the quarter-span of the bottom chords are currently loosed in almost all five trusses and no load acting on the bars. The center columns that support the trusses in the second story (column B) are generally sound, with minor to moderate deterioration detected near the floor level.

Figure 5. Condition map of the timber structures in levels 1 and 2 of the paper mill building (3D view)

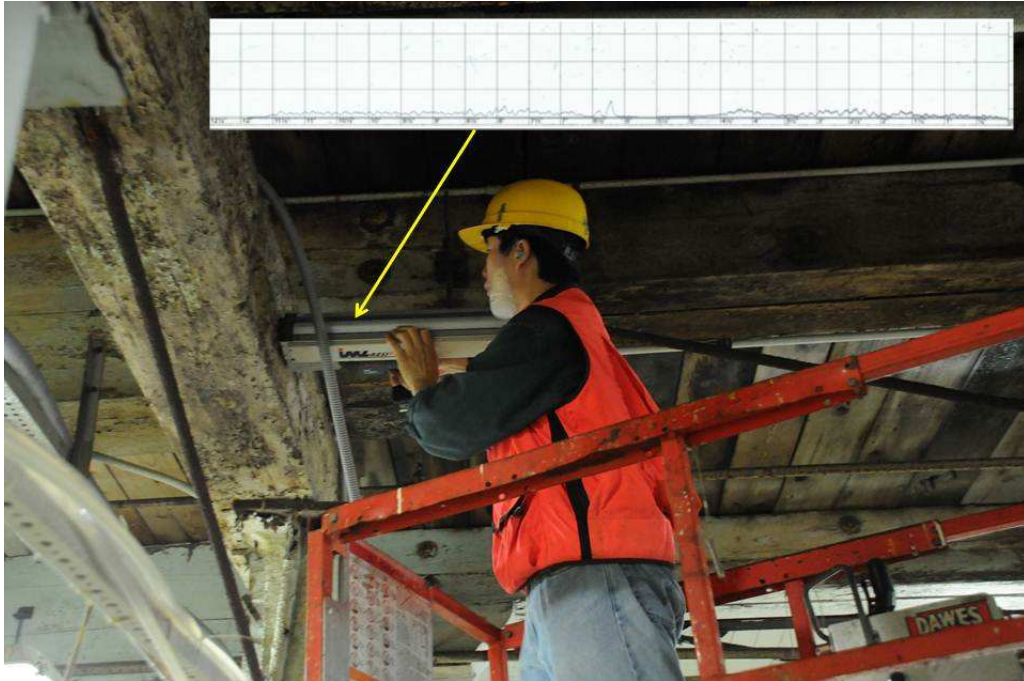
Figure 6. Longitudinal beam in row A: resistance drilling test showed little or no resistance, an indication of severe internal rot.

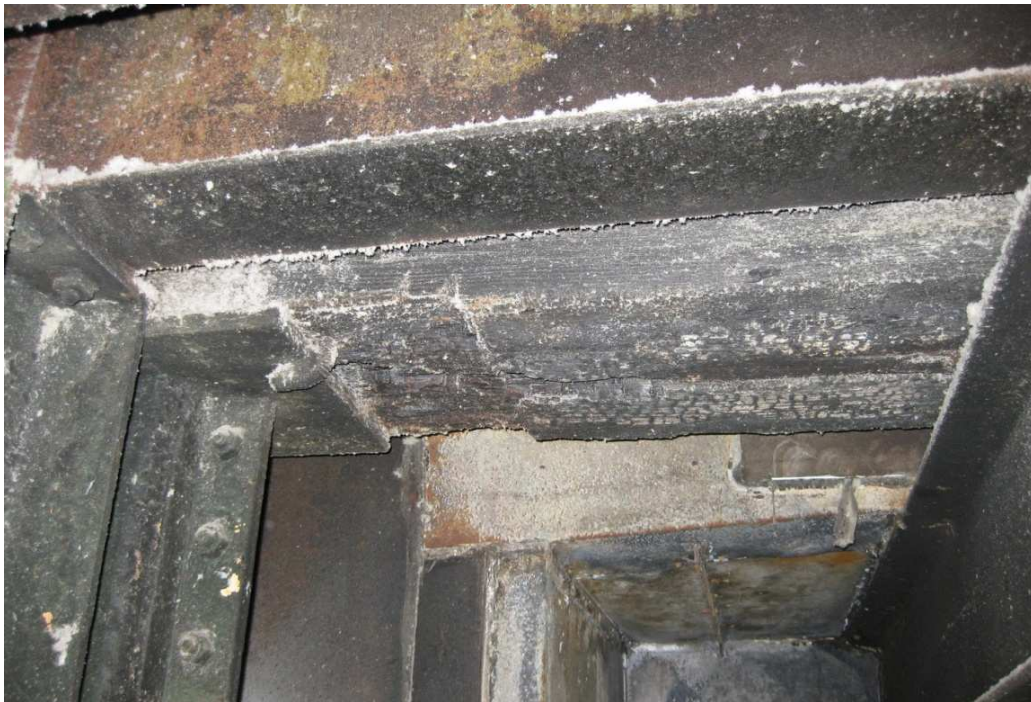
Figure 7. Longitudinal beam between A8 and A9a exhibits fire damage. The effective cross-section of the charred beam has been reduced significantly.
