# Condition Assessment of Iowa Timber Bridges Using Advanced Inspection Tools

## Summary

In: Wacker, J.; Krohn, J., eds. Proceedings, 2nd International Conference of Timber Bridges. Washington, DC: WoodWorks – Wood Products Council, 2013.

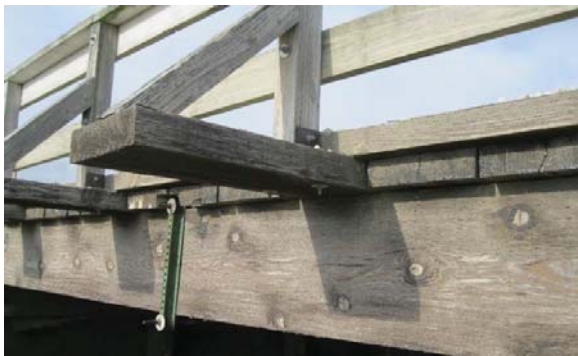
*Fig. 8 Bremer 2 guardrail detail*

Bremer 2 is situated in a shallow sag curve on 160<sup>th</sup> St. and has a gravel wearing surface, although there were small signs of asphalt on the curbs. The deck planks were found to be in good condition, all seated well on the girders, and had gaps between adjacent planks of approximately 3 mm (0.125 in.) to 13 mm (0.5 in.). The guardrails were constructed of untreated dimension lumber which had been painted and were connected to the bridge by simply anchoring the rail posts on top of deck planks that were cantilevered off the edge of the bridge, see Fig. 8. This guardrail detail is not vehicle-impact sufficient and the members are showing sign of deterioration.

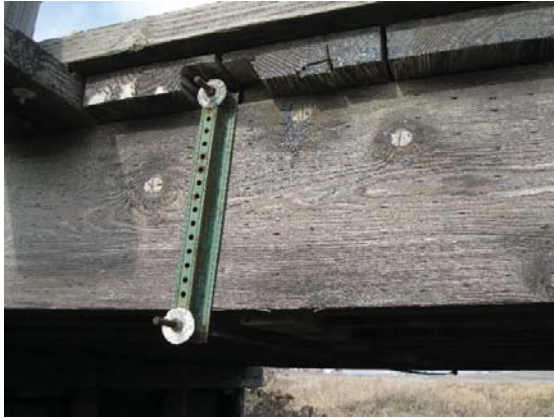
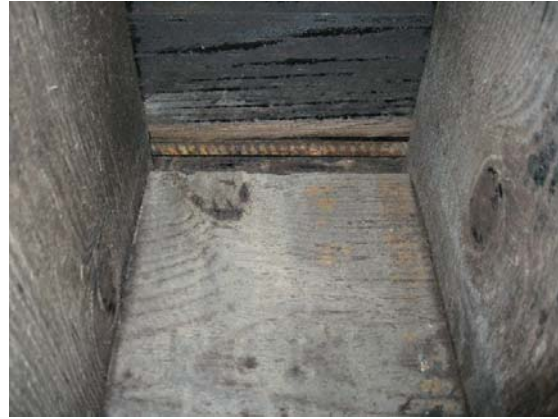
*Fig. 9 Steel tension rod on Bremer 2*

Bremer 2, like all the other Bremer bridges inspected, also had timber block diaphragms located at midspan between all girders. In addition, at midspan were steel tension rods (one above and below the girders) that ran the full width of the bridge. See Fig. 9 for photos of the timber diaphragms and steel tension rod details, respectively. Both the timber diaphragms and steel tension rods were in satisfactory condition on Bremer 2.

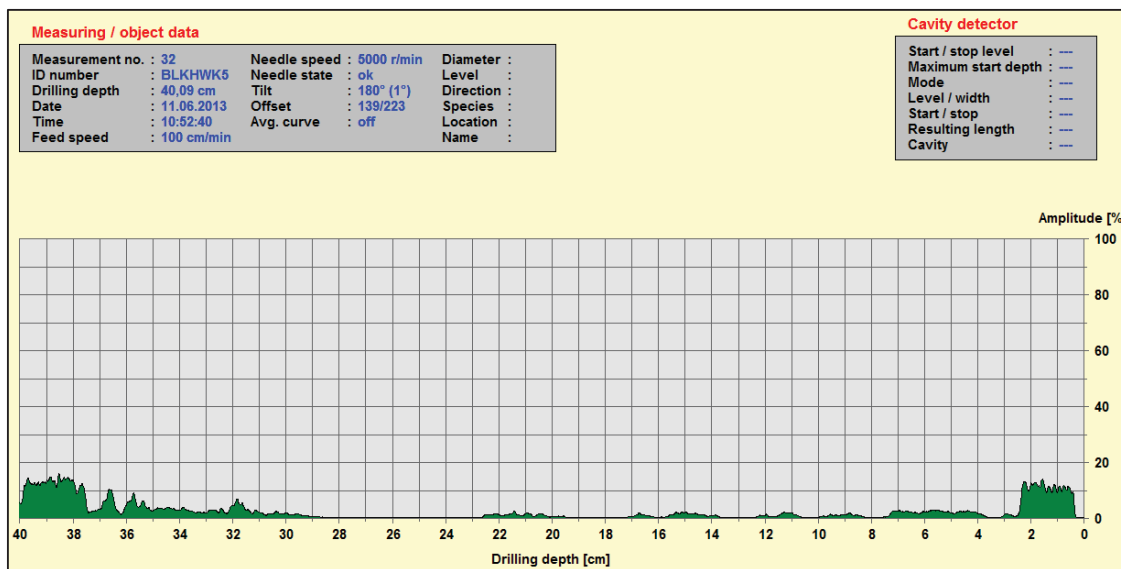
Fig. 11 Resistograph plot from girder G25, location 32, of Blackhawk 5

From below, Blackhawk 5 was generally in pretty good condition. Noteworthy items include: some girders were found to have settled under load approximately 3 to 6 mm (0.125 to 0.25 in.) at the EOB; shimming was present at EOB between a couple abutment piles and the abutment cap; G19 had a plywood shim placed between it and the deck planks over its entire length as well as section loss due to a large splinter at midspan that was approximately 3-3.4 m (10-11ft.) in length. Girder G25 had the most significant deterioration. Hammer sounding, in addition to the ease with which the moisture meter pins could be inserted into the member, quickly identified a problem area that began at approximately 0.7 m (2 ft.) from BOB and extended to just past midspan. This area was investigated extensively with the stress wave timer and resistograph, the results of which are summarized below.

Stress wave and resistograph readings were conducted at numerous location on girder G25 of the Blackhawk 5 Bridge. A sample resistograph plot is presented in Figs. 11. The stress wave readings along the member, along with comparison of resistograph readings helped identify and bound the location of the deterioration in girder G25. Areas of the plot that flatline to zero relative resistance (y-axis) levels are indicative of advanced decay.

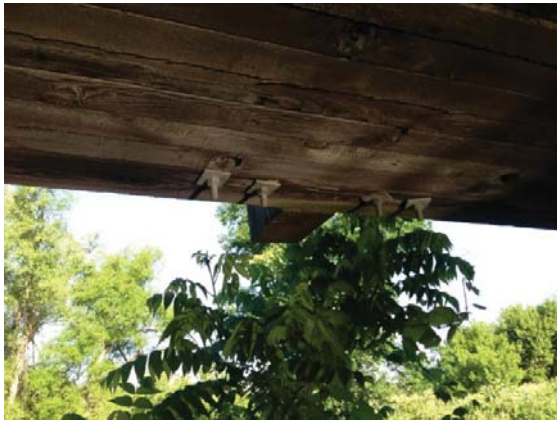
Clarke 3 has a gravel wearing surface that due to grading has all the scuppers partially to completely blocked. The most obvious signs of damage were at locations of physical connections, such as the guardrail post connections (see Fig. 12), and the longitudinal joint between deck panel sections where the lag screws have begun to push through the bottom of the deck and split the bottom of the member (see Fig. 13).

*Fig. 12 Damage at connection detail between guardrail post and deck, Clarke 3*

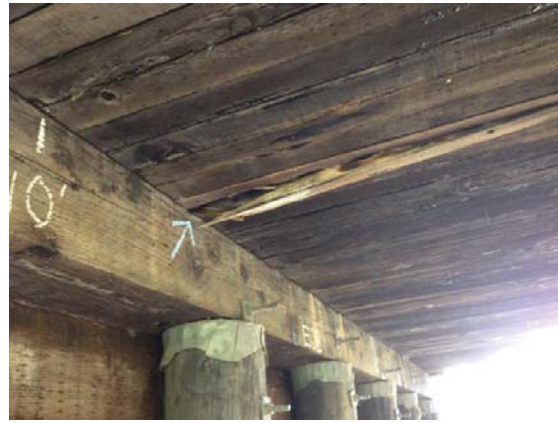
*Fig. 13 Damage at longitudinal deck panel connection, Clarke 3*

Stress wave readings and resistograph readings at random locations revealed no areas of concern even around the areas where the deck was damaged/deteriorated due to the panel connection detail.
