# Exterior Decay of Wood–Plastic Composite Boards: Characterization and Magnetic Resonance Imaging

Forest Prod. J. 66(1/2):4–17.

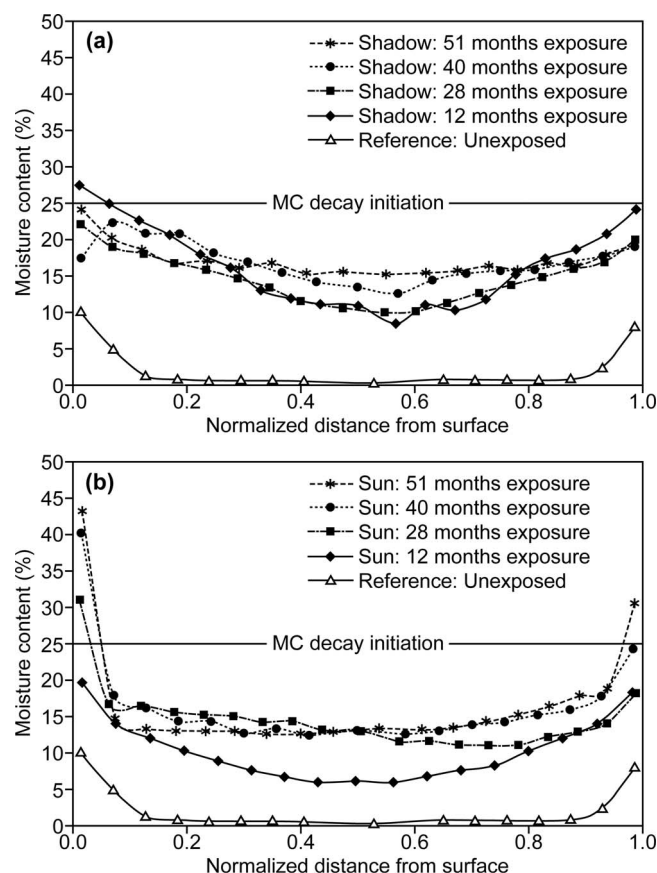
Figure 6.—Moisture content and distribution of (a) shadow and (b) sun boards during their first 51 months of exposure near Hilo, Hawaii.

MC and distribution of the WPC boards during the first 51 months of exposure in both shadow and sun locations are shown in Figure 6. MC and distribution in the graphs indicate relatively moderate WA by the boards during this period. The increase of MC in the core of the boards to 15 to 20 percent after 51 months of exposure seemed to approach the equilibrium MC associated with wetting and drying cycles. The MC in wood exceeded 25 percent only in narrow zones near the board surface in both sun and shadow locations. No severe degradation of the WPC board by

fungus decay was expected to occur at this time. The lack of significant decay after 51 months was further confirmed by the density measurements described above, which indicated no obvious density loss in the cross-sectional samples during this period of exposure.

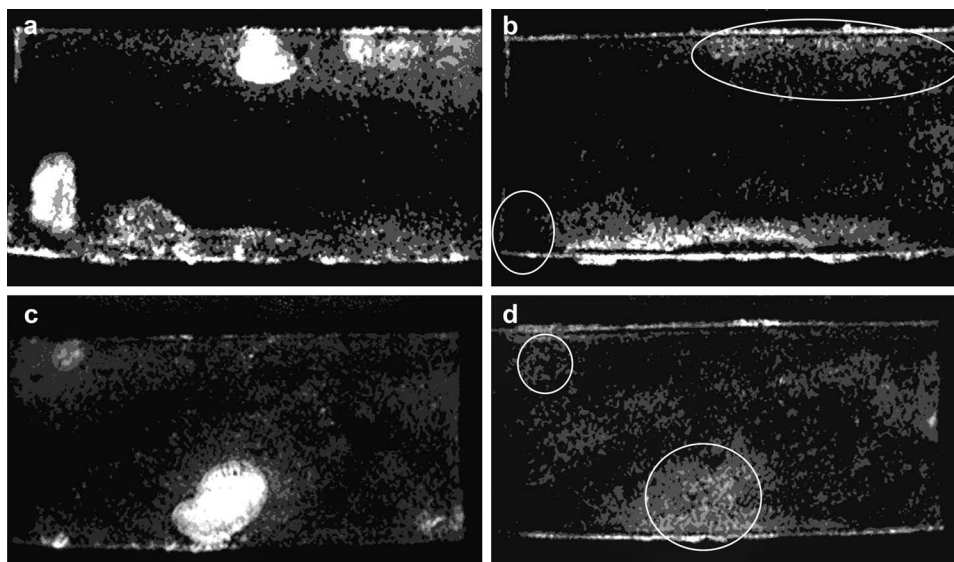
Figure 9.—Magnetic resonance images of the shadow board obtained in Plane 1 at (a) Side A showing the slice at the bottom surface of the board, (b) Side A showing the slice about 8 mm above the bottom surface of the board, (c) Side B showing the slice at the bottom surface of the board, and (d) Side B showing the slice about 8 mm above the bottom surface of the board. Images (a) and (c) mirror the bottom side of the board shown in Figure 4b.

shown in Figure 9. Fungal fruiting bodies, which appear as relatively bright white ovular features, indicating a high concentration of free water, are apparent in images obtained at the very bottom surface of the board. Figure 9a, an image obtained in Plane 1 of the bottom of Side A, shows the presence of free water associated with three fungal fruiting bodies, which were previously seen in Figure 4b. In the same area, another image obtained in the same plane 4 mm above the bottom surface of the board shows that in the vicinity of two of the three fungal fruiting bodies, there is an increase in localized moisture, as indicated by gray regions along the top edge of the image (Fig. 9b). However, there is an obvious lack of free water in the bottom left corner of the image, in an area directly adjacent to the third fungal fruiting body. Figure 9c shows an image obtained in Plane 1 of the bottom of Side B of the board, again displaying the moisture-abundant fruiting bodies present. An MRI slice obtained 4 mm above this area indicates the significant presence of free water throughout the greater portion of the

imaged area, and in particular, at both locations immediately adjacent to fungal fruiting bodies (Fig. 9d).

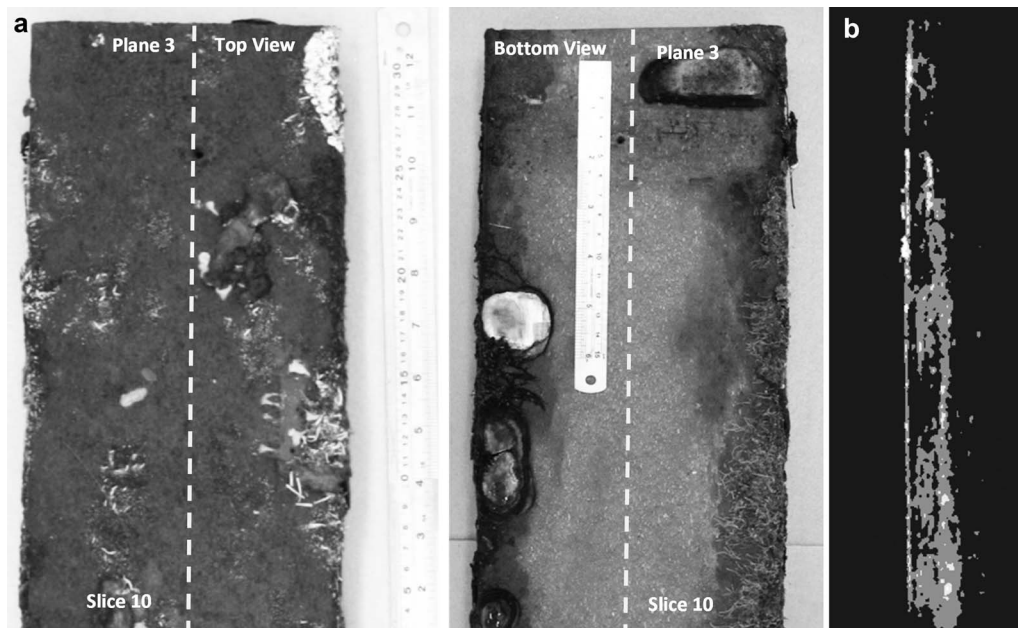
A similar pattern of free moisture distribution was also observed in images obtained in Plane 3 of the shadow board segment from both Side A and Side B (Figs. 13 and 14). In both images, a clear moisture-rich layer surrounding the surface of the samples is apparent, as is a significant reverse moisture gradient originating from the core of the cross section.

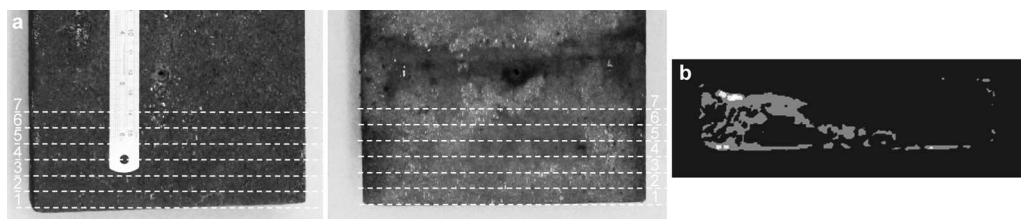
For the board segment exposed in sun, images of the sample cross sections often appeared without the typical light-colored border, indicating a high MC near the surface but a relatively high free water concentration in their core. Figure 16 shows an example of this phenomenon where an image was obtained in Plane 2 of the sun board at Side B,

approximately 32 mm from the edge of the board (Slice 4). Another example of this phenomenon can be observed in Figure 17, which shows an image obtained in Plane 3, Side A of the same board, approximately 32 mm from the longitudinal edge on the left-hand side based on the top view of the board. There appears to be a lack of a thin moisture-rich layer at the outer exposed surface of the sample, which is on the left-hand side of the image.

Figure 16.—Images of the sun board at Side B of the board showing (a) location of the slices and (b) magnetic resonance image obtained in Plane 2 of Slice 4.

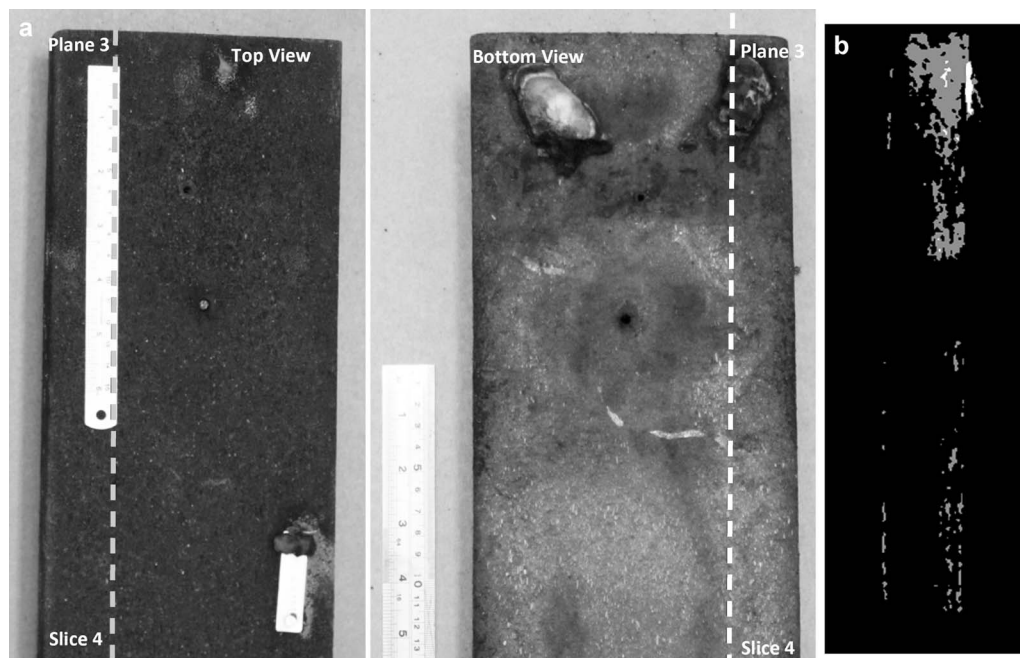
However, there is an apparent concentration of free water inside the sample near the top of the image (Fig. 17b). This moisture distribution pattern was similarly observed in a Plane 3 cross section from Side B of this sun board segment, obtained approximately 56 mm from the longitudinal edge of the board (Fig. 18). Again, there is clearly a moisture-rich layer at the exposed surface of the board; however, there appears to be a thin zone of high free water content in the core of the sample.

Figure 17.—Images of the sun board at Side A of the board showing (a) location of the slice and (b) magnetic resonance image obtained in Plane 3 of Slice 4.

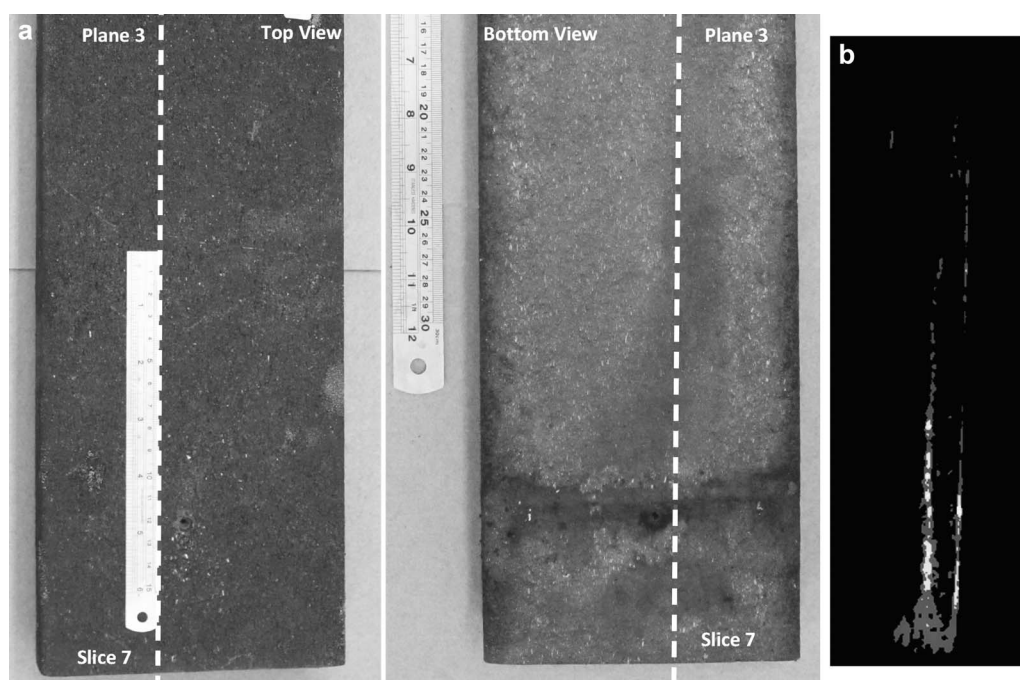
Figure 18.—Images of the sun board at Side B of the board showing (a) location of the slice and (b) magnetic resonance image obtained in Plane 3 of Slice 7.
