# Nondestructive Assessment of Wood Members from a Historic Viewing Tower

Research Note  
FPL–RN–0349

August  
2017

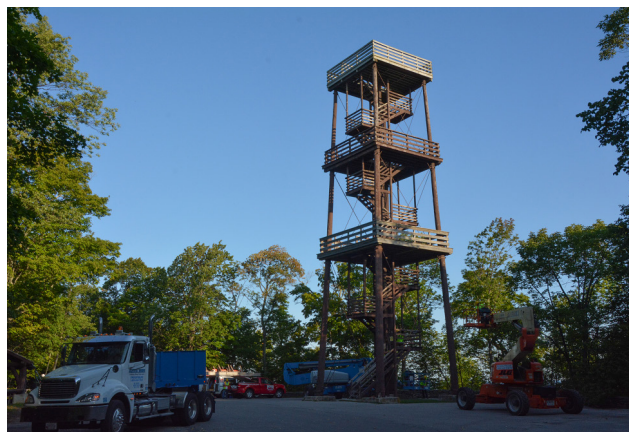
**Figure 1. Eagle Tower, Peninsula State Park, Door County, Wisconsin.**

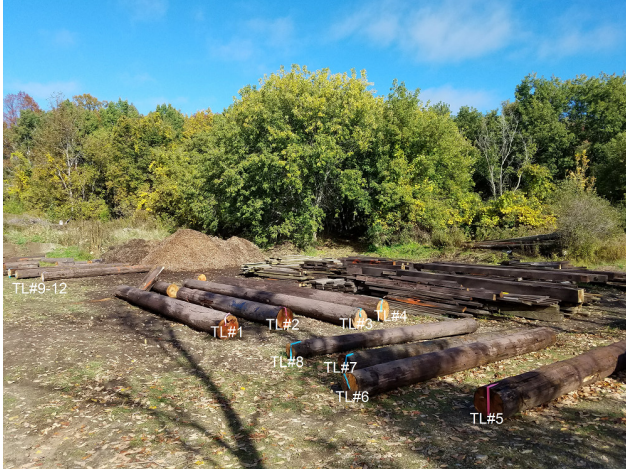
**Figure 2. Materials from the dismantled tower.**

1. All of the large timbers should be stored under cover and off the ground. This will minimize further deterioration.
2. None of the members should be reused in any load-bearing application. Reuse of any recovered materials should be limited to non-load-bearing applications, for example, as interior paneling in offices, signage, or craft-type products.

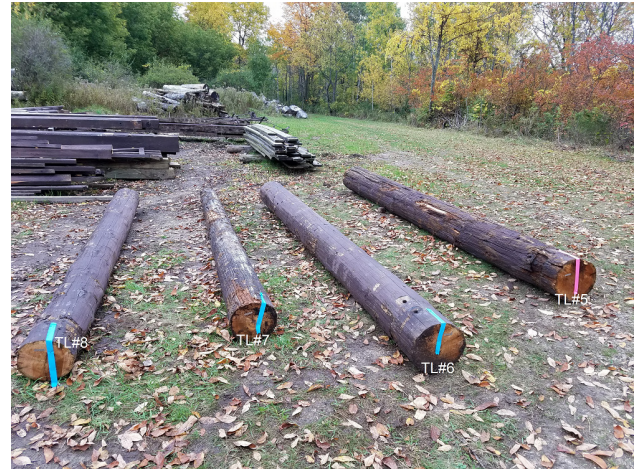
**Figure 4. Timber sections TL#5 through TL#8 were from the uppermost portion of the tower's legs.**

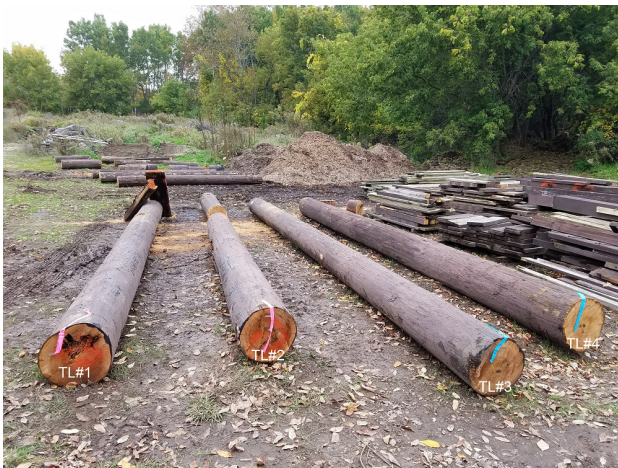
**Figure 3. Sections from the four timbers that served as legs for the tower. Sections identified as TL#1 through TL#4 were the leg sections that rested on concrete support pads.**

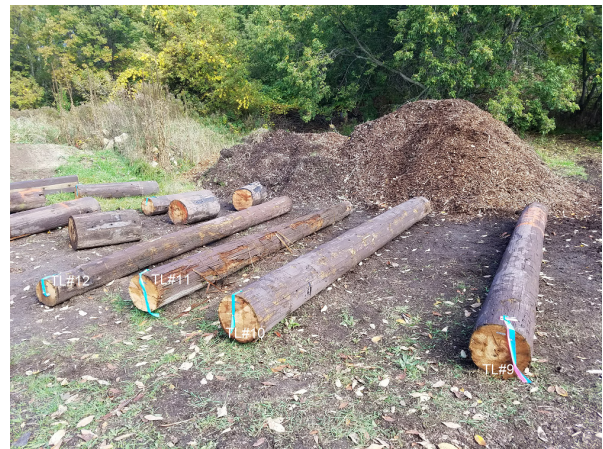
**Figure 5. Timber sections TL#9 through TL#12 were the middle section of the tower's legs.**

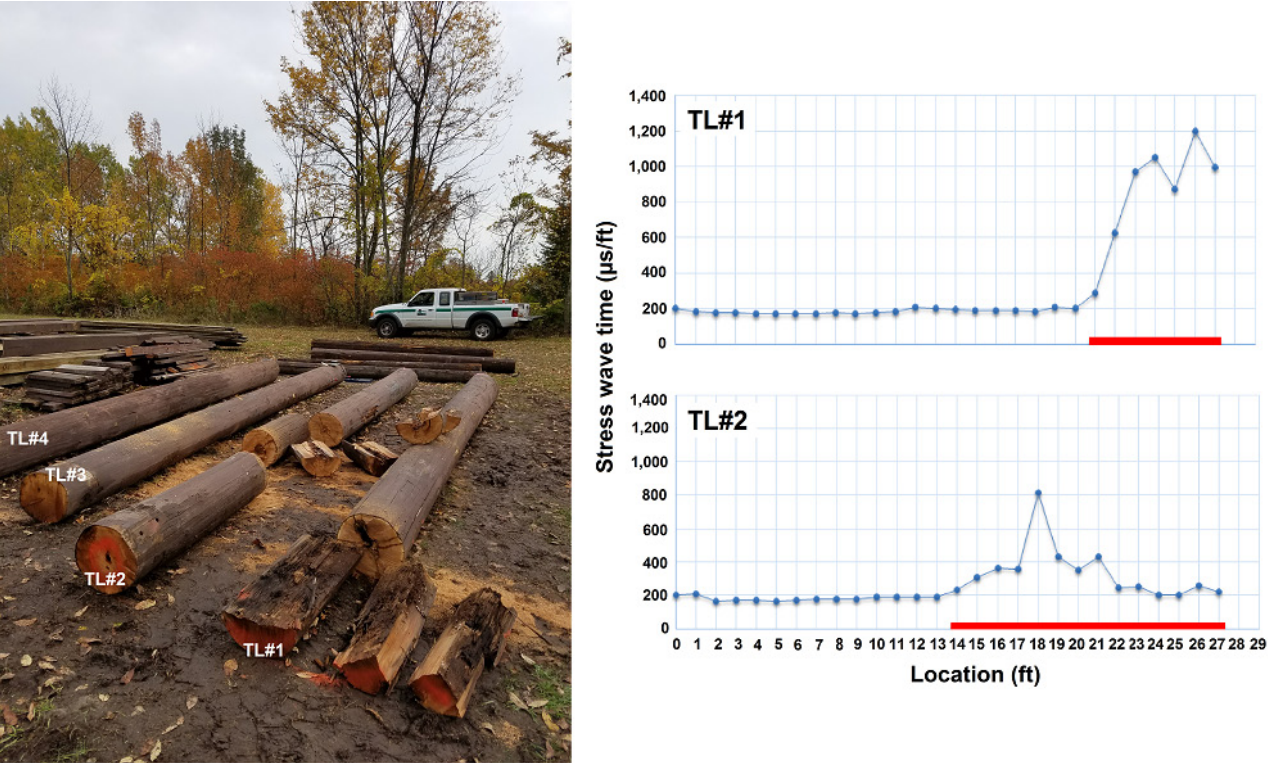
Figure 6. Timber sections TL#1 through TL#4, with corresponding stress wave transmission test results. Test results indicated severe deterioration in sections TL#1 and TL#2.

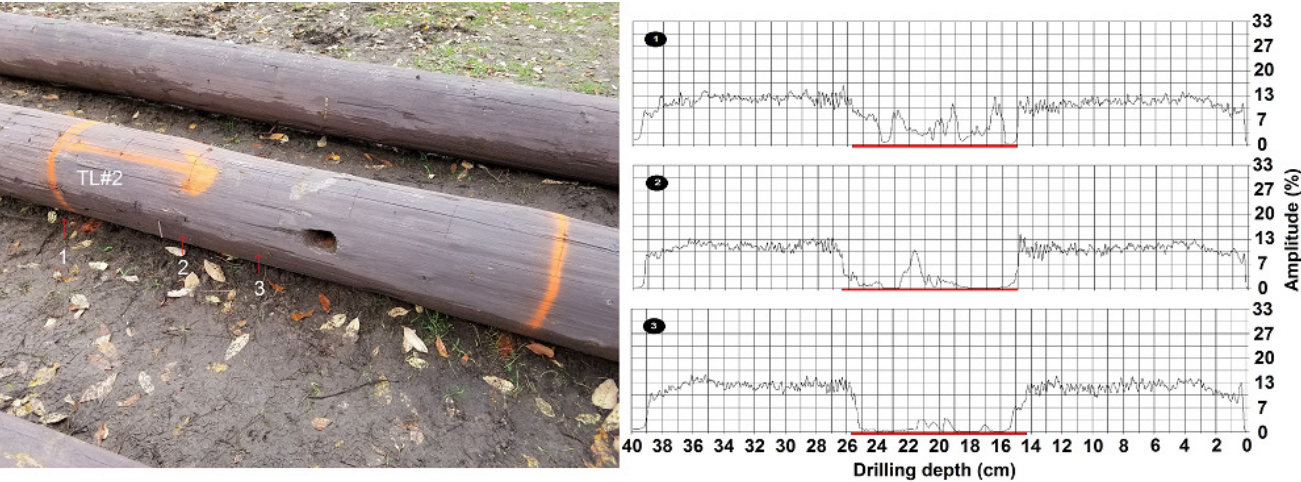
Figure 7. Microdrilling resistance results indicated deterioration in the vicinity of a bird nest in the timber.

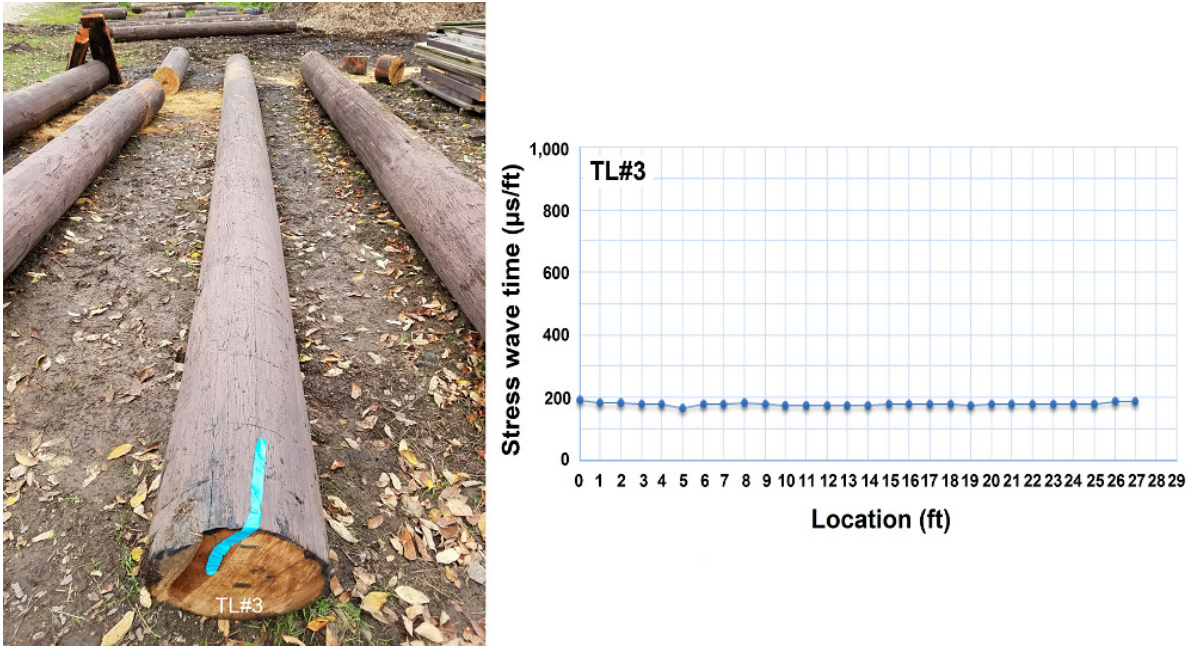
Figure 8. Timber section TL#3 and corresponding stress wave test results. No deterioration was observed.

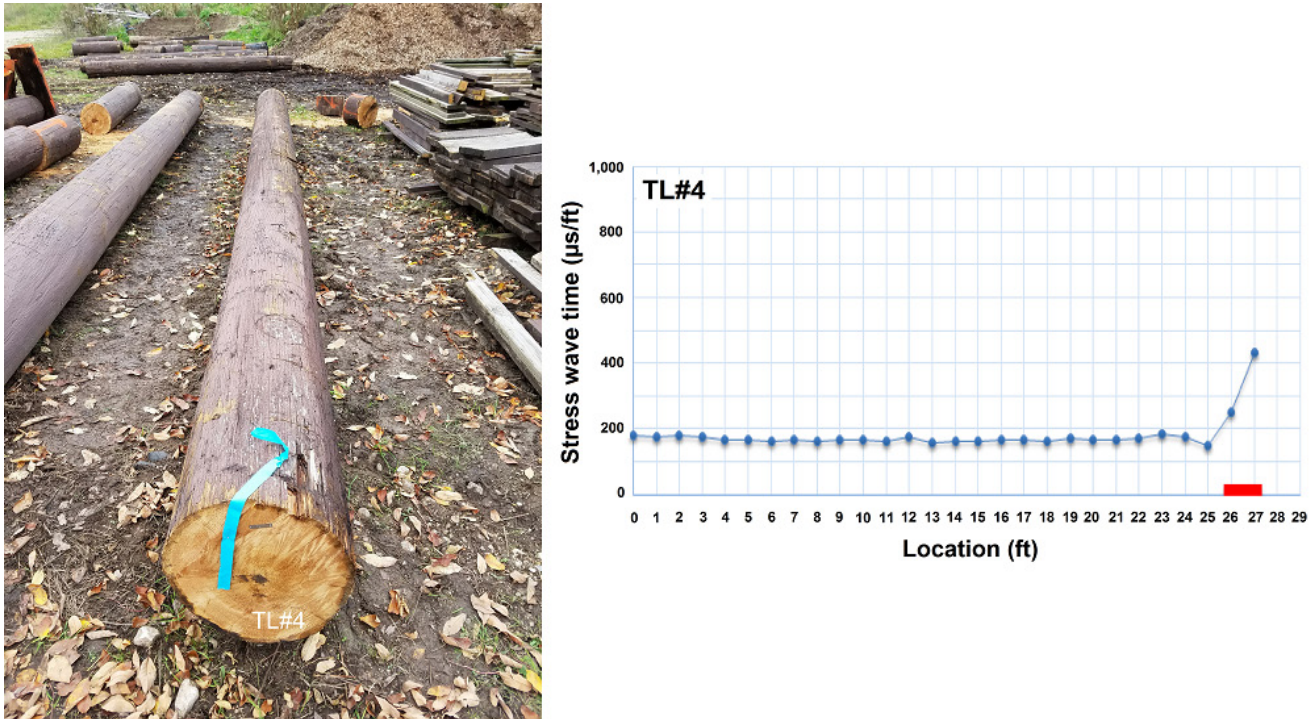
Figure 9. Deterioration was noted for timber section TL#4.

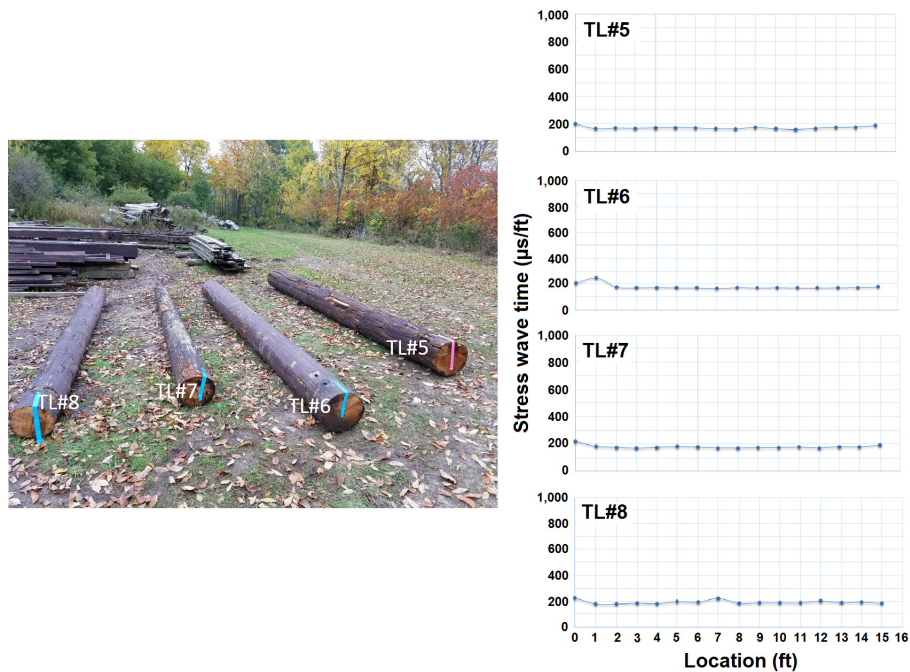
Figure 10. Results obtained from stress wave tests of the uppermost sections of the tower's legs.

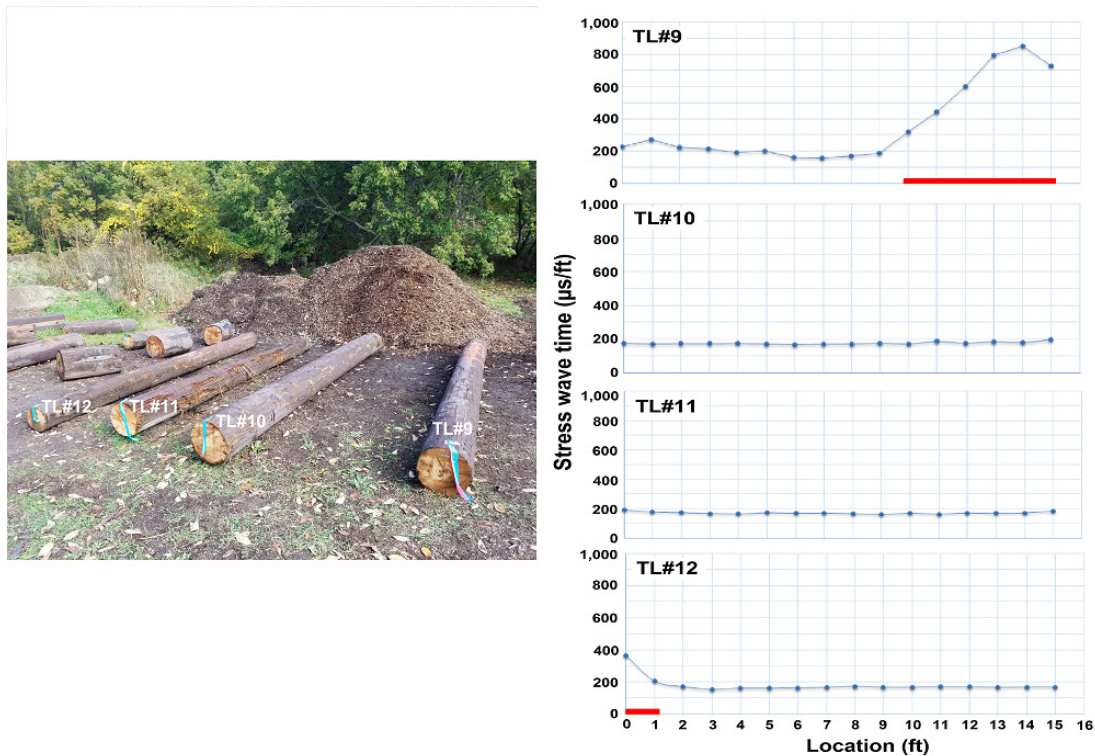
Figure 11. Test results from the middle sections of the tower's legs.

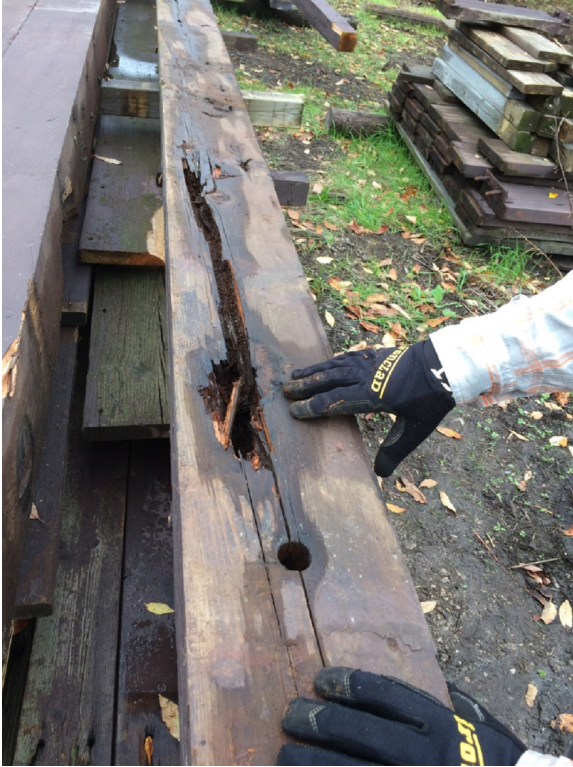
Intensive testing of the four large timbers that served as the legs for the tower was conducted. Figures 2 through 5 show the dismantled timbers. Each timber was sawn into three sections prior to testing. Figures 6 through 11 show each of the sections and corresponding test results. One of the legs was severely deteriorated with significant decay throughout its entire length. Another leg had significant deterioration. The other two contained limited areas of deterioration. A visual inspection of many of the horizontal cross members from the tower revealed significant deterioration. One of these members was severely split and was deteriorated along its entire length (Fig. 12).

**Figure 12. Horizontal support member that contained severe deterioration.**
