**Comparative Durability of Timber Bridges in the USA**

James P. Wacker and Brian K. Brashaw

Paper prepared for the IRG48 Scientific Conference on Wood Protection  
Ghent, Belgium  
4-8 June 2017

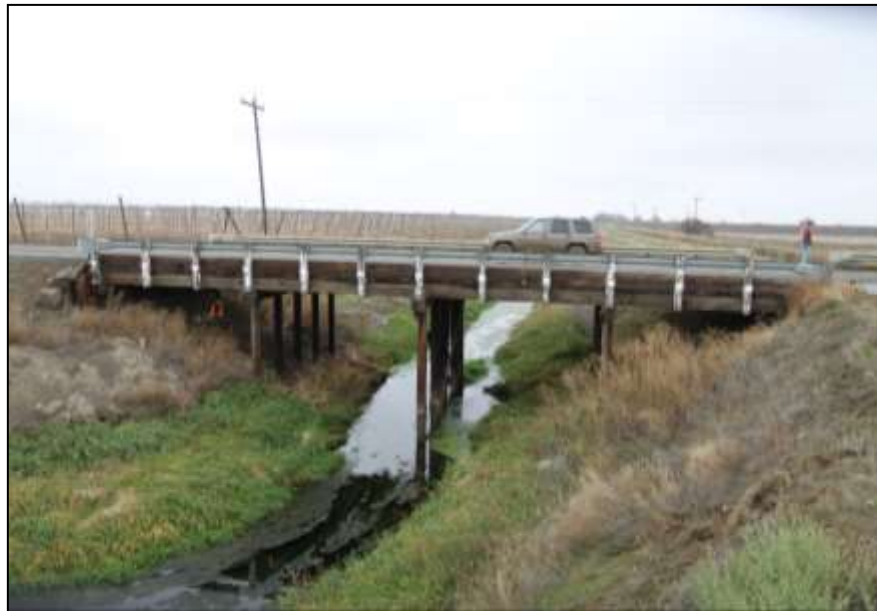
Several examples of outstanding sawn girder bridge durability were discovered; one from Yakima County, Washington is shown in Figure 4. This bridge has no record of repair or rehabilitation, with the exception of one sister beam added near the deck edge. It has been in-service for approximately 75 years and still maintains an average daily traffic of 1,600 vehicles and trucks. The bridge remains in satisfactory condition (NBI condition rating of 6) with no measurable section loss or deterioration at critical locations.

Figure 4: Durable example of a 75-year old sawn girder bridge located in Yakima County, Washington which still remains in satisfactory condition.
