# Residential Tornado Safe Room from Commodity Wood Products

## Impact and Wind Pressure Testing

General Technical Report  
FPL–GTR–254

February  
2018

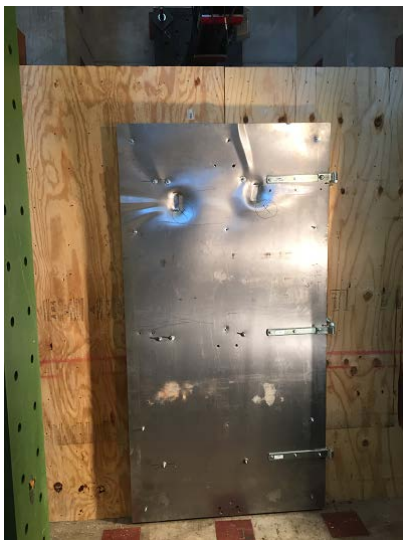
The impact tests resulted in significant dents in the tornado safe room door. However, occupants would have been fully protected because there was no missile penetration, no debris was created, and the door deflected less than 3 in. (Fig. 10 and Appendix B). After impact, the hinge was undamaged and the door opened and closed properly. The second impact test, which was directed at the cane bolt

**Figure 10. Door impact damage.**

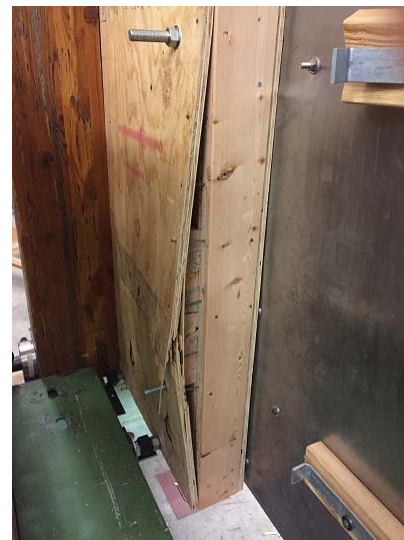
**Figure 12. Damage caused by impact adjacent to door opening. No debris created, but deflection >3 in. occurred.**

To rectify this problem, three 14-gauge (0.07-in.-thick) sheet steel angles (4 by 4 in.) were fabricated to reinforce the door jamb (Figs. 13 and 14). Initially, these angles were

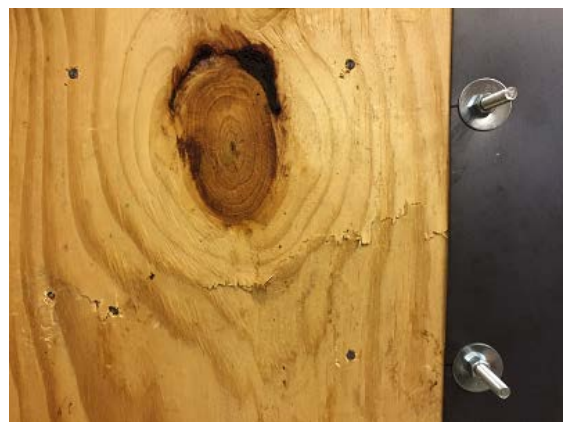
**Figure 16.** Effect of using 14-gauge door jamb reinforcement. Note that only slight cracking of the plywood resulted from the impact.

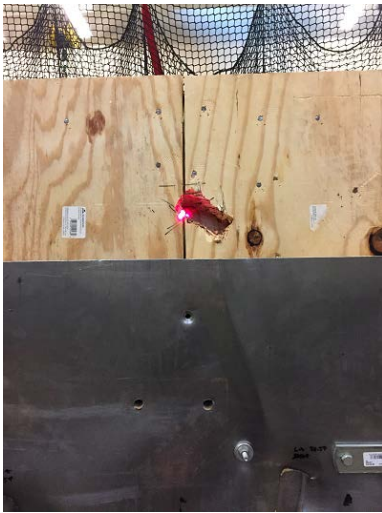
**Figure 17. Exterior damage caused by impact test of roof-wall interface and head jamb.**

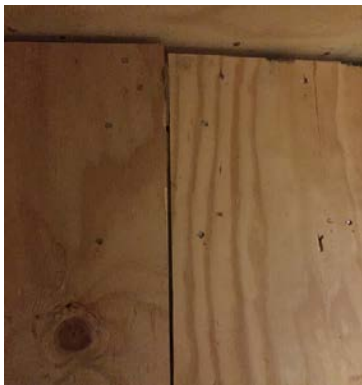
**Figure 18. Interior damage caused by impact test of head jamb.**

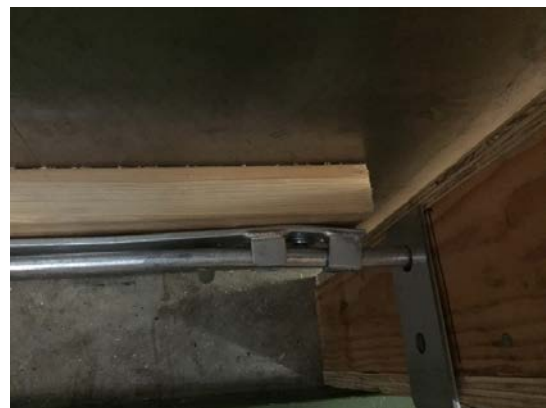
**Figure 28. Bending of cane bolt caused by wind suction at two times design load.**

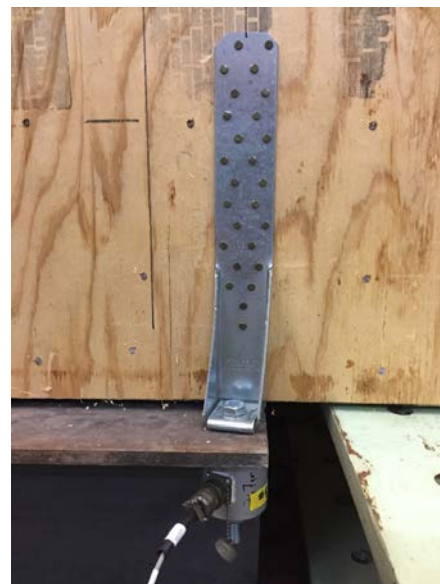
For both tests at 1.5 times design, the room and its components showed no major damage or distress. Increasing the load to 2 times design resulted in some bending of the tie-downs and some slight nail pullout from the tie-downs (Figs. 34 and 35). This pullout was more pronounced in the test when the room was oriented as in Figure 31.

**Figure 34. Bending of tie-down at two times design load.**

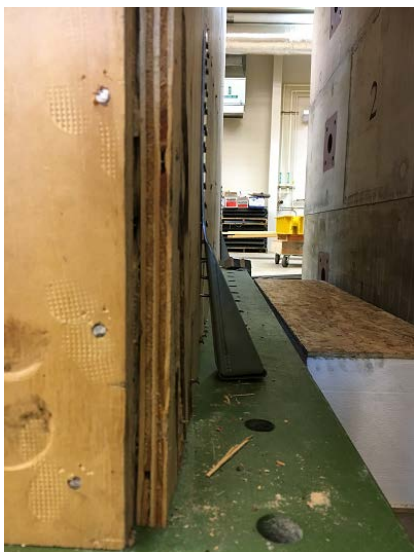
**Figure 35.** Nail pullout of tie-down at two times design load.

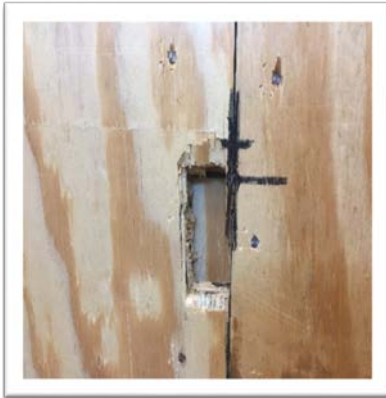
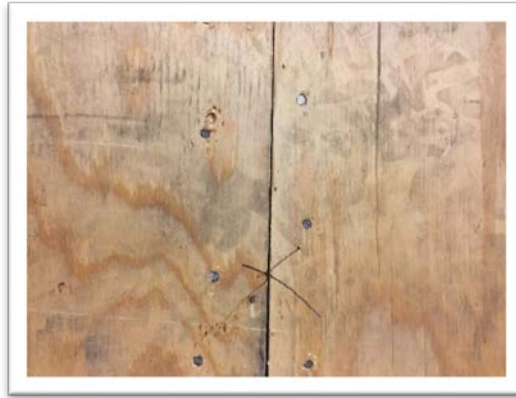
| Panel number | Panel construction | Missile speed (mi/h) | Front penetration (in.) | Permanent deflection (in.) | Panel/door perforated (Y/N) | Observed damage | Passed test? (Y/N) | Additional notes |
|---|---|---|---|---|---|---|---|---|
| 1 | Roof panel<br>three 2 by 8s, 23/32-in.<br>plywood one side | 103 | 2.0 | <1.0 | N | None to<br>backside | Y | Impact at center<br>of panel |

Left: front of panel penetration; Right: backside of panel.

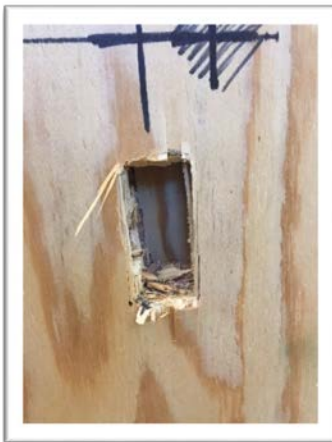
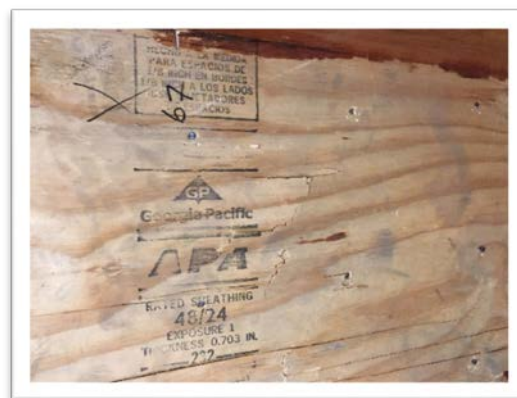
| Panel number | Panel construction | Missile speed (mi/h) | Front penetration (in.) | Permanent deflection (in.) | Panel/door perforated (Y/N) | Observed damage | Passed test? (Y/N) | Additional notes |
|---|---|---|---|---|---|---|---|---|
| 1 | Roof panel<br>three 2 by 8s,<br>23/32-in. plywood<br>one side | 104.1 | 2.2 | 1.0 | N | Slight cracking of<br>plywood, no debris | Y | Impact at edge<br>of panel |

Left: front of panel penetration; Right: slight cracking on backside of panel.

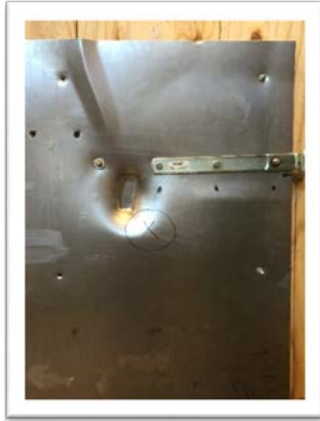
| Door number | Door construction | Missile speed (mi/h) | Front penetration (in.) | Permanent deflection (in.) | Panel/door perforated (Y/N) | Observed damage | Passed test? (Y/N) | Additional notes |
|---|---|---|---|---|---|---|---|---|
| 1 | Three sheets 23/32-in. plywood 18-gauge steel sheets both faces | 104.4 | 1.3 | <1.0 | N | Large dent | Y | Impact test on upper hinge. Door operated properly after test. Hinge undamaged. |

Impact test to hinge.

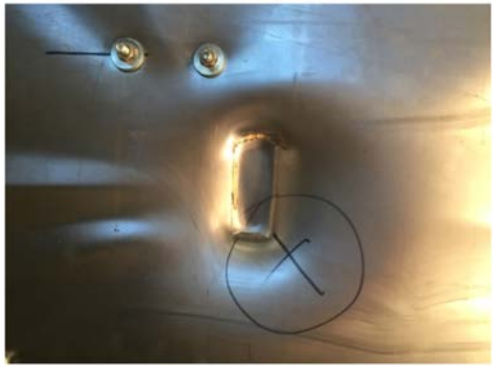
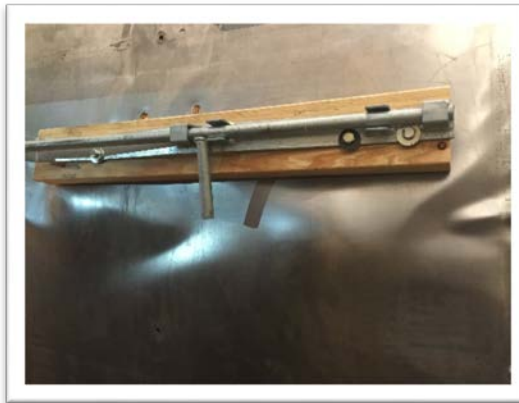
| Door number | Door construction | Missile speed (mi/h) | Front penetration (in.) | Permanent deflection (in.) | Panel/door perforated (Y/N) | Observed damage | Passed test? (Y/N) | Additional notes |
|---|---|---|---|---|---|---|---|---|
| 1 | Three sheets 23/32-in. plywood 18-gauge steel sheets both faces | 102.0 | 1.5 | <1.0 | N | Large dent | Y | Impact test on upper latch. Latch required release with hammer. |

Left: front of door after impact; Right: back of door after impact.

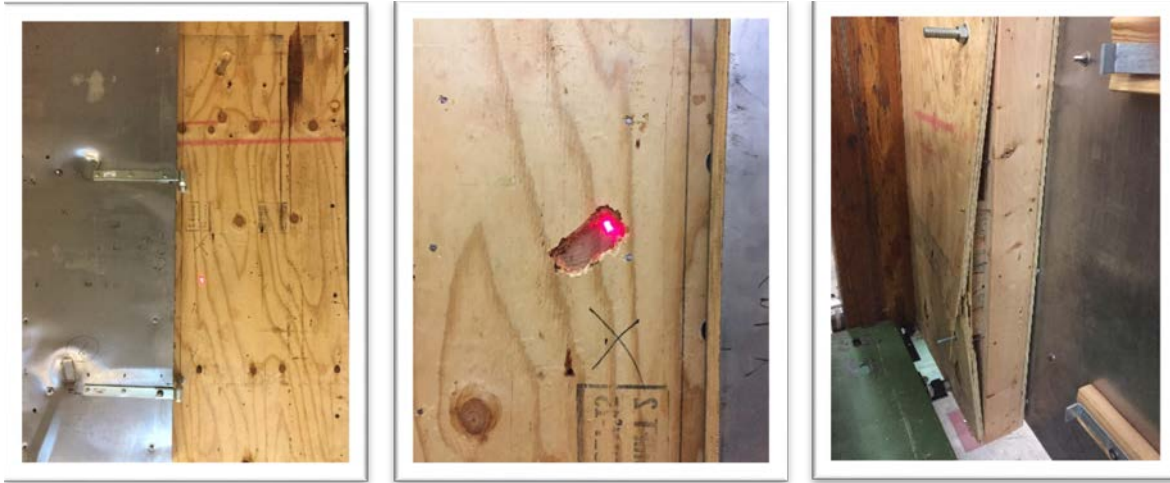
| Panel number | Wall construction | Missile speed (mi/h) | Front penetration (in.) | Permanent deflection (in.) | Panel/door perforated (Y/N) | Observed damage | Passed test? (Y/N) | Additional notes |
|---|---|---|---|---|---|---|---|---|
| 1 | 2 by 8 beams, two sheets 23/32-in. plywood | 100.3 | 1.9 | 4.0 | N | Excessive deformation | N | No debris. Permanent deformation >3 in. |

Left: front of panel before impact test; Center: front of panel after impact test; Right: back of panel after impact test.

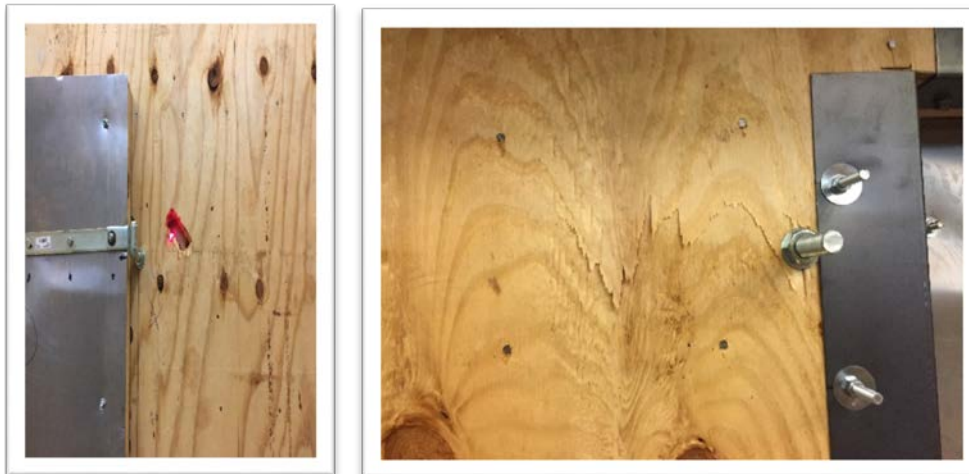
| Panel number | Wall construction | Missile speed (mi/h) | Front penetration (in.) | Permanent deflection (in.) | Panel/door perforated (Y/N) | Observed damage | Passed test? (Y/N) | Additional notes |
|---|---|---|---|---|---|---|---|---|
| 1 | 2 by 8 beams, two sheets 23/32-in. plywood, 14-g steel angle reinforcement around door | 100.3 | 1.5 | <1.0 | N | Slight cracking of plywood | Y | No debris |

Left: front of panel after impact test; Right: back of panel after impact test.

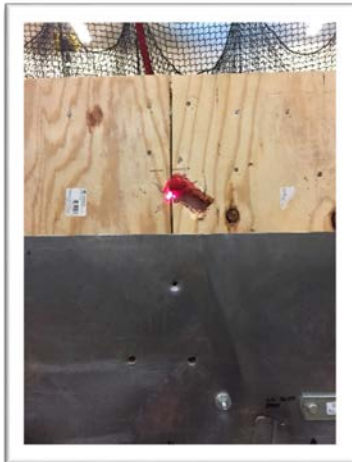
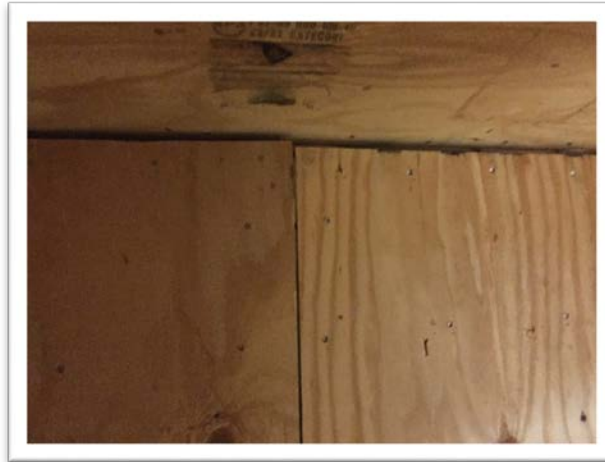
| Panel number | Wall construction | Missile speed (mi/h) | Front penetration (in.) | Permanent deflection (in.) | Panel/door perforated (Y/N) | Observed damage | Passed test? (Y/N) | Additional notes |
|---|---|---|---|---|---|---|---|---|
| 1 | 2 by 8 beams, two sheets 23/32-in. plywood, 14-g steel angle reinforcement around door | 106.3 | 2.6 | <1.0 | N | Slight separation of plywood joint at interior | Y | No debris, no distress to door frame |

Left: head jamb exterior damage; Right: head jamb interior damage.

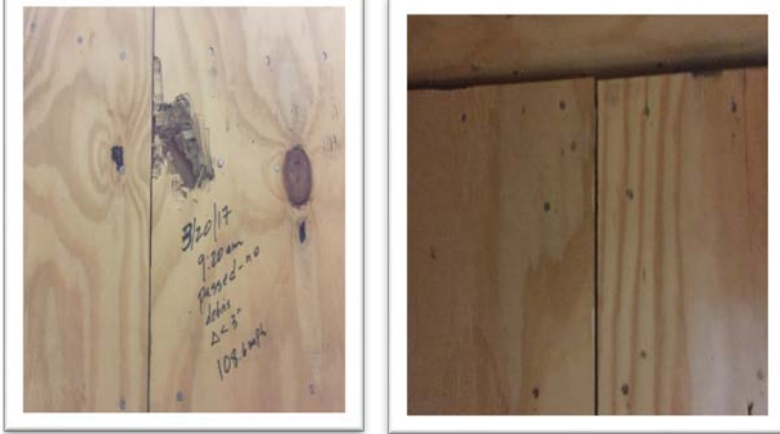
| Location<br>(see Figs. 21–22) | Wall<br>construction | Missile<br>speed<br>(mi/h) | Front<br>penetration<br>(in.) | Permanent<br>deflection<br>(in.) | Panel<br>perforated<br>(Y/N) | Observed<br>damage | Passed<br>test?<br>(Y/N) | Additional<br>notes |
|---|---|---|---|---|---|---|---|---|
| A | 2 by 8 beams,<br>two sheets<br>23/32-in. plywood | 108.6 | 2.6 | <1.0 | N | Slight<br>separation of<br>plywood<br>(interior) | Y | No debris |

Left: exterior damage after impact; Right: interior damage after impact.  
(impact location: 1.5 in. right, 7.5 in. below top center of room side.)

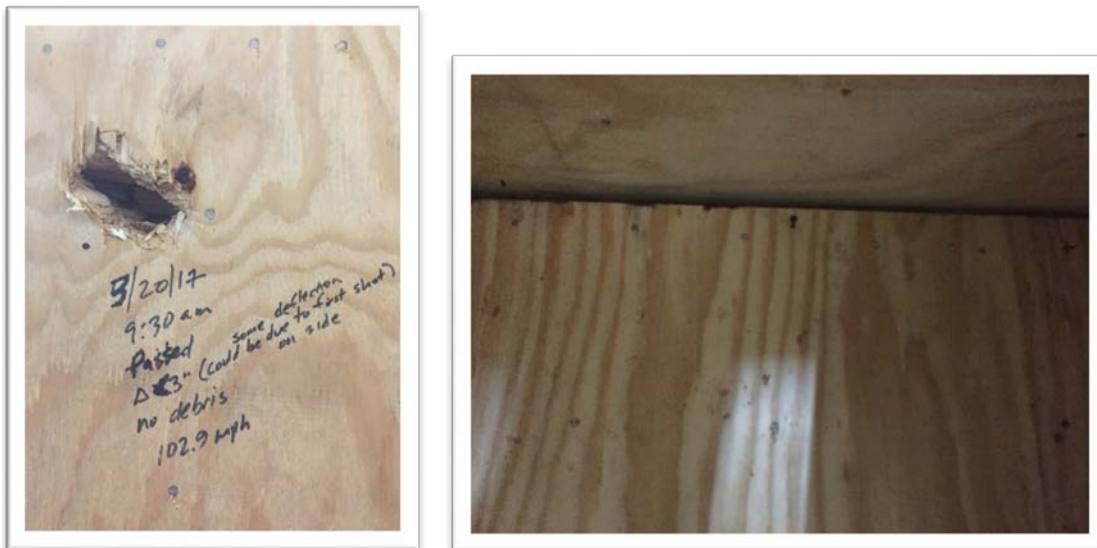
| Location<br>(see Figs. 21–22) | Wall<br>construction | Missile<br>speed<br>(mi/h) | Front<br>penetration<br>(in.) | Permanent<br>deflection<br>(in.) | Panel<br>perforated<br>(Y/N) | Observed<br>damage | Passed test?<br>(Y/N) | Additional<br>notes |
|---|---|---|---|---|---|---|---|---|
| B | 2 by 8 beams,<br>two sheets<br>23/32-in. plywood | 102.9 | 4.5 | 2.3 | N | Slight bending<br>of plywood<br>(interior) | Y | No debris |

Left: exterior damage after impact; Right: interior damage after impact.  
(impact location: 27 in. left of center, 8.5 in. below top of room side.)

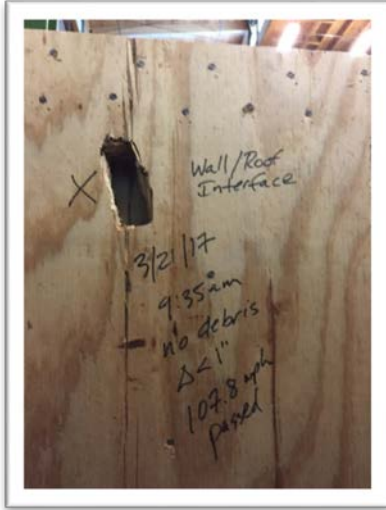
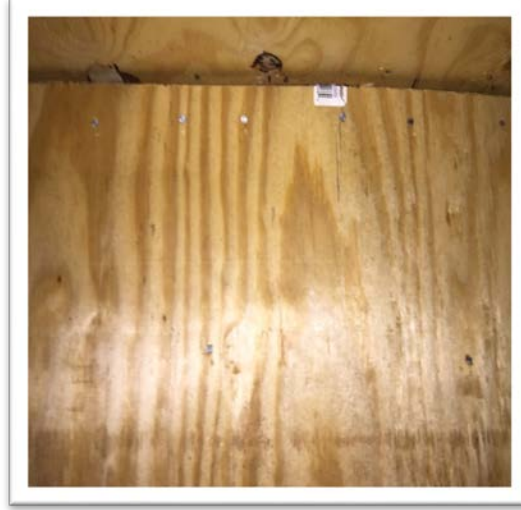
| Location<br>(see Figs. 21–22) | Wall<br>construction | Missile<br>speed<br>(mi/h) | Front<br>penetration<br>(in.) | Permanent<br>deflection<br>(in.) | Panel<br>perforated<br>(Y/N) | Observed<br>damage | Passed<br>test?<br>(Y/N) | Additional<br>notes |
|---|---|---|---|---|---|---|---|---|
| C | 2 by 8 beams,<br>two sheets<br>23/32-in. plywood | 107.8 | 1.9 | 1.0 | N | Slight<br>bending of<br>plywood<br>(interior) | Y | No debris |

Left: exterior damage after impact; Right: interior damage after impact.  
(impact location: 29 in. left of center, 7 in. below top center of room side.)

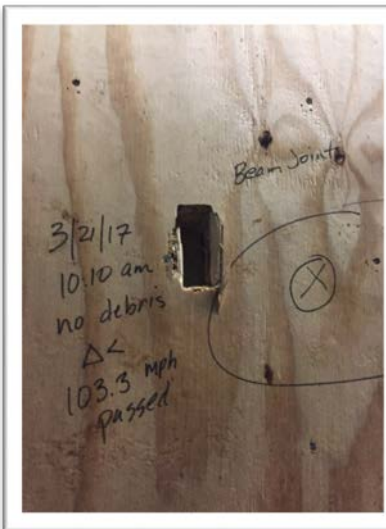
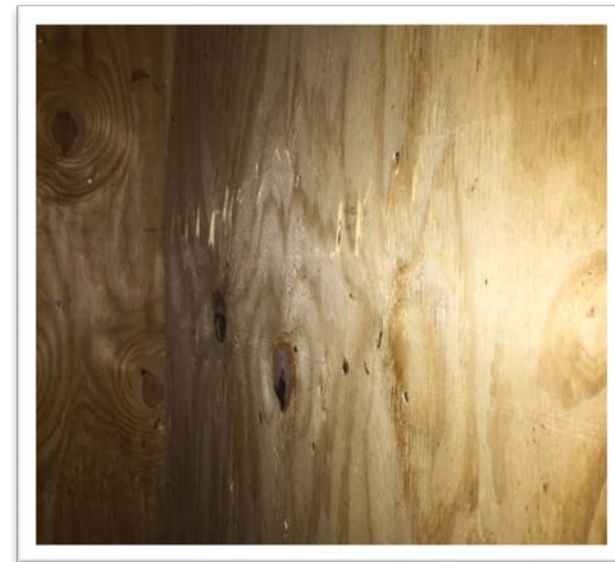
| Location<br>(see Figs. 21–22) | Wall<br>construction | Missile<br>speed<br>(mi/h) | Front<br>penetration<br>(in.) | Permanent<br>deflection<br>(in.) | Panel<br>perforated<br>(Y/N) | Observed<br>damage | Passed<br>test?<br>(Y/N) | Additional<br>notes |
|---|---|---|---|---|---|---|---|---|
| D | 2 by 8 beams,<br>two sheets<br>23/32-in. plywood | 103.3 | 2.4 | 1.0 | N | Slight cracking<br>of plywood<br>(interior) | Y | No debris |

Left: side of room before impact; Right: inside of side of room after impact.  
(impact location: 30 in. right of center; 22 in. below top of room side.)

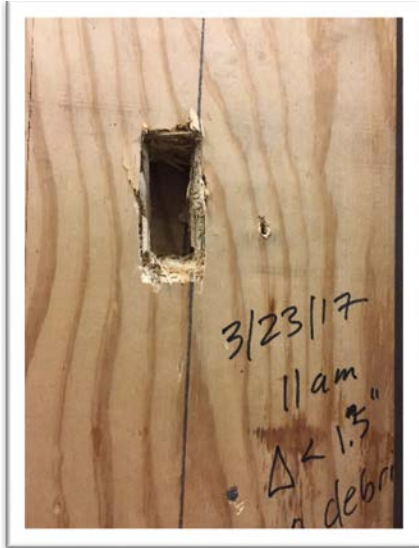
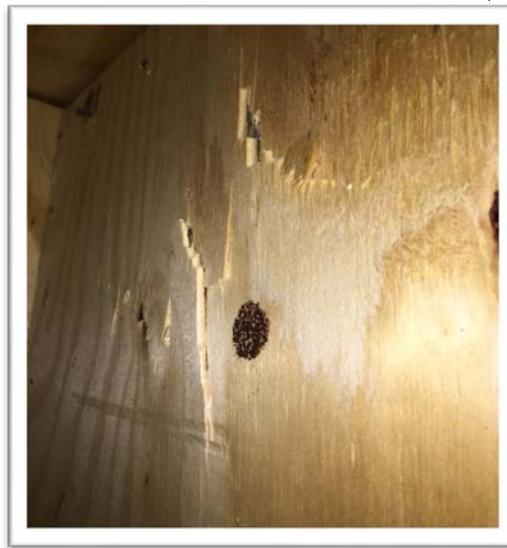
| Location<br>(see Figs. 21-22) | Wall<br>construction | Missile<br>speed<br>(mi/h) | Front<br>penetration<br>(in.) | Permanent<br>deflection<br>(in.) | Panel<br>perforated<br>(Y/N) | Observed<br>damage | Passed<br>test?<br>(Y/N) | Additional<br>notes |
|---|---|---|---|---|---|---|---|---|
| E | 2 by 8 beams,<br>two sheets<br>23/32-in. plywood | 106.5 | 2.5 | 1.4 | N | Slight<br>separation of<br>plywood<br>(interior) | Y | No debris |

Left: front of room after impact test; Right: back of panel after impact test.  
(impact location: 32 in. right of center, 16 in. down from top.)

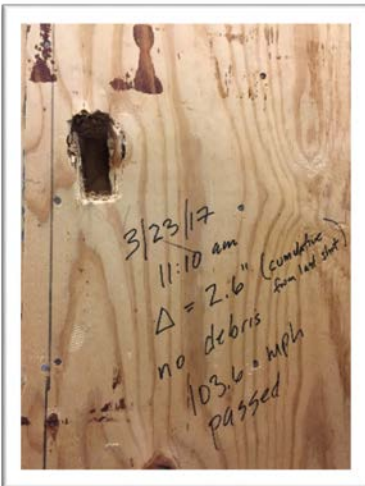
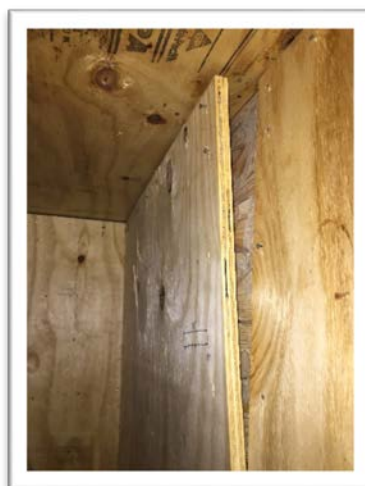
| Location<br>(see Figs. 21-22) | Wall<br>construction | Missile<br>speed<br>(mi/h) | Front<br>penetration<br>(in.) | Permanent<br>deflection<br>(in.) | Panel<br>perforated<br>(Y/N) | Observed<br>damage | Passed test?<br>(Y/N) | Additional<br>notes |
|---|---|---|---|---|---|---|---|---|
| F | 2 by 8 beams,<br>two sheets<br>23/32-in. plywood | 103.6 | 2.5 | 2.6 | N | Separation of<br>plywood<br>(interior) | Y | No debris.<br>Cumulative<br>damage from<br>previous test. |

Left: front of room after impact test; Right: back of panel after impact test.  
(impact location: 3 in. right of center, 27.5 in. down from top.)

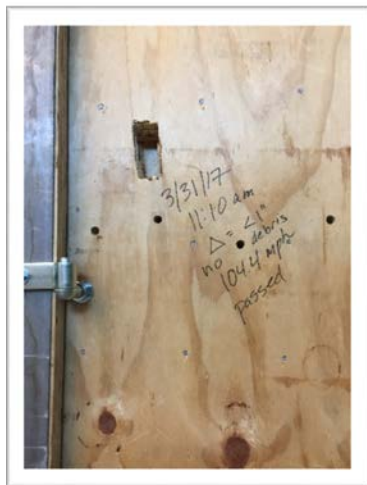
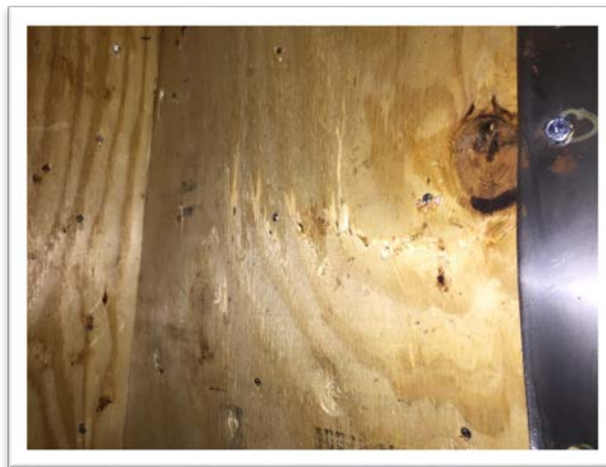
| Location<br>(see Figs. 21–22) | Wall<br>construction | Missile<br>speed<br>(mi/h) | Front<br>penetration<br>(in.) | Permanent<br>deflection<br>(in.) | Panel<br>perforated<br>(Y/N) | Observed<br>damage | Passed<br>test?<br>(Y/N) | Additional<br>notes |
|---|---|---|---|---|---|---|---|---|
| G | 2 by 8 beams,<br>two sheets<br>23/32-in. plywood | 104.4 | 2.3 | 1.1 | N | Cracking of<br>plywood<br>(interior) | Y | No debris |

Left: front of room after impact test; Right: back of panel after impact test.  
(impact location: 18.5 in. down, 20.5 in. left of top right corner.)
