# Assessment of Fastener Corrosion and Salt Damage in the Bilge of the *Eureka*

Research Note  
FPL–RN–0356

March  
2018

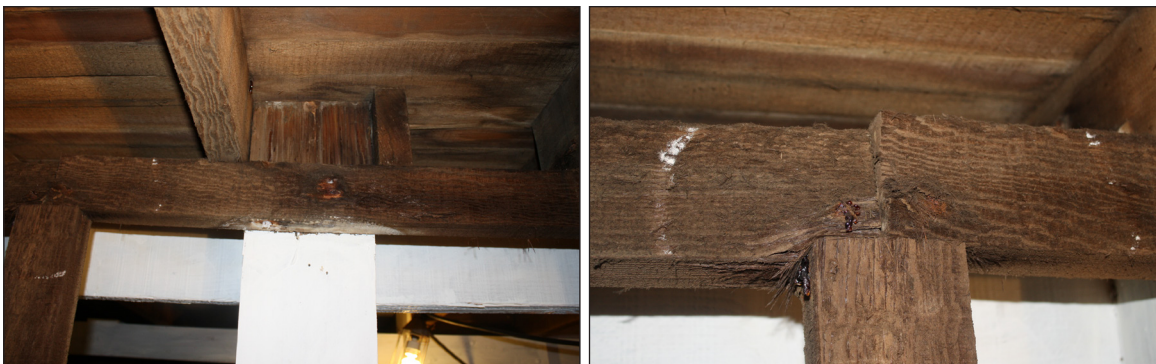
Visually, the bilge in the aft of the ship was in better condition. There was less standing water in this bilge. Also, there were new wood beams that had been added to support the deck above. This was important because there were signs of structural failure of some of the old (original) joists (Fig. 3).

**Figure 3. (Left) New structural members to hold up deck; (Right) Structural failure of old wooden beams caused by salt damage.**

Figure 10 shows an SEM micrograph of the wood taken from one of the salt-damaged joists (Fig. 3). The SEM shows classic signs of salt damage; the tracheids are separated from each other and embrittled. The embrittlement can be detected by fractured tracheids. The “fuzzy” appearance of the salt-damaged wood in Figure 3 comes from large agglomerates of these separated tracheids. The salt damage can also be observed by salt crystals, which appear as cubes along the tracheids. As part of the SEM analysis, energy dispersive x-ray spectroscopy (EDS) was performed to identify the elements present. In addition to carbon and oxygen, the wood sample in Figure 10 contained large amounts of sodium, calcium, and chlorine, further confirming salt damage in the wood.

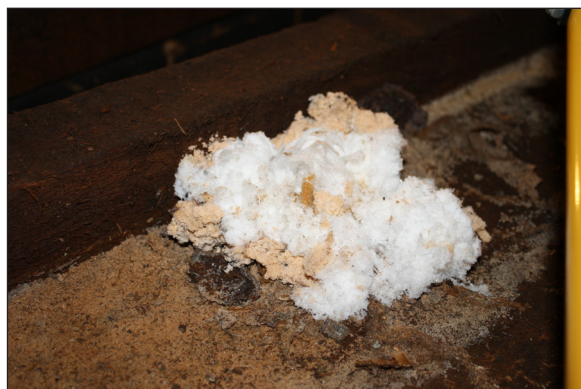
The forward bilge had several inches of standing water. According to the park service staff, there was no bilge pump in this section of the ship and there had not been a bilge pump for several years. In this section of the ship, there were large formations of a white substance (assumedly a result of corrosion) on top of each of the large metal bolts in the keelsons (Fig. 4). There was also a section on the ceiling planking of the ship that was exhibiting brown rot decay (Fig. 5).

**Figure 4. White corrosion product on top of metal fasteners in the forward bilge.**

Figure 11 is an SEM micrograph from the white corrosion deposit (Fig. 4). The white deposit appeared mostly amorphous but contained some cubic crystals. EDS confirmed that the cubic crystals were indeed crystals of rock salt (NaCl). The amorphous region was predominantly sodium chloride with iron in it as well (presumably from the corroded fastener underneath the surface).

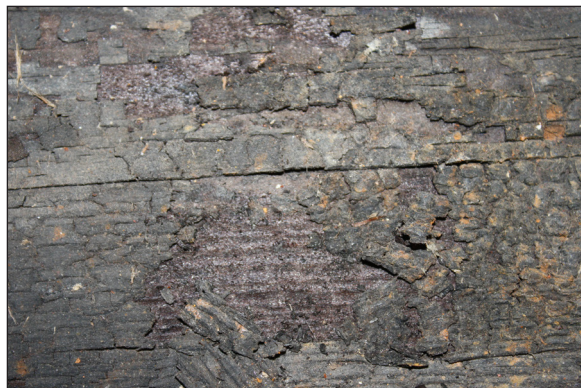
**Figure 5. Brown rot decay on ceiling planking (side wall) of forward bilge.**

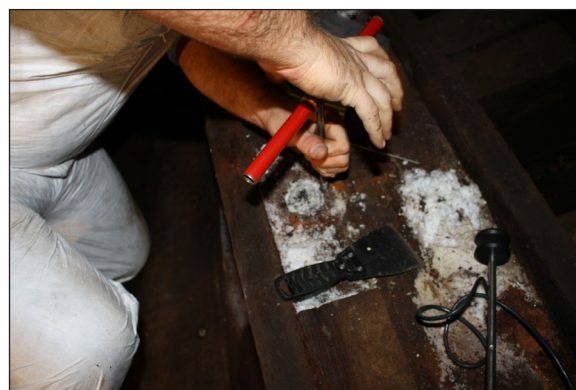
**Figure 6. Increment core being taken on a keelson near two corroded bolts that were identifiable by white corrosion product blossoms.**

In total, 16 gravimetric moisture content readings were taken. The moisture contents ranged from a low of 17% in the ceiling planking of the ship to a high of 88%, which was taken in one of the keelsons near a salt pile. The mean moisture content was 45%; the median was 34%. The measured wood moisture contents were in the range in which corrosion and biodeterioration are likely to occur.

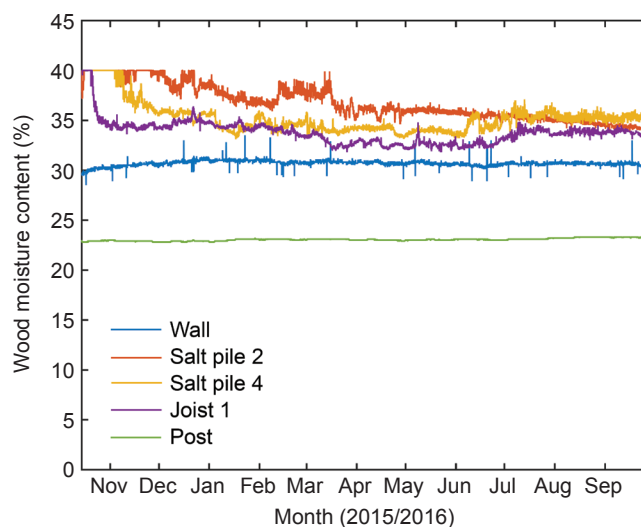
Figure 8 shows the wood moisture content (averaged on an hourly basis) at five different locations in the forward bilge during the same time period. The sensors cannot read moisture contents above 40%. There was very little movement in the moisture readings throughout the year. All of the moisture readings were above the threshold moisture content for wood damage mechanisms such as corrosion and biodeterioration (Jakes and others 2013). The moisture content was highest in the salt piles near the keelsons and lowest in the posts. It should be noted that salt in the wood will increase measured moisture content by an unknown amount relative to the true, gravimetric moisture content.

Figure 8. Hourly average wood moisture contents (measured using the electrical resistance method).

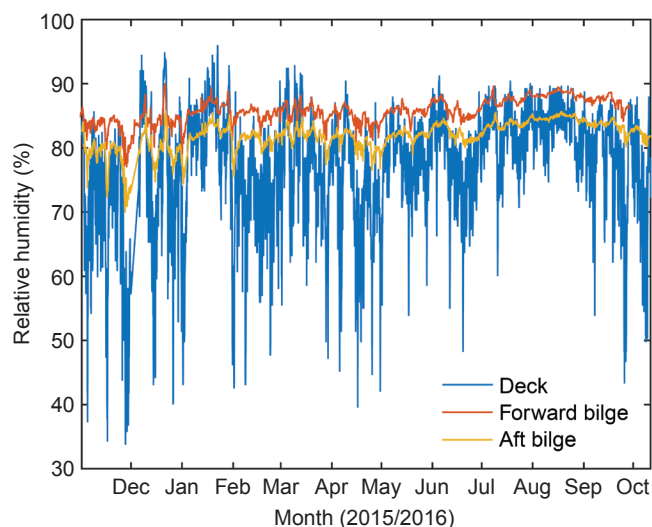
Figure 9 compares the average hourly relative humidity (RH) in the forward and aft bilges with the RH on the deck of the ship. Large fluctuations in RH on the deck caused some fluctuations in the bilge. However, the fluctuations were severely dampened. The variations in RH in both bilges responded to changes in RH on the deck in the same way. However, for all measurements, the RH in the aft bilge was lower (by about 5%) than that in the forward bilge.

Figure 9. Hourly average relative humidity measurements on the deck of the ship (blue) and in the forward (orange) and aft (yellow) bilges.

To preserve the *Eureka*, moisture needs to be removed from the bilge. Standing water needs to be removed. Furthermore, the high humidity in the bilge also needs to be controlled. In most modern commercial ships, active dehumidification systems are used to control moisture in the bilge. An active dehumidification system could be placed in the *Eureka* to keep the wood members at an acceptable moisture content and control salt damage. To prevent further salt damage in the wood, the RH in the bilge should be kept below 70% (Price and Brimblecombe 1994).

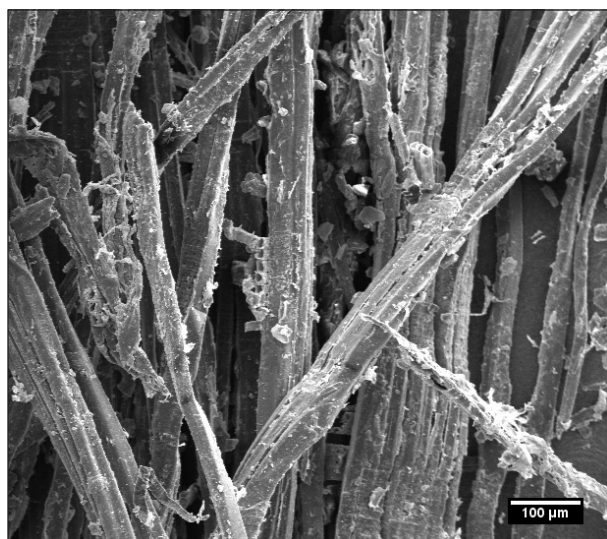
**Figure 10.** Scanning electron micrograph of salt-damaged wood taken from a joist in the forward bilge.

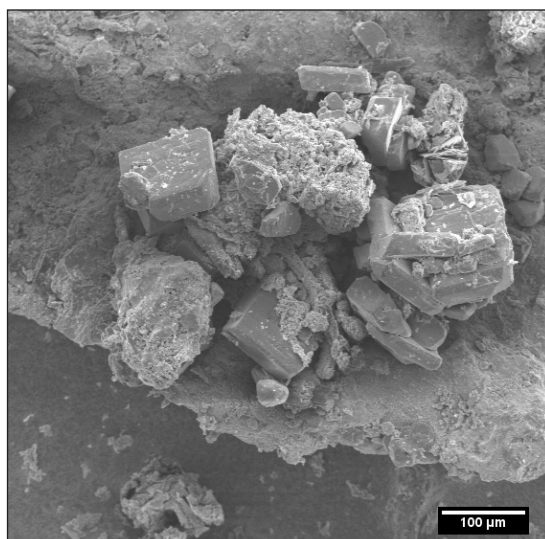
**Figure 11.** Scanning electron micrograph of a white deposit on top of a corroded fastener (also shown in Fig. 4).

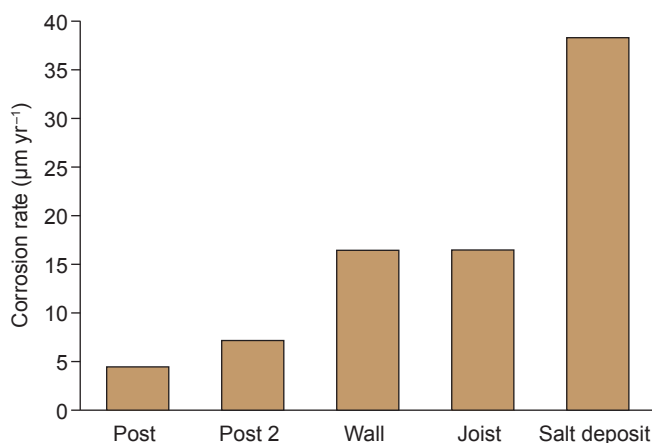
The measured corrosion rates are shown in Figure 12. The nails were driven at similar locations to the wood moisture content probes (Fig. 8). The amount of corrosion exhibited in the fasteners increased with increasing wood moisture content. Two of the recovered nails were driven into posts; these nails had the lowest rates of corrosion. The nails that were driven into the ceiling planking and the joist within the forward bilge both had similar amounts of corrosion. The most corrosion was observed for the nail driven into the keelson near a salt deposit.

The corrosion rate measured near the salt deposit was  $40 \mu\text{m yr}^{-1}$ . For reference, the corrosion rates of steel embedded in preservative-treated wood in a 100% RH environment were less than  $35 \mu\text{m yr}^{-1}$  (Zelinka 2014). Therefore, the keelsons in the *Eureka* represent a relatively severe corrosive environment for the large embedded bolts.

**Figure 12.** Corrosion rates of carbon steel fasteners measured at various locations in the bilge of the *Eureka*.

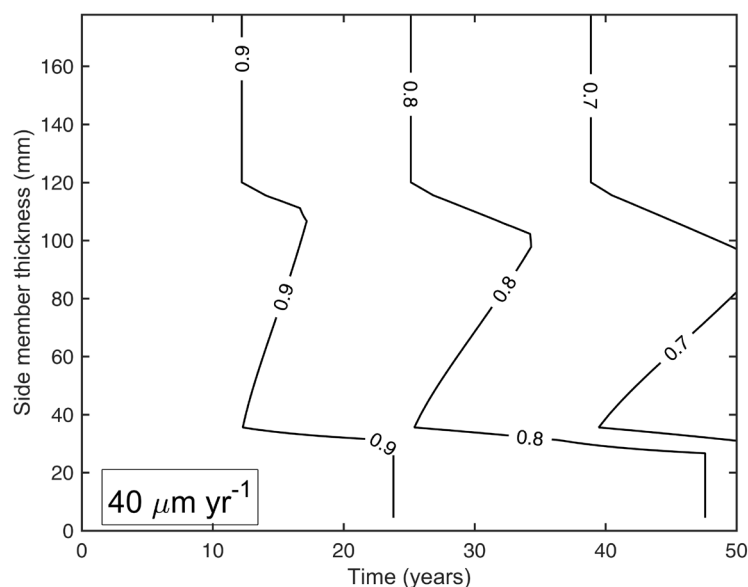
**Figure 13. Estimated loss in lateral strength of the bolted connection as a function of time and wooden side member thickness. Each line represents a 10% loss in capacity.**

However, the strength loss depends on not just the corrosion rate but the bolt diameter, bolt length, and wood material properties. A corroded bolt (19 mm in diameter and 350 mm long) was discovered in the bilge of the *Eureka* near a salt pile. If that is representative of the other bolts in the keelson, we can calculate the effect of the corrosion on the remaining strength of the bolt using the method of Zelinka and Rammer (2012). This analysis is shown in Figure 13, which presents lines that represent a 10% decrease in the lateral capacity of the joint as a function of time and side member thickness. The lines are not straight because the failure mode changes as the wooden side member thickness changes. The analysis shows that after 50 years, the bolted connection still had between 60% and 70% of its original strength.

It should be noted that the analysis in Figure 13 was based off a single corrosion rate measurement and the bolt geometry taken from a bolt found within the bilge that may or may not be representative of the actual fasteners used in the *Eureka*. This is an estimate of the remaining strength of the bolted connections, and the actual residual capacity of bolts within the *Eureka* may be greater or less than this.
