Research  
Paper  
FPL-RP-581

# Performance of Back-Primed and Factory-Finished Hardboard Lap Siding in Southern Florida

February 2000

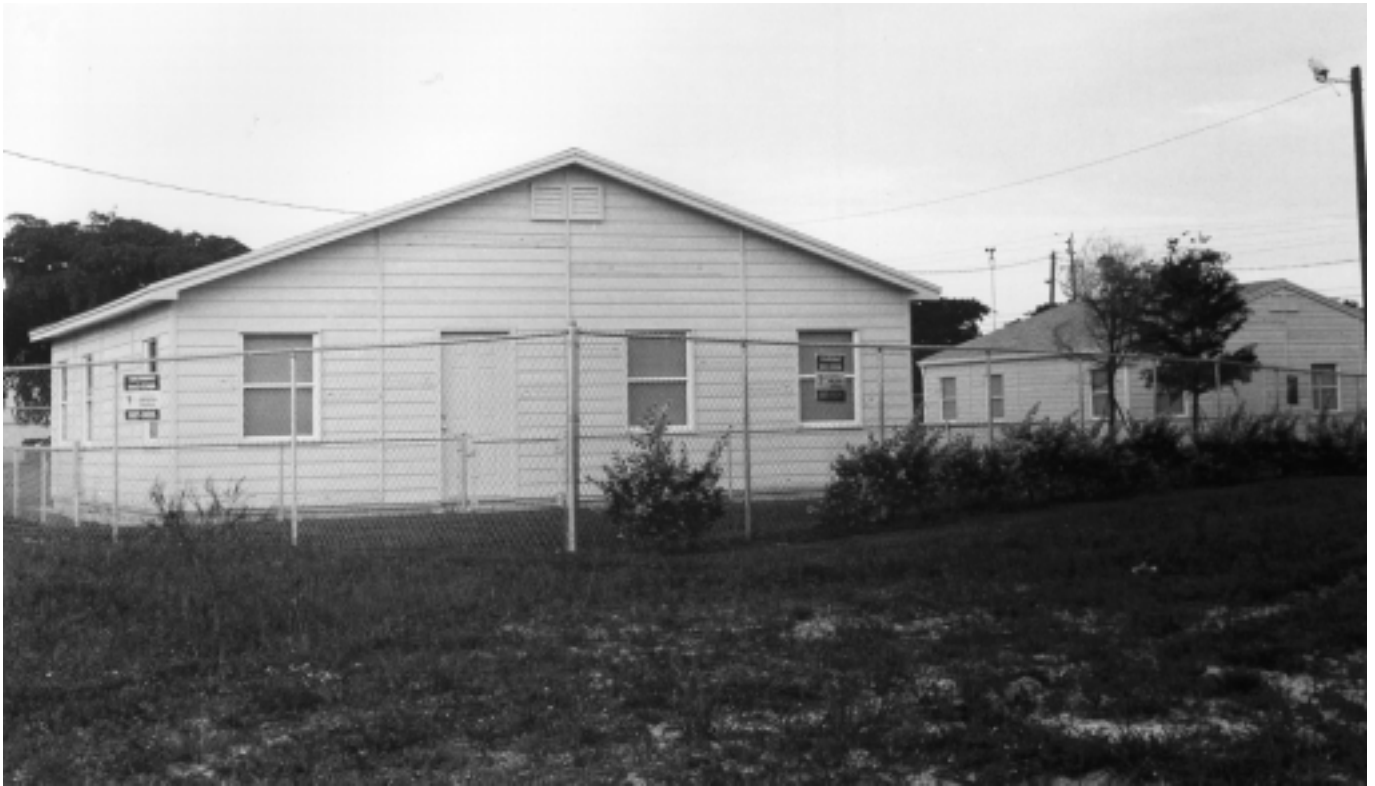
There was no difference in siding moisture content between the two buildings. The moisture content of the trim, however, was generally lower on the overhang building. The overhangs also significantly reduced water leakage around windows. There was evidence of water leakage behind the window trim below more than half of the windows on the guttered building. The leakage occurred between the window unit and the bottom trim, even though the trim was carefully caulked with high-quality urethane caulk. In May 1997, the moisture content of the wood trim was generally between 9% and 12%, but we found several locations with moisture contents more than 20%. The leakage did not lead to decay of the siding or elevated siding moisture content. We found decay in a pine doorjamb on the guttered building.

Figure 1—Test building with overhang (foreground) and test building with gutters (background).

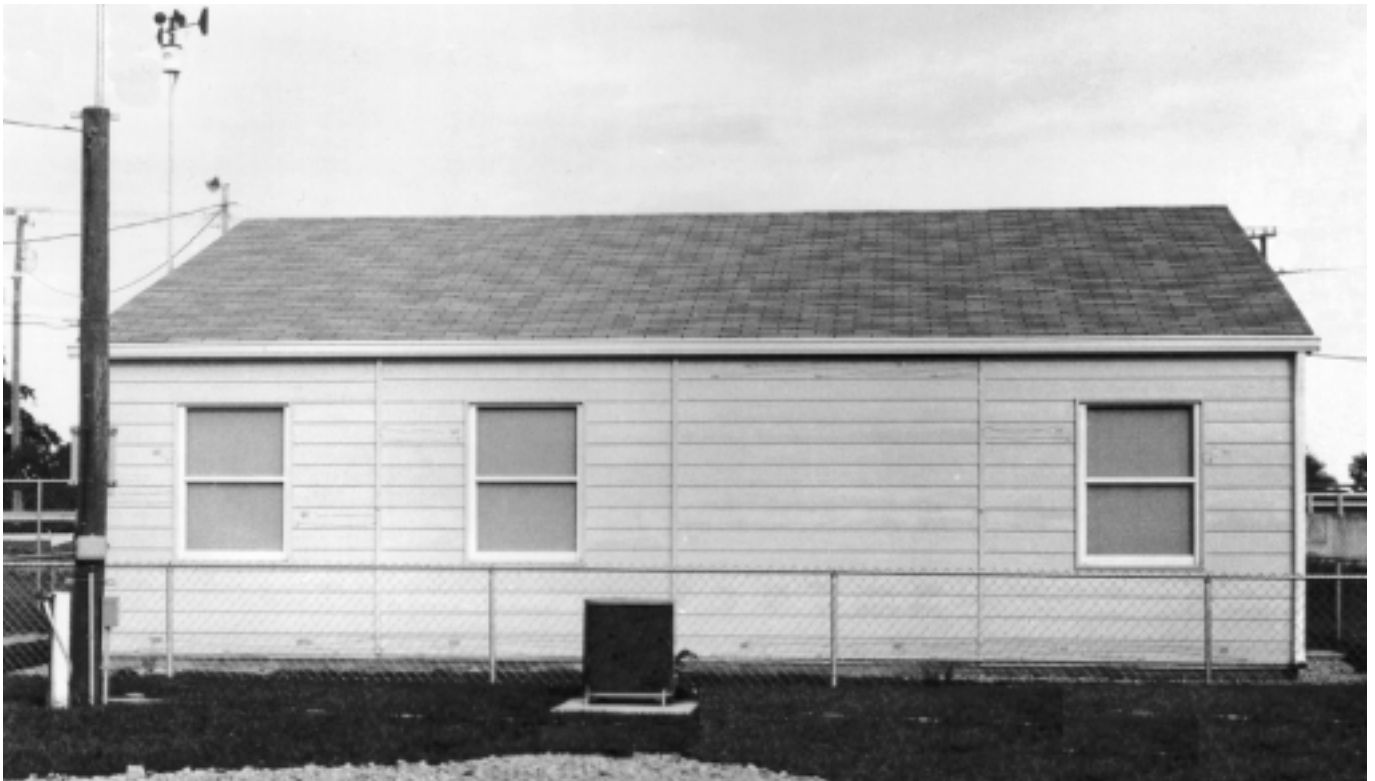
Figure 2—Test building with gutters (side view).

We found water stains on the back of siding below at least half of the windows on the guttered building. In contrast, on the overhang building, we did not see any staining of siding below windows. On the guttered building, stained siding backs were observed below windows in walls GNa, GNc, GNd, GSc, GWa, and GWd. Another two windows (GEb and GWb) may also have leaked. Water leakage apparently occurred between the window unit and the bottom trim or lower portions of side trim. This occurred despite careful caulking with high quality urethane caulk. Caulk adhesion failed at some wood-wood joints (trim) and at some wood-metal joints (window), which led to the window water leakage. Although the water stains on siding backs indicated that water leakage into the siding system had occurred, there was no evidence of damage to the siding. Tracing of stains across the backs of successive siding courses indicated that the water eventually drained to the front of the siding or evaporated.

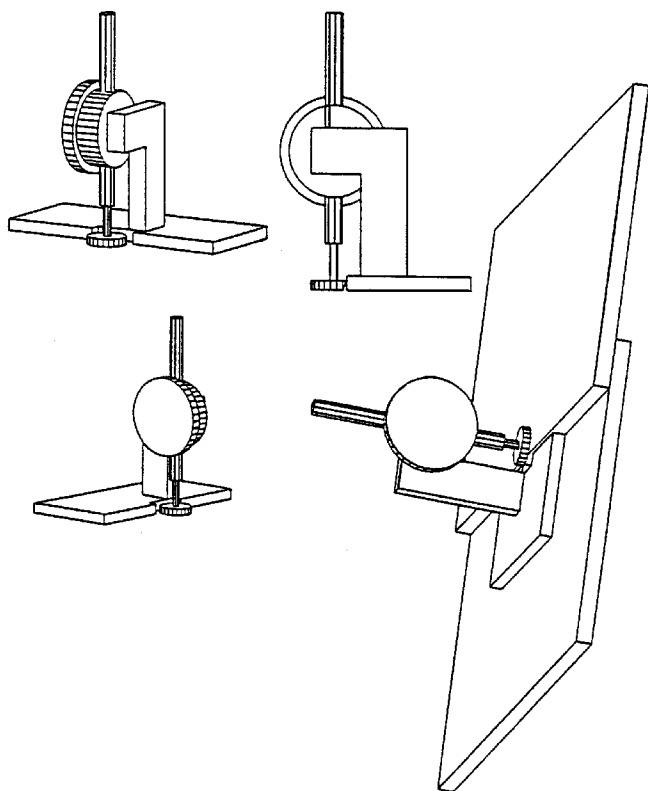
The siding condition was visually inspected every 3 months. Thickness of the lower left and right edges of each siding board was measured in-place during each visit, using a specially designed tool (Fig. 14). At each inspection, photographs were taken to document any visual changes in the siding. In total, 10 site inspections were performed between December 1994 and May 1997. The last inspection took place just before the siding was removed in May 1997.

**Figure 14—Thickness measurement device.**

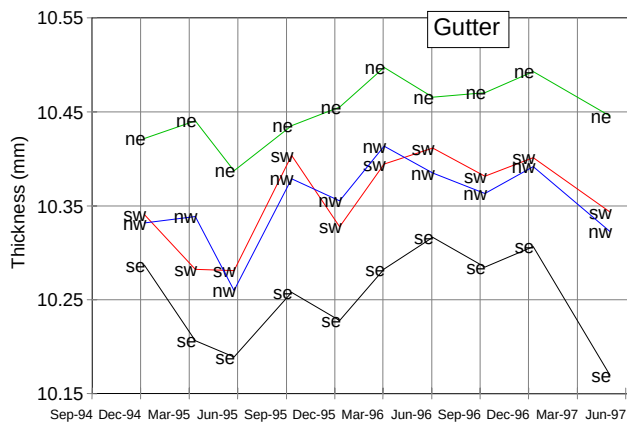
thickness swell of the siding was less than 3% during the entire exposure. There was no appreciable difference in lateral nail resistance between unexposed boards and siding that was on the building for 2½ years. There is no evidence that back-priming this siding lowered in-service moisture content. Siding on south-facing walls tended to be drier, but the type of wall construction or weather barrier had no detectable effect on moisture content of the siding.

**Figure 15—Results of thickness measurements on guttered building, by wall orientation (northeast, northwest, southeast, southwest).**

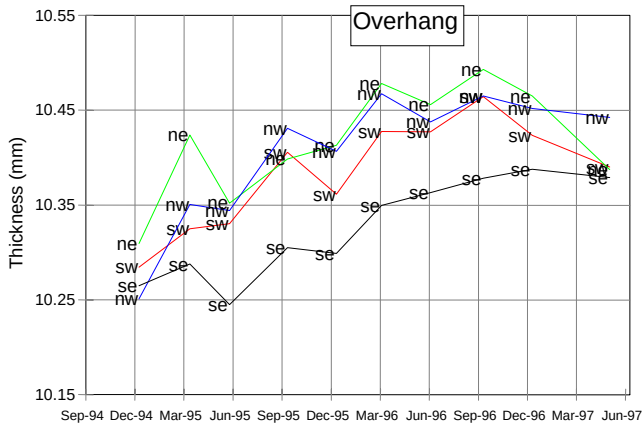
**Figure 16—Results of thickness measurements on overhang building, by wall orientation (northeast, northwest, southeast, southwest).**
