# Drone-enabled bridge inspection methodology and application

Junwon Seo<sup>a,\*</sup>, Luis Duque<sup>a</sup>, Jim Wacker<sup>b</sup>

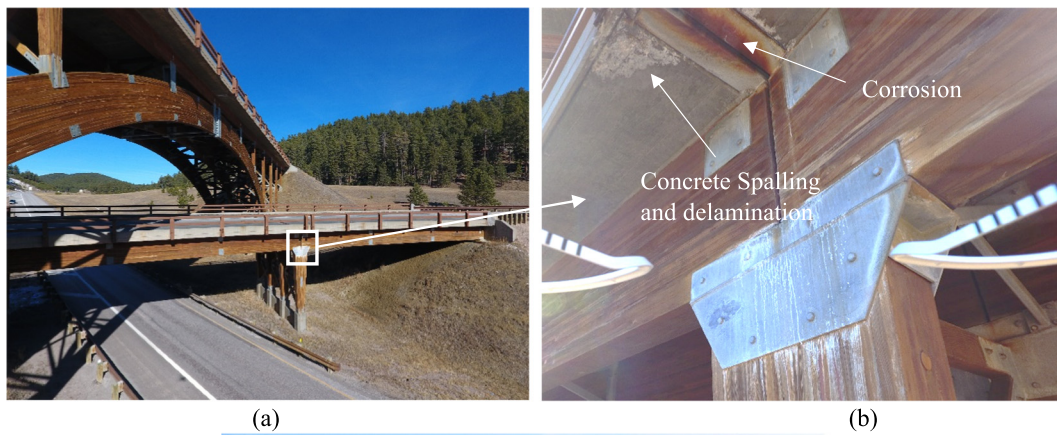
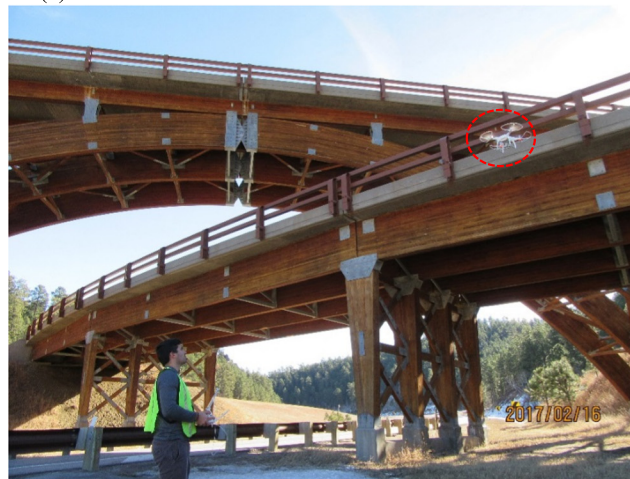
Fig. 7. Sample images obtained from the timber girder bridge inspection: (a) glulam girder bridge overview (taken by Junwon Seo using drone); (b) damage on timber girder bridge (taken by Luis Duque using drone); and (c) drone flying near girder (taken by Junwon Seo using digital camera).

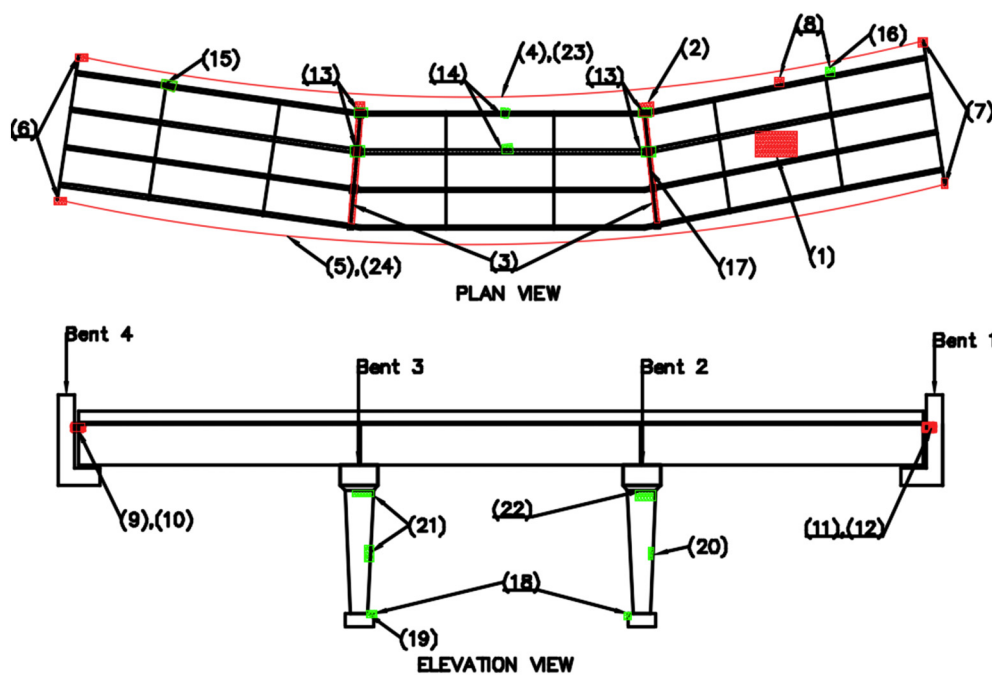
Fig. 8. Timber girder bridge layout with identified damage.

Note: red marks in plan and elevation views indicate concrete damage, green marks represent timber damage. Also, red lines in plan view denote minor cracks along the parapet and rusting in railing in a longitudinal direction. (For interpretation of the references to color in this figure legend, the reader is referred to the web version of this article.)

| Structural component | SDDOT inspection report | Drone-enabled inspection report | Comparison |
|---|---|---|---|
| Underside of deck | Near Stringer 1 at Joint 2: cracking delamination, and discoloration<br>Bays 2 and 3 at Joint 2: joint cracking and minor scaling<br><br>Bays 2 and 3 at Joint 3: joint scaling, cracking, and delamination<br>Near Girder 1 parapet along entire deck: has cracking and discoloration<br><br>Near Girder 4 parapet along entire deck: scaling, cracking, delamination, and efflorescence<br><br>Near Girder 4 at Joint 4: spalling and exposed rebar<br><br>Near Girder 4 at Joint 1: cracking, discoloration, and efflorescence<br>Bay 2 at Joint 4: Scaling, delamination and efflorescence in Bay 2 | (1) Bay 2 between Joints 1 and 2: white efflorescence<br>(2) Near Girder 4 at Joint 2: corroded exposed rebar, spalling, delamination, and efflorescence<br>(3) Along Joints 2 and 3: corrosion, spalling, delamination, and discoloration<br>(4) Near Girder 4 Parapet along entire deck: minor cracks and discoloration especially near railings<br>(5) Near Girder 1 Parapet along entire deck: minor cracks and spalling especially near railings<br>(6) Near Girders 1 and 4 at Joint 4: concrete cracking, spalling, exposed rebar, discoloration, and water damage<br>(7) Near Girders 1 and 4 at Joint 1: cracking and discoloration<br>(8) Near Girder 4 between Joints 1 and 2: water leakage | There are no major differences between the damage reported by SDDOT and the drone-enabled inspection report. minor differences include water damage between spans captured using the drone and not reported by SDDOT. |
| Abutment | North Abutment near Girder 1: is spalled off and has exposed rebar<br>North Abutment near Girder 1: spalling<br><br>South Abutment near Girder 4: efflorescence, scaling, and spalling<br>South Abutment on Bays 1 and 2: scaling and spalling | (9) North Abutment near Girder 1: spalling and corroded exposed rebar<br>(10) North Abutment near Girder 4: cracking, efflorescence, rust stains, and water damage<br>(11) South Abutment near Girders 1 and 4: spalling, efflorescence, and moisture<br>(12) South Abutment on Bays 1 and 2: concrete spalling | There are no major differences between the damage reported by SDDOT and the drone-enabled inspection report. |
| Girder | At supports at Joints 2 and 3: bottom of girders has discoloration and decay due to trapped water and debris<br>Girder 3 at Joint 3: surface scratch<br><br>N/A<br><br>N/A | (13) Girders 3 and 4 at Joints 2 and 3: bottom surface on both girders has discoloration and stains due to water leakage<br>(14) Girders 3 and 4 between Joints 2 and 3: stains at bottom of both girders<br>(15) Girder 4 between Joints 3 and 4: some moisture<br>(16) Girder 4 between Joints 1 and 2: some moisture | Moisture damage between bents was identified using the drone but not reported by SDDOT. |
| Column | Pedestals at Bent 2: horizontal crack along Bay 2 pedestal wall and crack along top of left side of Column 3 pedestal<br>Pedestals at Bent 3: spalling with expose rebar on right side of pedestal and vertical cracks at top left side of Column 3 and left side of Column 4<br>Column 4 pedestal at Bent 2: horizontal crack<br>Pedestal wall Bay 2 at Bent 2: longitudinal crack on top<br>N/A | (18) Column 4 Pedestal at Bents 2 and 3: minor spalling, cracking, and efflorescence<br>(19) Column 1 Pedestal at Bent 3: minor spalling and exposed rebar<br>(20) Columns 2, 3, and 4 at Bent 2: minor cracks<br>(21) Column 4 at Bent 3: minor cracks and stains on top<br>(22) Column 4 at Bent 2: stains on top | No major differences other than minor cracks observed on the columns which were not included in the SDDOT report. |
| Railing | Paint is peeling due to heavy rust in locations throughout, especially on the Railing near Girder 4. | (23) Heavy rusting on Railing at different sections near Girder 4<br>(24) Mild rusting on Railing near Girder 1 | No difference. |

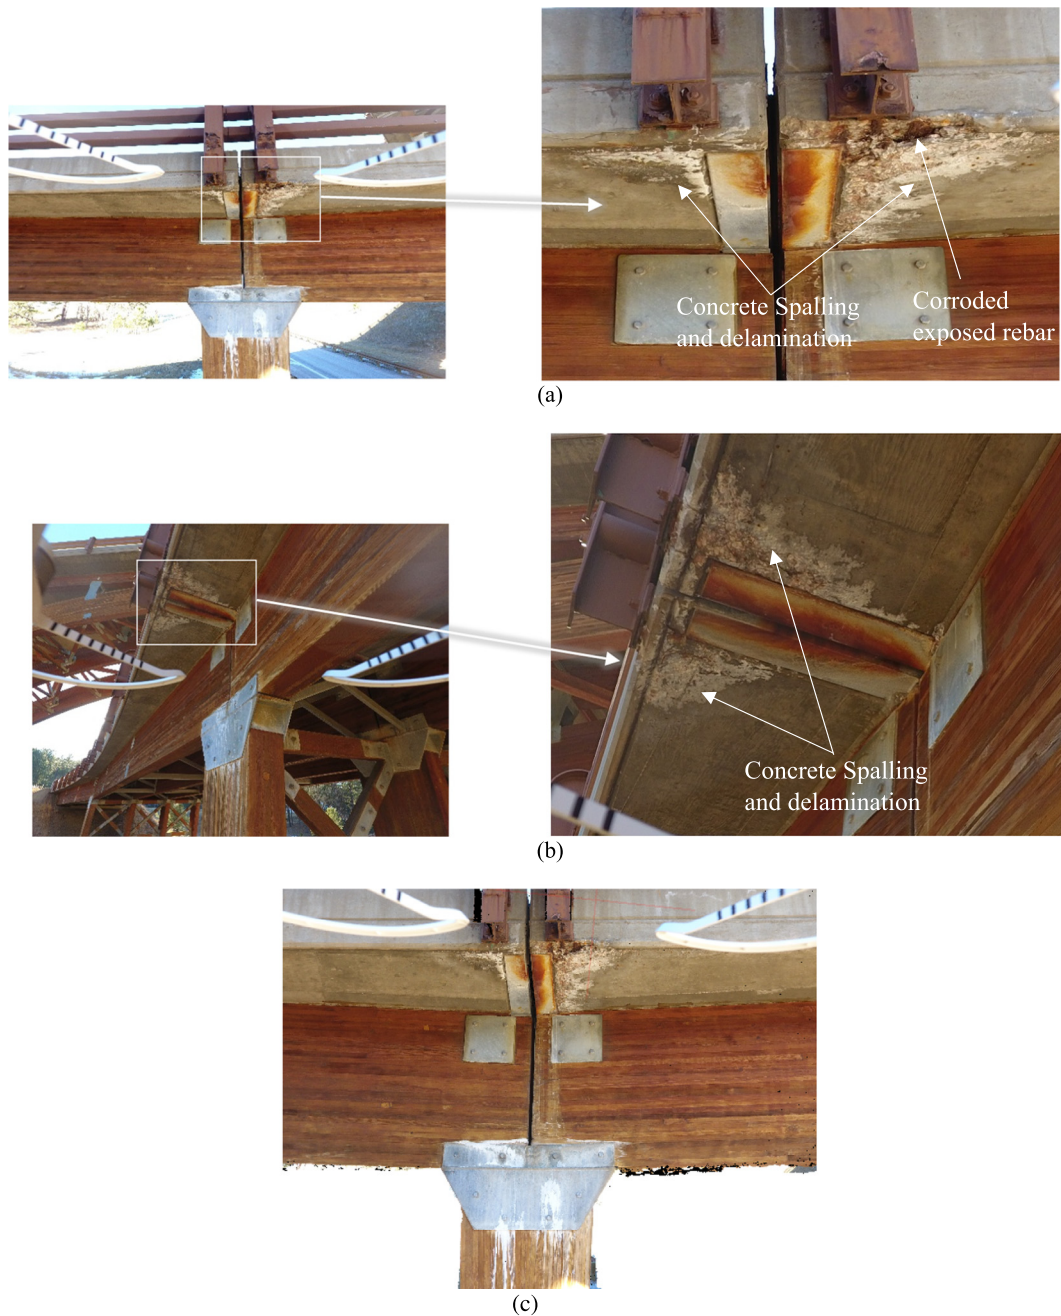
**Fig. 9.** Underside of deck sample damage gathered using drone (taken by Junwon Seo): (a) concrete spalling and corrosion with exposed rebar near Girder 4 at Joint 1; (b) concrete spalling near Girder 4 at Joint 3; and (c) 3D virtual model of Joint 2 near Girder 4 using PhotoScan.

In general, the inspected deck had a large amount of moisture-related damage at the joints (see Fig. 9a and b) as expected from the historical inspection reports. Fig. 9a shows concrete spalling and exposed rebar near Girder 4 at Joint 2, and Fig. 9b presents concrete spalling and delaminations near Girder 4 at Joint 3. Further, a representation of the damage near Girder 4 at Joint 2 was created using PhotoScan to create a 3D virtual model in order to better visualize it in 3D virtual space as seen in Fig. 9c.

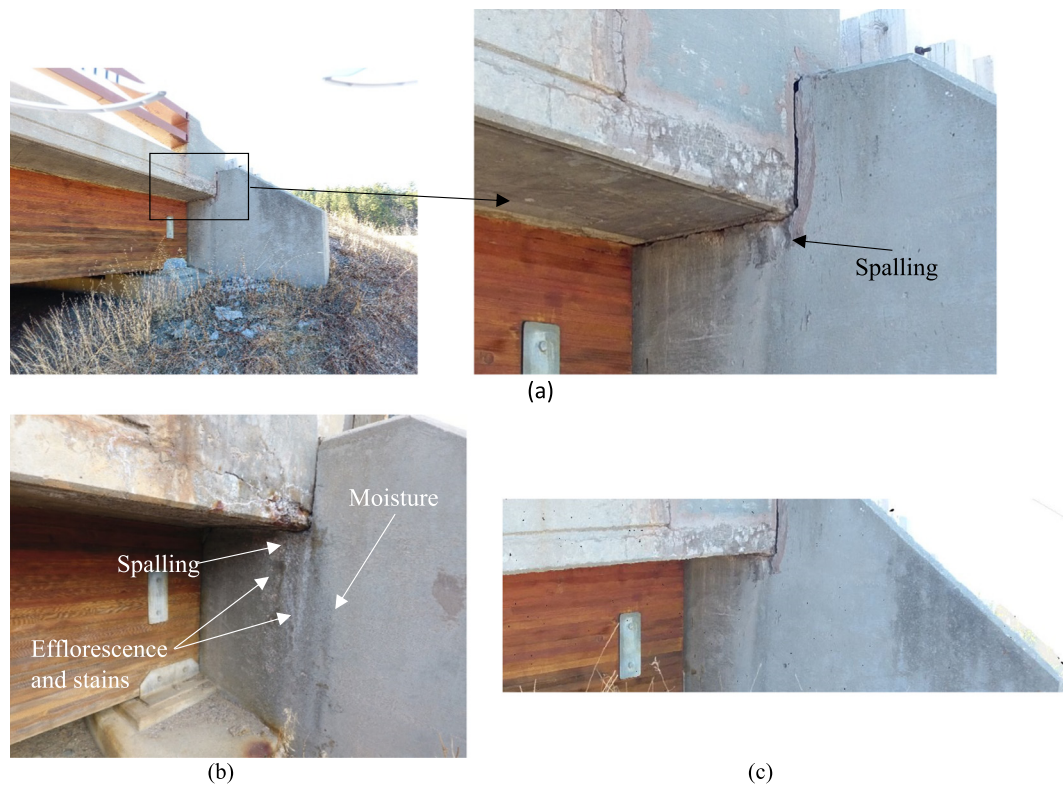
**Fig. 10.** Sample abutment damage detected using drone (taken by Luis Duque): (a) Spalling on South Abutment near Girder 1; (b) spalling and discoloration of concrete caused by moisture at North Abutment near Girder 4; and (c) 3D virtual representation of South Abutment near Girder 1.

The abutments were in overall good condition. Only minor damage, such as cracking and discoloration, was observed during the drone-enabled inspection as seen in Fig. 10a and b. Fig. 10a shows spalling on the South Abutment near Girder 1, and Fig. 10b displays spalling, efflorescence, and moisture on the North Abutment near Girder 4. Additionally, using PhotoScan, the damage on the South Abutment near

Girder 1 was successfully recreated in 3D virtual space as seen in Fig. 10c.

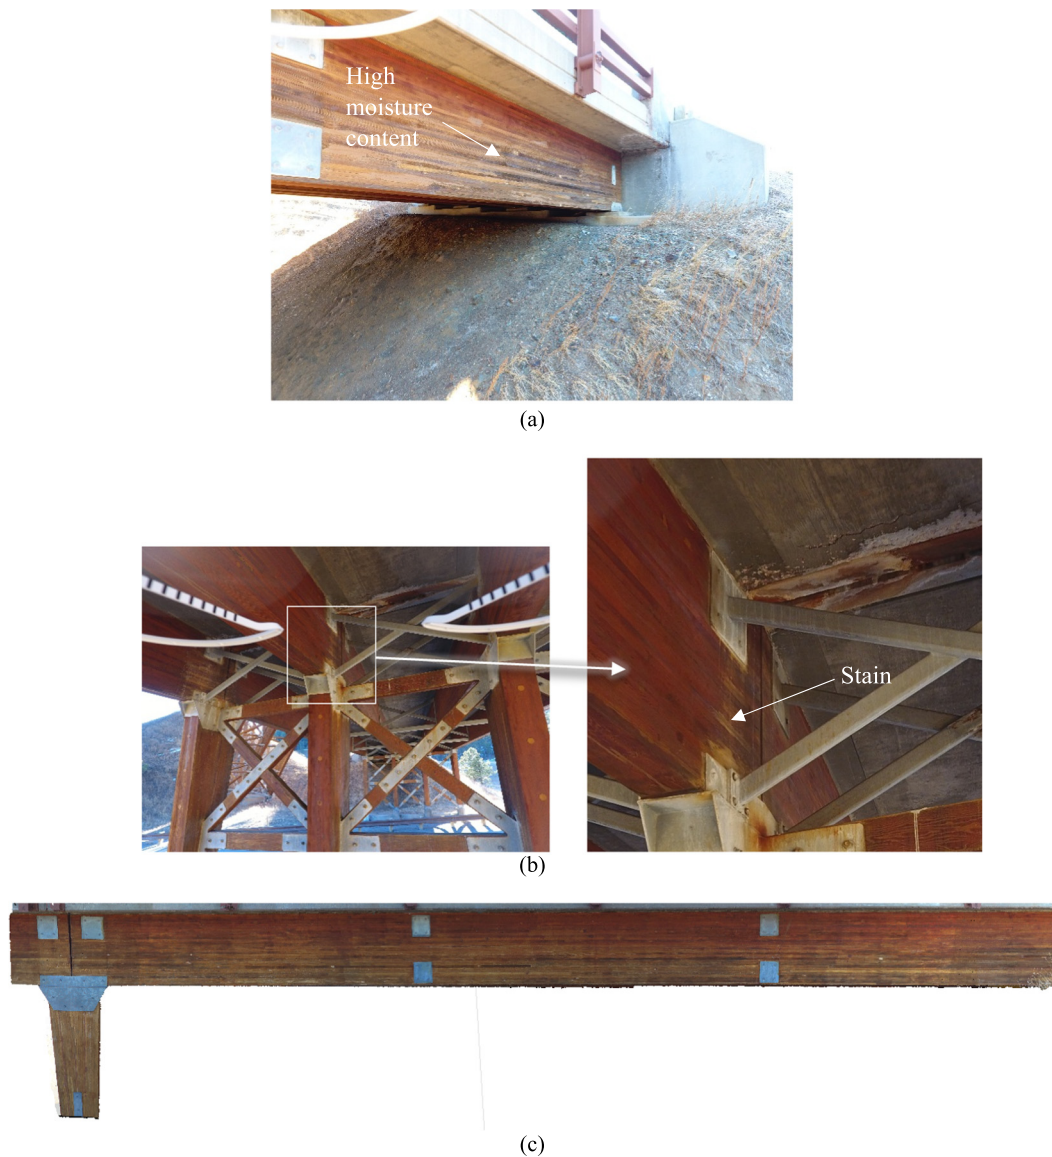
Overall, the girders were in good condition despite some minor water damage caused by water coming from the deck. In detail, the ends of the girders presented some stains and discoloration possibly caused by calcium deposits from the chemical reaction between salt, water, concrete, and steel, especially during the winter season. Sample images of the identified damage can be seen in Figs. 11a and 12b. Fig. 11a shows high moisture on Girder 4 between Joints 3 and 4, and Fig. 11b illustrates stains due to water leakage from the deck. With the aid of PhotoScan, Girder 4 between Joints 3 and 4 was successfully recreated in 3D virtual environment.

**Fig. 11.** Sample girder damage detected using the drone (Taken by Luis Duque): (a) moisture damage on the side of Girder 4 between Joints 3 and 4; (b) stains on the side of Girder 3 at Joint 3; and (c) 3D virtual representation.

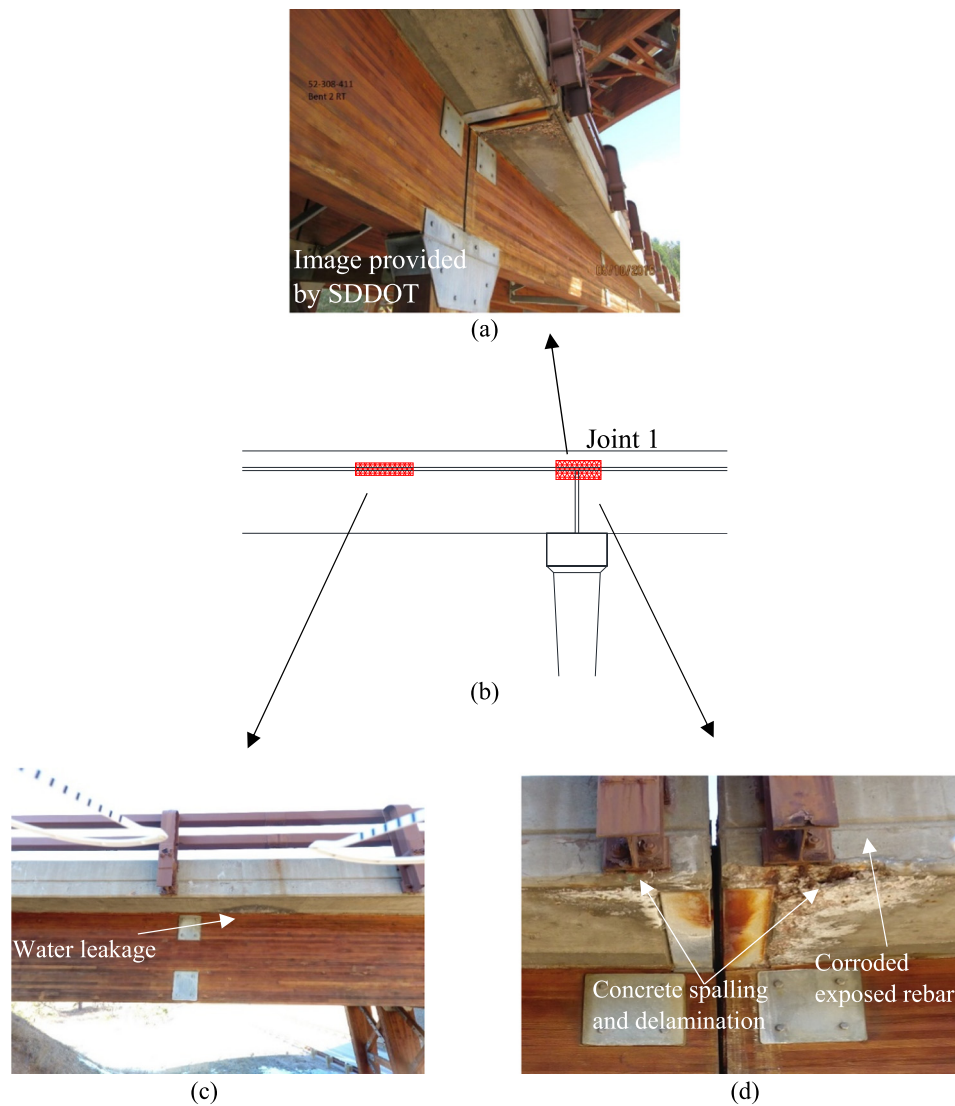
The inspection report developed based on the drone-enabled bridge inspection findings coincided with the damage reported by the SDDOT. As expected, damage, such as concrete spalling, corrosion, and exposed rebar, was observed near joints due to water leakage from the surface of the deck. A visual comparison of images provided by the SDDOT to those gathered using the drone can be seen in Fig. 12. The image provided by the SDDOT is shown in Fig. 12a to provide a visual comparison to those taken using the drone as seen in Fig. 12c and d. It is evident that the images are of similar quality, and for the underside of deck, the drone was able to capture a closer view. In terms of quantifiable damage, the SDDOT identified a 0.3 m by 0.6 m spalled area with exposed rebar at Joint 2. Throughout a damage pixel-based method, the spalled

area measurement was determined to be 0.18 m<sup>2</sup>. Both measurements are identical, confirming the accuracy of the UAV-based inspection.

**Fig. 12.** Comparison of results between drone-enabled and conventional inspections: (a) image provided by SDDOT [20]; (b) damage locations [20]; (c) water leakage under deck between South Abutment and Joint 1 (taken by Luis Duque using drone); and (d) concrete spalling and corrosion with exposed rebar near Girder 4 at Joint 1 (taken by Luis Duque using drone).

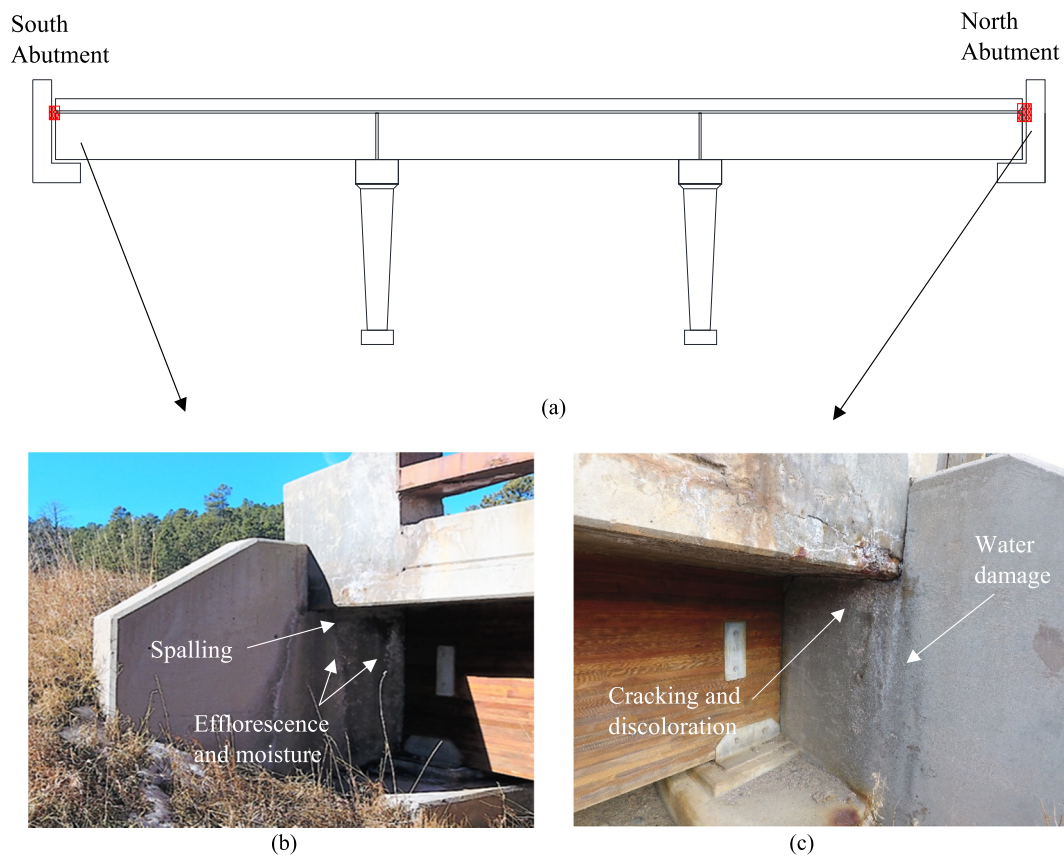
Overall, the abutments were in good condition and the identified damage (see Fig. 13a) coincided with the inspection report provided by SDDOT. No major damage was observed other than some minor damage, such as cracking, spalling, and discoloration on the South Abutment (see Fig. 13b) and discoloration and water leakage on the North Abutment (see Fig. 13c). It can be noted that there were no images provided by the SDDOT to be compared for the abutments. It also can be noted that the SDDOT did not included any quantifiable data for the Abutment damage.

**Fig. 13.** Sample damage on Abutment: (a) schematic of damage location on abutment; (b) damage on South Abutment near Girder 4 (taken by Luis Duque using drone); and (c) damage on North Abutment near Girder 4 (taken by Junwon Seo using drone).

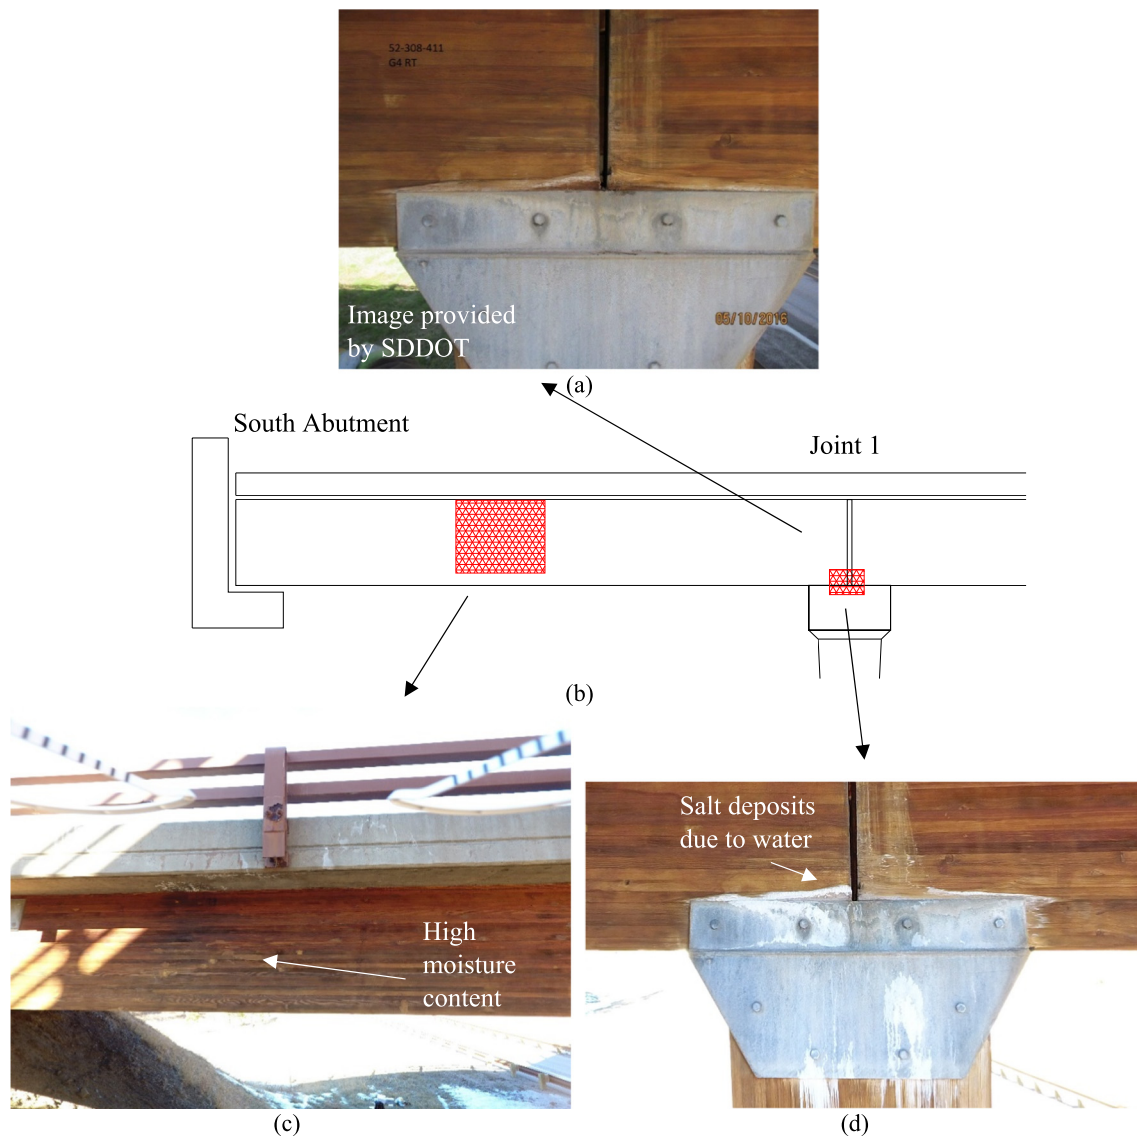
The identified damage on the girders reported by SDDOT was observed using the drone. Fig. 14a shows an image provided by the SDDOT to be compared to drone-enabled images (see Fig. 14c and d). The images gathered using the drone were of comparable quality to the one provided by SDDOT, confirming the ability of the drone to obtain high-quality data for damage identification. Note that some damage, such as moisture on Girder 4 between Joints 1 and 2 and Girder 4 between Joints 3 and 4, was not specified by the SDDOT. This damage must have been recent and demonstrated the importance of frequent routine inspections using drones to evaluate the damage and prevent unrepairable structure failure. Lastly, the SDDOT did not include quantifiable data for the bridge inspection aside from a 5.08 cm (2 in) by 5.08 cm (2 in) surface scratch on the bottom of

Girder 1 between Joints 2 and 3. This damage was also measured using the UAV images.

Fig. 14. Comparison of identified damage on girder: (a) image provided by SDDOT [20]; (b) damage location [20]; (c) damage on Girder 4 between South Abutment and Joint 1 (taken by Junwon Seo using drone); and (d) salt deposits due to water coming from deck at support of Girder 4 at Joint 1 (taken by Junwon Seo using drone).
