# Field Application of UAS-Based Bridge Inspection

Junwon Seo<sup>1</sup>, Luis Duque<sup>1</sup>, and James P. Wacker<sup>2</sup>

Transportation Research Record  
1–10

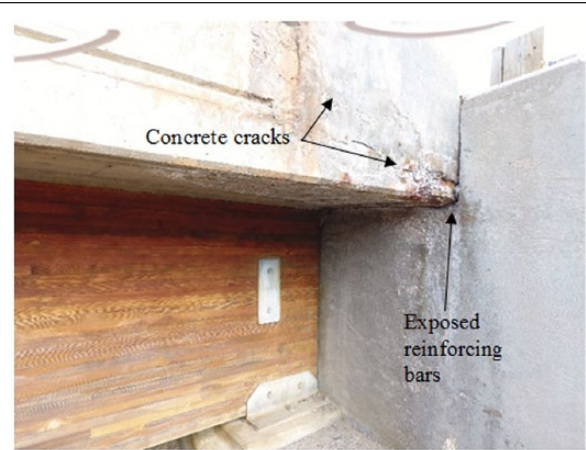
data acquisition to eliminate any unnecessary distractions from the picture-taking process while flying under such harsh weather conditions. Using the recorded videos, sample images were obtained to identify damage as seen in Figure 4a. Figure 4a shows concrete cracks and high moisture resulting from water leakage at the North Abutment of the bridge. It has been proved that the video-based inspection facilitated the acquisition of image information necessary for the damage identification. Figure 4b shows the UAS approaching components of the bridge.

**Figure 4.** Sample images obtained from the timber girder bridge inspection on February 17, 2017: (a) concrete cracking and water damage at abutment location and (b) UAS approaching the bridge (captured by Junwon Seo).

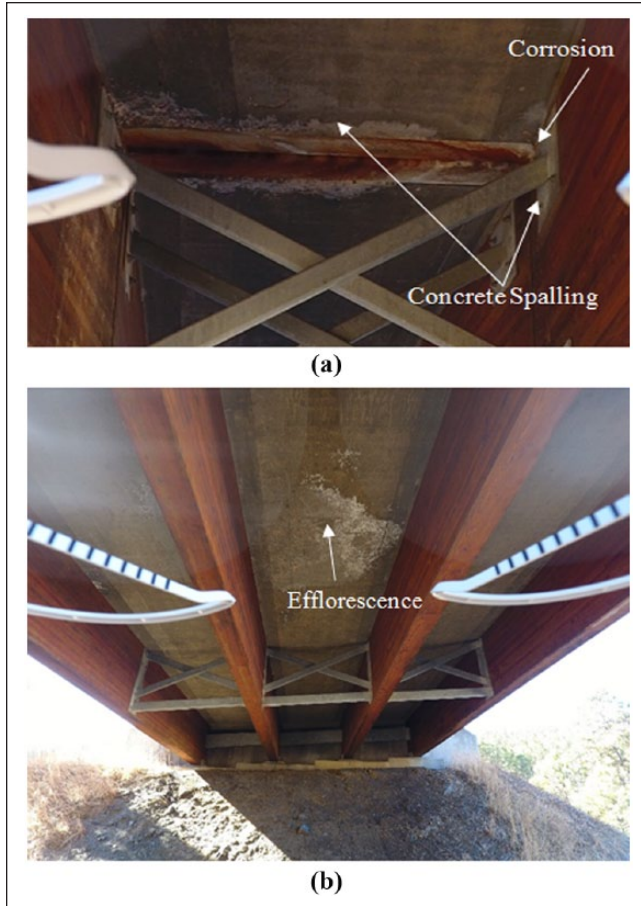
**Underside of Deck.** Overall, the deck had several water leakage areas causing moisture-related damage such as corrosion. Sample images of the damage are presented in Figure 5. Figure 5a corresponds to corrosion, spalling and exposed rebar at Girder 4 and Joint 1, and Figure 5b shows efflorescence in Bay 2 between South Abutment and Joint 1.

**Figure 5.** Underside of deck damage detected using UAS: (a) concrete spalling and corrosion with exposed rebar at Girder 4 and I and (b) efflorescence in Bay 2 between South Abutment and Joint I.

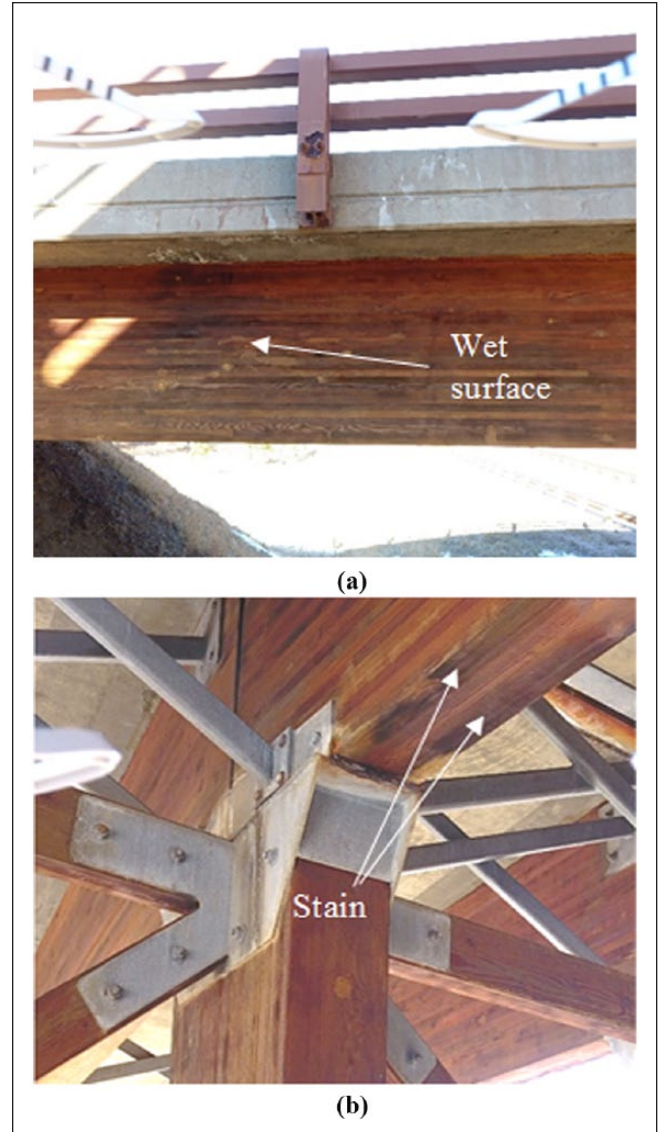
**Girders.** The girders were generally in good condition, with some moisture caused by water leakage resulting from the deck. Some stains and discoloration were also apparent on some girders, possibly caused by calcium deposits and corrosion coming from the chemical reaction of the water with concrete and steel. Sample images of the damage identified on the

girders are shown in Figure 6, *a* and *b*. Figure 6*a* shows visible moisture corresponding to Girder 4 between South Abutment and Joint I, and Figure 6*b* shows stains under Girder 3 at Joint I caused by corrosion of the steel connection bracket.

**Figure 6.** Girder damage detected using the UAS: (a) moisture damage on the side of Girder 4 between South Abutment and Joint I and (b) stains under Girder 3 at Joint I.

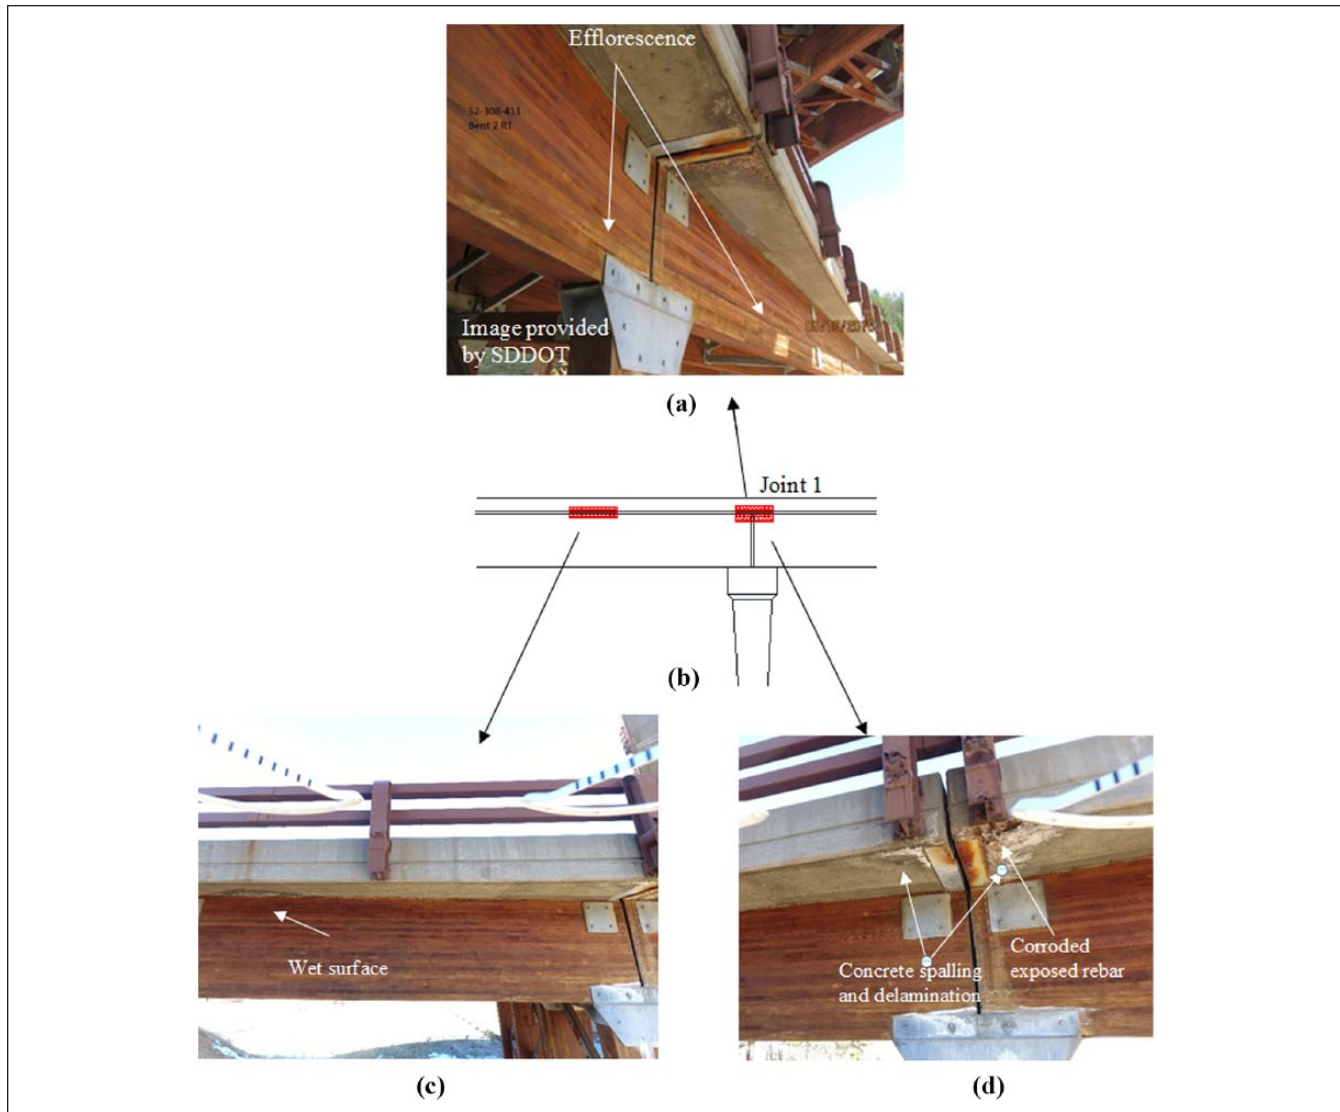
**Deck.** The UAS was able to identify the damage underneath the deck as identified from the South Dakota DOT inspection report. As reported before, some concrete spalling, delamination, and cracking were observed near joints and abutments. Figure 7 shows sample damage on the deck captured using the UAS. A representative picture provided by the South Dakota DOT (see Figure 7*a*) is included to visually compare the quality of images between the South Dakota DOT and the UAS-enabled bridge inspection. The partial

**Figure 7.** Sample damage on deck near Girder 4: (a) image provided by South Dakota DOT (13), (b) damage locations, (c) water leakage under deck between South Abutment and Joint 1, and (d) concrete spalling and corrosion with exposed rebar near Girder 4 at Joint 1.

bridge plan containing the specific damage locations represented by red hatched boxes is included in Figure 7b. It is apparent that the images are comparable, and the damage is identified. The water leakage under the deck between South Abutment and Joint 1 (see Figure 7c) and cracking, spalling, and exposed rebar (see Figure 7d) were identified using the UAS. Only one quantified area of damage was provided by the South Dakota DOT. The damage is identified as a 0.3 m (1 Ft) by 0.6 m (2 Ft) spalled area with exposed rebar at Joint 1. The same area was calculated using an image-based methodology detailed in Duque et al. (11). The results for the measurement was  $0.18 \text{ m}^2$  ( $1.96 \text{ Ft}^2$ ). It can be observed that the results are identical, confirming the ability of the UAS to identify and quantify damage on the structure.

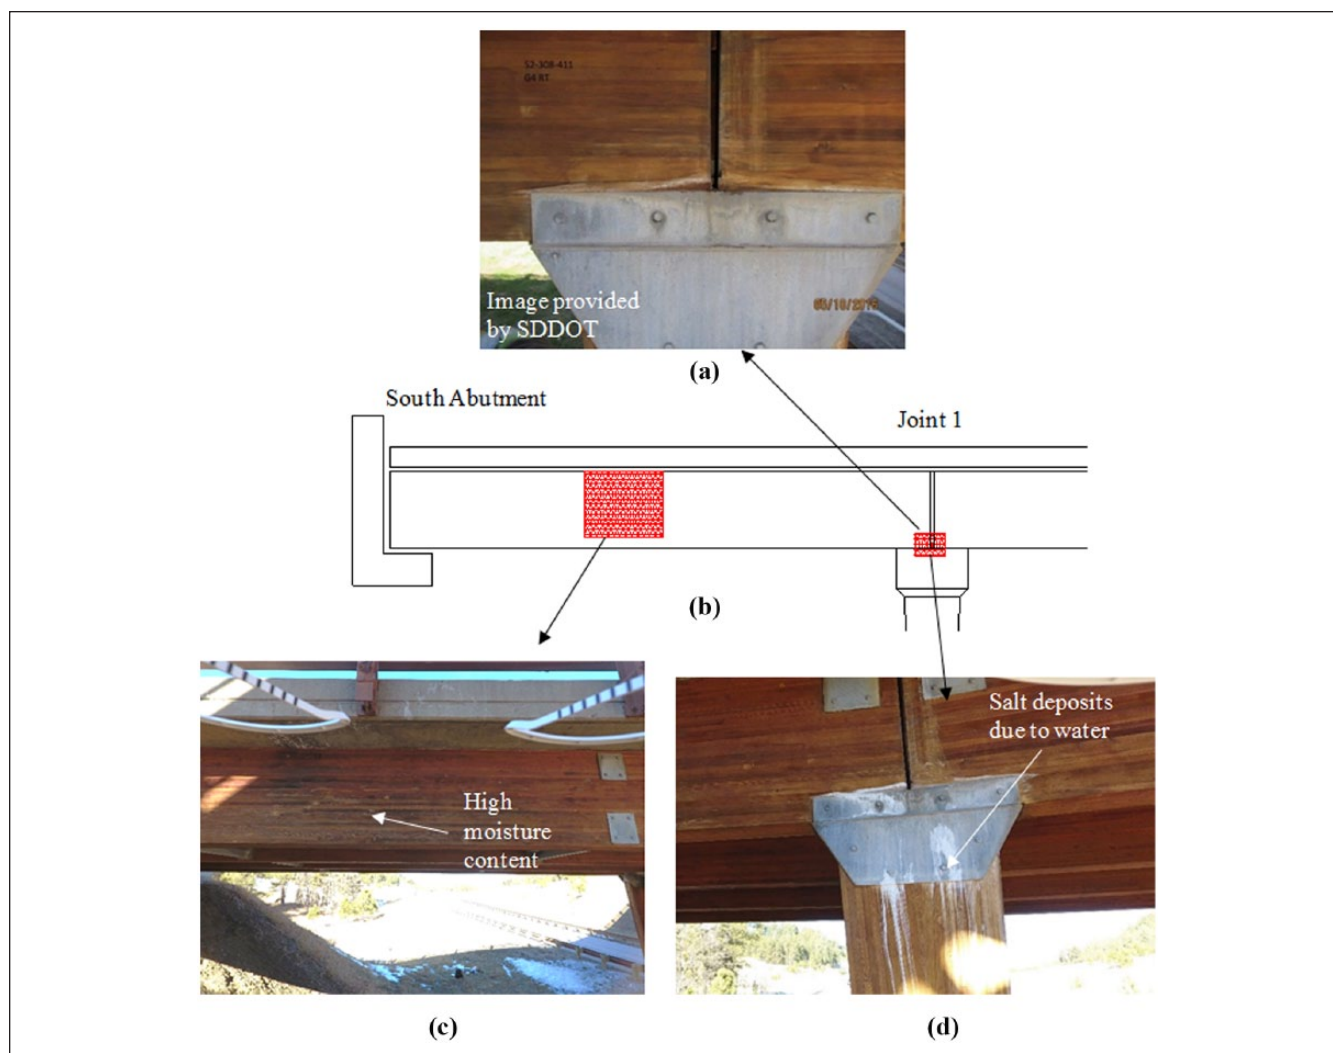
**Girders.** The damage detected on the girders using the UAS coincided with the report provided by South Dakota DOT. A picture provided by South Dakota DOT (see Figure 8a) is included to compare with those taken by the UAS. Several damaged areas caused by high moisture content were localized on the girders (see Figure 8b). For example, some moisture on Girder 4 between South Abutment and Joint 1 was identified, as seen in Figure 8c. Girders damaged because of high moisture were also recognized in other areas, especially near joints, as seen in Figure 8d. Note that the South Dakota DOT does not specify moisture-related damage of Girder 4 between South Abutment and Joint 1 and Girder 4 between North Abutment and Joint 2. Finally, the South Dakota DOT did not report quantifiable damage apart from a 5.08-cm (2-in.) by 5.08-cm

**Figure 8.** Sample damage on girder: (a) image provided by South Dakota DOT (13), (b) damage location, (c) some moisture on the side of Girder 4 between South Abutment and Joint 1, and (d) salt deposits caused by water coming from the deck at the support of Girder 4 at Joint 1.

(2-in.) surface scratch on the bottom of Girder 1 between Joints 1 and 2 which was also measured using the data from the UAS.
