## Timber Bridge Inspection Using UAV

Luis Duque, S.M.ASCE<sup>1</sup>; Junwon Seo, Ph.D., M.ASCE<sup>2</sup>; and James Wacker, M.ASCE<sup>3</sup>

Junwon Seo, Luis Duque, James Wacker. Timber Bridge Inspection using UAV. 2018. In: Proceedings of the ASCE Structures 2018, March 21-23, 2018. Fort Worth, TX. American Society of Civil Engineers, Reston VA. 10p. (electronic proceedings). 2018

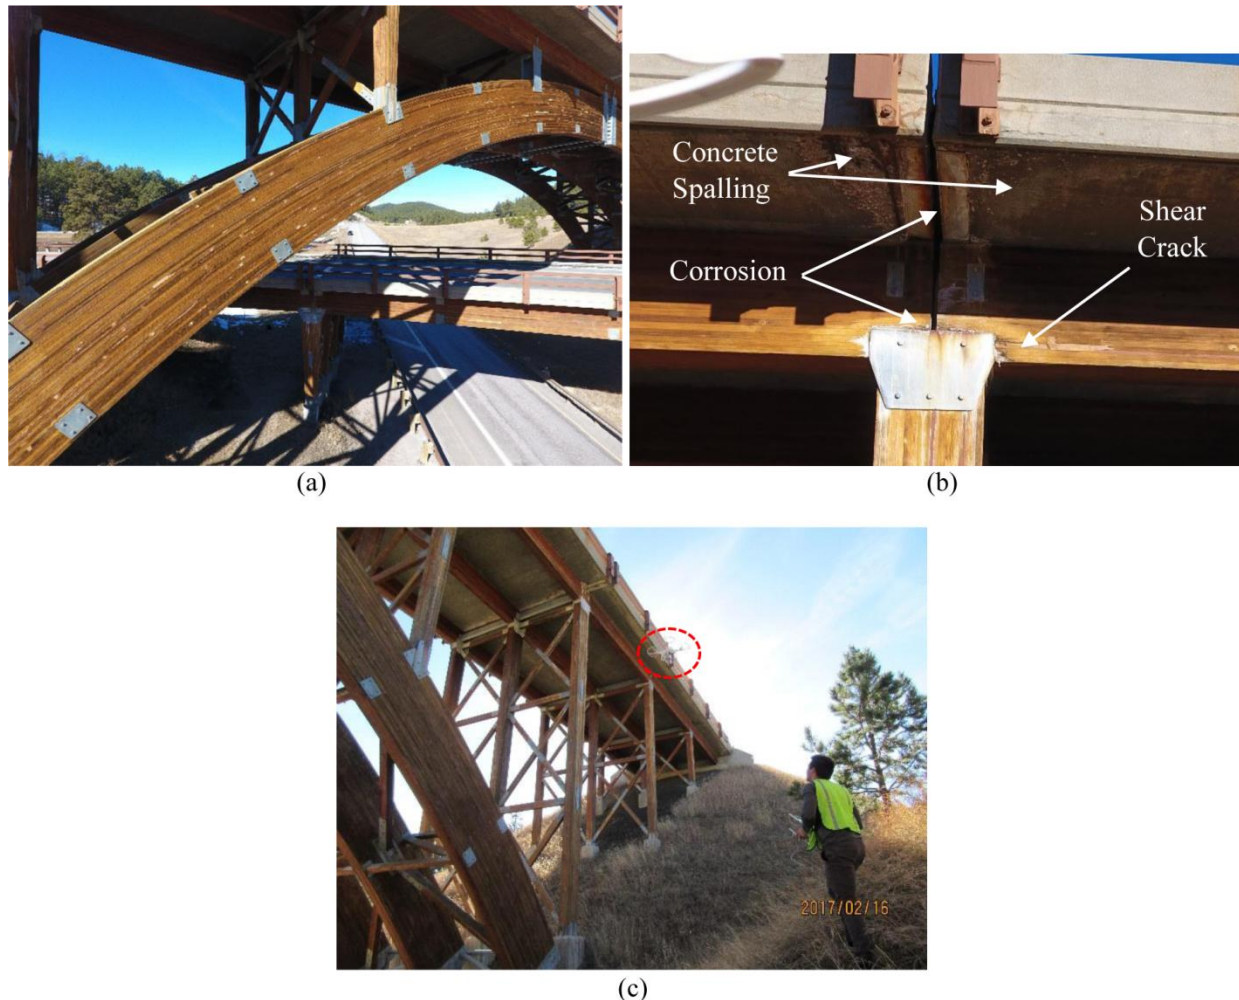
**Fig. 4. Sample images for the drone-enabled bridge inspection: (a) close view of the arch; (b) identified damage on deck joint; and (c) operation of the drone near the bridge – Courtesy of Junwon Seo.**

The drone-enabled bridge inspection was conducted without inconveniences over two days. The drone successfully operated near structural components during the first day of inspection to capture small details such as cracks on the structure. The weather conditions were appropriate and allowed for an efficient inspection of the structural components. During the second day of inspection, high wind speeds impeded the normal conduction of the bridge inspection. Due to the inability to maintain a stable flight and approach the structure safely, while capturing images, a video-based data gathering approach was studied. The video-based approach allowed the PIC to fly without any distractions caused by the picture taking process. Sample images for the inspection of the Keystone Wye Bridge are presented in Figs. 4a and 4b. Fig. 4a shows a close view of the glued-laminated arch and Fig. 4b presents damage on one of the joints of the concrete deck. Also, the operation of the drone near the bridge can be seen in Fig. 4c.

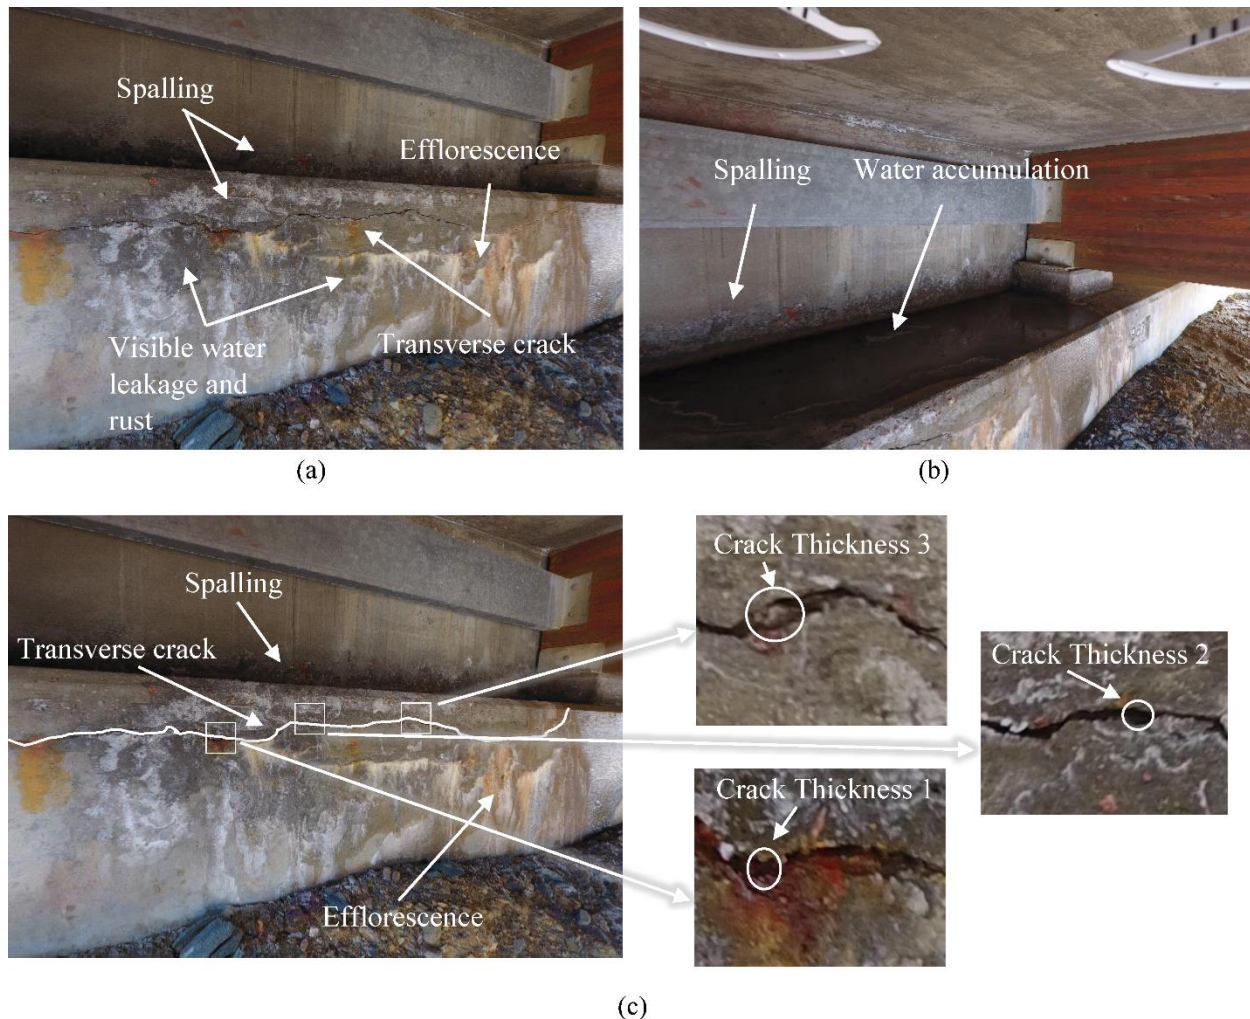
**Fig. 5. Sample abutment damage detected using the drone on North Abutment: (a) transverse concrete crack, visible water leakage, efflorescence, and spalling; (b) water accumulation over crack; and (c) quantified damage on North Abutment on Bay 1 – Courtesy of Luis Duque.**

**Table 1. Damage Quantification for North Abutment**

| <b>Identified damage</b> | <b>Pixel-Based Measurements and Observation</b> |
|---|---|
| Transverse crack length | 354 cm |
| Crack thickness 1 | 1.42 cm |
| Crack thickness 2 | 2.08 cm |
| Crack thickness 3 | 1.75 cm |
| Spalling | Spalling along bay width |
| Efflorescence | White surface with accumulation and rust stains |

The abutments presented some critical damage, such as cracks. For instance, a significant transverse crack was observed on the north abutment as seen in Fig. 5a. Some water leakage along the surface of the abutment was observed as seen in Fig. 5b. Further, the quantification of the damage on the north abutment (see Fig. 5c) was completed using the pixel-based methodology described previously and listed in Table 1.

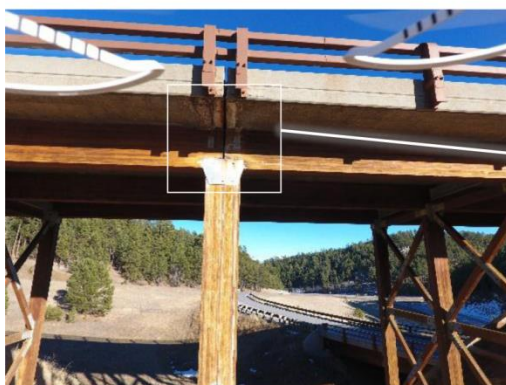
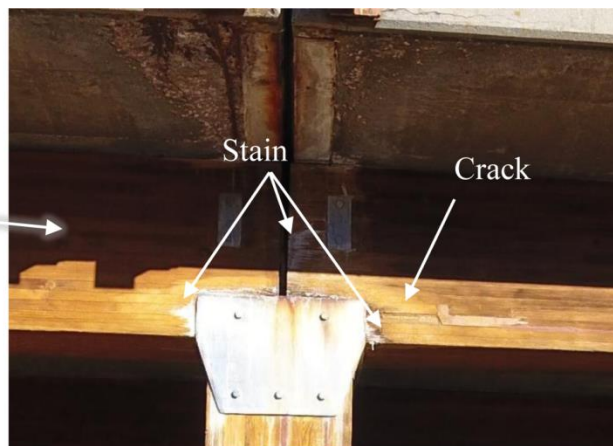
(a)

The stringers were found to be in good condition. Some minor deterioration at supporting areas, especially near deck joints were visible due to water leakage. One visible shear crack on Stringer 1 at Joint 4 was found as seen in Fig. 6a. Fig. 6b shows stains on Stringer 1 between Joints 3 and 4. The damage on Stringer 1 at Joint 4 was also quantified using the pixel-based measurement approach as seen in Fig. 6c. The quantifiable damage is presented in Table 2.

**Fig. 6. Sample stringer damage detected using drone:**  
**(a) damage at Joint 4; (b) damage on Stringer 1 between Joints 3 and 4; (c) quantified damage on Stringer 1 at Joint 4; and (d) image provided by SDDOT for comparison.**  
 – Courtesy of Junwon Seo.

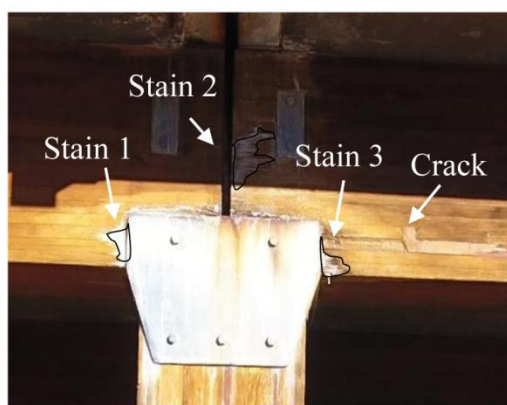
(c)

| <b>Identified damage</b> | <b>Pixel-Based Measurement</b> |
|---|---|
| Crack (timber split) | 31.2 cm |
| Stain area 1 | 98.7 cm <sup>2</sup> |
| Stain area 2 | 210.3 cm <sup>2</sup> |
| Stain area 3 | 64.5 cm <sup>2</sup> |

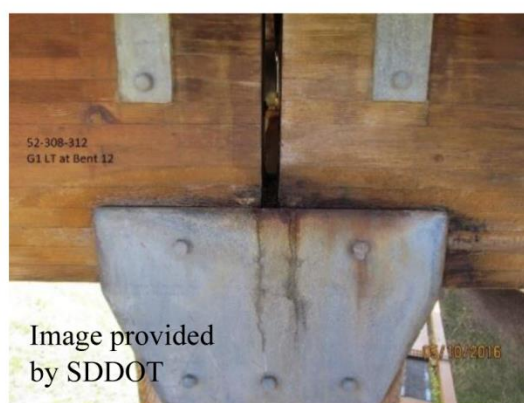
(d)

The results gained from the drone were related to the inspection reports provided by the SDDOT. Some horizontal cracks on Stringer 1 and 3 reported by the SDDOT were not fully observed due to high wind conditions during the second day of inspection. Fig. 6d shows an image provided by SDDOT with some sharp cracking at the support of Stringer 1 at Joint 4 and can be compared to Fig. 6a.
