# Reliability of acoustic tomography and ground-penetrating radar for tree decay detection

**METHODS:** One hundred and forty-seven individual trees of 33 species were inspected at a historic park in Yangzhou, Jiangsu Province, China, using a combination of visual inspection, acoustic tomography, GPR scanning, and resistance micro-drilling methods. Special image processing procedures were developed to analyze the acoustic and radar images and to estimate the proportion of compromised wood.

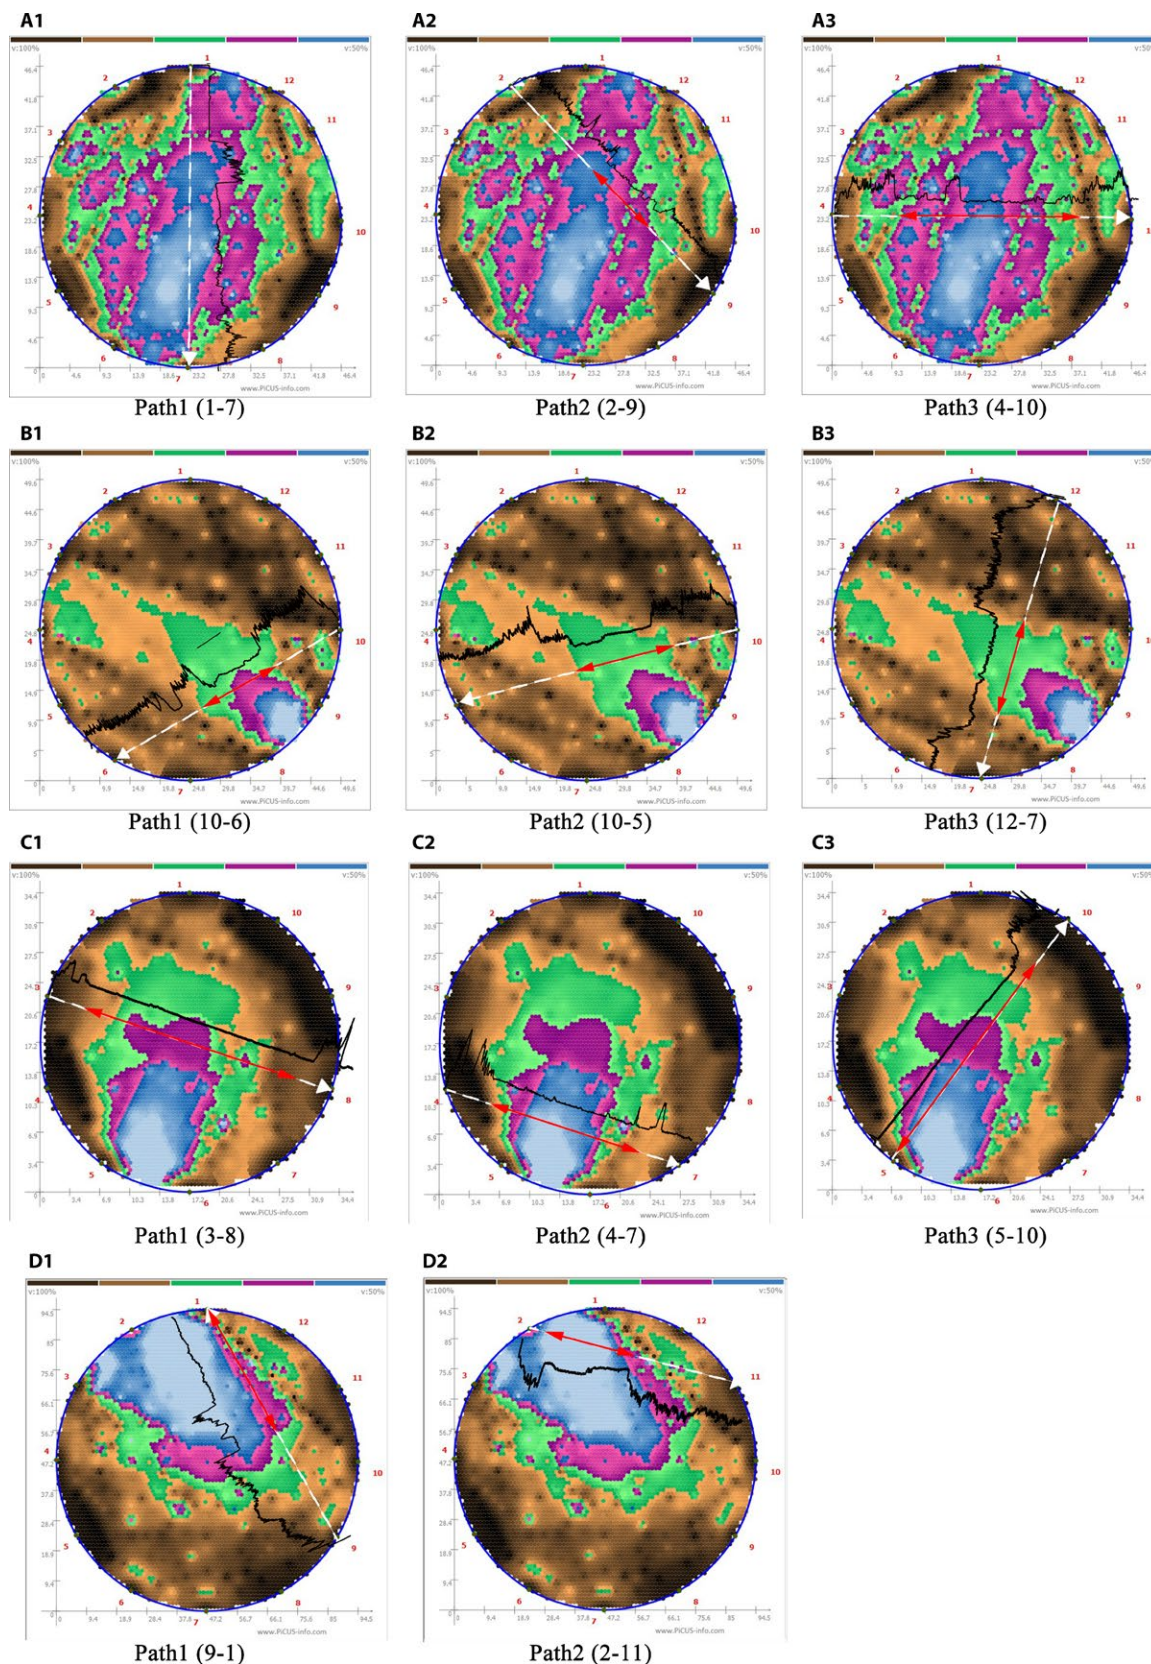
**FIGURE 2.** The PiCUS tomogram superimposed with the RESISTOGRAPH profile in selected drilling paths. A1–A3 = tree no. 30, B1–B3 = tree no. 71, C1–C3 = tree no. 90, D1–D2 = tree no. 100. The white dashed arrows indicate the drilling path and drilling direction, the red arrows show the depth of the decay region, and the black lines represent the superimposed resistance profiles.

In each of the images in Fig. 2, white dashed arrows indicate the drilling path on the tree trunks, black lines represent the superimposed resistance profiles, and red arrows show the depth of internal decay or cavity. In the case of tree no. 30 (Fig. 2A), the compromised wood area accounted for 64.4% of the trunk cross section. Resistance profiles matched the size of the compromised wood in path 3 (4–10), but not in path 1 (1–7) or path 2 (2–9). This indicates that the defect area is likely a combination of internal rot and a large lateral crack extending to the edge of the trunk. In this case, it is

difficult to estimate the exact size of internal decay, but the presence of one or multiple large lateral cracks has a dominating effect on the tomogram. In trees no. 71 (Fig. 2B), 90 (Fig. 2C), and 100 (Fig. 2D), the resistance profiles matched the area of the compromised wood in almost all of the drilling paths, indicating internal decay and cavities are the main defects in these trees.

Trees no. 102 and 104 both contain open cavities and compartmentalized decay that can be visually observed. The significant proportion of the compromised wood on these five trees (no. 30, 90, 100, 102, and 104) suggest that they are in high risk of failure and special precaution measures should be taken.

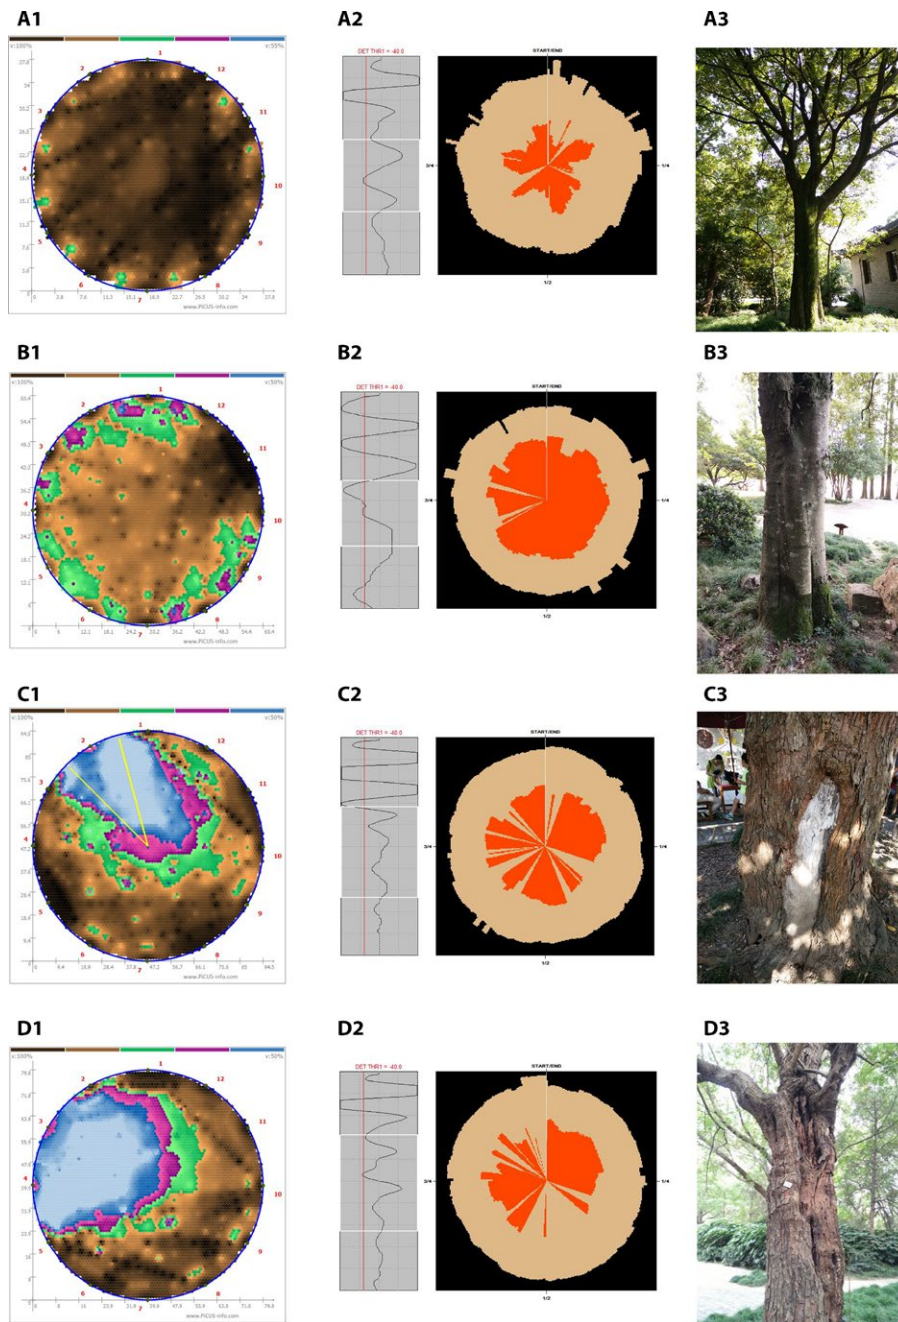
**FIGURE 5.** Comparison of the TRU radar image and the corresponding PiCUS tomogram for a healthy tree (A) and for defective trees (B–D). A1–A3 = tree no. 78, B1–B3 = tree no. 109, C1–C3 = tree no. 100, D1–D3 = tree no. 104. The proportion of compromised wood for tree no. 78: 14% (TRU) vs. 0% (PiCUS); tree no. 109: 37.3% (TRU) vs. 21.9% (PiCUS); tree no. 100: 17.3% (TRU) vs. 41.4% (PiCUS); and tree no. 104: 20.1% (TRU) vs. 42.1% (PiCUS).

For four selected trees of different conditions, the TRU radar images and PiCUS tomograms were compared (Fig. 5). For tree no. 78, which was indicated as being sound and healthy by the PiCUS tomogram and visual inspection, the radar image indicated a center decay area of 14% (i.e., a false positive). Fifty-one out of the 60 trees scanned by TRU fell into this category, representing 85% false positive predictions. For trees no. 109, 100, and 104, radar images correctly detected the presence of internal decay and cavities, but the location and size of the defect do not match the corresponding PiCUS tomograms as shown in Figures 5B–D.
