Research  
Paper  
FPL-RP-550

# Field Performance of Timber Bridges

## 7. Connell Lake Stress-Laminated Deck Bridge

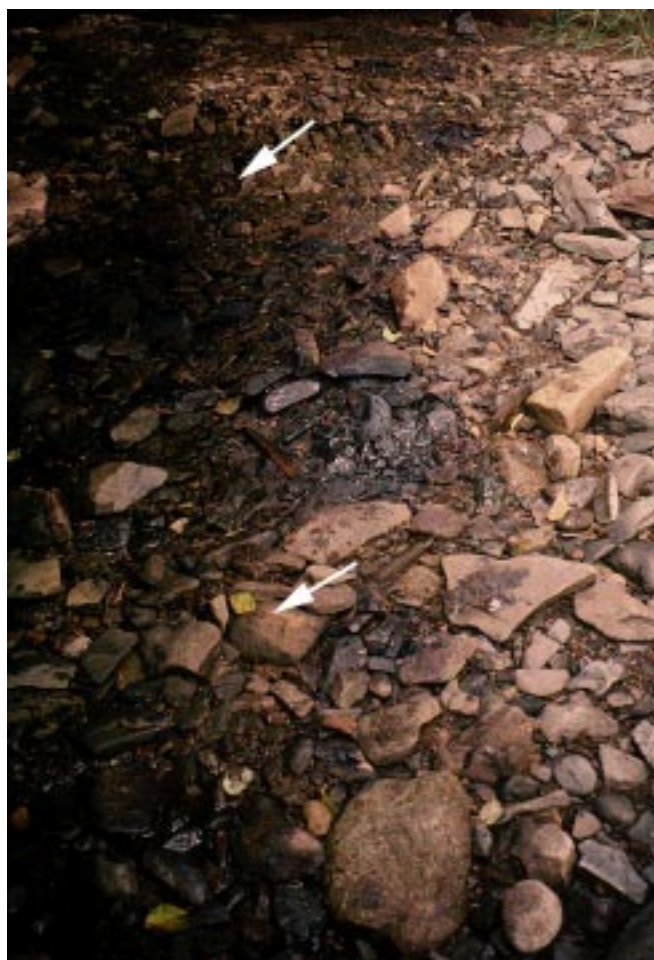
preservative treatment envelope of the members. Inspection showed evidence of wood preservative loss with preservative accumulations on the wood surface as well as on the stream bottom (Fig. 18).

**Figure 18—Excessive preservative leaching from laminations onto streambed.**

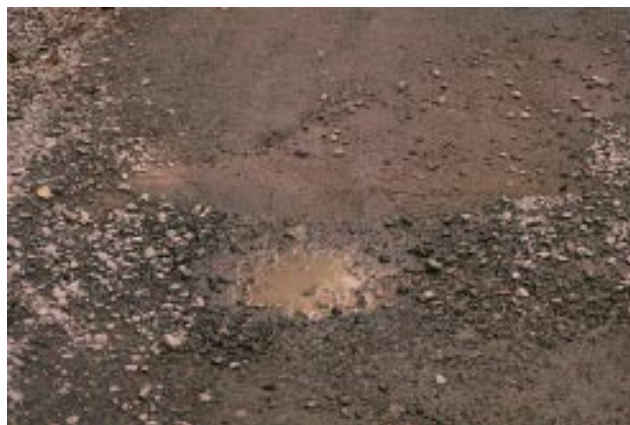
Inspection of the timber plank wearing surface indicated minor plank wear and checking. Aside from these items, the wood planks were in good condition and showed no other signs of distress. A 2-in. layer of soil has been tracked onto the bridge deck and potholes have developed in the unpaved approach roadway at both bridge ends (Fig. 19). The soil on the bridge deck can trap moisture and inhibit drainage, which may lead to premature deterioration. The potholes increase vehicle impact to the bridge that can cause damage to the preservative deck treatment and timber components.

**Figure 19—Soil on deck surface should be removed, and potholes along end of bridge should be filled.**

- We anticipate that the 2-in. accumulation of soil on the deck will result in deterioration because of trapped moisture and lack of drainage, and the potholes along the deck ends will result in deck edge wear and impact loading. The soil should be removed from the deck surface and the potholes should be filled. Paving the approach roadways would prevent pothole creation and their adverse effects.

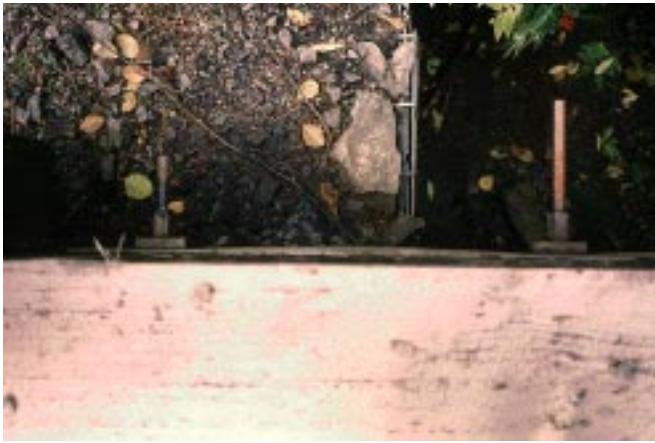
**Figure 20—Crushing of outside laminations, causing a wave distortion of the bearing plates.**

at a lower cost than the channel bulkhead system (Ritter 1990). Inspection indicated that the portion of the bearing plates near the bars were crushing approximately 0.5 in. into the outside laminations, but no crushing was observed between the bars. This has caused a wave distortion of the bearing plates (Fig. 20). Crushing may have occurred as a result of insufficient bearing plate area for the strength of the exterior lamination, insufficient plate thickness for uniform force distribution, or reduced outer lamination strength because of the high moisture content level. It is probable that the crushing occurred after the initial bar tensioning and is not expected to continue unless the bars are retensioned.

- The use of the continuous bearing plate bar anchorage system did not prevent crushing of the outside laminations. Further crushing may occur if the bars are retensioned.
