Research  
Paper  
FPL-RP-552

# Field Performance of Timber Bridges

## 9. Big Erick's Stress-Laminated Deck Bridge

November 1996

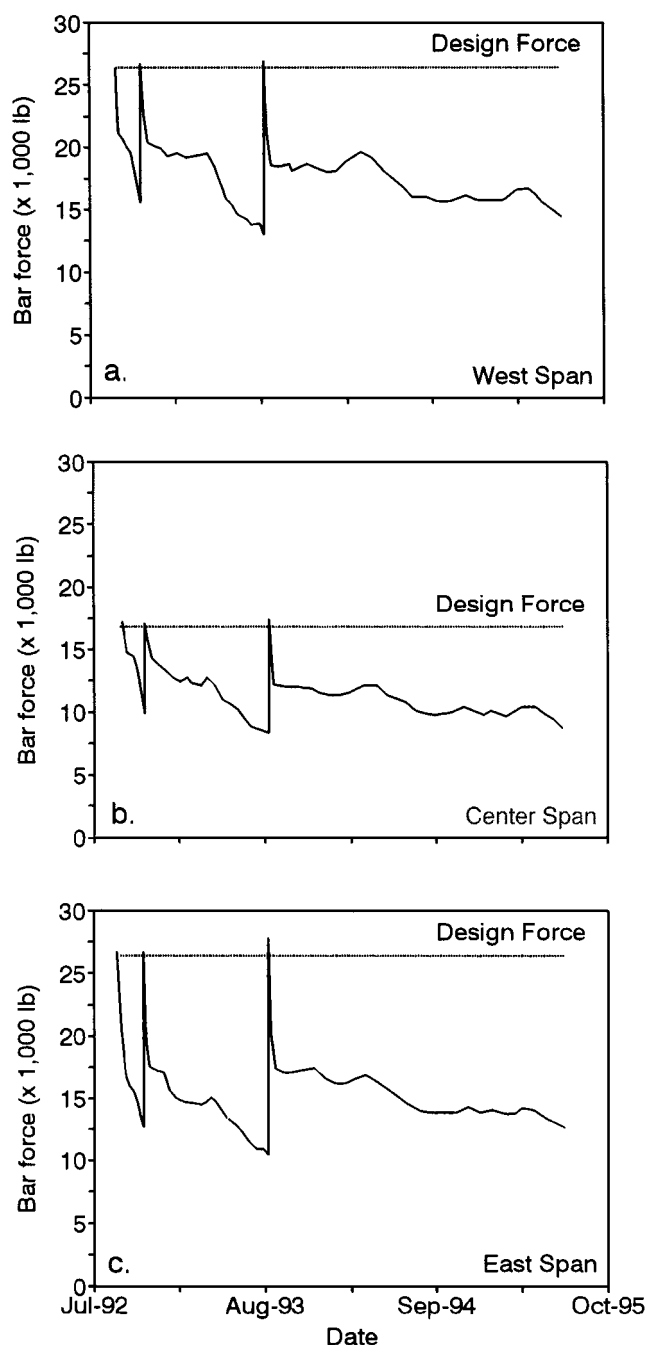
The average trend in bar force, starting at the third stressing, is shown in Figure 18. At the third stressing, all bars were tensioned to the design level of 100 lb/in<sup>2</sup>, or 26,400 lb for the approach spans and 16,800 lb for the center box. After 2 months, all three spans lost 40 to 50 percent of the design bar force and the bars were retensioned. Eleven months after installation, all three spans lost 50 to 60 percent of the design bar force and were tensioned again. Approximately 2 weeks after this fifth bar tensioning, the bar force stabilized at approximately 70 percent of the design bar force, then decreased slowly for the remainder of the monitoring period. At the conclusion of monitoring, bar force values were 14,800 lb

**Figure 18—Average trend in bar force, starting at the third bar tensioning for (a) west, (b) center, and (c) east spans.**

for the west span, 8,700 lb for the center span, and 12,500 lb for the east span, which is 45 to 55 percent of the design bar force. With each bar tensioning, the rate of bar force loss decreased, although the overall amount of bar force lost between stressings remained relatively equal.

caused by the long-term compressive force of the steel bars acting on the wood microstructure. The rate of stress relaxation was greater on the Big Erick's bridge when compared with other stress-laminated bridges and was probably the result of the high moisture content in the timber laminations. An additional factor affecting bar force loss was the prefabrication methodology of completing two of the recommended bar tensionings on partial-width sections. This methodology diminished the positive effects of repetitive tensionings, because the bars were not full width until the third tensioning. Another plausible cause of bar force loss was crushing of the exterior laminations on the approach spans. Crushing was observed under the bearing plates during construction and the monitoring period. The rate of crushing and the corresponding bar force loss decreased with each subsequent bar tensioning. This is discussed in detail in the Condition Assessment section.

- Following the final design bar tensioning, two additional bar tensionings were required due to rapid loss of bar force. The decrease in bar force was primarily attributable to transverse stress relaxation in the wood laminations with additional effects from crushing of the approach span exterior laminations near the bar anchorages. It is anticipated that the bridge will require retensioning in the near future. In addition, as the moisture content decreases, the bar force will also decrease until an equilibrium moisture content is reached. Therefore, bar force should be checked annually and retensioned as necessary until it reaches a constant level.

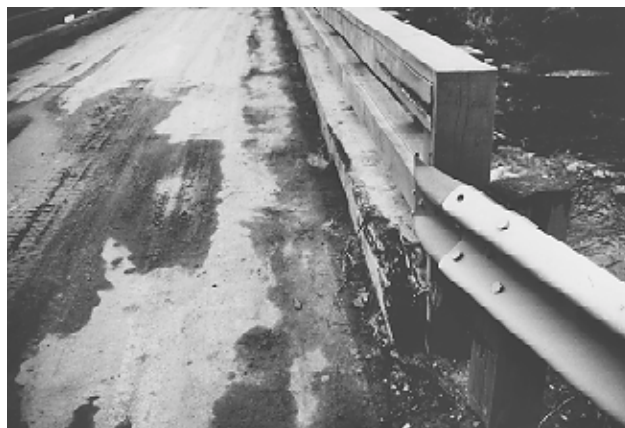
**Figure 27—Vehicle damage to curb and rail system observed during a site visit near the end of the monitoring period.**

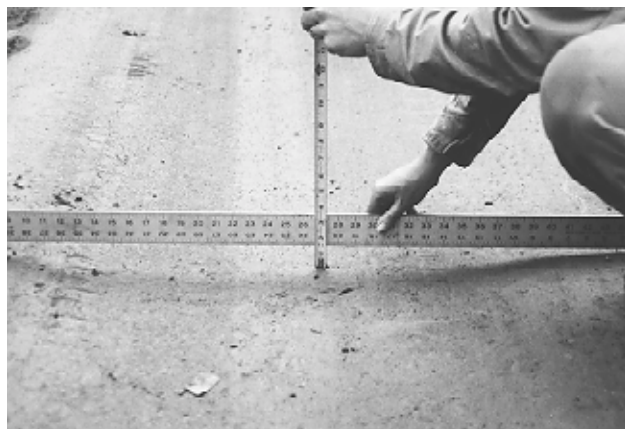
The asphalt wearing surface was observed to be in poor condition at the conclusion of the monitoring period. Large transverse cracks were observed at the piers and at the west abutment. At the west pier, transverse cracking has heaved 1 to 2 in. above the roadway grade. Longitudinal rutting was also observed along two vehicular wheel lines in the asphalt on the bridge and the approach roadway, which varied from 0.5 to 1.5 in. in depth. The rutting is most severe at the center span (Fig. 28). Rutting was first observed 11 months after bridge installation and increased during the monitoring period. The heaving and rutting were probably caused by a poor asphalt mix and will cause rain water to remain on the deck for extended periods. This condition also tends to trap a substantial quantity of gravel and other debris on the surface from the unpaved road. The debris accumulations could lead to premature deterioration of the wearing surface.

**Figure 28—Rutting of asphalt wearing surface measured at the center span during a site visit for load test 2.**

- The asphalt wearing surface has longitudinal ruts and heaving at the piers, which contribute to increased standing water and debris on the surface of the bridge. These conditions could lead to premature deterioration of the wearing service.

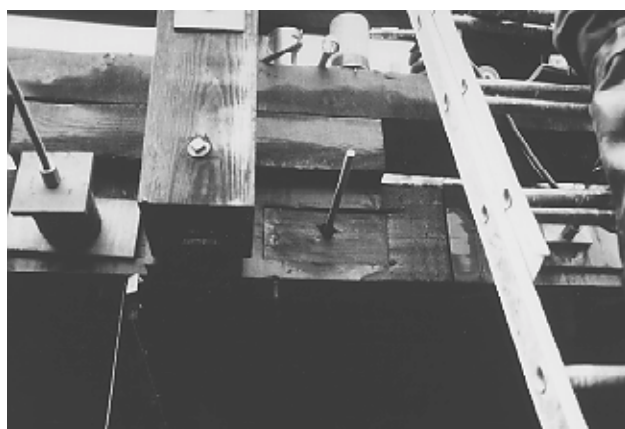
bearing plates into the Southern Pine glulam exterior laminations of the center span. However, crushing of the Eastern Hemlock laminations on the approach spans was first observed during bridge construction and continued progressively until the end of monitoring (Fig. 29), and seems to have contributed to short-term bar force loss after bar tensioning. This crushing occurred even though the bearing plates were properly designed, based on published values for compression perpendicular to grain adjusted for wet-use conditions. This indicates that the published design values for compression perpendicular to grain may not be representative of the material for use in this application. The use of a treatable hardwood species, such as oak or maple, on the outer laminations has been shown to perform well without crushing problems (Ritter and others 1995).

**Figure 29—Visible crushing of approach span, Eastern Hemlock lumber lamination, observed after the removal of the bearing plate at the final site visit.**

- The use of high moisture content Eastern Hemlock sawn lumber on the outside laminations of the approach decks adversely affected the performance of the bar anchorages. The wood crushing observed was approximately 0.75 in. underneath the bearing plates. The inclusion of hardwood laminations for the two exterior laminations would have greatly enhanced the bar anchorage performance.
