# 100-Year Performance of Timber–Concrete Composite Bridges in the United States

James P. Wacker, M.ASCE<sup>1</sup>; Alfredo M. P. G. Dias<sup>2</sup>; and Travis K. Hosteng, M.ASCE<sup>3</sup>

**Abstract:** The use of timber–concrete composite (TCC) bridges in the United States dates back to approximately 1924 when the first bridge was constructed. Since then a large number of bridges have been built, of which more than 1,400 remain in service. The oldest bridges still in service are now more than 84 years old and predominately consist of two different TCC systems. The first system is a slab-type system that includes a longitudinal nail-laminated deck composite with a concrete deck top layer. The second system is a stringer system that includes either sawn timber or glulam stringers supporting a concrete deck top layer. The records indicate that most of the TCC highway bridges were constructed during the period of 1930–1960. The study presented in this paper discusses the experience and performance of these bridge systems in the US. The analysis is based on a review of the relevant literature and databases complemented with field inspections conducted within various research pr

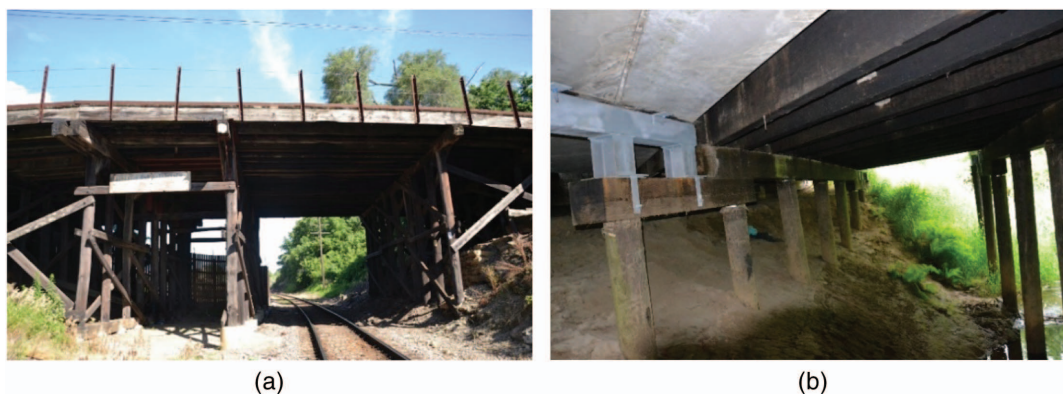
In the NBI, construction of this bridge type was reported before 1920; however, no other information could be found about these bridges. Some of these bridges are located at Rockford, Illinois, and one of them was constructed in 1901 [Fig. 3(a)]; however, the actual field inspection identified an old timber sawn stringer-type bridge that was widened with a concrete deck extension, which

**Fig. 3.** (Color) (a) Bridge built in 1901 in Illinois; and (b) bridge where new concrete members were added to an original timber beam bridge. (Images by Alfredo M. P. G. Dias.)

probably led to its ambiguities within the data included in the NBI (original construction, later addition of concrete extension).

Similar NBI data ambiguities are found in other locations such as Wisconsin or Washington State where the addition of concrete components was used in conjunction with an existing timber bridge. This type of widened bridge was incorrectly coded in the NBI as a timber girder bridge with a concrete deck [Fig. 3(b)]. This indicates that the actual number of timber–concrete bridges still remaining in service is likely less than the 1,645 included in the current NBI data sets. In Fig. 4, the quantity of TCC bridges is plotted by the state and decade (date of construction).

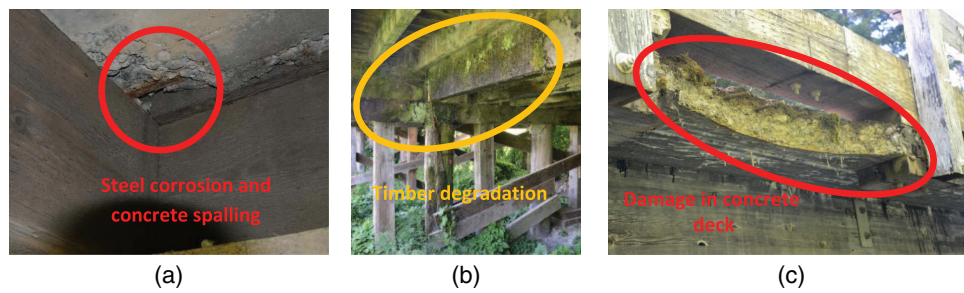
**Fig. 10.** (Color) Examples of (a) steel; (b) timber; and (c) concrete degradation found by the inspections. (Images by Alfredo M. P. G. Dias.)

In spite of the general good condition of the bridges, there were several deficiencies common in a large number of bridges. The most common deficiencies found were cracks in the concrete or asphalt deck, timber degradation, steel corrosion, and mechanical damage in timber and/or concrete (Fig. 10).

Most of deficiencies were related in different ways to contact with moisture. For the timber bridges the contact of the supports, piles, and/or stringers with soil or water was the main reason, but contact with vegetation or the existence of animal nests were also found. In TCC bridge decks the presence of an upper concrete deck layer prevented most of the moisture contact with timber, which is one of the most important advantages of this system. Nevertheless, in many bridges this was not entirely effective due to poor design or performance of the bridge solutions. More specifically, two main problems were found: lack of or poorly designed concrete deck overhang (Fig. 11) and expansion joints or cracking of the concrete deck (Fig. 12). In spite of these deficiencies, the TCC bridges remain in service and, in many cases, are still providing an adequate level of service. This is likely due to the use of oil-type (creosote or

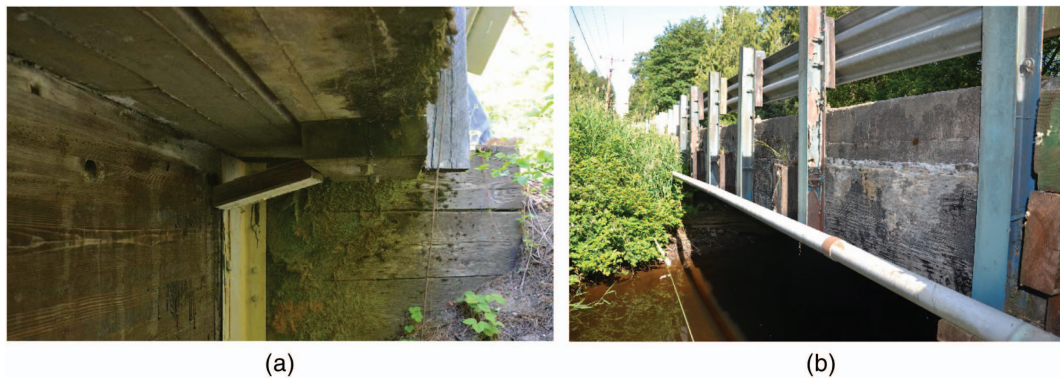
**Fig. 11.** (Color) (a) Good; and (b) bad examples of concrete overhanging. (Images by Alfredo M. P. G. Dias.)

Different overhang configurations were identified in the bridges inspected, with overhang widths that varied between 5 and 61 cm usually connected to the top of the timber member. The presence of an overhang, even with a poor design, always provided a significant level of shelter protection to the timber members on the underside. Conversely, in decks without overhangs the side timber members were always in poor condition due to the direct weathering and in some cases had been previously replaced.

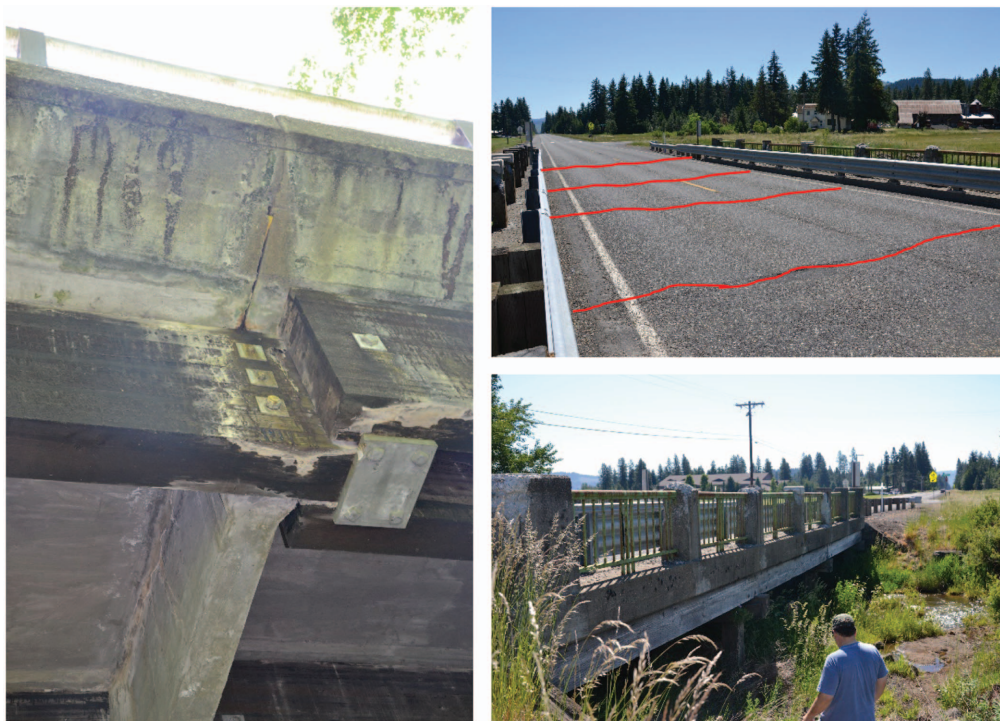
**Fig. 12.** (Color) Expansion joints and crack in the concrete member allowing water into the glulam girders. (Images by Alfredo M. P. G. Dias.)

It was also clear from the inspection that a very weak zone of the TCC decks are the expansion joints and the supports. The expansion joints must be carefully designed in order to allow an adequate performance and water flow, preventing the rainwater from moving into the deck underside and saturating the supporting timber members. Cracks were commonly found in the concrete deck surface above the end supports due to girder rotational uplift. In many continuous bridges (which are the majority), the location of the intermediate supports could be identified from the deck surface due to the presence of relatively broad cracks. From underneath, there were always signs of water leakage and in many situations degradation associated with these concrete deck flaws.

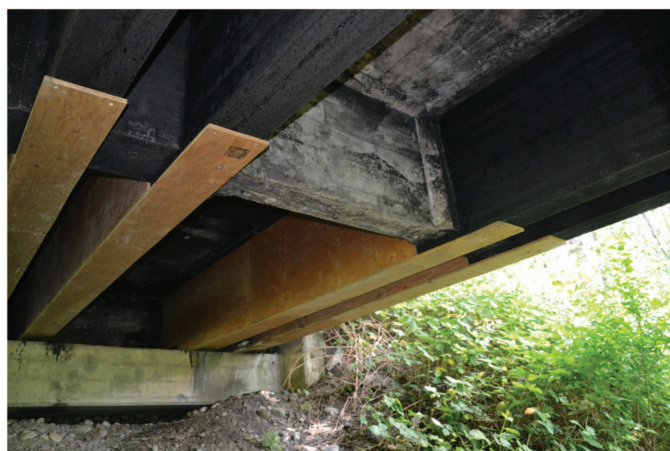
**Fig. 13.** (Color) Fire damage in the timber members of a TCC bridge (treated plywood was added to reduce the fire damage potential). (Image by Alfredo M. P. G. Dias.)

Some of these bridges were in close proximity to urban areas, and in a few cases evidence of human habitation was found beneath the bridge. In these situations, remains of campfires were visible near the abutments, which damaged the glulam bridge members (Fig. 13). Fire-retardant-treated plywood was added to the glulam girders near the bridge supports to shield them from further fire damage.

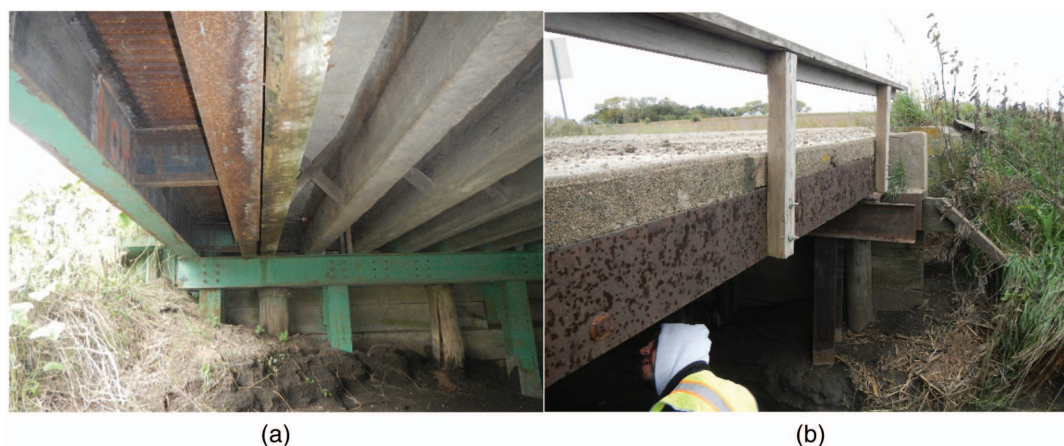
**Fig. 14.** (Color) (a) Widening; and (b) reinforcement of TCC bridges. (Images by Alfredo M. P. G. Dias.)

Interventions have also been undertaken to mitigate damage in specific timber members, such as foundation poles or side beams. In these conditions the replacement of the timber members by steel members was often adopted (Fig. 14).

In many TCC bridges the increasing traffic demands motivated bridge widening efforts (Figs. 14 and 3). This demonstrates the TCC's long-term bridge durability: after 60, 70, or 80 years of service the condition was still good enough to not replace, but instead

to just widen. The added benefit of this approach is that the inadequate drainage issues along the bridge deck edges (curb or scupper zones) are solved.
