# Long-Term Moisture Monitoring Results of an Eight-Story Mass Timber Building in the Pacific Northwest

Shiling Pei, M.ASCE<sup>1</sup>; Jake Stogdill<sup>2</sup>; Samuel V. Glass<sup>3</sup>; Samuel Zelinka<sup>4</sup>; Steven Kordziel<sup>5</sup>; and Paulo Cesar Tabares-Velasco<sup>6</sup>

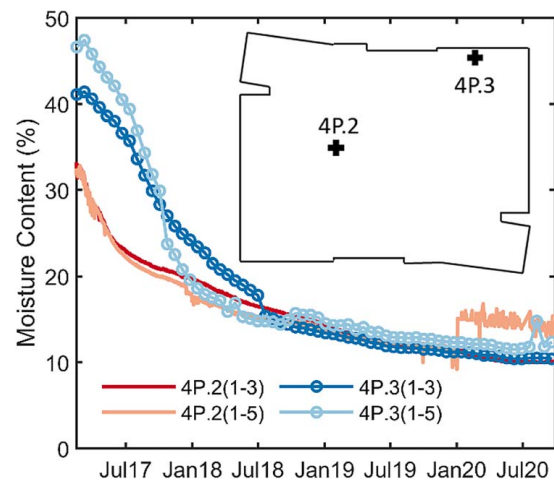
**Fig. 2.** Moisture Content for Locations 4P.2 and 4P.3.

indicate that the wetting is more severe at the perimeter location, registering an MC above 35% during construction. After about 18 months, all readings on the fourth floor fell below 19% and stayed below that level thereafter. The MC for these sensors seems to stabilize between 10% and 15% in the long term. The high-frequency variation at the end of the monitoring period was believed to be caused by loose instrument probe contact. The sensors are not very sensitive under 10% MC [i.e., a loose probe (open circuit) will show a reading of around 7%–8% MC] based on information provided by the sensor manufacturer. The floor diaphragm was constructed using 5-ply CLT. One can see from Fig. 2 that the four remaining sensors belong to two panel location groups but were measuring different layers of the CLT material.

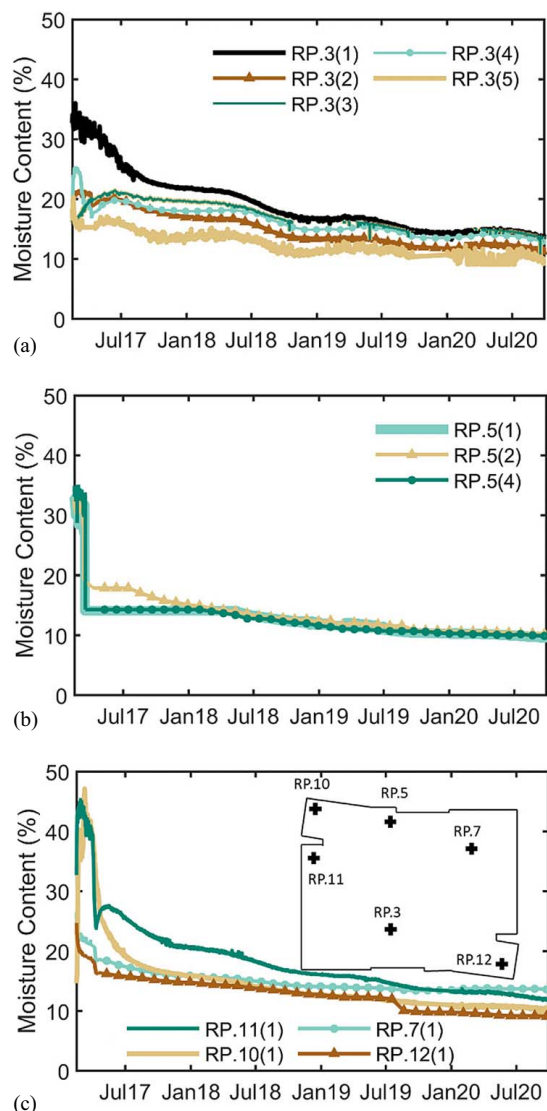
**Fig. 3.** Moisture Content for Locations: (a) RP.3; (b) RP.5; and (c) RP.7 through RP.12.

with a single sensor in the first layer [various, Fig. 3(c)]. The time history of the MC recording for all these locations is shown in Fig. 3. The straight line jumps shown in the data were due to data loss over that period of time.

MC data from all locations on the roof indicated the drying of roof panels over time. While the roof panels were exposed to heavy rain during construction and remained very wet at the time of applying roofing membrane and insulation, all of the locations monitored dried out to under 19% MC after about 18 months from the start of construction. There have been some concerns on the effect of a vapor-impermeable membrane on the long-term drying process of CLT. However, it is clear from some of these sensors [especially the top layer sensor from Fig. 3(a)] that the CLT monitored in this building was able to continuously dry out even with the membrane applied when the wood was still wet. After 3 years, the MC of all monitored locations on the roof was below 15%, with most locations showing a continued drying trend (i.e., MC data showing a negative slope over time).

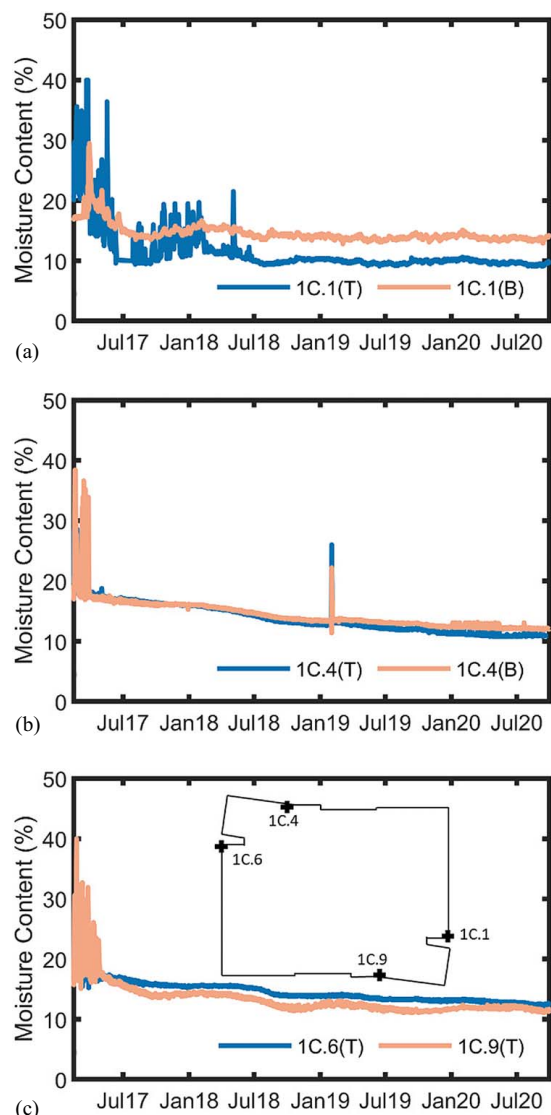
**Fig. 4.** Moisture Content data for (a) Location 1C.1; (b) Location 1C.4; and (c) Locations 1C.6 and 1C.9.

monitored in this study were exposed to the environment. All of the functional glulam-MC sensors were located at the first-story (ground floor) columns. The long-term MC data for all these columns are illustrated in Fig. 4. It can be seen that all column locations started very wet due to exposed construction, but these members dried very fast after the building was completed and enclosed. This is expected because such members are exposed and vertical, therefore leaving little chance of sustained rainwater absorption. All glulam monitoring locations reached a stable MC after 18 months after construction, with some moisture spike events likely due to accidental wetting during occupancy. However, the wetting effect very quickly dissipated by itself, demonstrating the drying benefit of the exposed wood members.

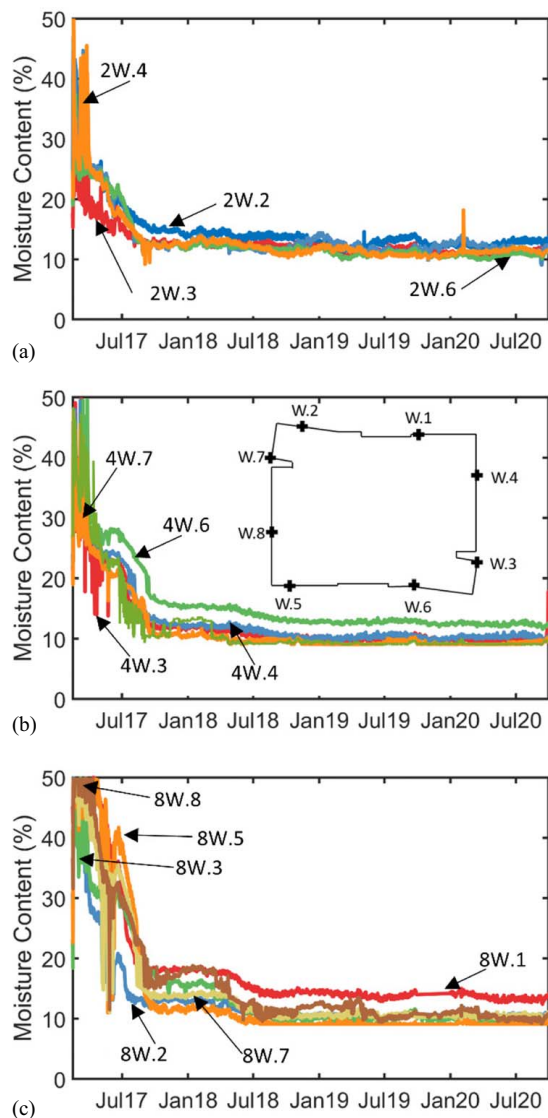
**Fig. 5.** Stud wall moisture content time history for Floor 2(a); 4(b); and 8(c).

treated for fire, which increases the conductivity of moisture sensors, resulting in higher readings. Therefore, the MC readings presented were a conservative estimation of how wet the wood was. The time history of MC data from all wood stud walls (SWs) is presented in Fig. 5. The MC readings of these studs started quite high, but all fell below 19% after the first year and stayed around 10%–15% throughout the rest of the monitoring period.

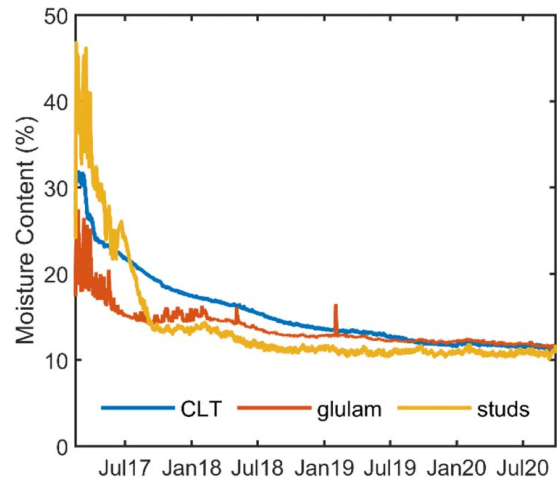
The average MC data from all functional sensors over about 3.5 years of monitoring period are plotted in Fig. 6 for different wood products. From the data, it can be observed that the CLT sensor locations exhibit a slower rate of drying than the glulams and stud walls. This agrees with the trend observed in the original paper with only 1 year of data. This is not surprising because CLT panels for this project were covered by a water vapor-impermeable membrane on the top face. It is clear from the long-term data that once all products dried out, the MC levels stabilized and there is no significant difference between the different products.

**Fig. 6.** Average moisture content time history of all data from CLT, stud walls (SWs) and glulam (GL).

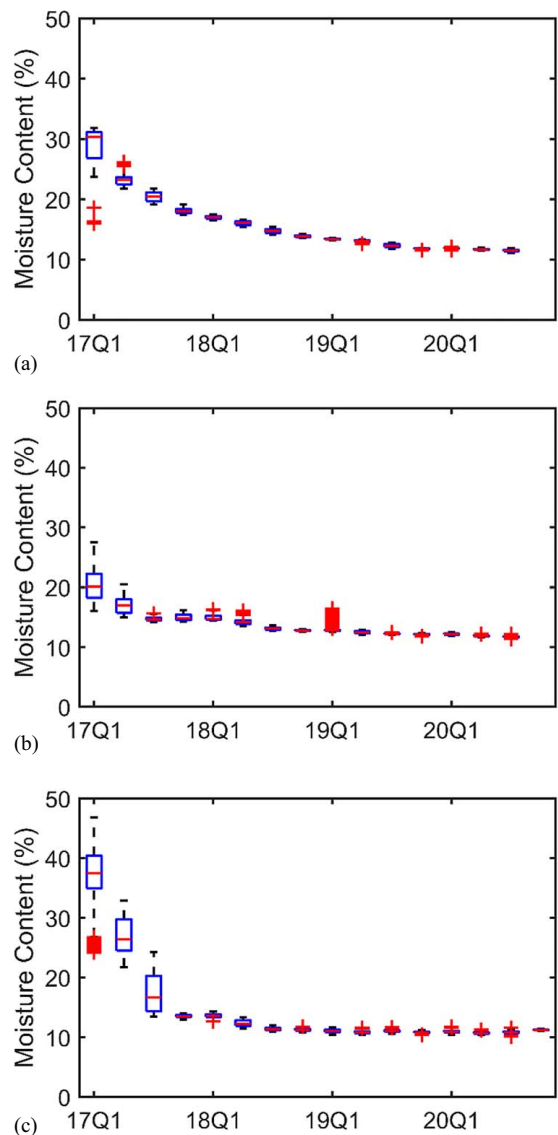
Fig. 7 illustrates the variability of measurements in different wood products. As expected, the variability for all products is most pronounced in early months, when there is no building enclosure in place. This variability is a direct reflection of different

**Fig. 7.** Box plots of moisture contents by product over time (Qi refers to date quarter from 2017 through 2020): (a) CLT; (b) GL; and (c) SW.

exposures to precipitation. Fig. 7 shows that by the third quarter of 2017, all glulam and stud wall products had below 20% moisture content, a threshold that represents risks for mold and decay (Carll and Highley 1999; Jakes et al. 2013).
