# Field Evaluation of Stress-Laminated Hardwood Timber Bridges with Extended Service Life

Justin M. Dahlberg<sup>1</sup>, James P. Wacker<sup>2</sup>

In: Proceedings of the World Conference on Timber Engineering, August 9-12, 2021, Santiago, Chile. Paper No: TE0503.

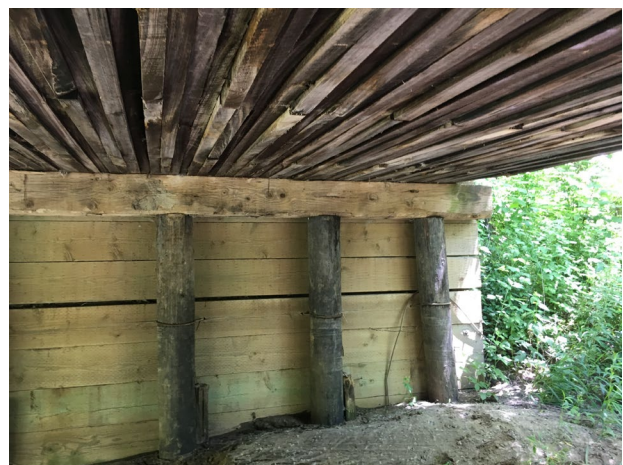
Inspection of the geometry of the Hibbsville Bridge indicates the stressing bar forces are too low preventing the timber laminations from acting as a unit connected by interlaminar friction. That is, the interlaminar stress is low enough to allow sliding between laminations on the vertical plane. As shown in Figure 7, laminations are frequently offset vertically at the butt joints up to 25 mm (1 in) and as much as 38 mm (1.5 in) in some locations. Longitudinal separation of the butt ends by 13mm (1.5 in) to 19 mm (0.75 in) was common and as much as 25 mm (1 in) in some locations (see Figure 8). The plane of the bottom side of the deck is uneven with laminations consistently varying from those immediately adjacent. The unevenness of the deck laminations was also apparent on the topside since there is no wearing surface, only some gravel debris, to obstruct viewing of the deck. Even with the low interlaminar stress, there were no noticeable separations between laminations.

*Figure 7 Hibbsville deck underside*

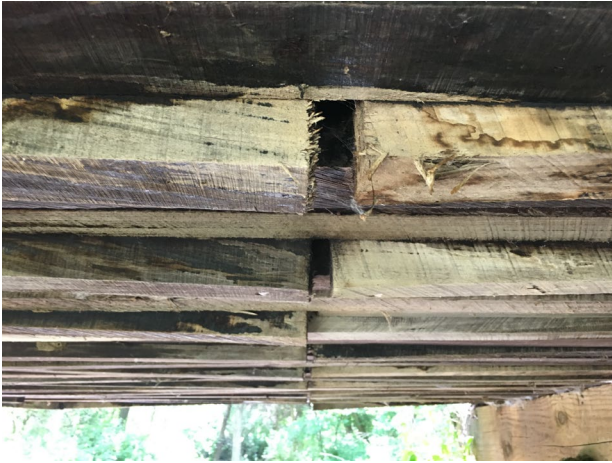
**Figure 8** Hibbsville gapping at lamination butt joints

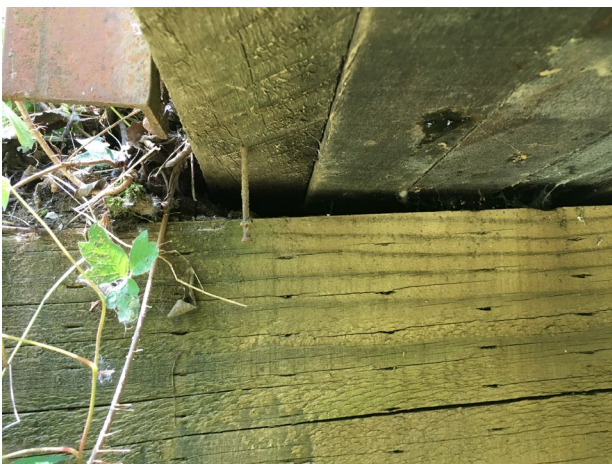
Additionally, the deck ends did not fully bear on the pile caps; the deck plane deflected upward at the corners. The measured upward movement with respect to the pile cap is 32 mm (1.25 in), 13 mm (0.5 in), 29 mm (1.13 in), and 13 mm (0.5 in), at the NW, SW, SE, and NE corners, respectively. A good example of this occurrence is shown in Figure 10. It is not clear what causes these distortions but is likely linked to the moisture accumulation along the curbs.

**Figure 10** Hibbsville deck uplift at corner bearing

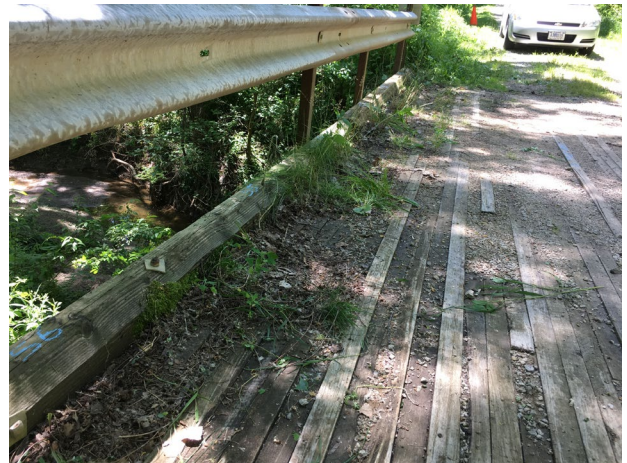
other bridges. However, as a general rule, many laminations appeared wavy with no clear patterning. Plant growth, pictured in Figure 11, was present at the curb lines and on top of the pile cap extensions beyond the bridge deck edge. Gravel and soil from the roadway on which this bridge is located is being tracked onto the bridge and accumulating in these areas. The soils and their inherent ability to retain moisture provide an environment conducive to ongoing plant growth and premature deck decay.

**Figure 11** Hibbsville curb line vegetation

As a general maintenance practice it is advised to remove debris from the deck surface and curb lines. Debris can impede deck drainage and trap moisture against the deck surface and/or curb line, thereby increasing the moisture content and creating an environment more suitable to accelerated degradation. Due to advanced degradation, it is recommended the curbs at Hoffman Run be replaced.

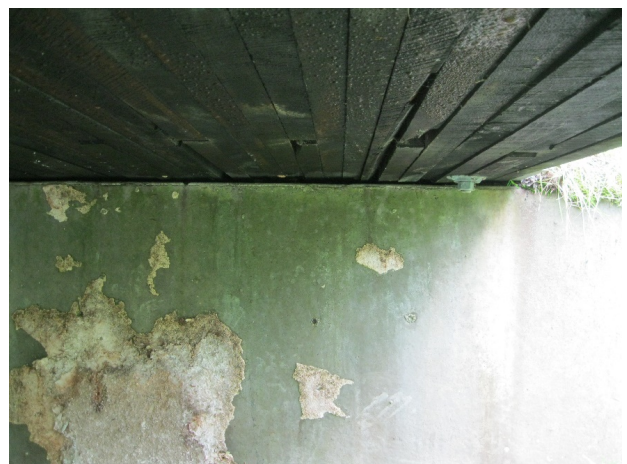
Visual inspection of the Hoffman Run Bridge revealed minor distortion in the stress-laminated bridge deck. The deck laminations did not fully bear on the abutment wall on both the north and south ends. Rather, uplift was present at three of the four corners totalling 13 mm (0.5 in), 19mm (0.75 in), and 19 mm (0.75 in) at the NW, NE, and SW corners, respectively (see Figure 12). In addition, a stringline was extended between the bottoms of the midspan guardrail posts which showed the bottom side plane varied in the transverse direction. A differential elevation of 35 mm (1.38 in) between the highest and lowest points on the deck was measured.

**Figure 12** Hoffman Run deck uplift at corner bearing

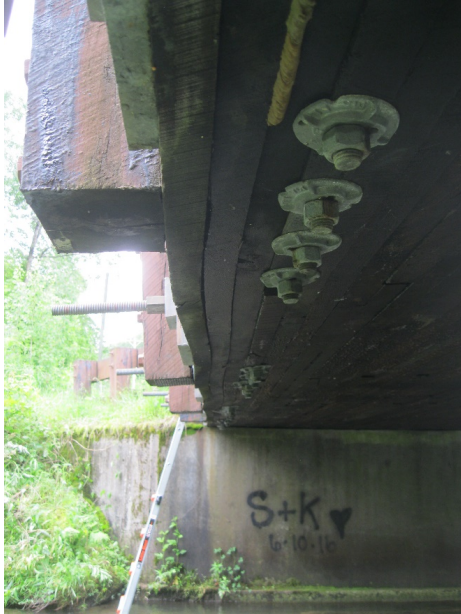
As shown in Figure 13, longitudinal undulations were observed in the outer laminations. Depressions inward were observed at the stressing bar locations. The

**Figure 13** Hoffman Run outer lamination waviness

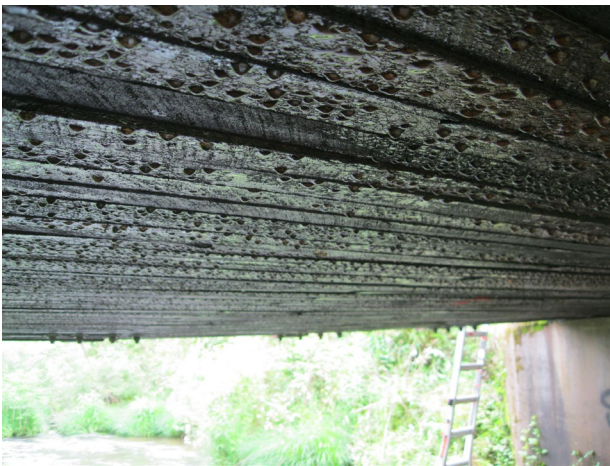
galvanized stressing bars remain in good condition. Checking was present along the outer lamination on the downstream side. The remaining laminations appeared in good condition with no apparent areas of decay or distress despite evidence of water seepage through the deck seen by the water beads on the deck underside. See Figure 14.

**Figure 14** Hoffman Run underside water accumulation

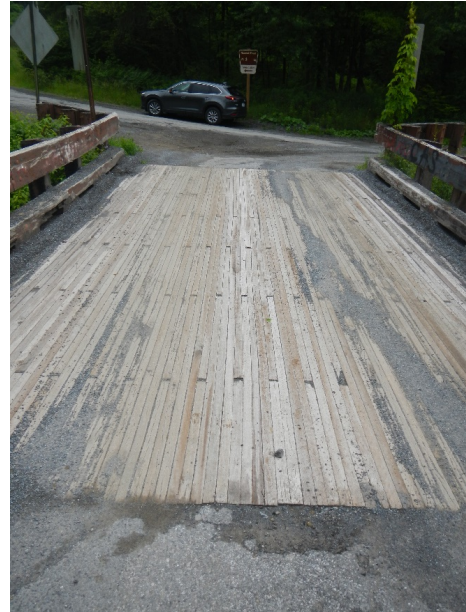
The topside, pictured in Figure 15, showed evidence of vehicle wear and abrasion on the wheel lines. Minor rutting or depressions at these locations was observed. There is a stop sign at the north end of the bridge and the braking action of vehicles is believed to contribute to the visible wear patterns. The butt joints between laminations were consistently gapped approximately 25.4 mm (1 in) to 32 mm (1.25 in) and, in almost all cases, the gaps were packed with soil.

**Figure 15** Hoffman Run topside of deck

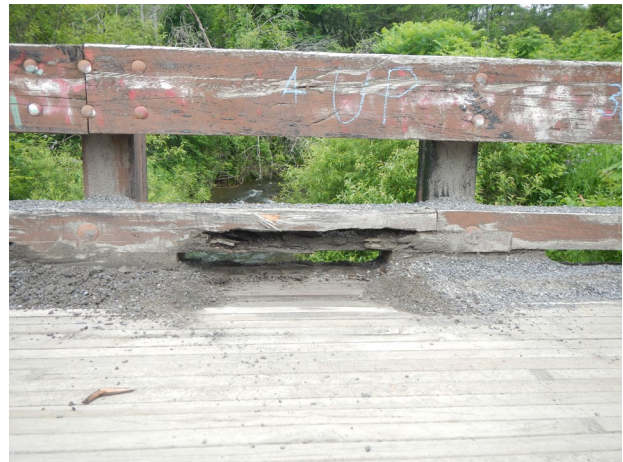
The topside was generally free of soil and debris with the exception being at the curb lines where soils have accumulated and hold moisture against the outermost laminations and curb. The west curb especially has experience significant decay as shown in Figure 16.

**Figure 16** Hoffman Run debris accumulation leading to significant decay of curb members.

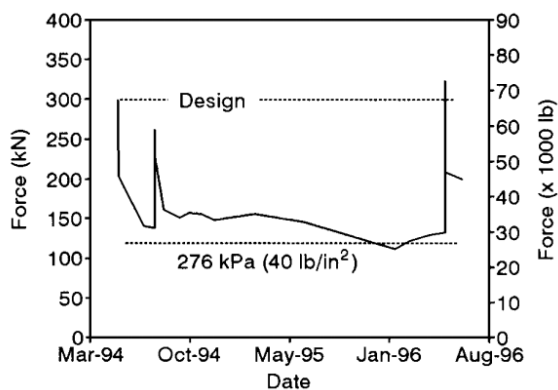
**Figure 17** Average bar force for Hibbsville 1994 – 1996.

In addition, Figure 17 and Figure 18 show the average bar force measured during the initial monitoring period post-construction for Hibbsville and Hoffman Run, respectively. These figures indicate a similar reduction in stressing bar force during a short period of time after initial or subsequent tightening of the bars.

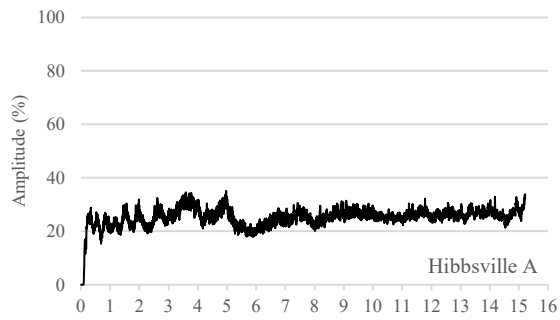
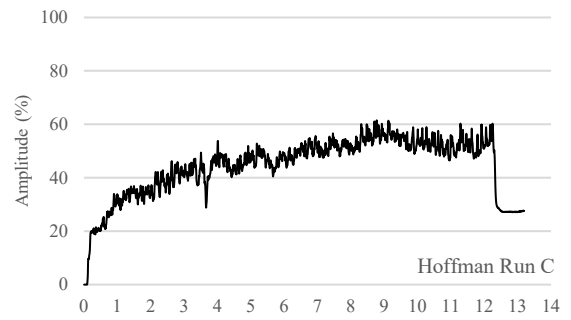
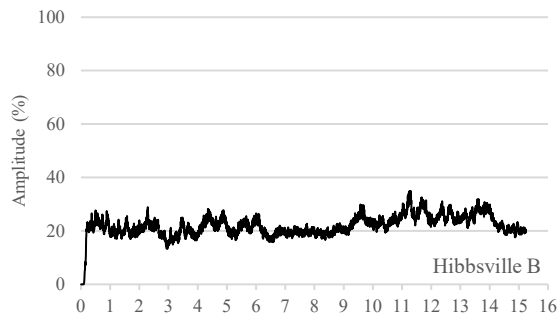
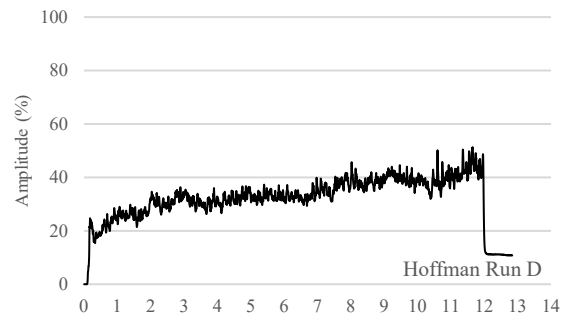
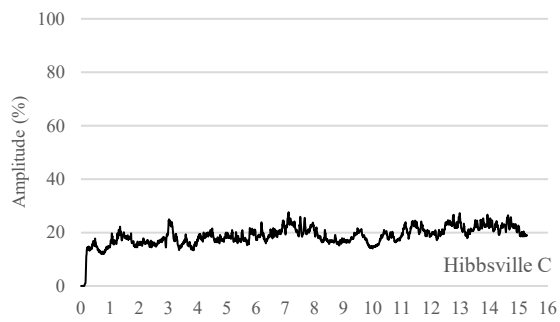
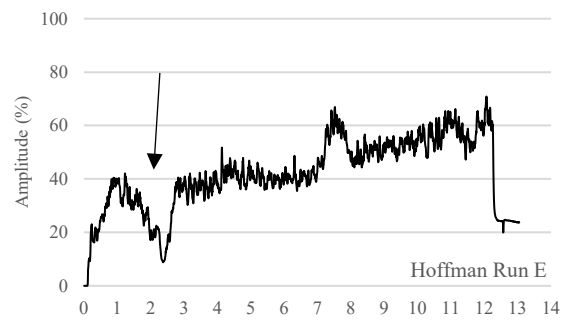
The results for each bridge generally show the timber is sound with few areas of reduced density. Specifically, Hoffman Run locations E, K, and L show areas where the density changes. The orientation of the drilling at location E is vertical (from the top side downward) which indicates the bit is penetrating a single timber lamination across its depth. This is pointed out by the arrows. A small area may be experiencing the onset of decay. The orientation of the drilling at locations K and L is horizontal (from outside inward at deck edge) which indicates the bit is penetrating multiple timber laminations across their widths. The reduction in density pointed out by the arrow is likely a result of reduced density in a single timber lamination.

**Figure 22** Hibbsville and Hoffman Run micro-drill resistance measurements versus depth (inches) of penetration (1 in = 25.4 mm)
