# Grayscale Drone Inspection Image Enhancement Framework for Advanced Bridge Defect Measurement

Transportation Research Record  
2021, Vol. 2675(8) 603–612  
© National Academy of Sciences:  
Transportation Research Board 2021  
Article reuse guidelines:  
[sagepub.com/journals-permissions](https://sagepub.com/journals-permissions)  
DOI: 10.1177/0361198121999605  
[journals.sagepub.com/home/trr](https://journals.sagepub.com/home/trr)

Euseok Jeong<sup>1</sup>, Junwon Seo<sup>1</sup>, and James Wacker<sup>2</sup>

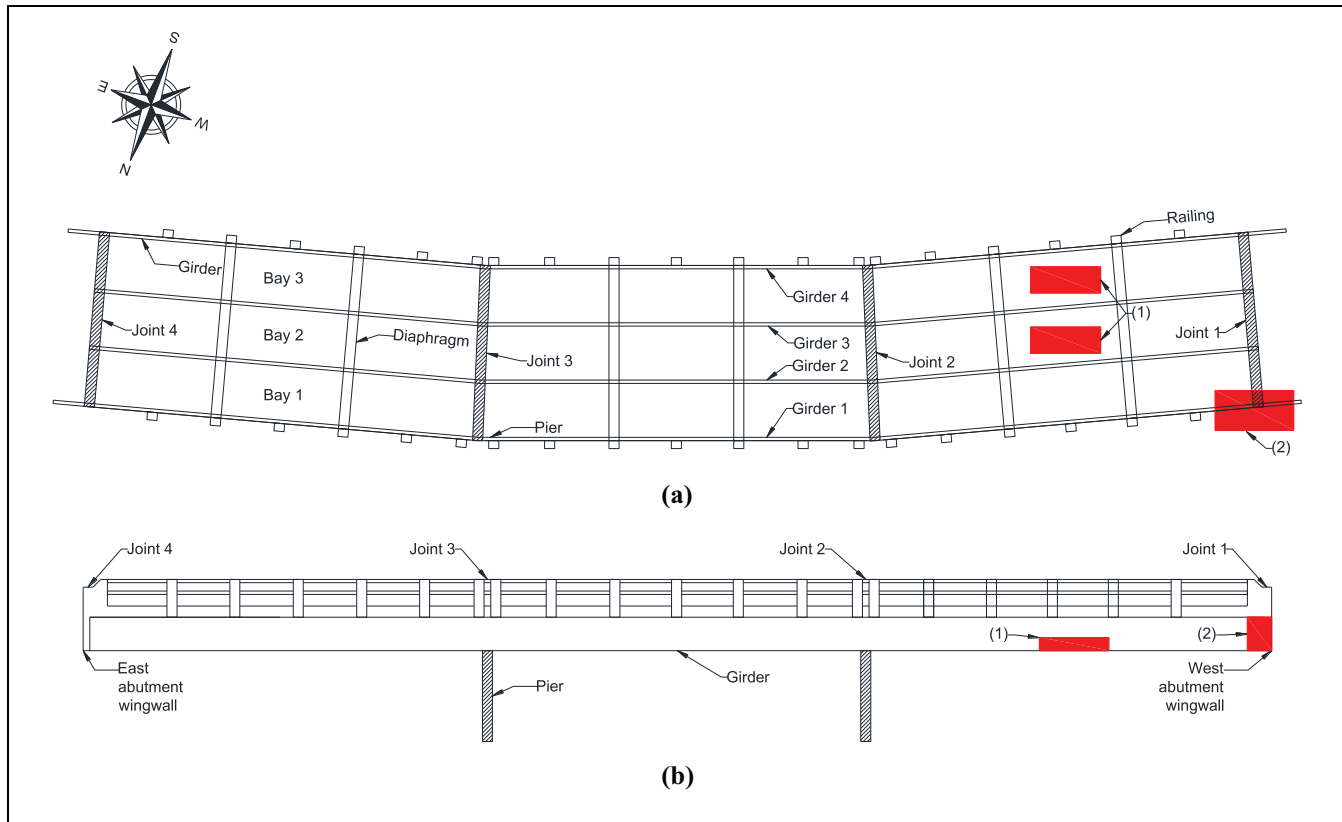
**Figure 3.** Sketch of three-span timber girder bridge with marked visible defect: (a) plan view and (b) elevation view.

A sketch for the bridge at the beginning of the framework application was developed based on the inspection report as shown in Figure 3. Figure 3, *a* and *b*, show the plan view and elevations of the bridge, respectively. During defect identification, a representative defect on the bridge is marked with red rectangles as displayed in Figure 3, *a* and *b*. Two locations (1) and (2) are marked. Defect 1 indicates defects because of water leakage, discoloration, efflorescence, and spalling underneath the

deck. Defect 2 includes spalling and water leakage on the abutment. For the safe drone-aided inspection underneath the deck, the remote controller operated the drone on its sport mode allowed for avoidance of any obstacles. The visual observer carefully monitored the drone in flight to inform the remote controller of any hazards or obstacles.

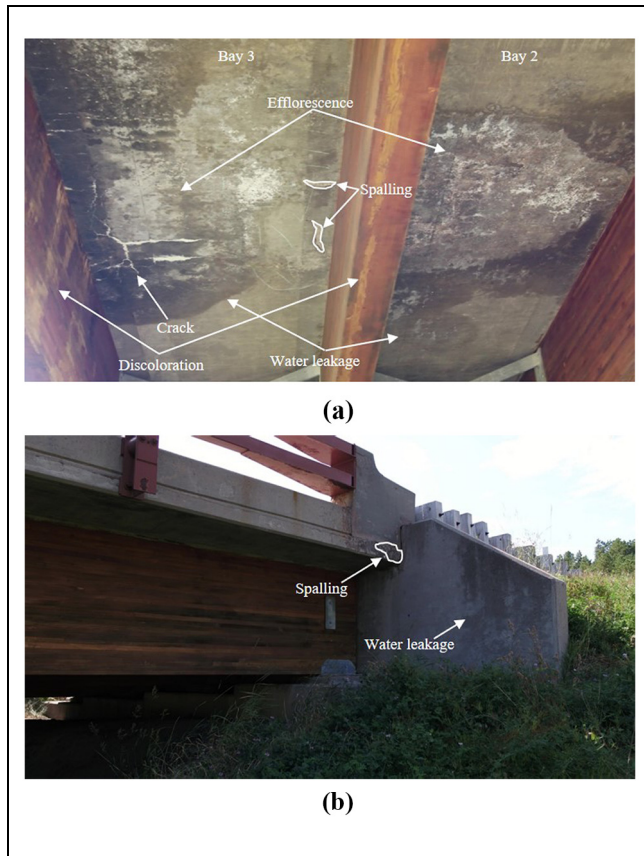
During the inspection, significant defects because of water leakage, crack, spalling, and efflorescence underneath the deck and discoloration on the timber girder (see Figure 4*a*) and spalling and water leakage on the abutment (see Figure 4*b*) were detected as shown in Figure 4. In Figure 4*a*, the area of spalling and discoloration and concrete cracks with built-up efflorescence are identified, but the boundaries of efflorescence and water leakage underneath the deck are not observed. These boundaries for efflorescence and water leakage were not used for the efficient defect quantification during image analysis using Figure 4*a* because of low brightness. On the other hand, the boundaries of deterioration because of spalling and crack were identified. In Figure 4*b*, the spalling and water leakage on the concrete abutment are identified, but the edge of each defect is still challenging to discover because of darkness of the inspection image.

**Figure 4.** Representative defect images obtained by drone: (a) water leakage, discoloration, efflorescence, crack, and spalling underneath the deck; and (b) water leakage and spalling on the abutment wingwall.

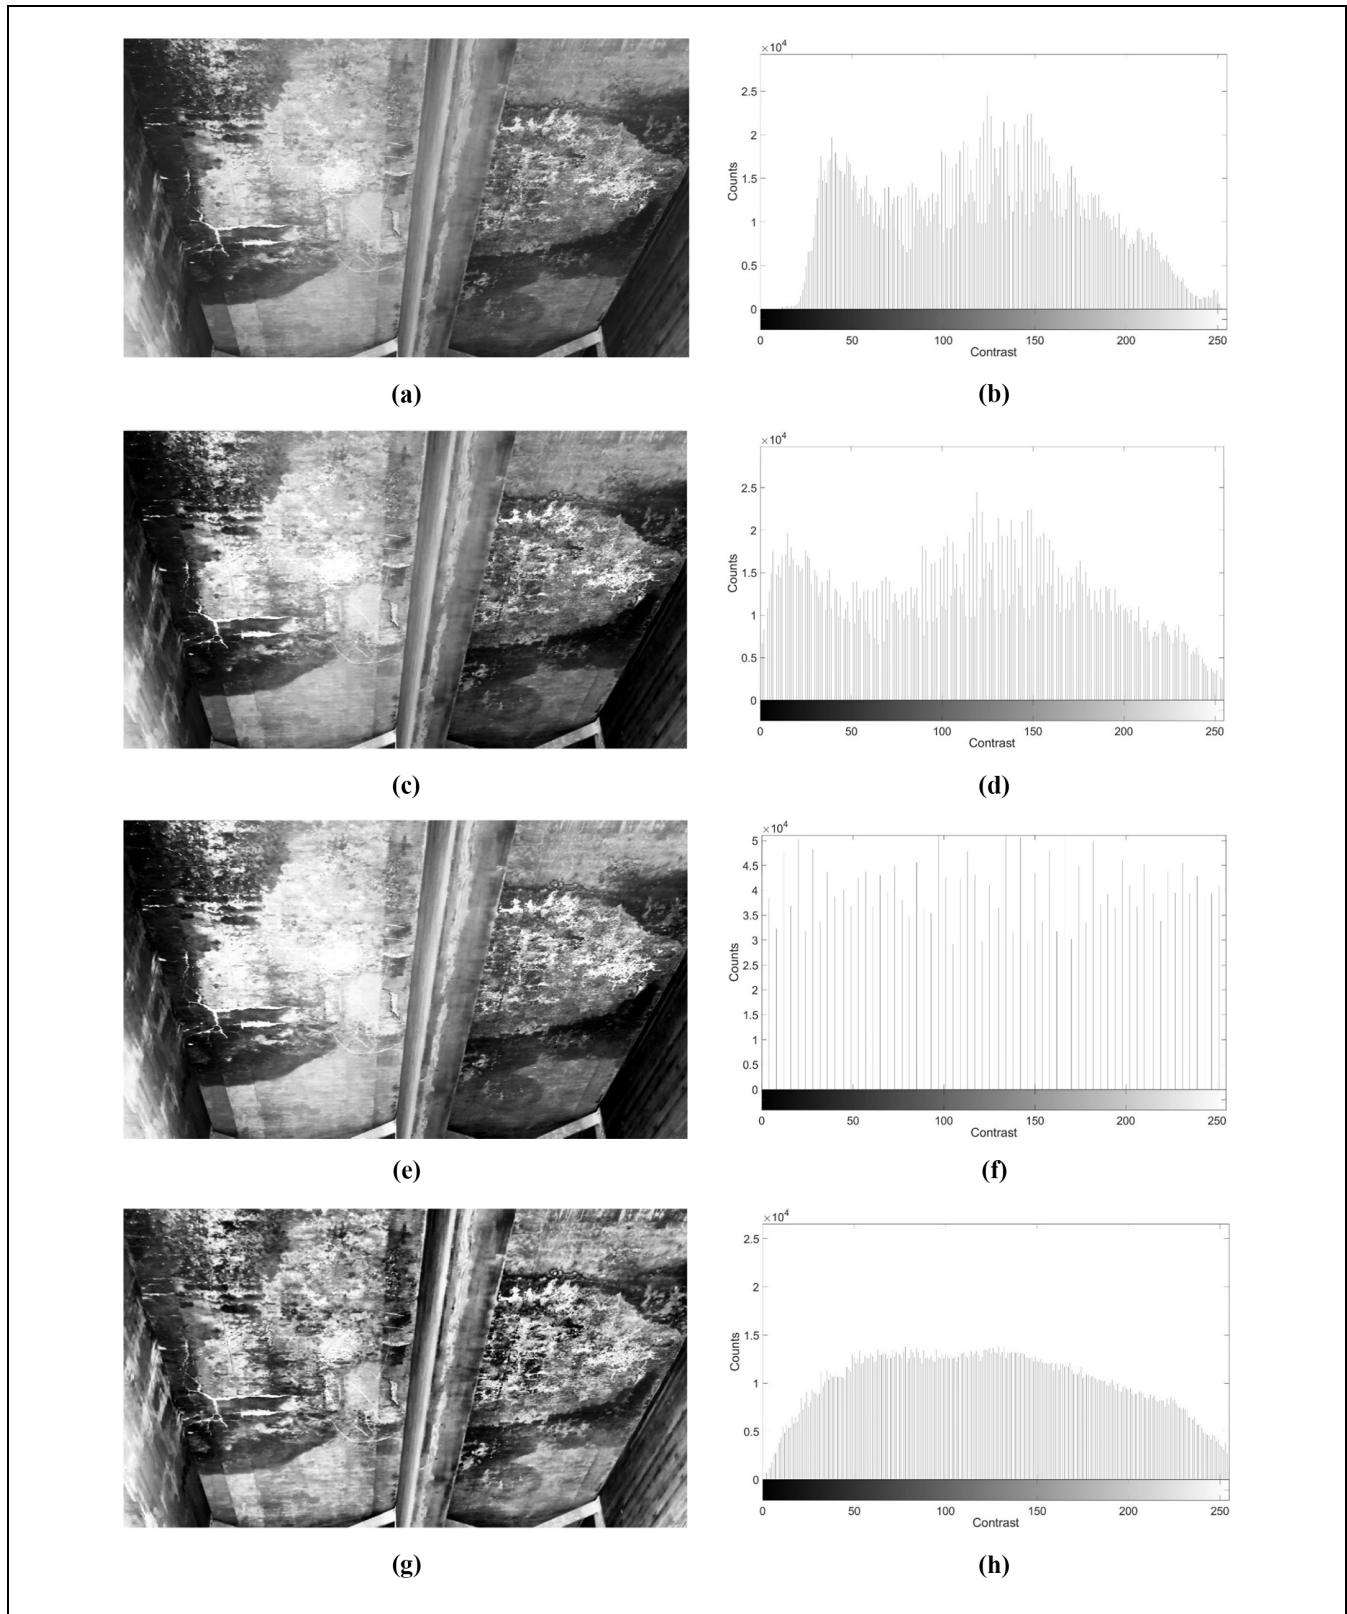
The relationship between the quality of image and the different techniques is examined by comparing the visibility of the images. In the grayscale image (see Figure 5*a*), the boundaries of deteriorations because of efflorescence and water leakage identified in Bays 2 and 3 are not observed clearly. As shown in Figure 5*b*, the contrasts (columns in Figure 5*b*) vary between 30 and 210 in this image. The visibility of the grayscale image is enhanced by the image intensity adjustment technique as shown in Figure 5*c*, indicating the areas of defects with slight improvement in contrast than in the grayscale image. The shapes of histograms shown in Figure 5, *b* and *d*, are observed to be similar. On the other hand, the areas of defects are not clearly observed after applying the histogram equalization technique as shown in Figure 5*e*. The boundaries of water leakage in Bay 3 are not identified in Figure 5*e*. Contrasts are degraded as displayed in Figure 5*e* as this technique utilizes only 64 bins (Figure 5*f*). The grayscale image enhanced with the adaptive histogram equalization technique shows significant improvement in visibility with clear boundaries of the defects because of water leakage and efflorescence as shown in Figure 5*g*. As shown in Figure 5*h*, the histogram of this technique shows uniform distribution of contrasts compared with the other techniques. The adaptive histogram equalization is considered the finest technique for the image enhancement for Figure 5*a*.

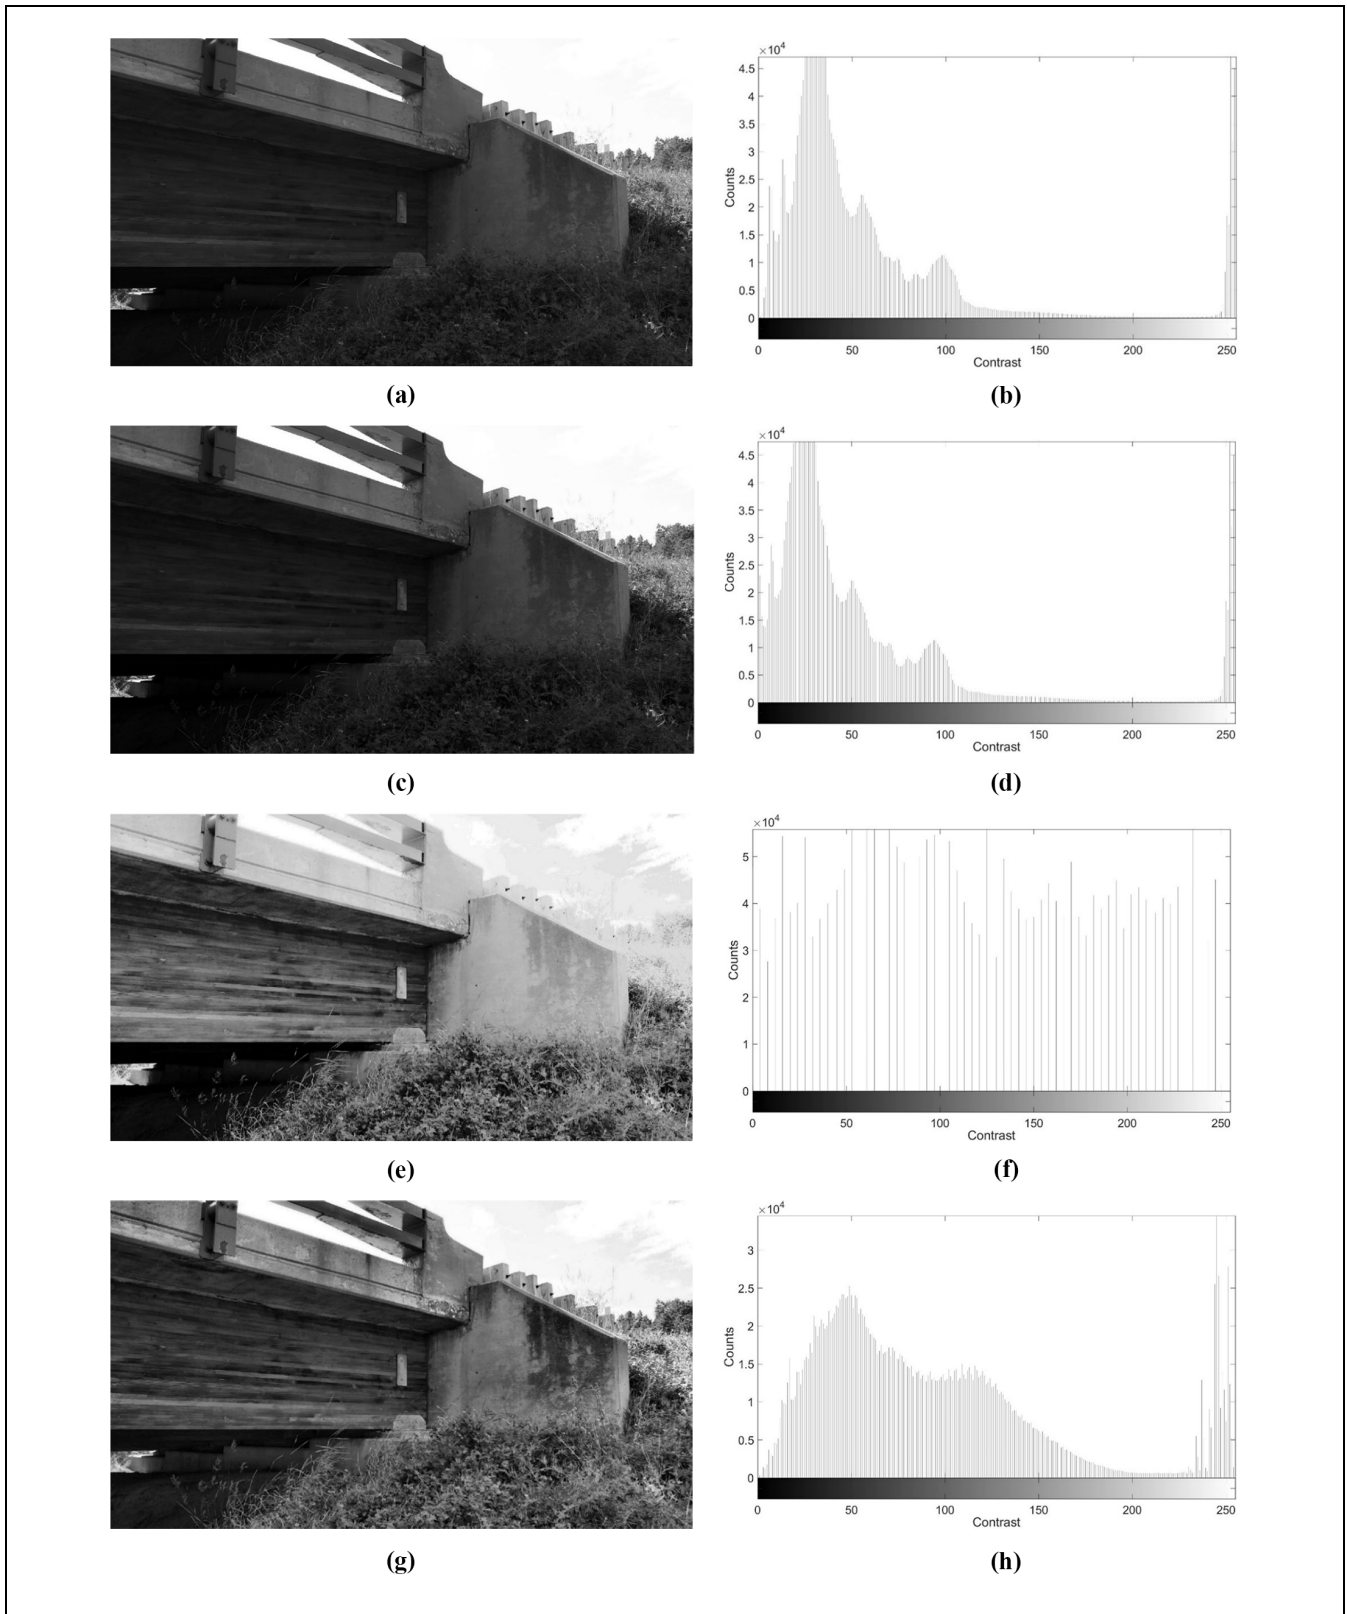
Figure 6 shows the applications of visibility enhancement technique for Figure 4*b*. Although the spalling and water leakage on the abutment wingwall are identified, the boundaries of the deteriorations are not observed distinctly in Figure 6*a* because of poor distribution of contrast (see Figure 6*b*). Figure 6*a* adjusted with the image intensity adjustment technique (Figure 6*c*) shows the similar image quality as that of Figure 6*a*, and the histogram of Figure 6*d* is also found to be analogous to Figure 6*b*. The boundaries of the defect area are also observed to be unclear as shown in Figure 6*c*. Compared with Figure 6, *a* and *c*, the grayscale image adjusted with the histogram equalization technique (Figure 6*e*) is observed to be significantly brighter as the ratio of the contrasts that are near to the white (contrast 255) are higher than in histograms of Figure 6, *b* and *d*. In Figure 6*e*, the area of water leakage on the abutment wingwall can be observed more noticeably than in Figure 6, *a* and *c*, but the boundaries of spalling cannot be detected obviously. The boundaries of defects because of spalling and water leakage are observed in the grayscale image adjusted with the adaptive histogram equalization as displayed in Figure 6*g*. The histogram of the image for this

technique (see Figure 6*h*) shows uniform distribution of contrasts compared with the other histograms. From these results of the image enhancement technologies, the adaptive histogram equalization is found to be the most appropriate technique for investigating the defects.

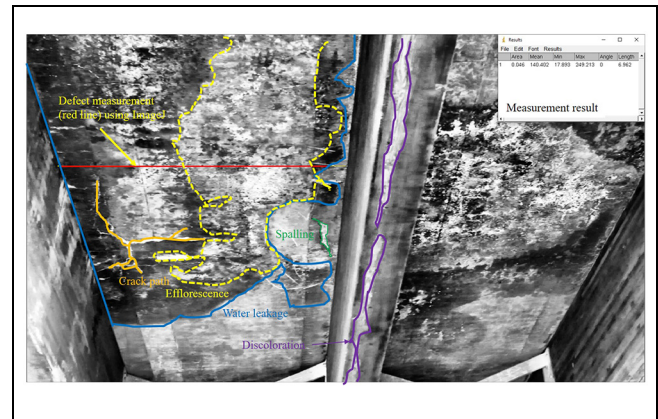
**Figure 7.** Measurement for the defect underneath the concrete deck.

Following the image enhancement techniques, spatial properties (i.e., area) of the visible defect inflicted on the bridge elements were quantified using ImageJ, which is the software to measure the length with the pixel-based technique. This software was able to measure the length of the defect using the number of pixels in the images. Note, it is required that the measured length be used directly for the defect quantification as the measured length is relative to each of the images. The actual length and the number of pixels of reference length that was determined based on the dimension of the bridge girder depth and width were employed from which the actual length of the defect can be calculated using the ratio between the defect and reference lengths. It should be noted that the direct measurements of the defect that can be used to calibrate the techniques were not able to be performed because the defects were located in inaccessible areas. According to the above defect measurement procedure, the identified defect underneath the deck (see Figure 5) and on the concrete abutment wingwall (see Figure 6) was measured. In Figure 5*g*, the areas of defects because of efflorescence, water leakage, discoloration, crack, and spalling were measured as shown in Figure 7. To detect the boundaries to each defect, a magnified grayscale image per defect was used to identify corresponding boundaries that were measured using ImageJ. With the enhanced grayscale images, the boundaries of deteriorations were more obviously observed compared with the use of the unfiltered image (refer to Figure 4), resulting in more accurate measurements. Following this procedure, the crack length and width, efflorescence, water leakage, spalling, and discoloration were measured along the identified orange lines, yellow dashed lines, blue lines, green lines, and purple lines, respectively, as marked in Figure 7. Specifically, in this figure, the defect in the image was marked with a red line and the length of the marked area was measured. With the same measurement processing, the areas of efflorescence, water leakage, crack, and spalling underneath the deck were measured to be  $3.75 \text{ m}^2$ ,  $4.21 \text{ m}^2$ ,  $0.02 \text{ m}^2$ ,  $0.74 \text{ m}^2$ , respectively, whereas the area of discoloration on the timber girder was measured to be  $2.12 \text{ m}^2$ . In particular, the measured crack width and length were, on average, 12.58 mm and 1.59 m, respectively. According to the South Dakota DOT (SDDOT) bridge inspection reports (27, 28), the efflorescence observed and field measured to

be approximately  $0.76 \times 0.91 \text{ m}^2$  ( $0.69 \text{ m}^2$ ) was reported but the field measurements for the other defects were not specifically presented in the report. The difference in the efflorescence acquired from the framework and inspection report can be attributed to the framework being able to clearly identify the boundaries to the efflorescence within the enhanced visualization of grayscale images.

4. Defects because of efflorescence, water leakage, crack, and spalling underneath the concrete deck and discoloration on the girder were identified and their areas were measured to be  $3.75 \text{ m}^2$  (efflorescence),  $4.21 \text{ m}^2$  (water leakage),  $0.02 \text{ m}^2$  (crack),  $0.74 \text{ m}^2$  (spalling), and  $2.12 \text{ m}^2$  (discoloration), individually.

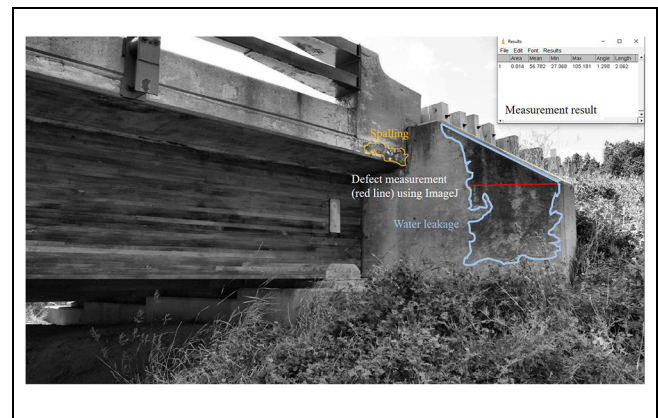
**Figure 8.** Measurement for the defect on the concrete abutment wingwall.

Defects because of spalling and water leakage were also quantified as depicted in Figure 8, following the identical procedure as described above. For this measurement, the grayscale image with the adaptive histogram equalization technique (see Figure 6*g*) was used as the final input image. Using ImageJ, the area of water leakage (blue boundaries in Figure 8) on the concrete abutment wingwall was measured and spalling on the concrete deck (orange boundaries in Figure 8) were measured to be  $1.63 \text{ m}^2$  and  $0.26 \text{ m}^2$ , individually on Figure 6*g*. The boundary detection and measurement were conducted following the same procedure as in the defect identification underneath the deck. According to the SDDOT inspection reports (27, 28), the size of spalling

was field measured to be  $0.61 \times 0.15 \text{ m}^2$  ( $0.09 \text{ m}^2$ ), but the measured area of water leakage was not included in the reports. The difference in the size of spalling can be caused by precisely identifying the spalling boundaries across the enhanced grayscale image against the field measurement.

5. On the concrete abutment wingwall, the water leakage and spalling were measured to be  $1.63 \text{ m}^2$  and  $0.26 \text{ m}^2$ , respectively, using the image adjusted with the adaptive histogram equalization application.
