General  
Technical  
Report  
FPL-GTR-142

# Evaluating Wood-Based Composites for Incipient Fungal Decay With the Immunodiagnostic Wood Decay Test

C. A. Clausen  
L. Haughton  
C. Murphy

December 2003

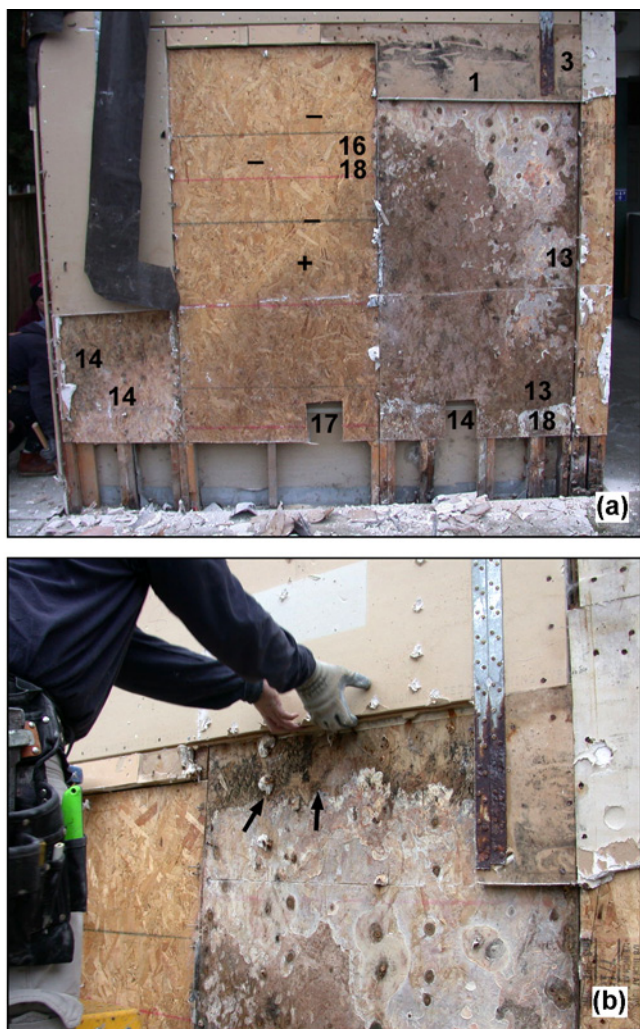
In the condominium complex, the area evaluated was directly beneath a window opening of a stair tower at the west elevation of a building. The primary exposures to wind and rain are from the south and east elevations. The window opening lacked flashing, and the underlying building paper had gaps in coverage as well as a “reversed” (bottom to top) lap. Together, these construction practices had led to water infiltration from the window opening into the wall cavity below, contributing to extensive wetting of the underlying gypsum and OSB sheathing as well as an adjacent LVL header. The stain pattern from water infiltration that crossed three OSB sheets revealed extensive damage to only the two outer sheets; the middle sheet was not damaged (Fig. 1a).

Removal of the sheathing and subsequent analysis, including identification of “mill stamps” on the back of the panels, showed that two types of OSB were installed at this area during construction. Inspection confirmed that both types of OSB panels had been installed prior to siding installation and final inspection of the structure. Samples of the two panel types were analyzed for predominant wood type, adhesive type, and additives, such as fungicide (Table 1).

**Figure 1—Oriented strandboard (OSB) sheathing beneath window opening. (a) Numerals indicate moisture content (MC) measurements. IWD results recorded as positive (+) or negative (–). (b) Arrows indicate interface between decay and mold fungal growth.**

There was a distinct line of demarcation between the fungal hyphae and extensive mold growth, as indicated by the arrows in Figure 1b. The mold was identified as *Stachybotrys chartarum*. The visible decay fungus was not culturable from the mycelial sample, but *Paecilomyces*, a common mold fungus, was repeatedly cultured and identified in the area of visible decay.

The IWD test does not react with *Paecilomyces* (Clausen and Ferge 1995). Wood can be too decayed to recover a culture of viable fungus or to give positive IWD results. In the case of advanced decay, where all wood components are involved, decay fungi eventually stop growing, whereas mold fungi produce copious spores that last for many years and can germinate whenever conditions are favorable. Both mold fungi and decay fungi require adequate moisture to initiate growth (Clausen 2002).

Immunoassay results were negative, even on visibly decayed OSB. Despite obvious Type 2, 3, and 4 deterioration, moisture content was uniformly below 20%, indicating a prolonged period of drying. The xylanase enzyme detected by the IWD test is somewhat resistant to denaturation by heat and drying because of a 50% carbohydrate coating (Green and others 1989), but this enzyme will denature over long periods of drying, possibly months or years. Dry conditions in excess of 2 years have been shown to result in negative IWD test results in decayed wood, indicating denaturation of the indicator enzyme (unpublished results). Results of a laboratory test on water-saturated OSB held at 70% relative humidity (RH) showed that OSB lost moisture at a rate of 10.8%/week ( $n = 14$ ), until reaching equilibrium after 4 weeks at 43% moisture by weight. This demonstrates that once OSB is water saturated, it dries slowly.

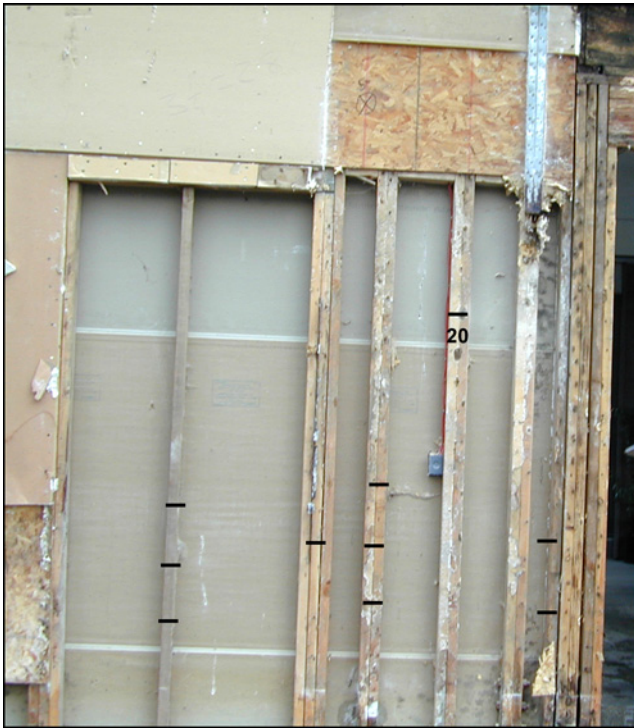
Framing members (Hem–Fir 2 by 4 lumber<sup>2</sup>) had been set directly on concrete, where perpetual wicking of moisture could occur. Advanced decay was visible on either end of the framing members directly beneath the decayed OSB panel. Surface mycelia were present on the entire face of the framing members when in contact with decayed OSB. Beneath the sound OSB panel, extensive decay was noted only where the framing members were in direct contact with concrete.

**Figure 2—MC measurement (20%) and IWD test results at sampling sites in framing beneath decayed OSB sheathing.**

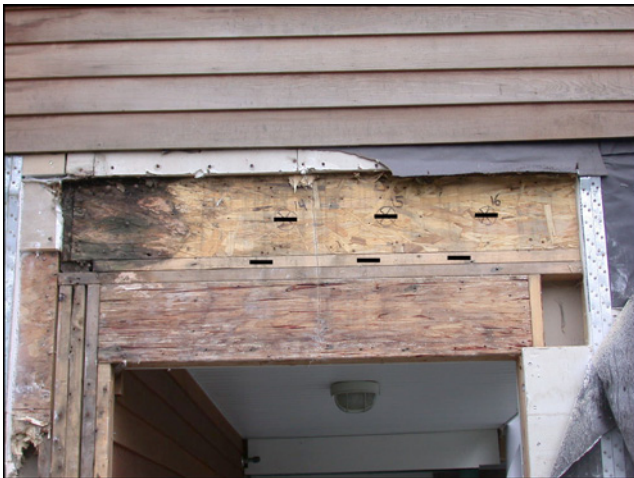
**Figure 3—Results at sampling sites in LVL header and door framing under window opening.**

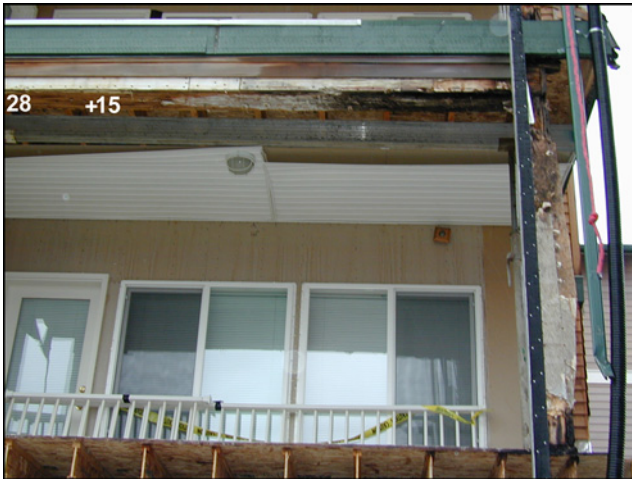
Figure 4—Results at two sampling sites in LVL deck frame.

A large area of a white-rot decay fungus was discovered on the OSB rim board covering the LVL deck frame. The fungus, isolated as a single-spore isolate of a white-rot fungus, could not be identified to genus. Sampling sites are indicated on Figures 4 to 7, and test results are compiled in Table 2.

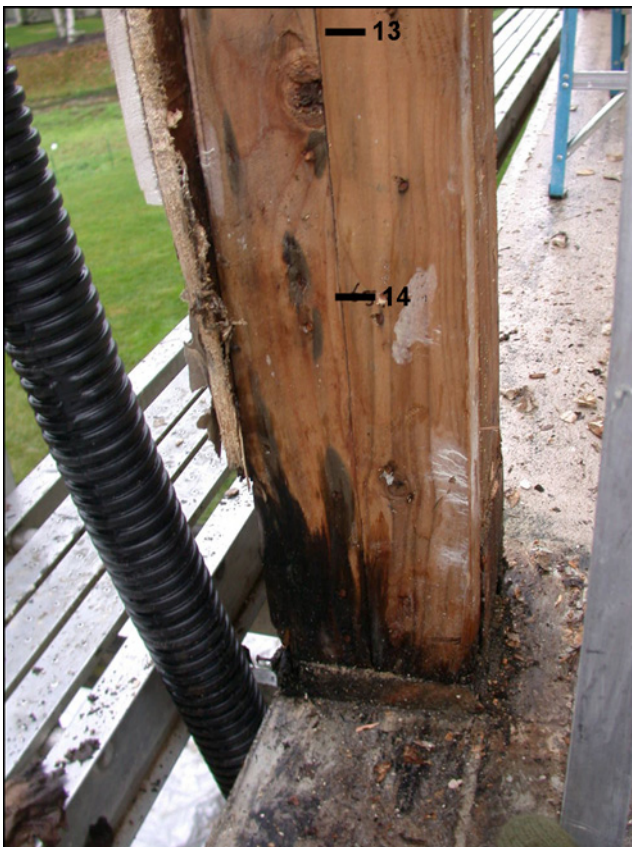
Figure 5—Results at two sampling sites in deck post.

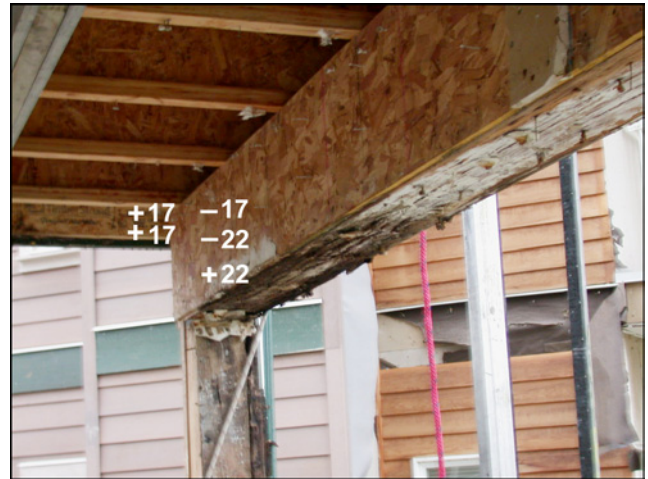
Figure 6—Results at sampling sites in OSB-sheathed deck frame and rim board.

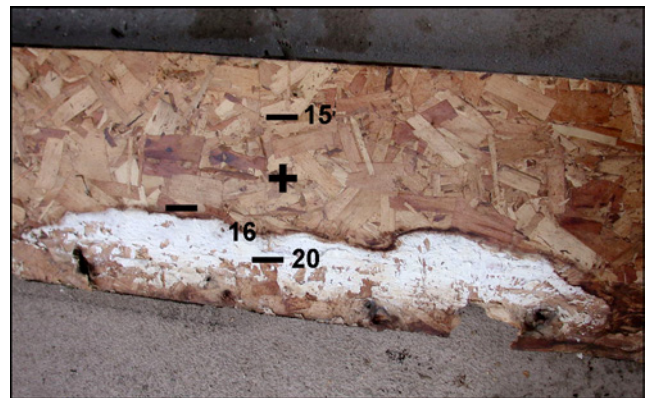
Figure 7—Results at sampling sites in backside of OSB sheathing over LVL deck frame (see Fig. 6).

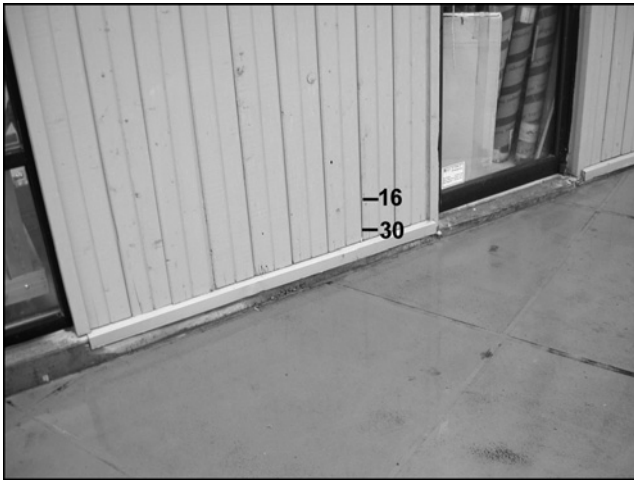
Visual inspection showed that painted 19-mm (3/4-in.) cedar T&G siding was abutted to flashing over a concrete sill. Moisture content of the siding was high (30%) at 25.4 mm (1 in.) from the bottom as a result of moisture wicking from the concrete sill as well as poor water drainage away from the building (see Fig. 8). Moisture content was 16% at 152 mm (6 in.) above that sampling site. Visual evaluation of the exterior siding did not reveal fungal growth. Cedar is naturally resistant to fungal decay (Simpson and TenWolde 1999). Abutting the T&G siding to the concrete sill plate raised the product above grade and may have inhibited moisture uptake.

**Figure 8—Results at sampling sites in tongued and grooved exterior siding.**

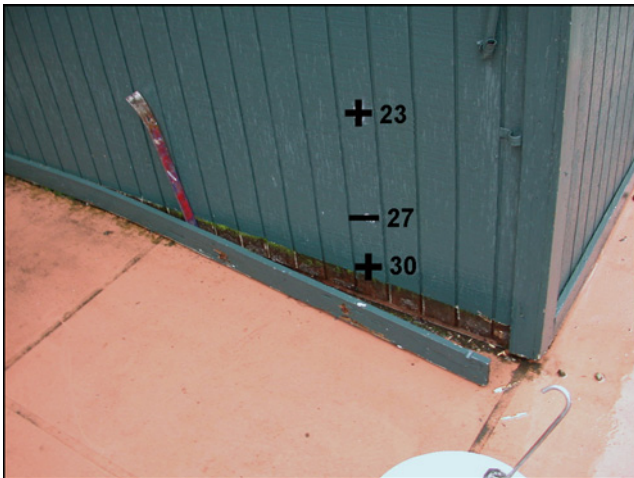
Visual inspection of the 12.7-mm (1/2-in.) composite siding showed that this product was in direct contact with the concrete walkway. A moisture content of 23% and positive IWD test results were seen up to 305 mm (12 in.) above the base-board. Composites may resist initial moisture uptake, but chronic exposure to moisture eventually results in water

**Figure 9—Results at sampling sites in exterior composite siding abutted to poorly drained concrete walkway.**

wicking and swelling of the composite product, increasing the likelihood of decay.

Removal of a base rim board revealed that the composite siding had been finished after the rim board was installed (Fig. 9). Behind the rim board, the product had softened and moss was growing from water saturation. Samples were taken at 25.4, 152, and 305 mm (1, 6, and 12 in.) from the bottom of the rim board with corresponding moisture readings of 30%, 27%, and 23%, respectively. Results are shown in Figure 9 and Table 2.
