# UAV-aided bridge inspection protocol through machine learning with improved visibility images

Euiseok Jeong<sup>a,2</sup>, Junwon Seo<sup>b,1,\*</sup>, P.E. James Wacker<sup>c</sup>

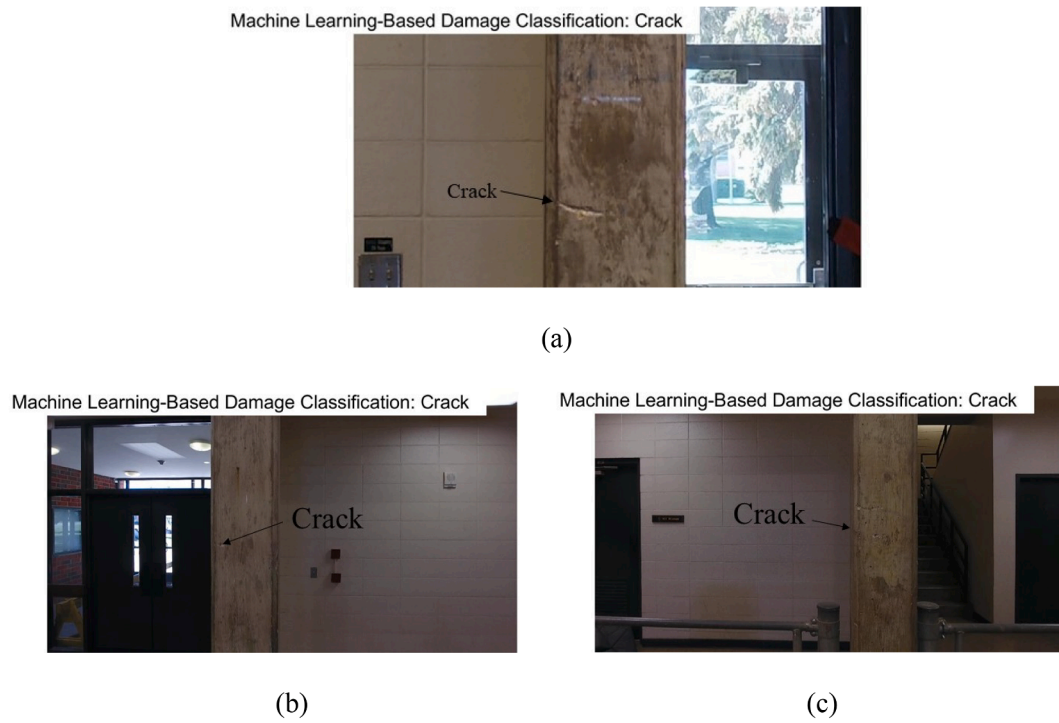
**Fig. 4.** Damage classification using CNN-based machine learning: (a) column A; (b) column B; and (c) column C.

In the first indoor inspection, UAVs captured 24,867 images of columns A through C in Animal Science Arena to identify any damage as displayed in Fig. 3. The images of the columns were examined in detail and a total of three noticeable cracks were visually observed on columns A through C. The damage classification using CNN-based machine learning coupled with the Residual Networks having 50 layers through MATLAB, 2020 was made as shown in Fig. 4 for three cracks on each of the columns.

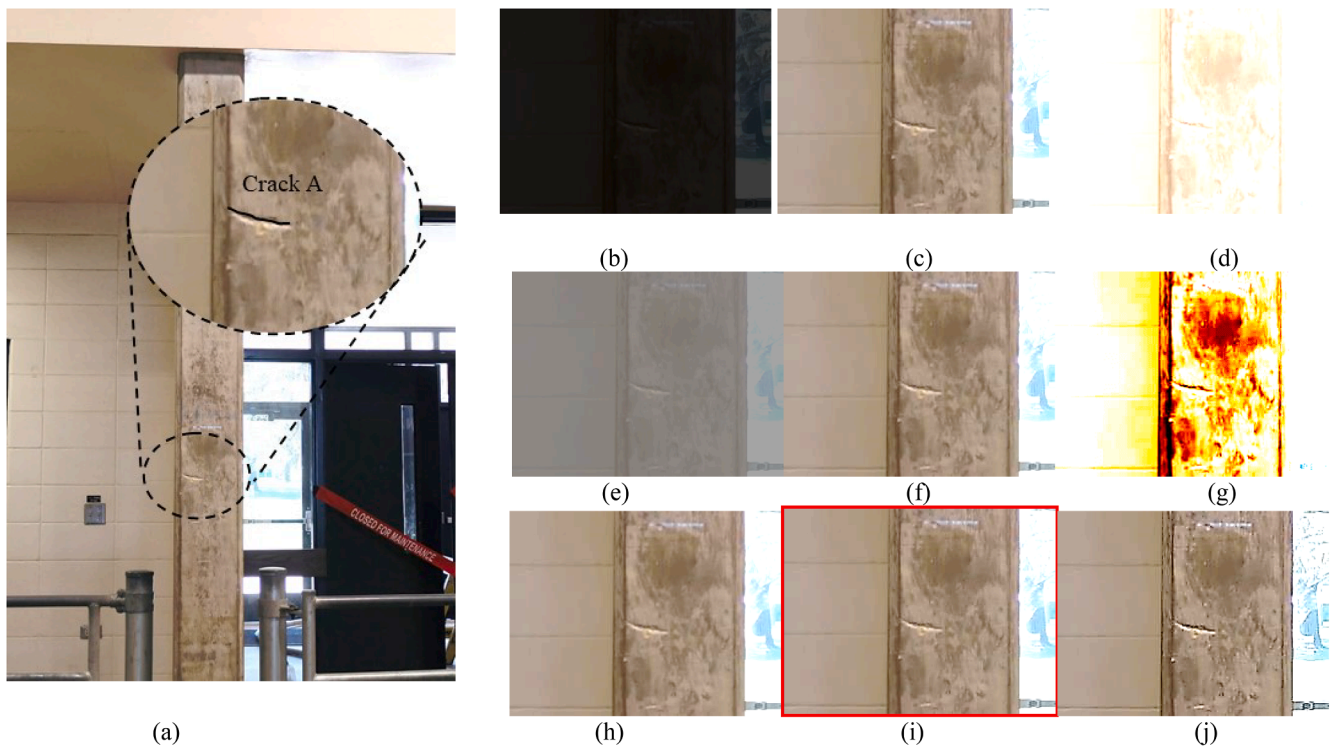
**Fig. 6.** Variation of images adjusted with brightness, contrast, and sharpness: (a) unfiltered crack image on column A; (b) filtered image with brightness  $-75\%$ ; (c) filtered image with brightness  $30\%$  (optimization for brightness); (d) filtered image with brightness  $70\%$ ; (e) Fig. 6c adjusted with contrast  $-75\%$ ; (f) Fig. 6c adjusted with contrast  $0\%$  (optimization for brightness and contrast); (g) Fig. 6c adjusted with contrast  $90\%$ ; (h) Fig. 6f adjusted with sharpness  $-25\%$ ; (i) Fig. 6f adjusted with sharpness  $40\%$  (optimization for all image properties); and (j) Fig. 6f adjusted sharpness  $90\%$ .

The trial-and-error evaluation with brightness, contrast, and sharpness adjustment can be done with the unfiltered UAV images to identify the improved visibility image called “an optimized image” as shown in Fig. 6. Fig. 6a shows the unfiltered UAV image of crack on column A. Image properties (i.e., brightness, contrast, and sharpness) can be adjusted from  $-100\%$  to  $100\%$  with its initial value being  $0\%$ . For instance, when the brightness of the UAV image was adjusted between  $-100\%$  to  $-80\%$ , the crack was not identified due to darkness under the brightness of  $-75\%$  as shown in Fig. 6b. The crack was also not observed when the brightness of the UAV image was adjusted between  $90\%$  and  $100\%$  due to overexposure. The crack (refer to Fig. 6c) was observed clearly when the brightness was adjusted between  $30\%$  and  $50\%$ , whereas the error of damage quantification was found to be  $0.53\%$  deemed as the least value when the UAV image was adjusted with  $40\%$  brightness (green circle) as displayed in Fig. 5a. With the improved visibility image adjusted with brightness, contrast adjustment was also conducted as depicted in Fig. 5b. The UAV image with  $0\%$  contrast showed the lowest percentage error (green circle) against direct measurement and was considered the contrast-based improved visibility image (see Fig. 6f). The sharpness of Fig. 6f was further adjusted to obtain the optimized image as shown in Fig. 5c. The UAV image adjusted with  $40\%$  sharpness showed the optimized image through this procedure as displayed in Fig. 6i.

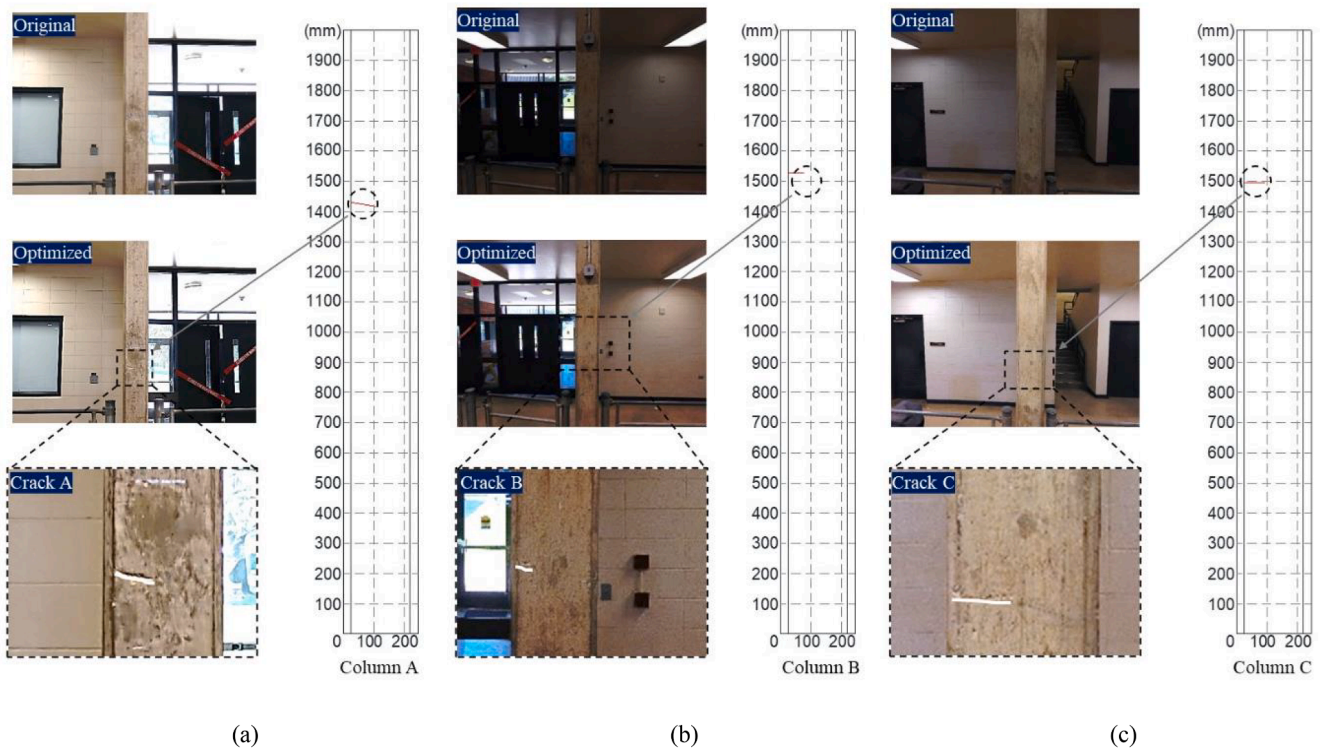
Fig. 7. Visual damage maps: (a) column A; (b) column B; and (c) column C.

Fig. 7a, b, and c show the unfiltered UAV inspection images, the optimized images, and corresponding damage maps for columns A, B, and C cracks, respectively. The unfiltered UAV inspection images are shown in Fig. 7a through 7c at the top left for each. After the image visibility improvement technique with the adjustment of image properties was applied to all the images to each of the columns, the following optimized inspection images were obtained: 1) column A crack image with the brightness of  $30\%$ , contrast of  $0\%$ , and sharpness of  $40\%$ ; 2) column B crack image with the brightness of  $40\%$ , contrast of  $20\%$ , and sharpness of  $40\%$ ; and 3) column C crack image with the brightness of  $30\%$ , contrast of  $10\%$ , and sharpness of  $20\%$ . To better observe damage, the magnified images for each crack are provided as well in these

figures. From the damage quantification with the optimized images, an average error of  $2.56\%$  of image analysis-based measurement was calculated against the direct measurement of the crack length of column A, B, and C cracks.

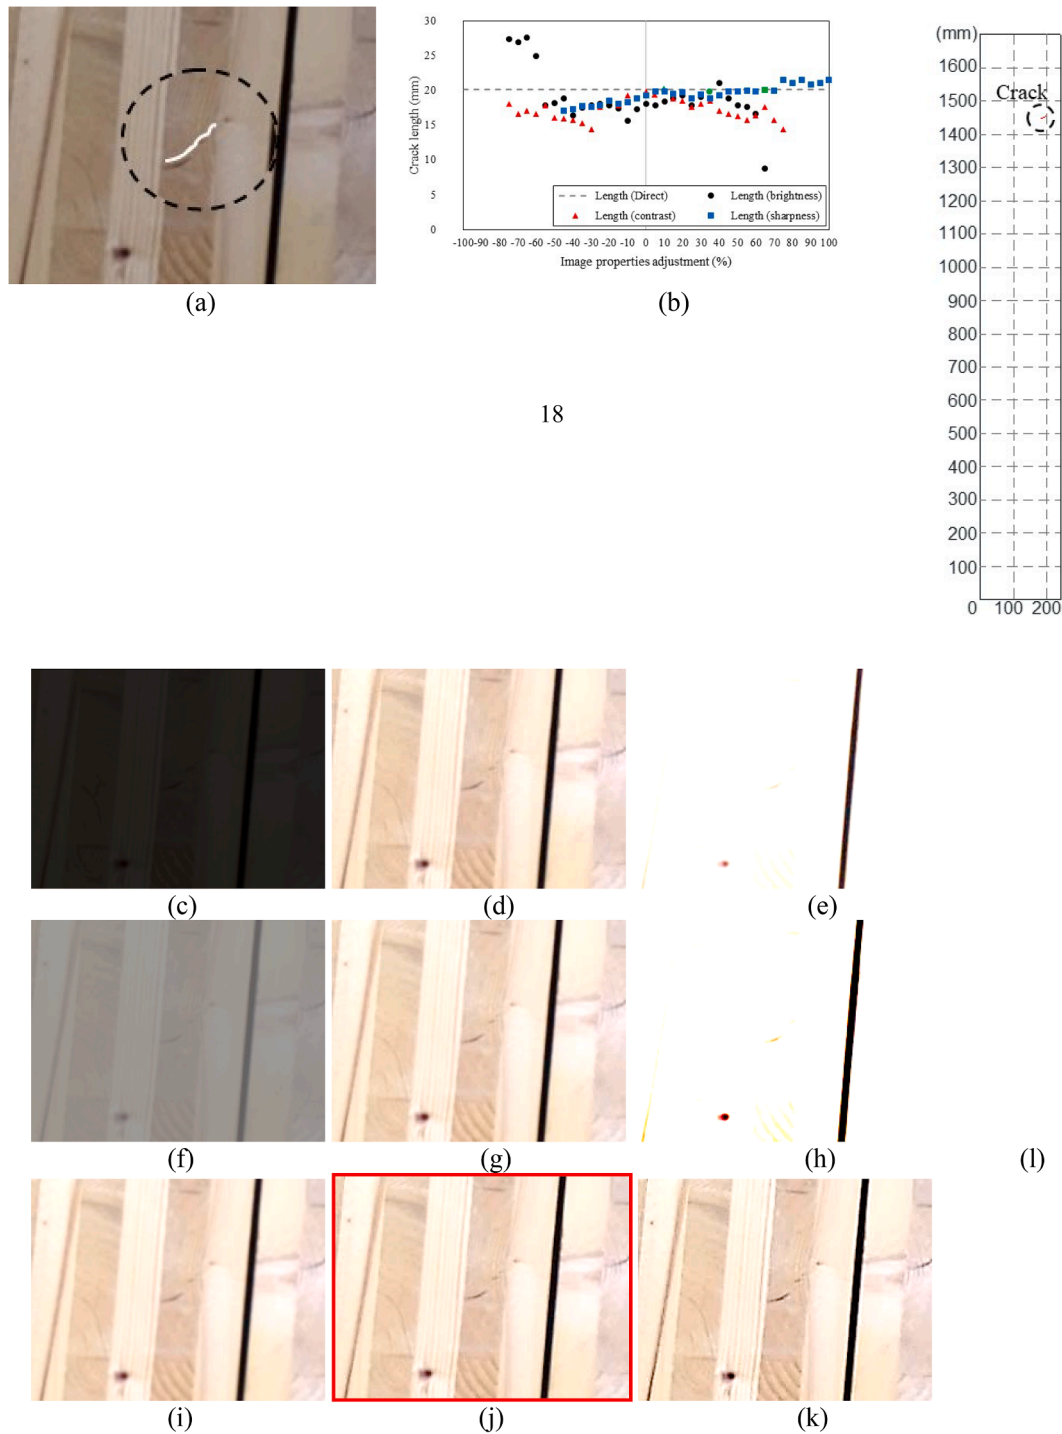
**Fig. 9.** Variation of images adjusted with brightness, contrast, and sharpness: (a) unfiltered crack image on CLT beam; (b) variation in crack size corresponding to brightness, contrast, and sharpness; (c) filtered image with brightness  $-75\%$ ; (d) filtered image with brightness  $35\%$  (optimization for brightness); (e) filtered image with brightness  $65\%$ ; (f) Fig. 9c adjusted with contrast  $-80\%$ ; (g) Fig. 9c adjusted with contrast  $10\%$  (optimization for brightness and contrast); (h) Fig. 9c adjusted with contrast  $80\%$ ; (i) Fig. 9f adjusted with sharpness  $-50\%$ ; (j) Fig. 9f adjusted with sharpness  $65\%$  (optimization for all image properties); (k) Fig. 9f adjusted with sharpness  $100\%$ ; and (l) visual damage map for CLT beam.

Again, Fig. 9c through 9k show the images according to the adjustment of brightness, contrast, and sharpness. The effect of brightness in the image is observed in Fig. 9c through 9e, and Fig. 9d shows the optimized image adjusted with the brightness of  $35\%$ . The crack was not observed in Fig. 9d and f due to darkness and over-illumination, respectively. With Fig. 9d, contrast adjustment was performed as displayed in Fig. 9f through 9h. During the contrast adjustment, the

contrast of  $10\%$  (see Fig. 9f) exhibited the lowest error against direct measurement as shown in Fig. 9b, whereas the crack was not observed visually in Fig. 9f and h due to inappropriate contrast adjustment. Finally, with Fig. 9g, the optimized image was obtained by adjusting the sharpness to  $65\%$  as shown in Fig. 9j. As Fig. 9i adjusted with the sharpness of  $-50\%$  has unclear crack edges, this figure is improper for this image visibility improvement technique. On the other hand, Fig. 9k that was adjusted with the sharpness of  $100\%$  shows the crack clearly,

but other edges are not clear due to over contrast. Using the optimized image, the damage quantification that was performed revealed an average error of 5.47% against direct measurement, and a corresponding damage map was created as shown in Fig. 9l.

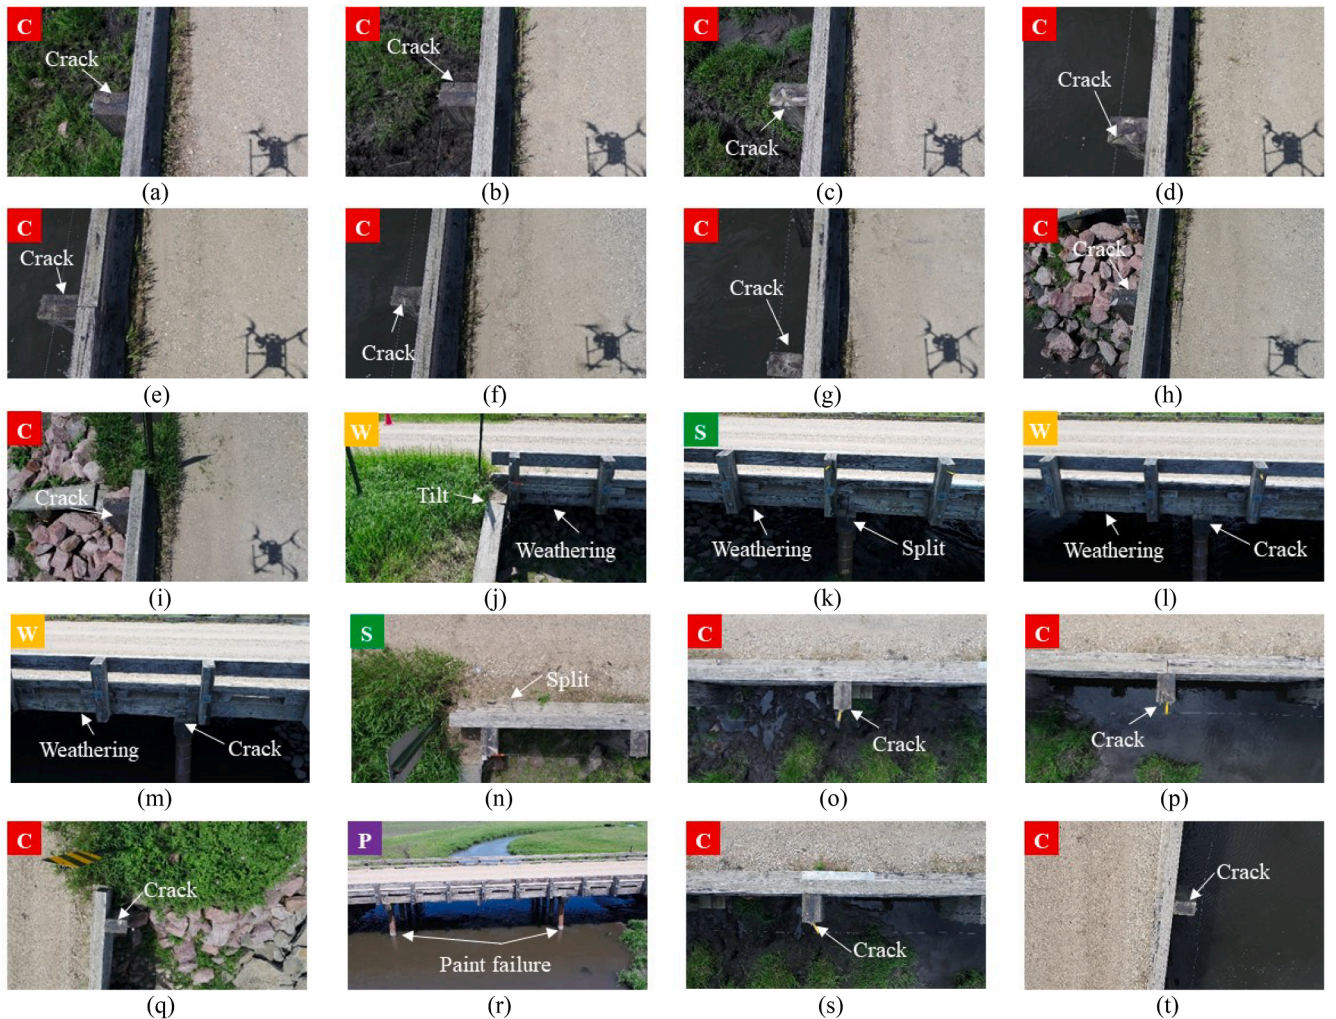
Fig. 13. Classified damage using UAV images: (a) crack on the railing on SS1; (b) crack on the railing on SS1; (c) crack on the railing on SS3; (d) crack on the railing on SS3; (e) crack on the railing on SS5; (f) crack on the railing on SS5; (g) crack on the railing on SS5; (h) crack on the railing on SS7; (i) crack on the railing on SS7; (j) tilt and weathering on NS1; (k) weathering and split on NS3; (l) weathering and crack on NS5; (m) weathering and crack on NS7; (n) split on NS1; (o) crack on the railing on NS1; (p) crack on the railing on NS1; (q) crack on the railing on NS7; (r) paint failure on NS; (s) crack on the railing on NS5; and (t) crack on the railing on NS5.

Upon the completion of CNN-based damage classification, various types of damage including crack (see Fig. 13a through 13i, 13l, 13m, 13o, 13p, 13q, 13s, and 13t), split (see Fig. 13k and 13n), tilt (see Fig. 13j), and paint failure (see Fig. 13r), and weathering timbers (refer to Fig. 13j through 13m) were further investigated manually from each of the UAV images to ensure that the CNN-based damage classification was able to identify individual damage types correctly. It is important to note that because the applied CNN algorithm was only capable of showing one damage classification result, another damage classification was not provided in the inspection images having more than one damage (i.e., Fig. 13j through 13m). With the UAV images in Fig. 13, image properties’ adjustment with the brightness of 20%, contrast of 20%, and sharpness of 30% was performed as shown in Fig. 14. Through this algorithm, the visibility of the inspection images was improved as in the process with indoor UAV inspection images. For instance, weathering in darkness (Fig. 13j through 13m) can be observed undoubtedly as depicted in Fig. 14j through 14m.

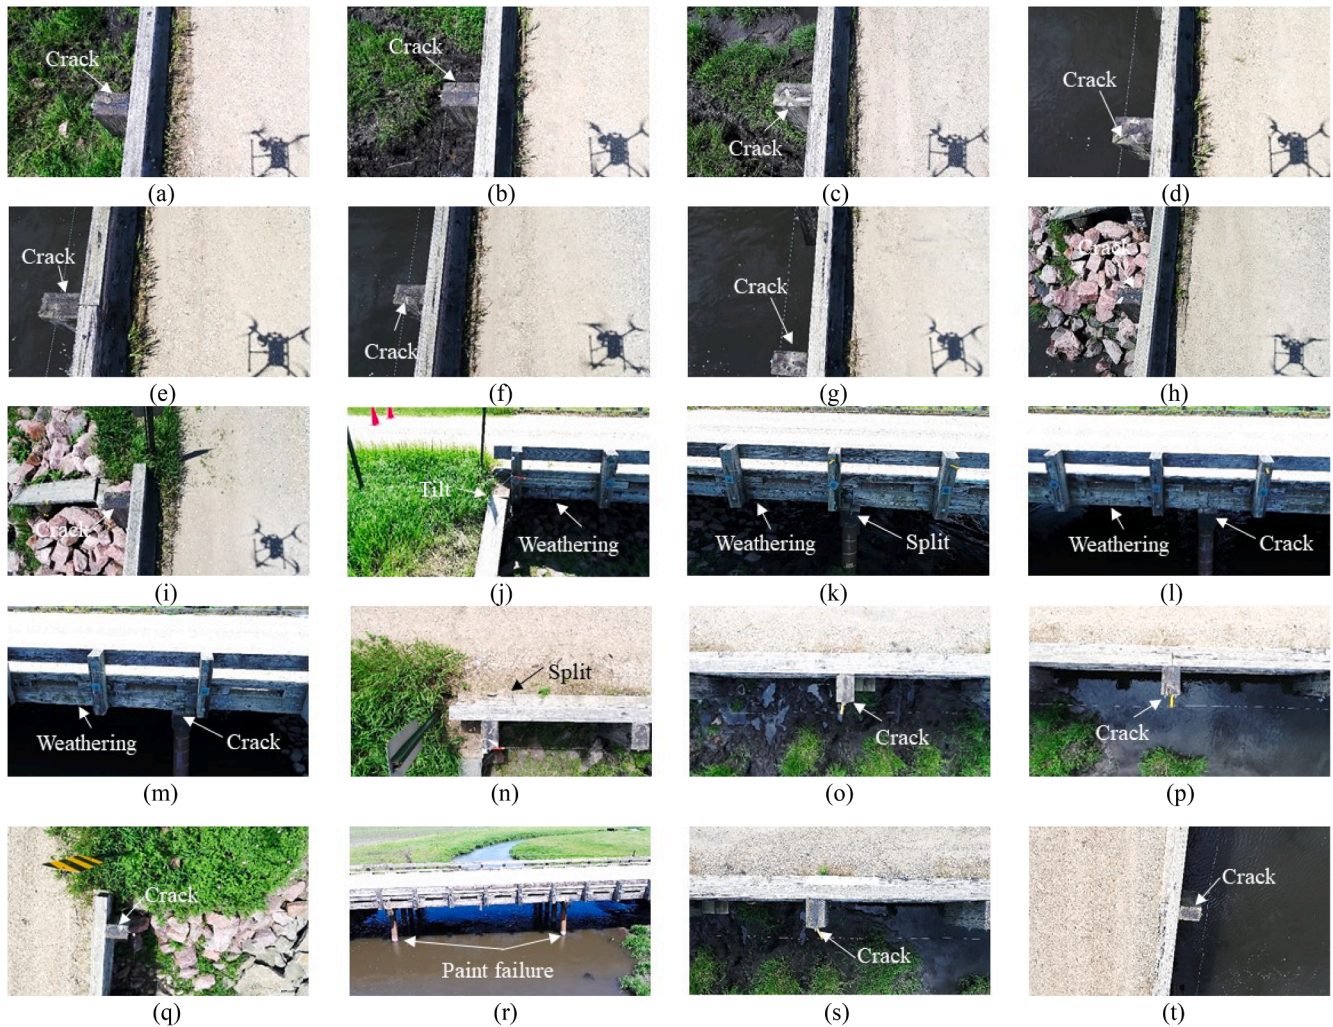
**Fig. 14.** Optimized UAV inspection images adjusted with the brightness of 20%, contrast of 20%, and sharpness of 30%: (a) crack on the railing on SS1; (b) crack on the railing on SS1; (c) crack on the railing on SS3; (d) crack on the railing on SS3; (e) crack on the railing on SS5; (f) crack on the railing on SS5; (g) crack on the railing on SS5; (h) crack on the railing on SS7; (i) crack on the railing on SS7; (j) tilt and weathering on NS1; (k) weathering and split on NS3; (l) weathering and crack on NS3; (m) weathering and crack on NS7; (n) split on NS1; (o) crack on the railing on SS1; (p) crack on the railing on NS1; (q) crack on the railing on NS7; (r) paint failure on NS; (s) crack on the railing on NS5; and (t) crack on the railing on NS5.

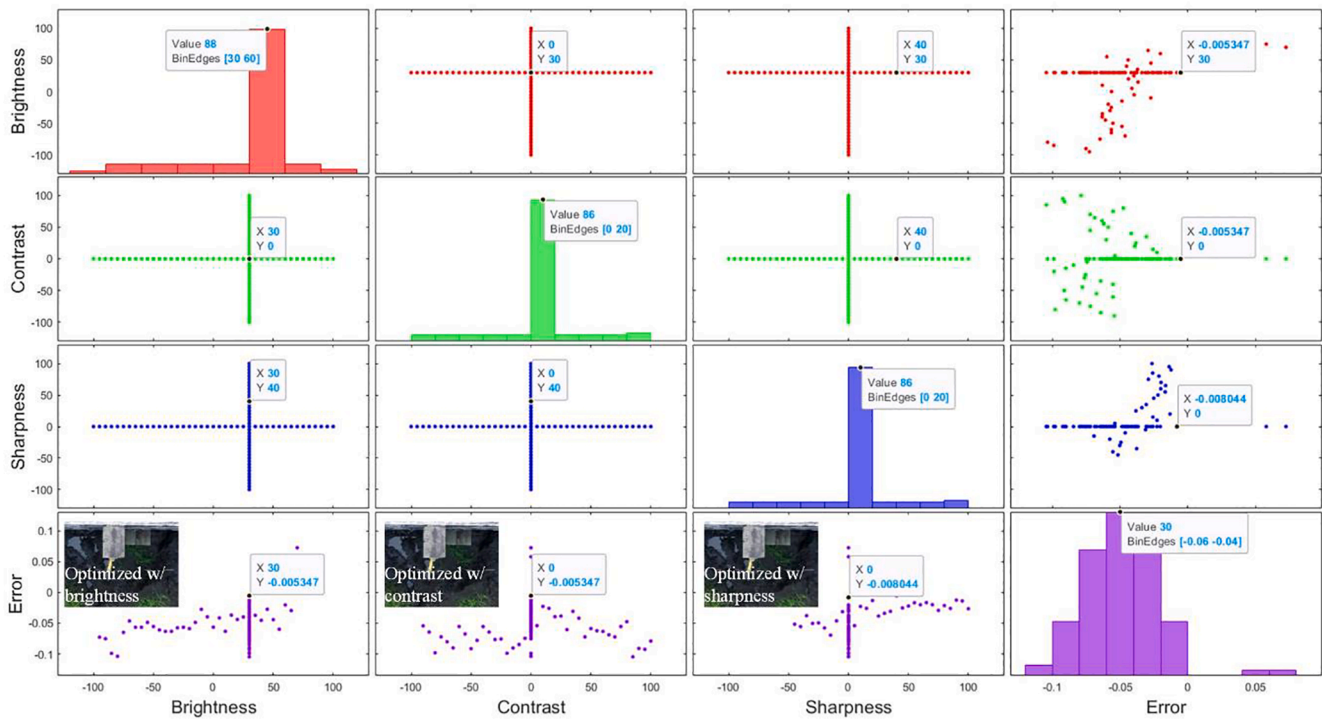
**Fig. 15.** Graphical representation for variation in accuracy of image analysis-based damage quantification corresponding to brightness, contrast, and sharpness along with errors.

image analysis-based damage quantification was evaluated as shown in Fig. 15. The crack on the railing post was measured taking account into the image properties’ variations. The UAV inspection image used for the crack quantification was adjusted with brightness of 30%, contrast of 0%, and sharpness of 0%. Note, this image was considered as the optimized image that shows an average error of 2.92 % only against the direct measurement. This figure includes the 12 scatter and 4 histogram charts created by considering the variability in brightness, contrast, and sharpness of the optimized image. As an example of explanations for these charts, the red histogram chart for brightness shows a mode at brightness between 30 and 60 and 88 defined as the number of data points within the brightness range. Similarly, the green and blue histograms for contrast and sharpness have an identical mode and data point number between 0 and 20. Data points in the red, green, and blue scatter charts for combinations of the image properties such as brightness-contrast and brightness-sharpness mean the frequency. As shown at the bottom of Fig. 15, meanwhile, purple charts show the relationship between image property values and errors that were calculated between image-based damage quantification and direct measurement. In these charts, values of the image properties closest to zero are considered as the optimized image. As an example of these purple charts, error-brightness and error-contrast show the minimum error value of  $-0.005347$  obtained at the brightness of 30% and the contrast of 0%, respectively.

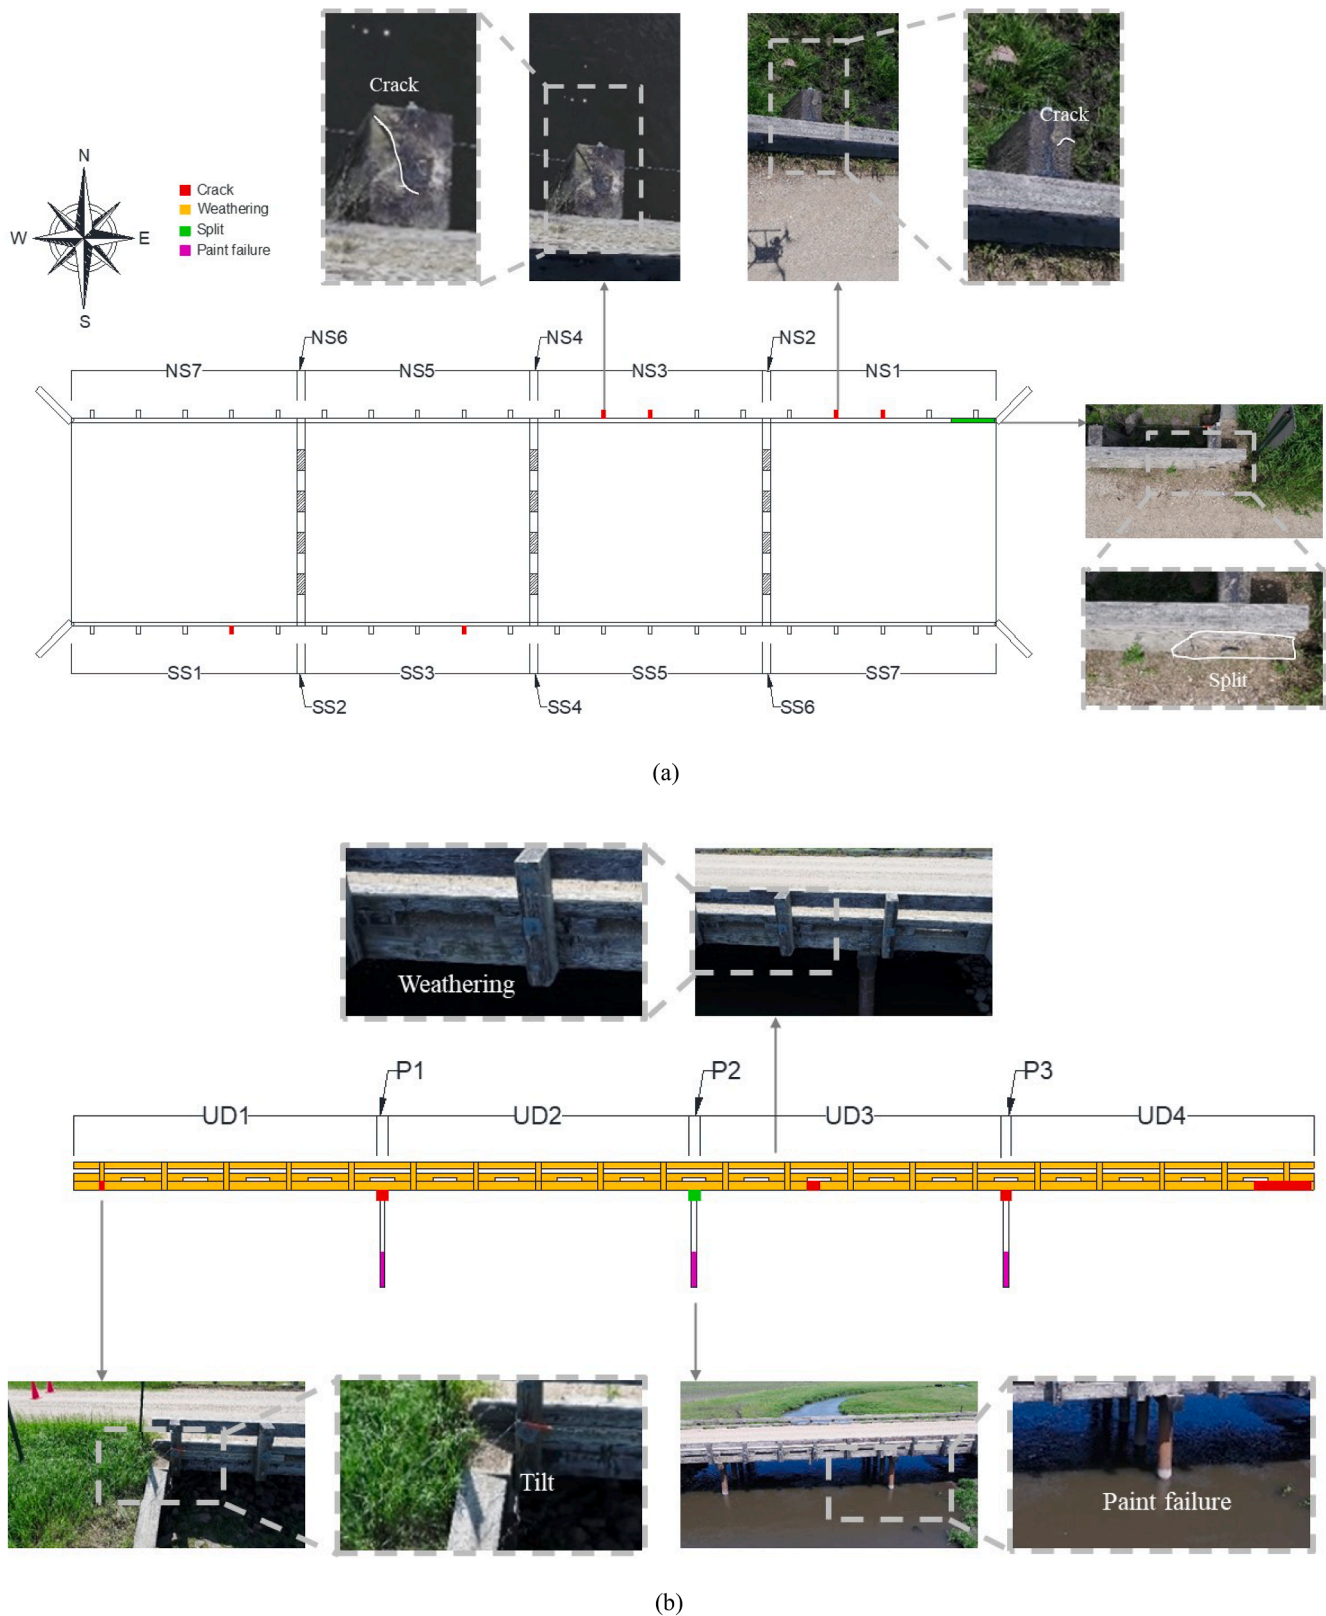
A damage map of the inspected bridge showing all the identified damage and corresponding optimized UAV inspection images is provided as shown in Fig. 16. The UAV images in this figure show different types of damage, including crack, split, weathering, tilt, and, paint peeling off. Note, the optimized images were obtained by performing the image visibility improvement process with the unfiltered UAV images with adjustment of image properties as stated before. The detailed damage descriptions provided from the inspection report completed by the bridge inspector, who are responsible for identifying any defects on the bridge, the quantified damage through the UAV-aided inspection protocol, and the direct measurements for accessible damage are also summarized in Table 2. It is worthwhile to note that the bridge

Fig. 16. Damage map for the studied bridge with representative optimized inspection images: (a) plan view and (b) elevation view.
