Forest Products Laboratory | Research Note FPL–RN–0425 | February 2024

# Condition Assessment of Wood Members in a Historic Building at the Veterans Affairs Medical Center in Tomah, Wisconsin

Robert J. Ross  
Laurice M. Spinelli Correa

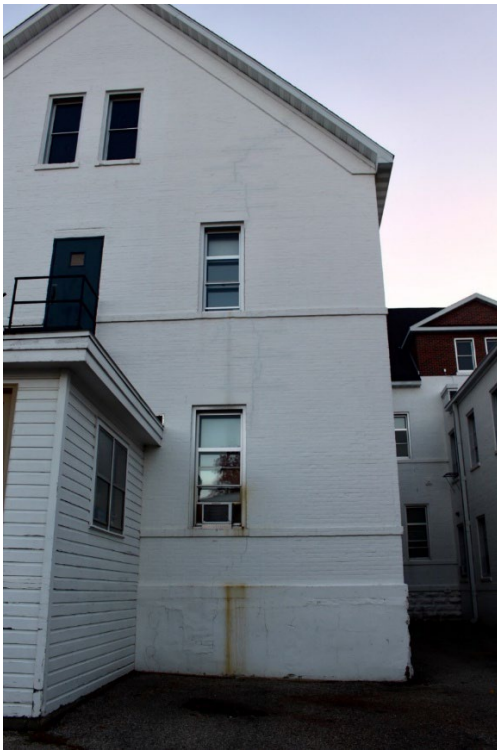
Based on our visual inspection, we found the building's condition to be cause for immediate concern. The basement of the building has considerable water damage. The water damage can be seen throughout outside walls, basement internal walls, timber beams, wood framing members, and wooden floors. Figure 2 shows one of the outside walls where a crack extends from the foundation to the roof. Figure 3 shows an exterior view of the building's foundation. Note that the foundation wall is bowing outward.

**Figure 2—Outside wall. Note crack that extends from the foundation to the roof.**

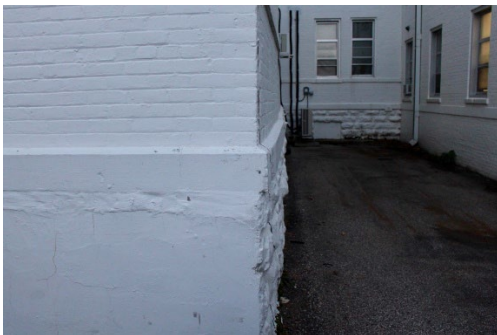
**Figure 3—Outside wall. Note outward bowing of the foundation.**

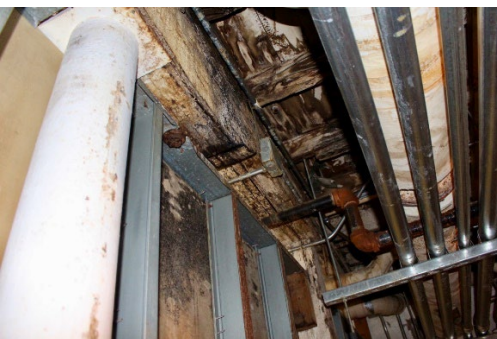
Water damage was observed in most rooms. Room 02333 presented the worst damage in the building, with severe wood decay and wood and paint discoloration, both caused by high moisture and humidity levels. Figures 4 and 5 show two of the damaged timber beams, and Figure 6 shows water infiltration on the floor system above the basement. Room 02336 was also severely affected by water damage, with evident mold, discoloration, and deteriorated members (Figs. 7 and 8). In addition to the water damage, mechanical failures can also be observed in the basement of the

**Figure 4—Room 02333, decayed timber beam and water-damaged floor system.**

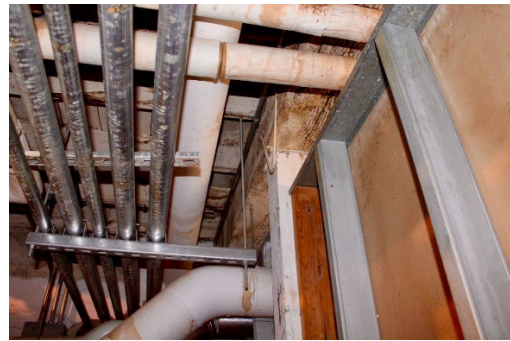
**Figure 5—Room 02333, decayed timber beam.**

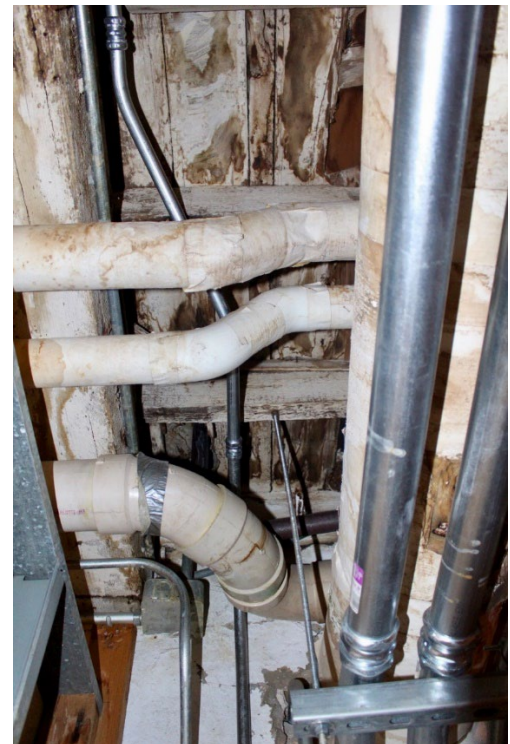
**Figure 6—Room 02333, water-damaged floor system.**

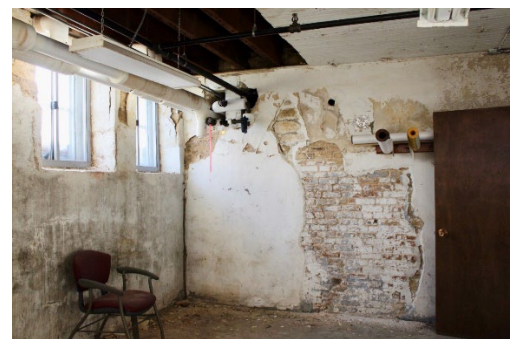
**Figure 7—Room 02336, water damage.**

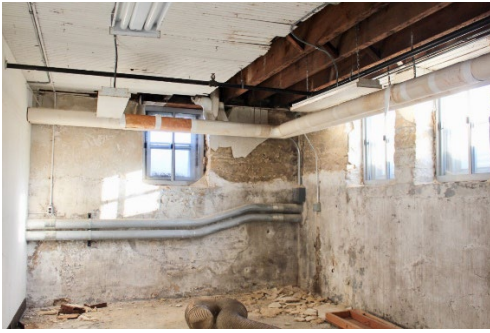
**Figure 8—Room 02336, wall damage.**

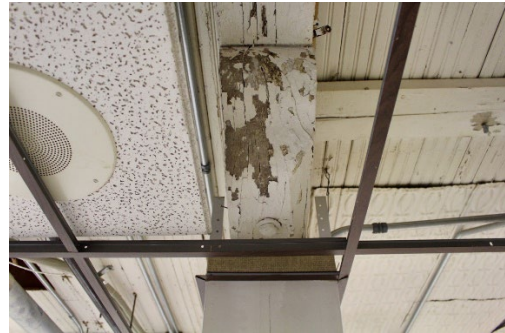
**Figure 12—Room 02305. Member shifting off-center.**

Examination of timbers in room 02305 revealed that several bolts and washers were no longer in contact with the timber (Fig. 11), which may indicate internal deterioration of the timber. We also observed some shifting of members and gap openings (Figs. 12 and 13).

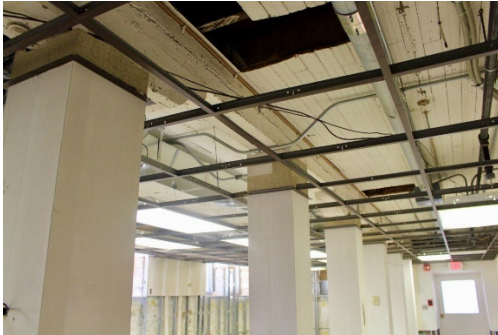
**Figure 9—Room 02305. Note horizontal split in timber beam.**

building. Figures 9 and 10 show two wood beams in room 02305 with splitting in the neutral axis going all the way along the longitudinal direction of the beam. Although surface checking is common in wood members, the magnitude of splitting we observed indicates a horizontal shear failure. The horizontal shear capacity of this timber is severely compromised.

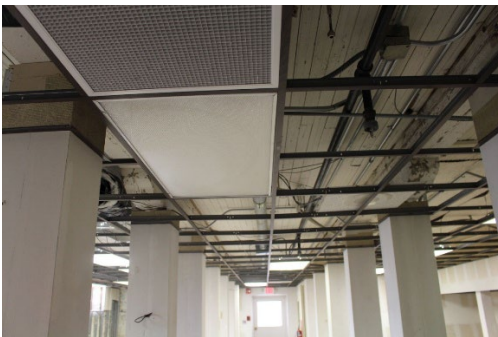
**Figure 10—Room 02305. Note horizontal split in timber beam (upper right of photo).**

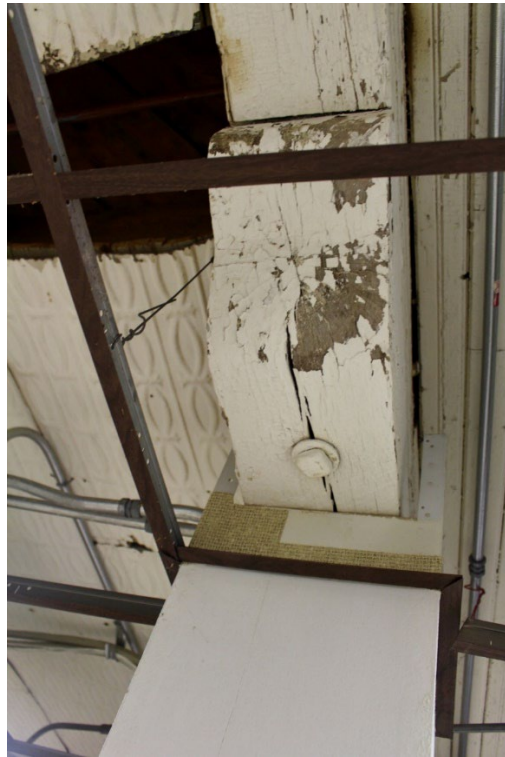
**Figure 13—Room 02305. Note horizontal splits surrounding bolt.**

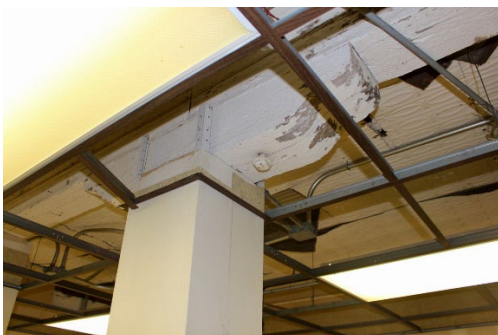
**Figure 11—Room 02305. Note that bolt is not in contact with the timber member.**
