# Bridge Deterioration Quantification Protocol Using UAV

Luis Duque, S.M.ASCE<sup>1</sup>; Junwon Seo, Ph.D., P.E., M.ASCE<sup>2</sup>; and James Wacker, M.ASCE<sup>3</sup>

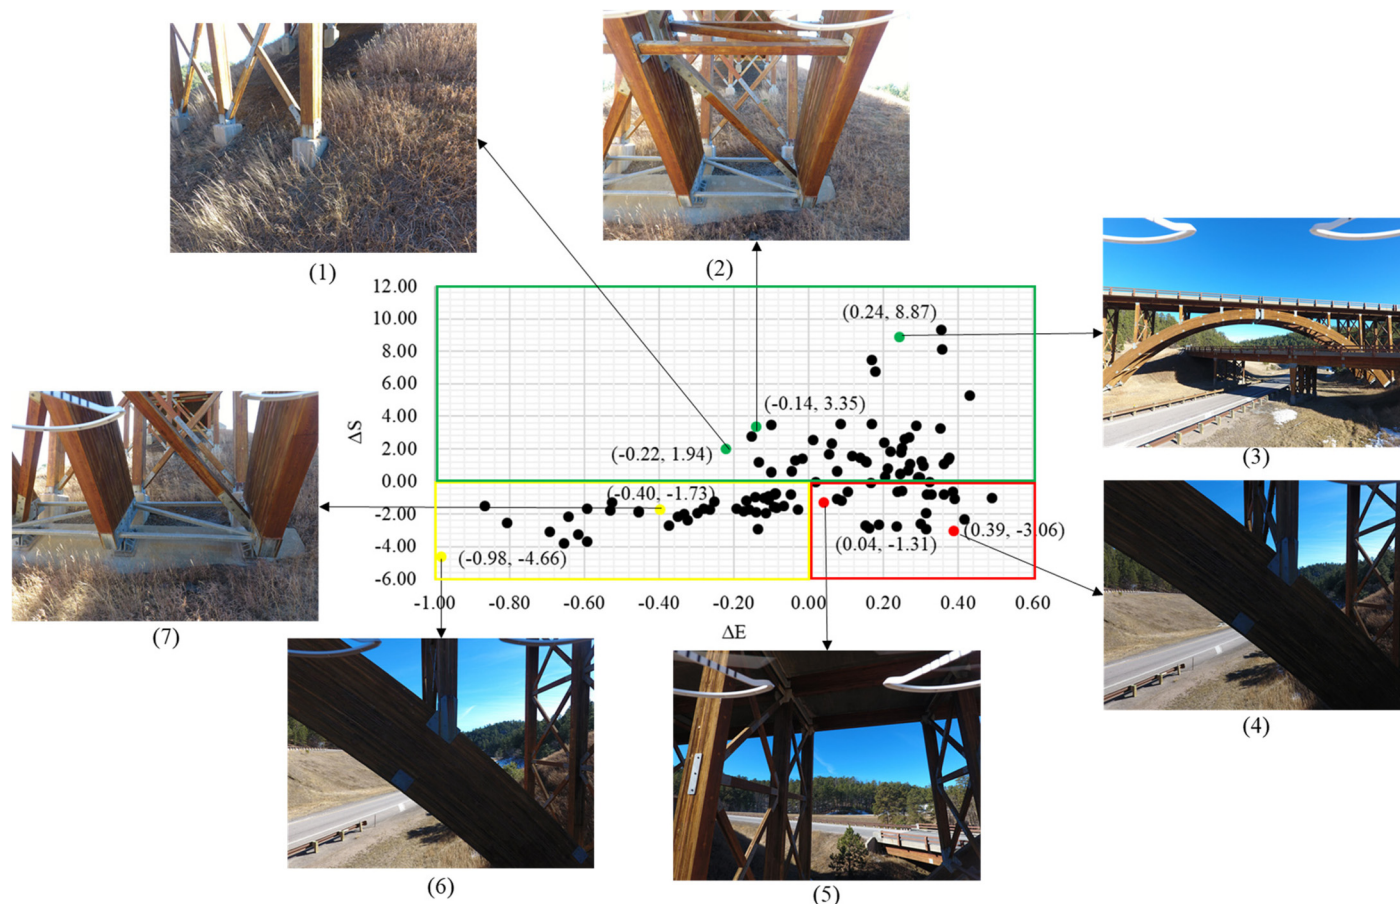
Seven sample images are presented in Fig. 7 numbered from 1 to 7 to validate the results obtained. It can be seen that Images 1–3 were high-quality images, as their entropy and sharpness were higher than the reference image, reflected by either a positive  $\Delta S$  and  $\Delta E$  or a positive  $\Delta S$  and a negative  $\Delta E$ . Images 4 and 5 were identified as low-quality images, as their  $\Delta E$  was positive and the  $\Delta S$  was negative. Similarly, Images 6 and 7 were classified as images that require visual assessment by the inspector, as both the  $\Delta S$  and  $\Delta E$  were negative when compared to the reference image.

From the sample images presented in the bottom-right area, it is evident that Image 4 was not suitable to identify damage because the arch was underexposed and no damage could be observed. In contrast, Images 6 and 7 would allow the inspector to observe damage on the structure because it was evenly exposed, and all bridge components were clearly visible. The comparison of Images 6 and 7 demonstrated the need to review the images that fall within the bottom-left area. Following this method, a total of 29 images were considered low-quality images not suitable for damage identification;

**Fig. 7.** Graphical representation of entropy–sharpness relationship results with sample images. (Images by Luis Duque, Junwon Seo, and James Wacker.)

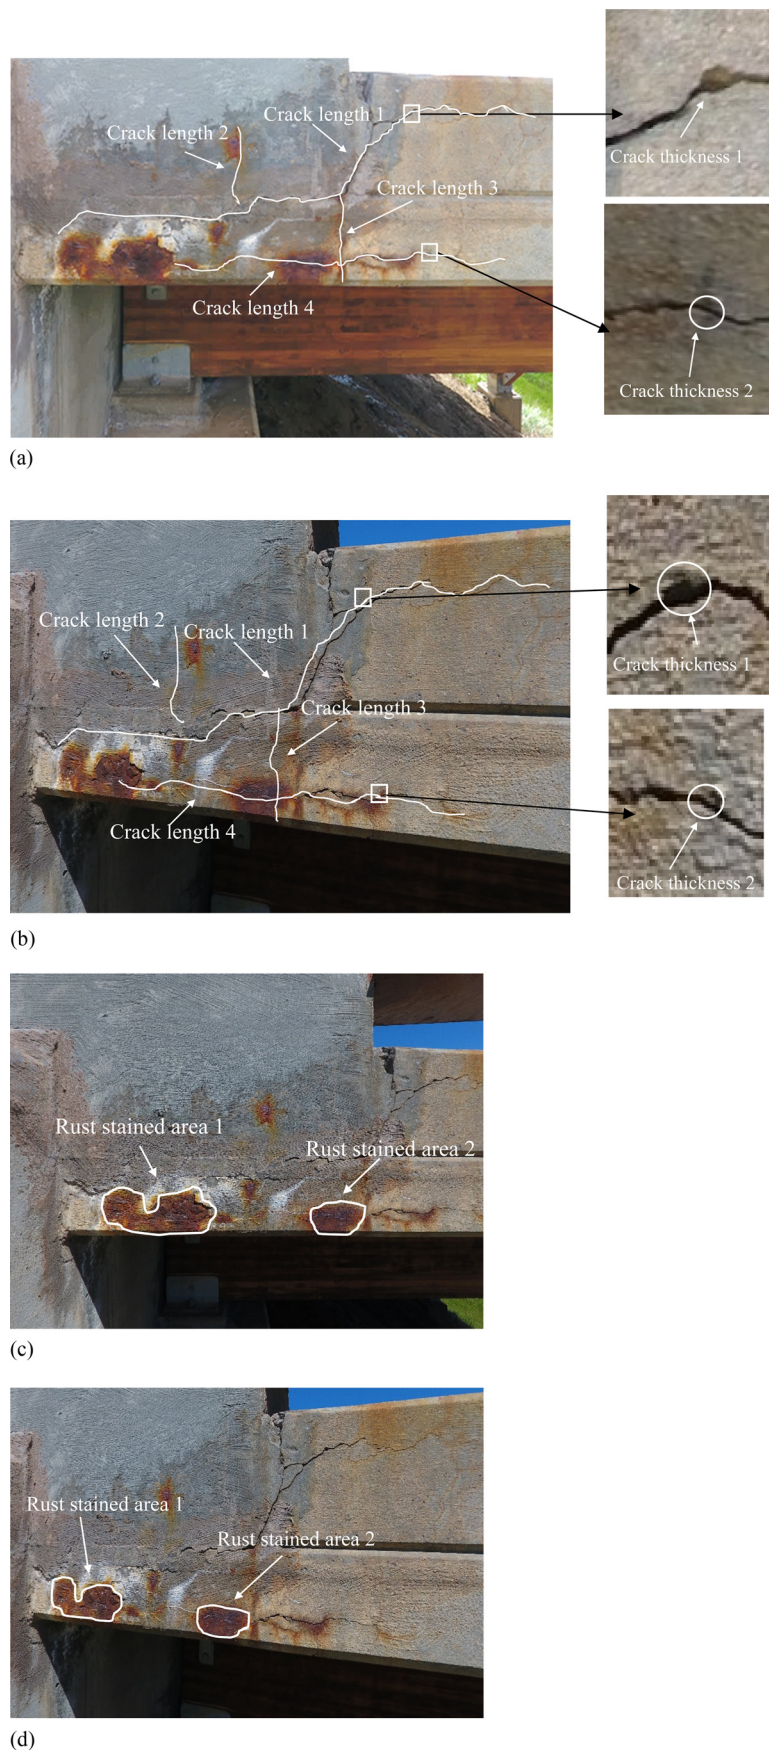
Contrary to the results for the image aligned to the damage, the analysis for the image taken to the side of the damage presented a percentage difference within 8.7 and 21.9 for the crack lengths and thicknesses, respectively, showing a significant decrease in accuracy. The decrease in accuracy can be attributed to image distortion caused by obtaining the picture to the side of the damage. It was identified that there was an inverse relationship between the accuracy of measurements and the angle between the field of view for the camera and the damage location. The complete set of results for the crack measurements with image distortion are also presented in Table 1.

For the identified rust-stained areas, an approximate area was calculated for the direct measurement. To achieve the measurement, linear segments along the edges of the rust-stained area were directly measured using a measuring tape. Then, using AutoCAD, the simplified irregular shape area was determined. In ImageJ, the available area function was used based on the predetermined scale to calculate the pixel-based area measurements and compare them to field measurements. ImageJ utilizes the scale information and the number of pixels inside the bounded area to complete the measurement. Due to the approximation for the direct measurements, the results were not as accurate as expected, with a percentage difference of 11.9% for the image aligned to the damage, as seen in Fig. 9(c). The study of the rust-stained area on the image to the side of the damage was conducted as seen in Fig. 9(d). As expected, a lower accuracy with a percentage difference of 47.1% when compared to field measurements was observed. The comprehensive results for the study of the rust-stained areas are also included in Table 1.

**Fig. 9.** Pixel-based damage quantification of damage near abutment of the Keystone Wye Bridge: (a) image aligned with damage; (b) image to the side of damage; (c) identified rust-stained areas for image aligned to damage; and (d) identified rust-stained areas for the image to the side of damage.

| Damage type | Identified damage | Photogrammetry-based measurement | Pixel-based measurement aligned to damage | Measurement difference (%) | Average value | AASHTO damage level |
|---|---|---|---|---|---|---|
| Crack thickness [cm (in.)] | 1 | 0.64 (0.25) | 0.66 (0.26) | 3.1 | 0.65 (0.26) | Poor or more |
| Rust-stained area [cm <sup>2</sup> (in. <sup>2</sup> )] | 1 | 228.4 (35.4) | 226.5 (35.1) | 0.84 | 227.45 (35.3) | Poor |

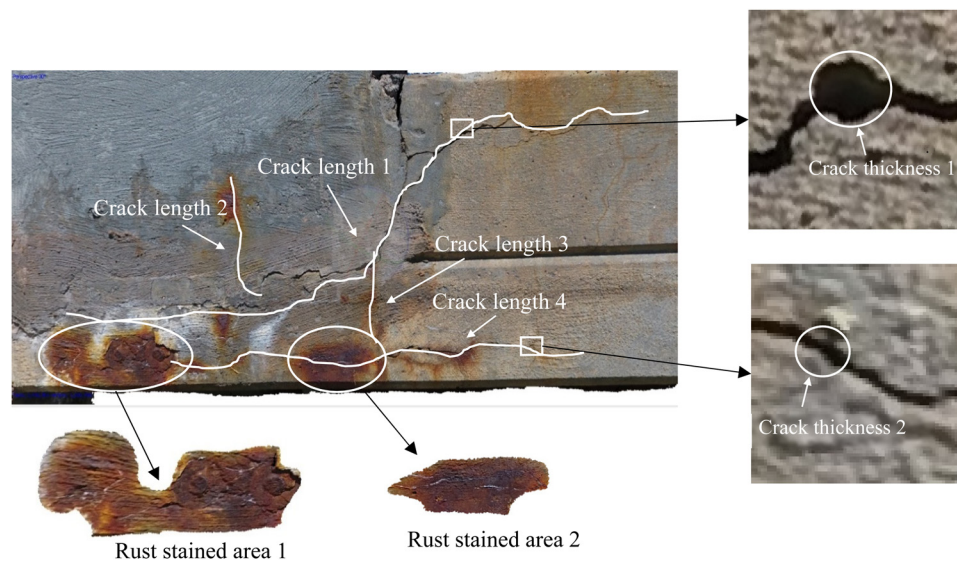
To conduct the measurements, a scale to georeference the 3D virtual model was defined. To establish the scale, the GPS location information from the UAV was utilized, in addition to the assignment of known distances on the 3D virtual model. Then, using the ruler tool, the measurements for the same crack lengths and thicknesses were obtained and compared to the field measurements. The results demonstrated the level of accuracy the method was able to obtain, with percentage differences within 3.5 and 7.4% for the crack lengths and thicknesses, respectively. The details of the results for the crack measurements can be seen in Table 2.

For the rust-stained area measurements, the desired area was isolated from the rest of the 3D virtual model, as seen in Fig. 10. Then, using the *area and volume* function available in PhotoScan, the measurement was completed. PhotoScan estimates the area of the isolated portion of the 3D virtual model by calculating the sum of individual areas for the triangles created to produce the surface of the 3D virtual model. The results were within an acceptable range, with a difference of 14.9% considering the field measurements were approximated. A summary of the results for the rust-stained area measurements is also included in Table 2.

**Fig. 10.** Photogrammetry-based 3D virtual model for damage quantification of damage near abutment of Keystone Wye Bridge.**Table 2.** Results from measurements obtained using PhotoScan
