Forest Products Laboratory | Research Note FPL–RN–0428 | November 2024

# Condition Assessment of the Northern Climatic Research House at the USDA Forest Service, Forest Products Laboratory

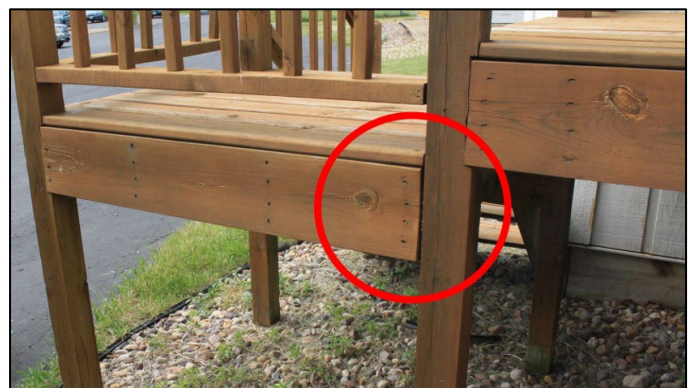
The back entrance stoop, leading into the kitchen, is cause for imminent concern. The back deck presents some wood decay. The joists are connected to the joist box (also called rim joist) with appropriate hangers, but the joist box, which carries the load of the joists, is not well connected to the support post (Fig. 3). This joist-box-to-post connection system is not sufficient.

**Figure 3—Joist-box-to-rail connection of back entrance deck showing insufficient fixity (photo property of Mississippi State University, used with permission).**

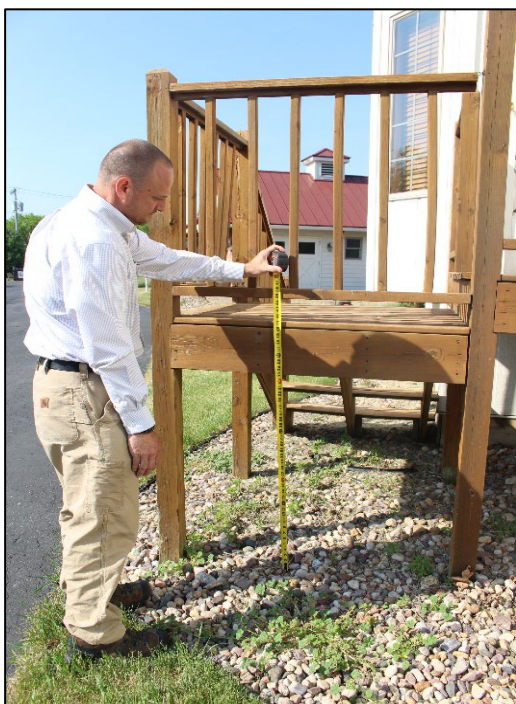
For safety, rail and guard systems are required on decks that are 30 in. or more off the ground. Rail and guard systems are supposed to resist a 200-lb lateral load applied at any location (International Residential Code, Section R312, R312.1.1 (ICC 2017)). At the back entrance stoop of the research house, the deck height is 41 in. (Fig. 4). In addition,

**Figure 4—Measuring the back entrance deck height to see if it is up to code (photo property of Mississippi State University, used with permission).**

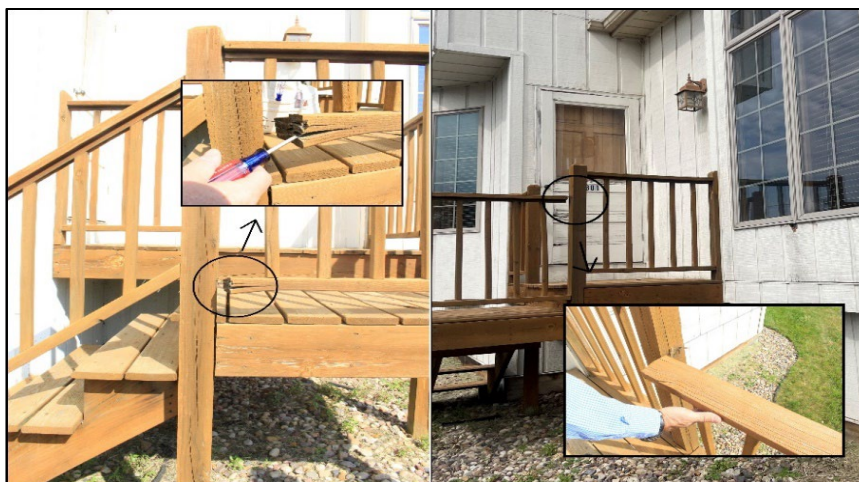
the rail-to-post connections have completely failed in several locations (Fig. 5). This failure renders the guard system unable to resist any loading. It appears that the rail-to-post connections were initially and inadequately connected with nonstructural #4 or #6 finish nails. This connection detail probably contributed to the guard system failure. It is recommended that this stair/stoop structure be

**Figure 5—Rail-to-post connections of the back entrance have completely failed in the highlighted locations (photos property of Mississippi State University, used with permission).**

immediately and actively closed to prevent any use until it can be replaced.

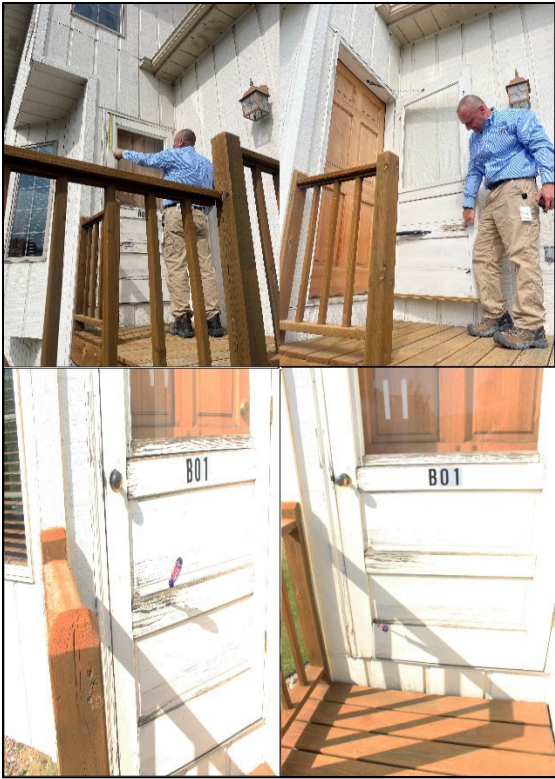
Also, the storm door leading from the kitchen to the stoop is deteriorated beyond repair (Fig. 6). In its current state, it is not functioning as needed, that is, as a means of preventing water infiltration into the structure. Replacement of the storm door appears to be the only option to restore its intended functions of energy savings and protection from water intrusion.

**Figure 6—Storm door on the back stoop is deteriorated (photos property of Mississippi State University, used with permission).**

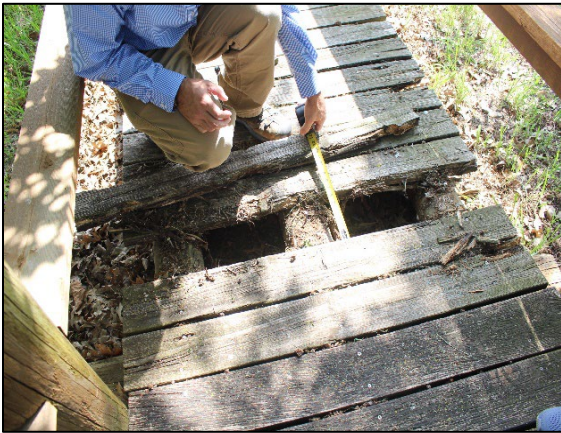
The accessibility ramp is severely deteriorated. The structural posts, carrying beams, deck boards, and rails are all deteriorated to some degree. Some of the deck boards have deteriorated to the extent that they can be removed by hand and are at risk of bending failure (Fig. 7). Many of the structural posts are decayed at their cores and hollowed out to the extent that they do not securely hold the rails. In many cases, the rails can be lifted off the posts (Fig. 8). The rails were let-in to the posts by mortise and tenon type construction. The mortise pockets appear to have served as water traps. As a result, the tops of the posts are severely decayed to a depth of approximately 12 in. or more. As such, the posts are no longer able to hold or remain fixed to the handrails. In many cases, the handrail boards are also decayed, particularly at the ends. Some of the support cross beams that are affixed to the posts and support the deck framing are severely deteriorated in their cores (Fig. 9).

**Figure 7—Deteriorated deck boards in the accessibility ramp. Some of the deck boards could be removed without effort (photo property of Mississippi State University, used with permission).**

In sum, the posts, carrying beams, decking, and handrails are severely decayed and need immediate replacement. Because many of the deck boards, many of the support beams, the structural posts, and the handrails are severely deteriorated, the structure must be closed and actively blocked. Two of the three entrance points to the ramp (the

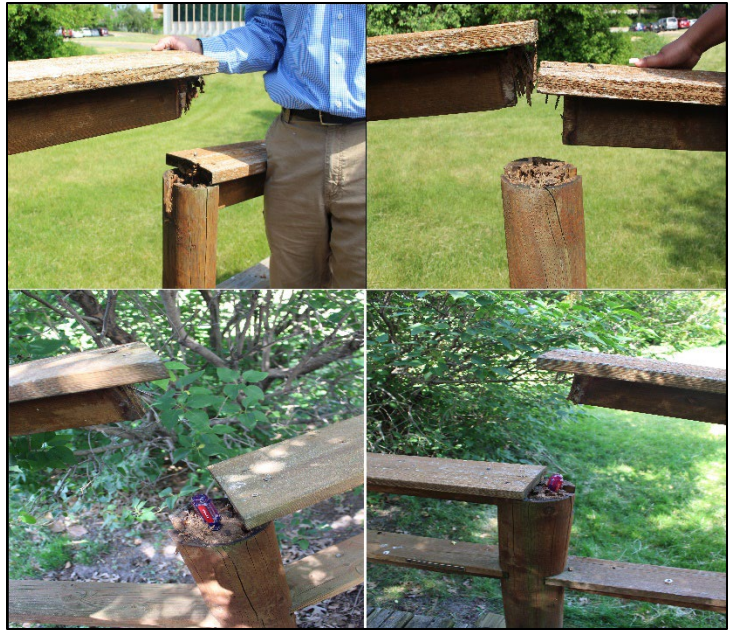
**Figure 8—Rail-to-post connections in the accessibility ramp were severely decayed. The rail can be removed from the post, and the post was also decayed. When the post was probed with a screwdriver, the screwdriver went in easily (photos property of Mississippi State University, used with permission).**

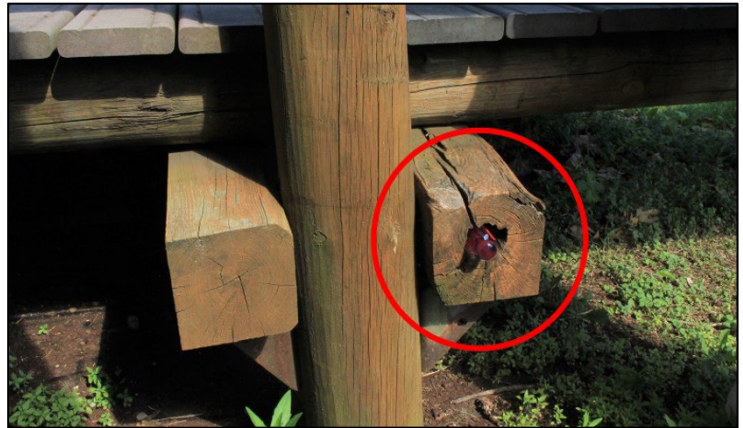
**Figure 9—Advanced decay in carrying beams that support the floor frame of the accessibility ramp (photo property of Mississippi State University, used with permission).**

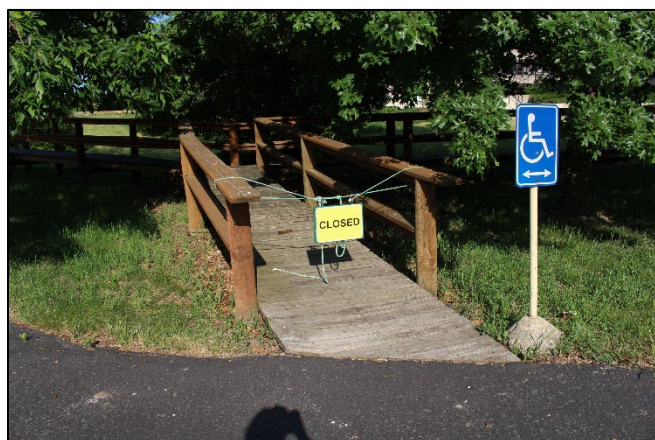
two along the paved driveway) are posted “closed” and blocked with rope (Fig. 10). One of the three entrance points to the ramp (the location where the ramp connects to the front porch) is open (Fig. 11). This entrance point should also be actively blocked and posted as closed to prevent pedestrian access to the ramp.

**Figure 10**—“Closed” sign and rope barricade at one of three entrance points to the accessibility ramp (photo property of Mississippi State University, used with permission).

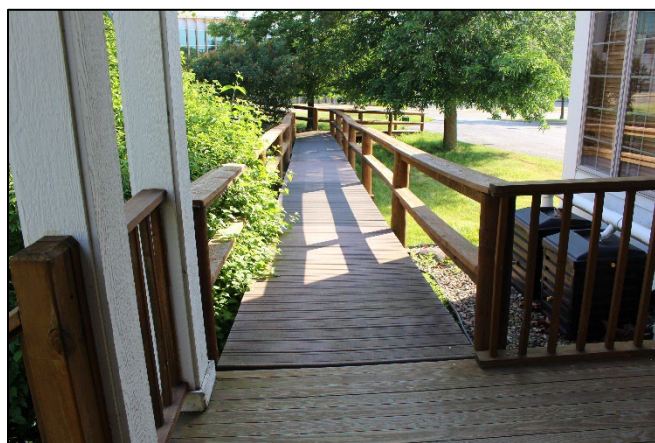
**Figure 11**—Front porch entrance point to the accessibility ramp, which should be posted as “Closed” and actively blocked to prevent pedestrian access (photo property of Mississippi State University, used with permission).

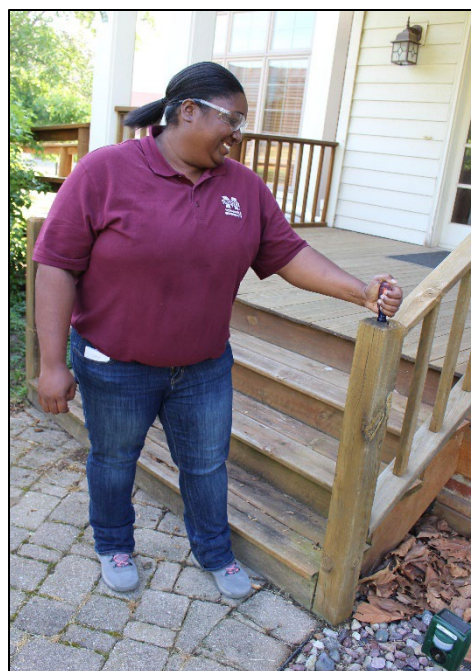
The front entrance deck rail posts have decay. A screwdriver was inserted into the top of the post to probe the extent of the decay (Fig. 12). The bottom of the post appeared to be connected to the stair stringer with screws. This method of post fixity is not considered sufficient to provide the 200-lb resistance as required by the building code (International Residential Code, Section R312, R312.1.1). The stair treads are decayed. Screwdrivers were inserted into the decayed portions to probe the extent of the deterioration (Fig. 13). The front porch flooring near the top of the steps has become unfastened because of fastener corrosion and rust,

**Figure 12**—A screwdriver was easily inserted into the front entrance deck rail post, showing the extent of the decay (photo property of Mississippi State University, used with permission).

and post trim is showing signs of deterioration (Figs. 14 and 15). It is recommended that the front porch steps, posts, rail, and guards be replaced and the front porch decking be refastened or repaired as necessary. The guard and railing system of the front porch are fastened with small (approximately 4d) finish nails, similar to that of the back stoop. This fastening system is inadequate and should be replaced. The condition of the front porch ceiling tongue and groove boards indicates that the porch takes on moisture (Fig. 16).

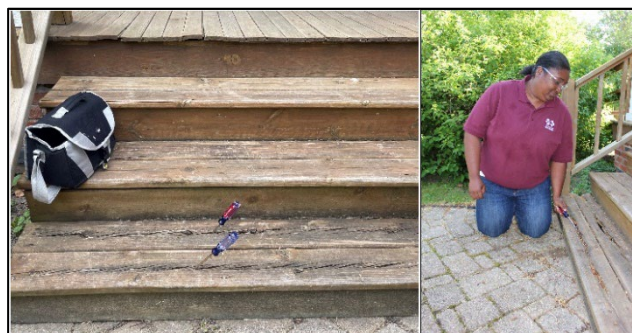
**Figure 13**—Screwdrivers were inserted into the decayed portions of the steps to the front porch, showing the extent of the deterioration (photos property of Mississippi State University, used with permission).

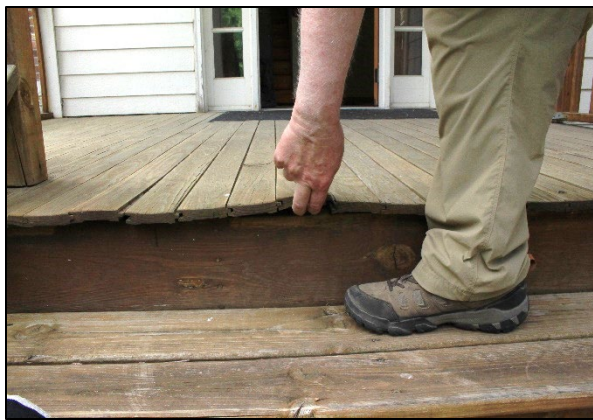
**Figure 14—The front porch flooring near the top of the steps has become unfastened due to fastener corrosion (photo property of Mississippi State University, used with permission).**

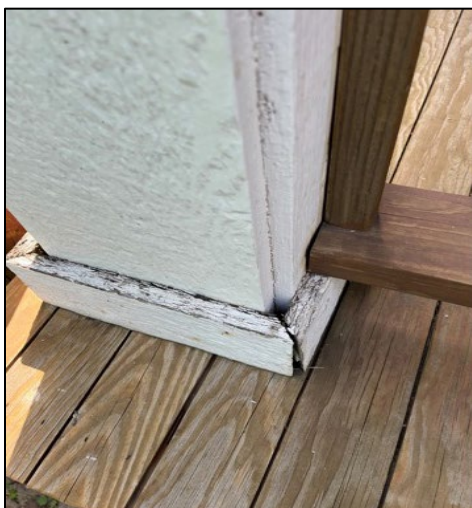
**Figure 15—Front porch post trim showing signs of deterioration (photo property of Mississippi State University, used with permission).**

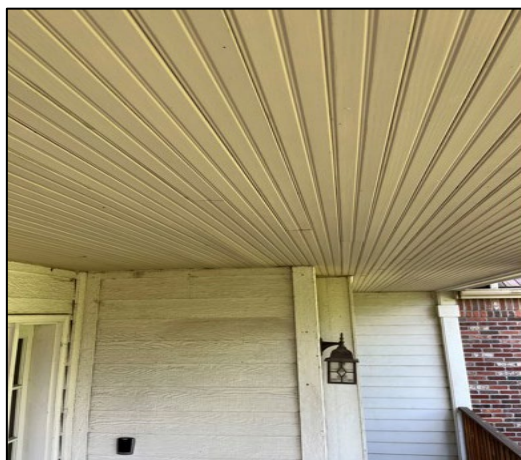
**Figure 16—Tongue and groove ceiling of the front porch is swelling, indicating moisture issues (photo property of Mississippi State University, used with permission).**

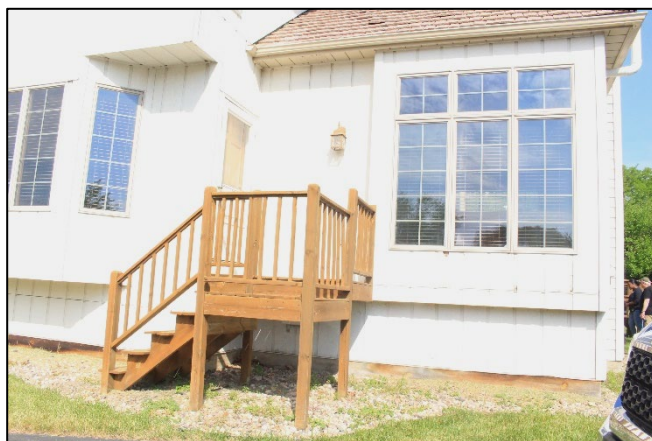
**Figure 17—Location of worst siding deterioration beneath and in the vicinity of the triple mullion dining room window (photo property of Mississippi State University, used with permission).**

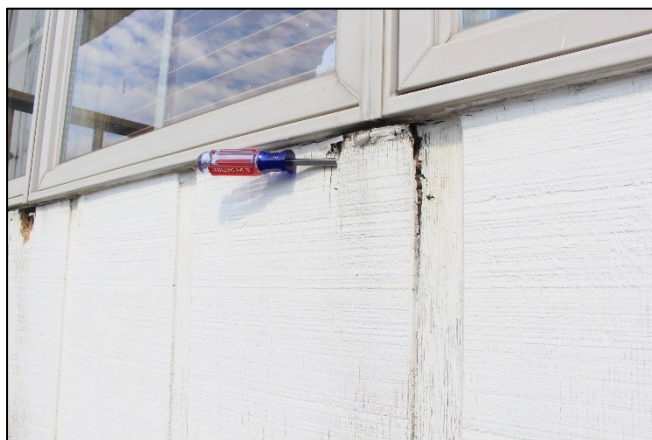
**Figure 18—Deteriorated siding under the dining room window (photo property of Mississippi State University, used with permission).**

If the decision is made to keep the structure, then repair and replacement of the siding is necessary. Another consideration is that the only portion of sheathing that was evaluated was under the decayed 18- by 48-in. section of siding that was removed. This section accounts for less than 1% of the clad area. The extent to which sheathing and potentially wall framing in the other 99+% of the wall area may be impacted by water intrusion and its negative effects on the wood is unknown.

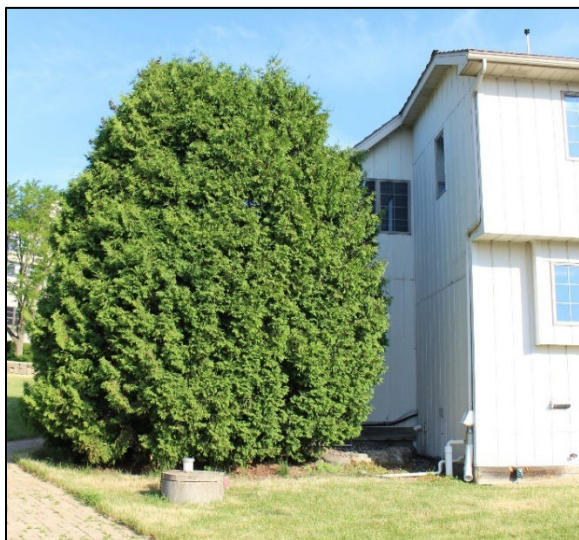
because of shade from a large tree located in close proximity to the exterior siding (Fig. 19). The shade from the nearby tree prevents and/or retards redrying of the siding after rain events, leaving the walls wet longer than walls that are in full sun and thereby accelerating decay.

**Figure 19—Large cedar tree in close proximity to the house (photo property of Mississippi State University, used with permission).**

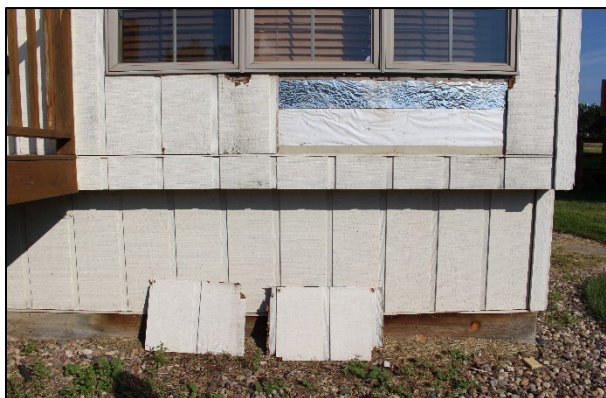
During the inspection, an approximately 18- by 48-in. section of T1-11 siding was removed from under the dining room triple mullion window unit (Fig. 20). The house wrap and flashing beneath the siding appeared intact and functional. The sheathing was probed by striking it with a hammer (Fig. 21). The sheathing appeared intact based on the hammer's sound and return bounce upon striking. Therefore, it is assumed that the wall framing beneath the sheathing in this area is also intact and not decayed. Siding in other areas where utilities are attached are showing similar signs of decay (Fig. 22) and some trim boards are showing signs of decay that was caused by paint failure (Fig. 23).

**Figure 20—Section of T1-11 siding removed from beneath the triple mullion dining room window (photo property of Mississippi State University, used with permission).**

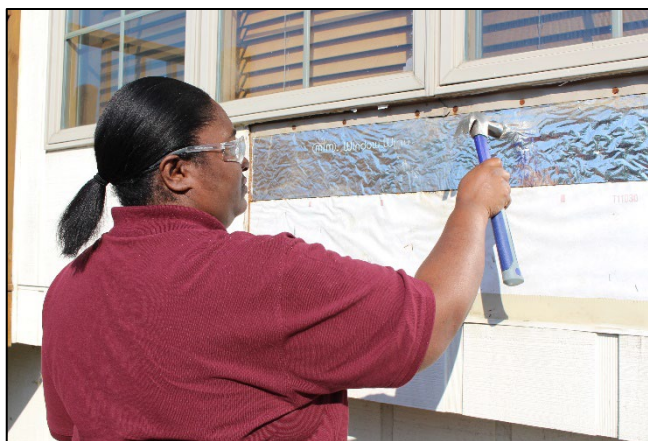
**Figure 21—A hammer was used to gently strike the sheathing to probe for decay and deterioration (photo property of Mississippi State University, used with permission).**

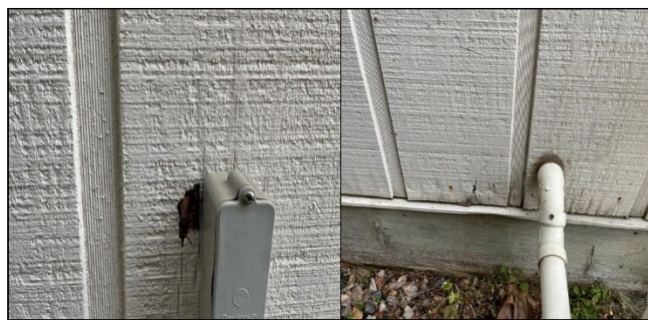
**Figure 22—Areas where utilities are attached are showing similar signs of decay (photo property of Mississippi State University, used with permission).**

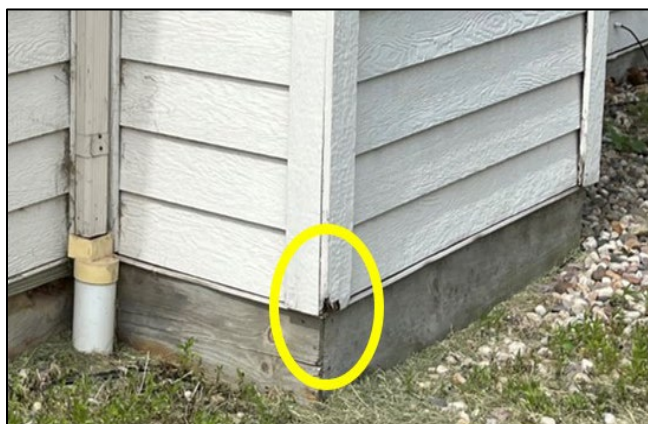
**Figure 23—Trim boards around the house are showing signs of decay due to paint failure (photo property of Mississippi State University, used with permission).**

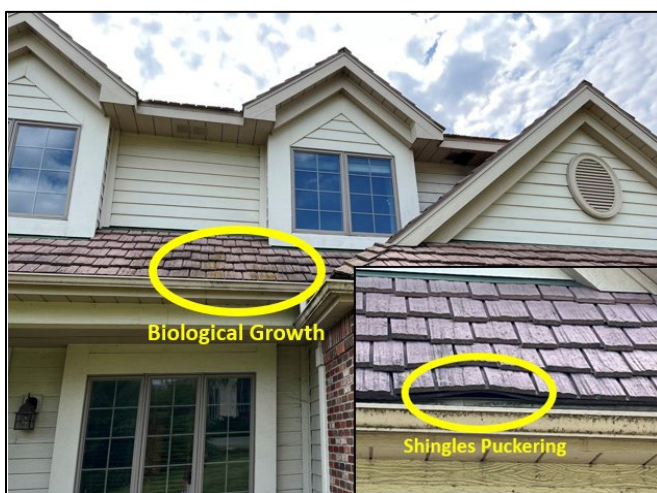
The roof shingles appear to be hand-split cedar shakes but are actually made from a wood-plastic composite material, the plastic of which came from recycled plastic milk containers. From the exterior, it is noticeable that the roof shingles are puckering (also known as buckling or lifting) in many areas (Fig. 24). Densified and compressed composites swell when exposed to moisture over prolonged periods. This swelling causes adjacent shingles to push on each other and ultimately lift off the roof structure. On the front side of the house, over the garage door and porch entry, it appears that both the shingles and the roof sheathing are lifting from the roof framing. As the shingles pucker and lift or separate from the roof, their ability to resist wind and shed wind-driven rain decreases. Similarly, when roof sheathing swells and lifts from the roof framing, it loses its ability to shed wind-driven rain. The intrusion of rain ultimately leads to deterioration within wood framing. In the research house, water damage was noted in the main stairwell between the first and second floors. This damage appears as a small blackish colored hole at the top of the stairwell ceiling, with rust colored splash marks beneath the hole. This moisture intrusion appears to be coming from a hole or penetration in the roof. Also, the shingles are showing signs of biological growth, which is an indication of water being held on the surface of the shingles (Fig. 24).

**Figure 24—Shingles showing signs of weathering, such as biological growth and puckering (photo property of Mississippi State University, used with permission).**

5. The siding on the southeast and southwest sides of the house needs repair and/or replacement.
  6. The roof shingles are puckering in many places because of irreversible moisture-induced swelling. This puckering has led to roof leaks. One such leak is noted inside the house at the ceiling of the main stairwell. If the decision is made to keep the building, the roof shingles will need to be replaced. Given the house's age (approximately 22 years), entire roof replacement, rather than piecemeal patching, is recommended.

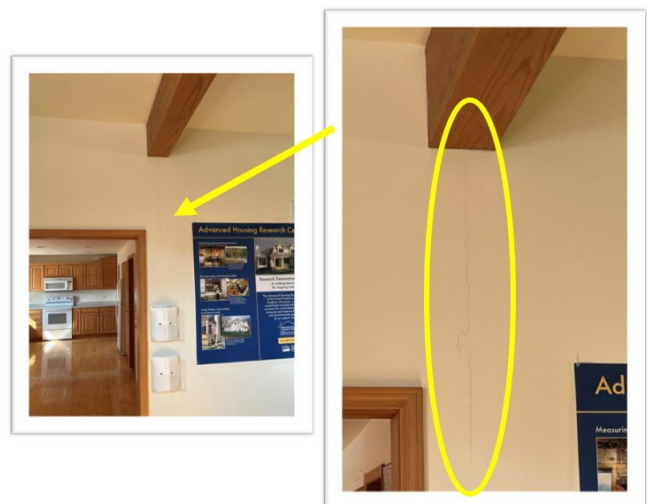
The soil around the house's foundation may be creating other issues. Signs of fracture or buckling of the drywall can be seen in Figure 25. A corresponding unleveling in the basement could explain this drywall buckling (Fig 26a and b). Deconstruction of the basement floor would be needed to further investigate the issue. This may be from soil erosion from rain and moisture; soil erosion can be seen in front of the garage (Fig. 26c).

**Figure 25—A fracture or buckling of sheet rock in the great room. The right-side header inside the great room shows fracture or buckling in the drywall above the door opening. This may correspond to soil settling or foundation movement on the left side in the basement (photos property of Mississippi State University, used with permission).**

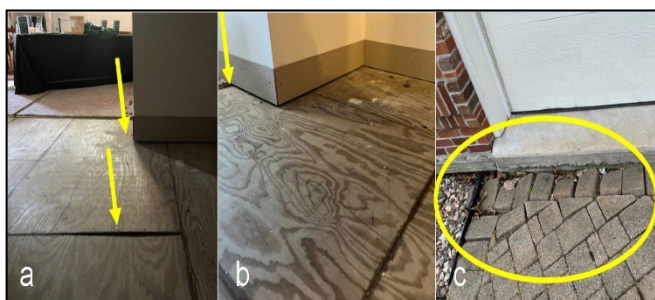
**Figure 26—Signs of settling in the foundation in the southwest portion of the basement (a and b) and in front of the garage (c). The treated plywood foundation shows unleveling underneath the left side pier supporting the left side great room wall (a and b). This may have been caused by water movement under the foundation. Other indications of water can be seen in the soil unleveling under the pavers located near the front left side of the garage approach (c) (photos property of Mississippi State University, used with permission).**

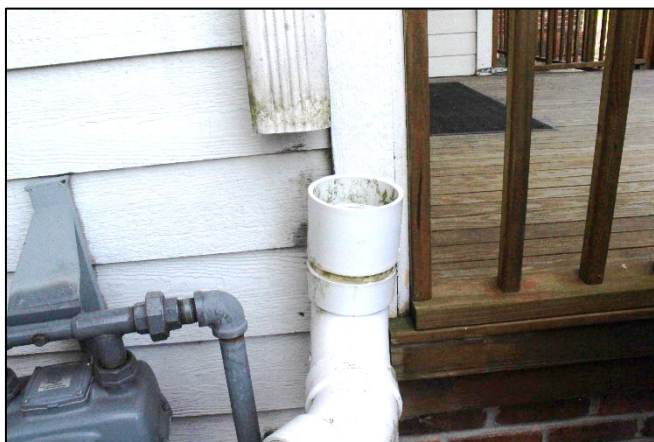
The disconnected downspout (Fig. 27), located at the front of the house, near the location where the accessibility ramp connects to the porch, is a possible contributor to the foundation/soil settling issues. The downspout is supposed to be connected to a water collection and drainage device. However, because it is disconnected, rain from the roof is being collected by the gutters, transferred through the downspout, and deposited immediately adjacent to the foundation at this location.

**Figure 27—Disconnected downspout near location where ADA accessibility ramp connects to the front porch (photo property of Mississippi State University, used with permission).**
