Forest Products Laboratory | Research Note FPL–RN–0429 | March 2025

# Condition Assessment of the Timber Frame Supporting USS *Cairo* at Vicksburg National Military Park, Vicksburg, Mississippi

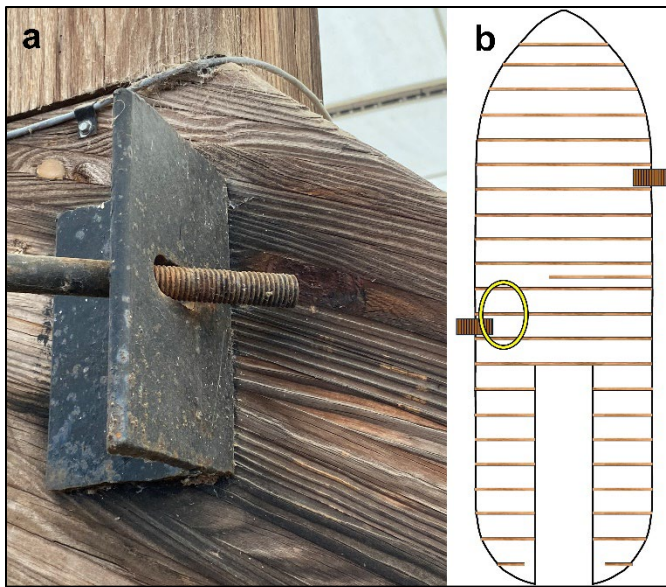
**Figure 4—Missing bolt on lateral support rod: (a) rod without bolt; (b) yellow oval shows location of rods without bolts on the USS *Cairo* display.**

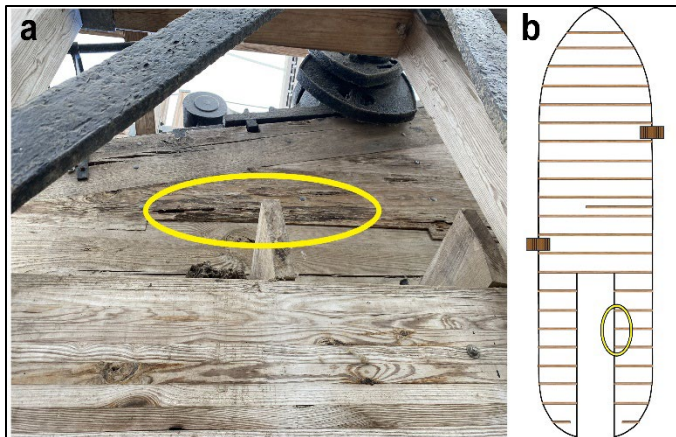
One area of particular concern is the white oak bulkhead located below the steam pistons attached to the aft paddle wheel assembly. There was evidence of extensive decay and the beginning of structural failure (Fig. 5). It is recommended that this area be, at a minimum, filled with a two-part wood epoxy or similar material to consolidate the member as well as seal off the damage to prevent further biodegradation.

**Figure 5—Area recommended for remedial treatment: (a) decayed region (inside yellow oval) of bulkhead of newer white oak supporting the steam-powered piston that originally moved the aft paddlewheel; (b) yellow oval shows location of decay region on the USS *Cairo* display.**

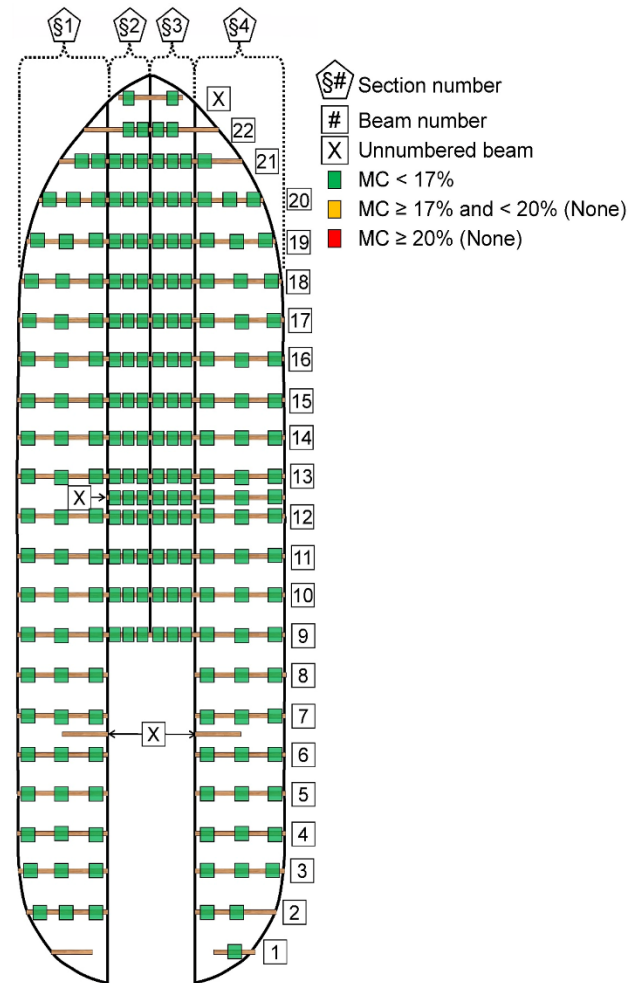
type moisture meter ranged between 8% and 15% MC, with most values falling within the 10% to 13% range. These ranges of MC, as shown in Figure 6, are slightly elevated but still below the required 17% to 20% MC range needed for growth of mold and decay fungi. The MC measurements are summarized in Figure 6, and Figure 7 shows how team members performed the moisture measurements.

Average MC and coefficient of variation (COV) for the four sections of the *USS Cairo* were determined and recorded in Table 3. Overall, MC in all four sections was below that required for growth of decay fungi (>25%). No areas of MC above 20% were found.

**Figure 6—Moisture content of glulam crib underneath the USS *Cairo*. Measurements taken using pin-type moisture meter. All values were below 17%. The four sections, left to right, are port (1), port center (2), starboard center (3), and starboard (4).**

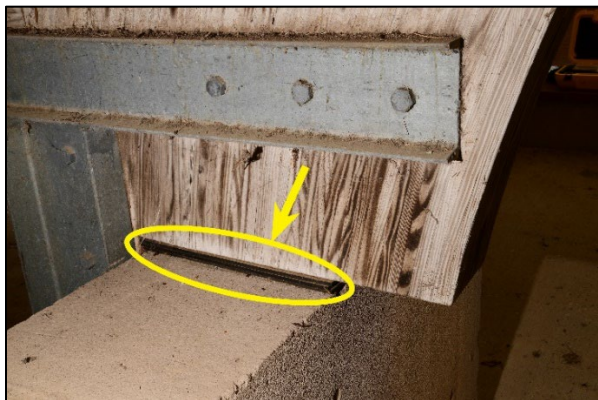
**Figure 8—Barrier material designed to prevent moisture transfer from concrete to glulam supports.**

- All moisture barriers between the concrete structure and the glulam that houses the USS *Cairo* should be assessed, and barriers that are worn or showing signs of failure indicated by an increased moisture reading (Sections 1 and 4) should be replaced.

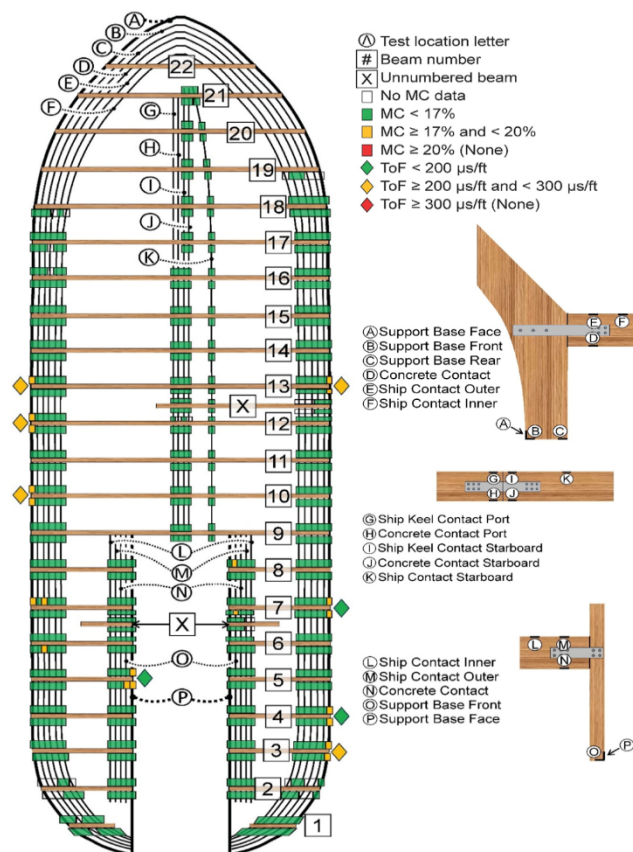
**Figure 9—Moisture content (MC) and time of flight (ToF) of glulam timber support structure for USS *Cairo*. Test locations identified by beam number, and location letter provided on diagrams to the right. Locations where MC was at or above 17% were also measured using stress wave ToF. Advanced decay was not found, but stress wave ToF revealed locations that should be monitored going forward.**

ship and along the keel. Each black line is labeled with a letter that corresponds to the test location as shown in the diagrams to the right. Green indicates low concern; yellow indicates moderate concern. Most moderate concern locations were midlength where the air flow around the glulam supports is minimal.

Moderate concern locations (17% to 20% MC) were further tested using stress wave time of flight (ToF). Stress wave time of travel was measured using a microsecond timer from Fakopp Enterprise Bt (Sopron, Hungary). Mechanical waves (sound or mechanical impact) travel faster in sturdy wood than in decayed wood. ToF less than 200  $\mu\text{s}/\text{ft}$  indicates sturdy wood; ToF between 200 and 300  $\mu\text{s}/\text{ft}$  should be monitored; ToF greater than 300  $\mu\text{s}/\text{ft}$  indicates decay. The Wagner L610 digital lumber moisture meter and Fakopp microsecond timer are shown in Figure 10a and b, respectively. No ToF measurements greater than 300  $\mu\text{s}/\text{ft}$  were observed. Several areas where MC was between 17% and 20% had ToF between 200 and 300  $\mu\text{s}/\text{ft}$ .
