Forest Products Laboratory | General Technical Report FPL-GTR-308 | February 2026

# Condition Assessment of the Wooden Mast of Historic Schooner *Grace Bailey*

On October 9, 2023, the main mast of the historic schooner *Grace Bailey* unexpectedly snapped at about two-thirds of its height and fell onto the deck, killing one passenger and injuring three others. The United States Coast Guard promptly initiated a formal investigation into the cause of the mast's sudden failure. At the request of the Coast Guard, the U.S. Department of Agriculture, Forest Service, Forest Products Laboratory (FPL) conducted an on-site evaluation of the broken mast on December 19, 2023. The inspection used nondestructive testing methods and included visual analysis, stress wave scanning, resistance micro-drilling, and fungal identification at FPL. Severe decay was identified from stress wave transmission measurements taken between 26 and 56 ft above the mast base in the bow-to-stern axis. Suspect wood ranged from 20 to 26 ft and from 56 to 58 ft along the same axis. Along the starboard-to-port axis, suspect wood ranged from 24 to 56 ft, with decay at 37 to 38 ft and severe decay at 45 ft. Results from f

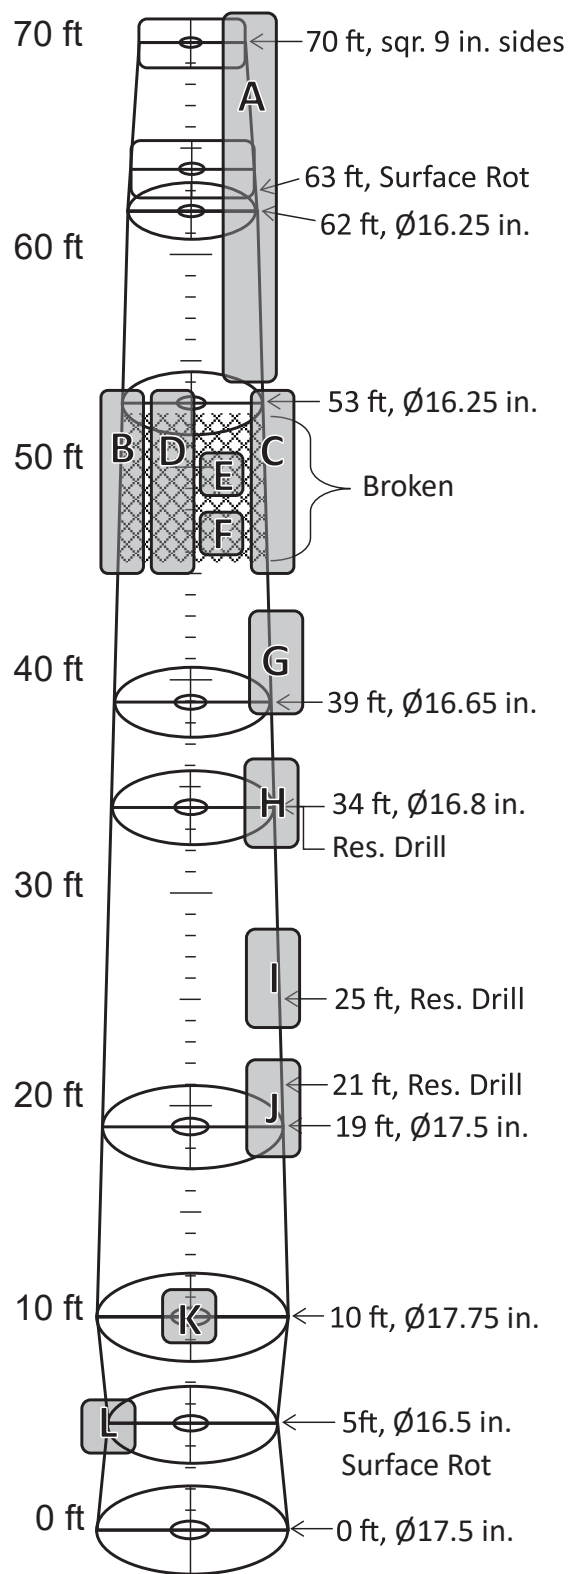
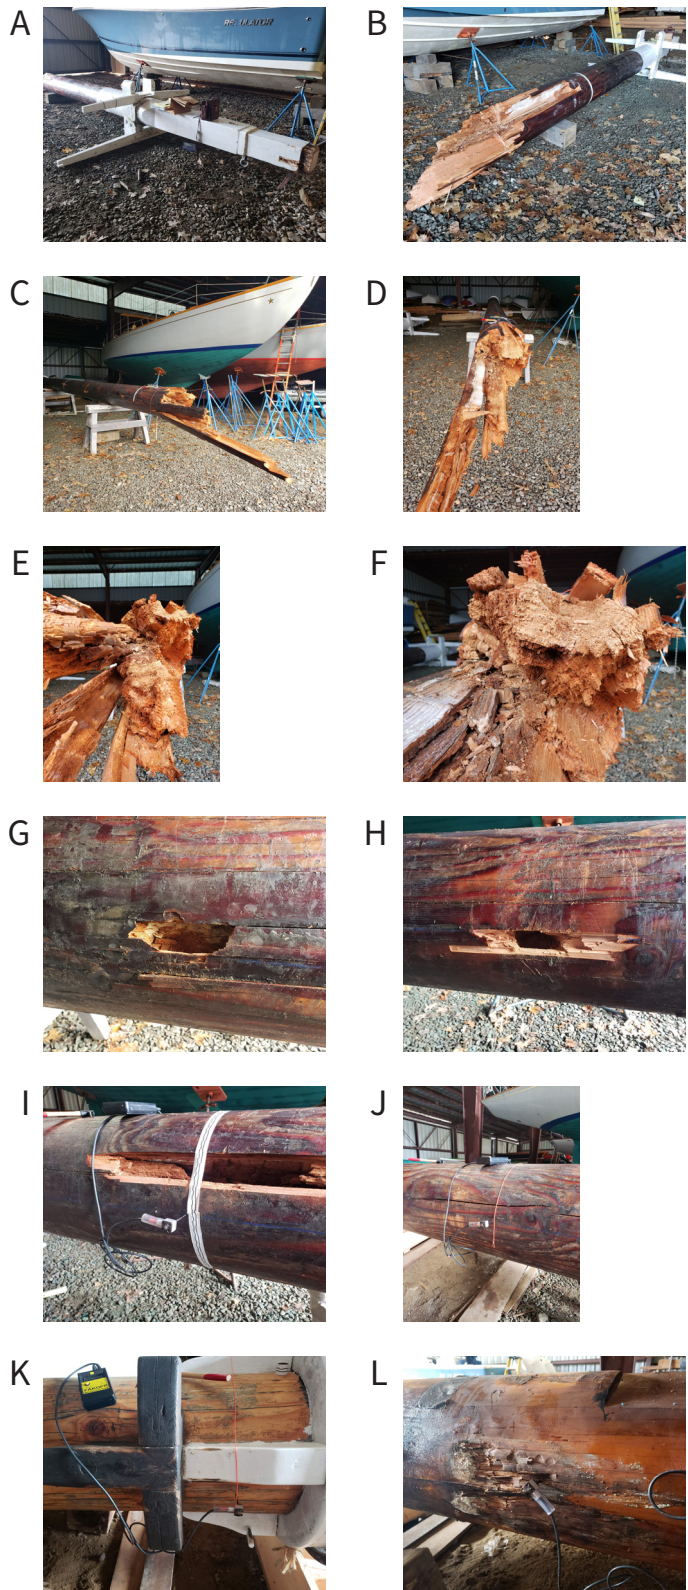
Figure 1 shows photographs of mast features and a diagram giving the approximate locations. Full-size images of these photographs are provided in the Appendix. The mast was broken approximately 20 ft from the top. Extensive, deep checks were observed on many sections of the mast. Surface deterioration from fungal decay was observed at 5 and 63 ft above the mast base. Some areas near the location of the failure indicated that probing tests using a pocketknife were conducted during the inspection after the incident.

**Figure 1.**—Diagram of the main mast of the *Grace Bailey* and photographs documenting the features observed along the mast. The location of each photo is identified in the diagram. A: broken top of the mast; B, C, D, E, F: fracture surface; G, H, I: examination holes created prior to inspection by the Forest Products Laboratory; J: first observable internal decay from stress wave scanning tests; K: mast at deck height; L: mast 5 ft above the base showing surface deterioration. Larger photographs are provided in the Appendix. Forest Service photos by Xiping Wang.

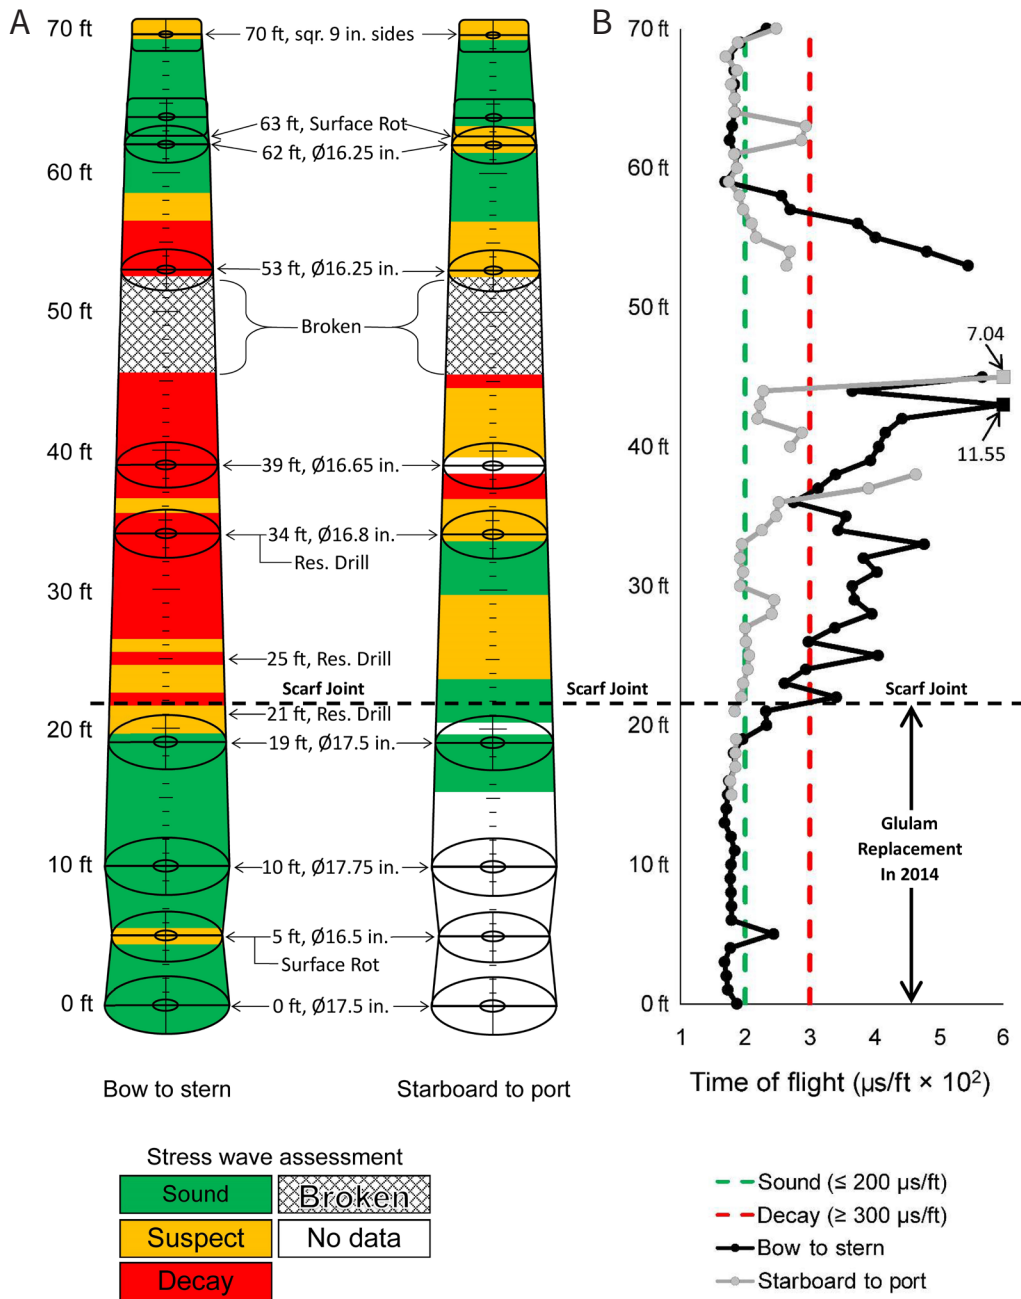
Figure 2 shows the distribution of stress wave transmission time or time of flight (ToF), expressed in microseconds ( $\mu\text{s}$ ), and mapping of the physical condition for the failed mast. The transmission time across the grain is normalized by the distance between the starting and stopping probes, yielding a common unit of  $\mu\text{s}/\text{ft}$  for ToF. Normal range of sound wood is less than or equal to  $200 \mu\text{s}/\text{ft}$ ; suspect wood is more than  $200$  and less than  $300 \mu\text{s}/\text{ft}$ ; above  $300 \mu\text{s}/\text{ft}$  is indicative of decayed wood. Figure 2 shows the ToF values by color along the length of the mast.

**Figure 2.**—Mapping of physical condition of the main mast of the *Grace Bailey*. A: the mast condition as indicated by stress wave transmission time for the directions of bow to stern and starboard to port. B: time of flight (ToF) values. Values between  $200$  and  $300 \mu\text{s}/\text{ft}$  are assumed to be suspect.

Measurements were taken at cross sections every 1 ft of mast length and in two perpendicular directions: from bow to stern and from starboard to port. Overlaid green shading indicates sound wood, yellow shading indicates suspect wood, and red shading indicates decayed wood. A chart of the numerical ToF values and thresholds for sound and decayed wood are also shown in Figure 2. Some locations had ToF values more than 600  $\mu$ s/ft, indicating advanced decay with severe structural degradation; the locations of highest ToF were located just above and just below the broken region of the mast, supporting the hypothesis that the mast broke in the region of worst decay. Severe decay was identified from the stress wave transmission measurements taken between 26 and 56 ft above the mast base in the bow-to-stern axis. Suspect wood ranged from 20 to 26 ft and 56 to 58 ft along the same axis. Along the starboard-to-port axis, suspect wood ranged from 24 to 56 ft, with decay at 37 to 38 ft and severe decay at 45 ft.

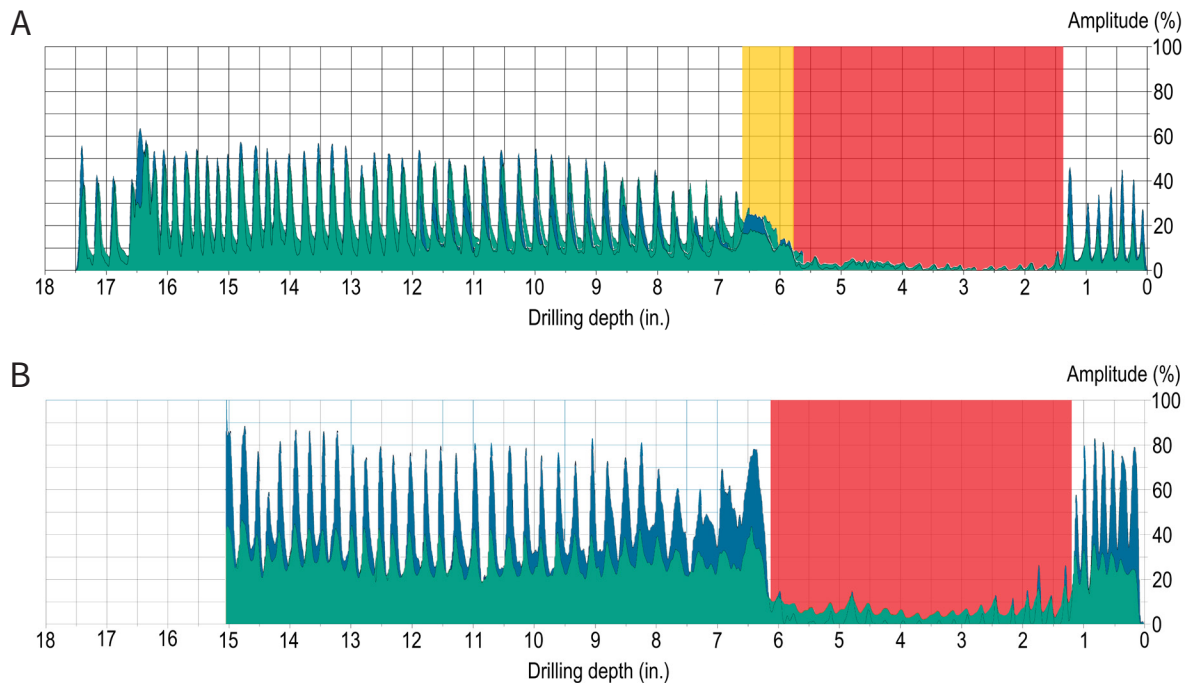
Coast Guard and FPL personnel performed resistance drilling of the mast independently. The Coast Guard took resistance drill measurements every 2 ft starting at the deck height along the mast and continuing until just below the cross bar. FPL took resistance drill measurements at three locations along the mast: 21, 25, and 34 ft based on the stress wave measurements. The FPL measurements at 21 ft were compared to the Coast Guard measurements at 20 ft. Both measurements showed areas of rot starting at or about 1.5 in. from the surface and extending to approximately 6 in. below the surface. The comparison showed good agreement between both sets of measurements. Variations were attributed to differences in drilling locations and difference in settings for the tool used. Figure 4A shows Coast Guard measurements at 20 ft; Figure 4B shows FPL measurements at 21 ft.

**Figure 4.**—Comparison of the U.S. Coast Guard (USCG) and Forest Products Laboratory (FPL) resistance drilling measurements of the *Grace Bailey* mast using the IML-RESI tool (IML North America, LLC, Meredith, NH, USA). A: USCG measurements at 20 ft height of the mast. B: FPL measurements at 21 ft height of the mast. Both measurements show decay starting at or above 1.5 in. from the front of the mast and extending radially to approximately 6 in.

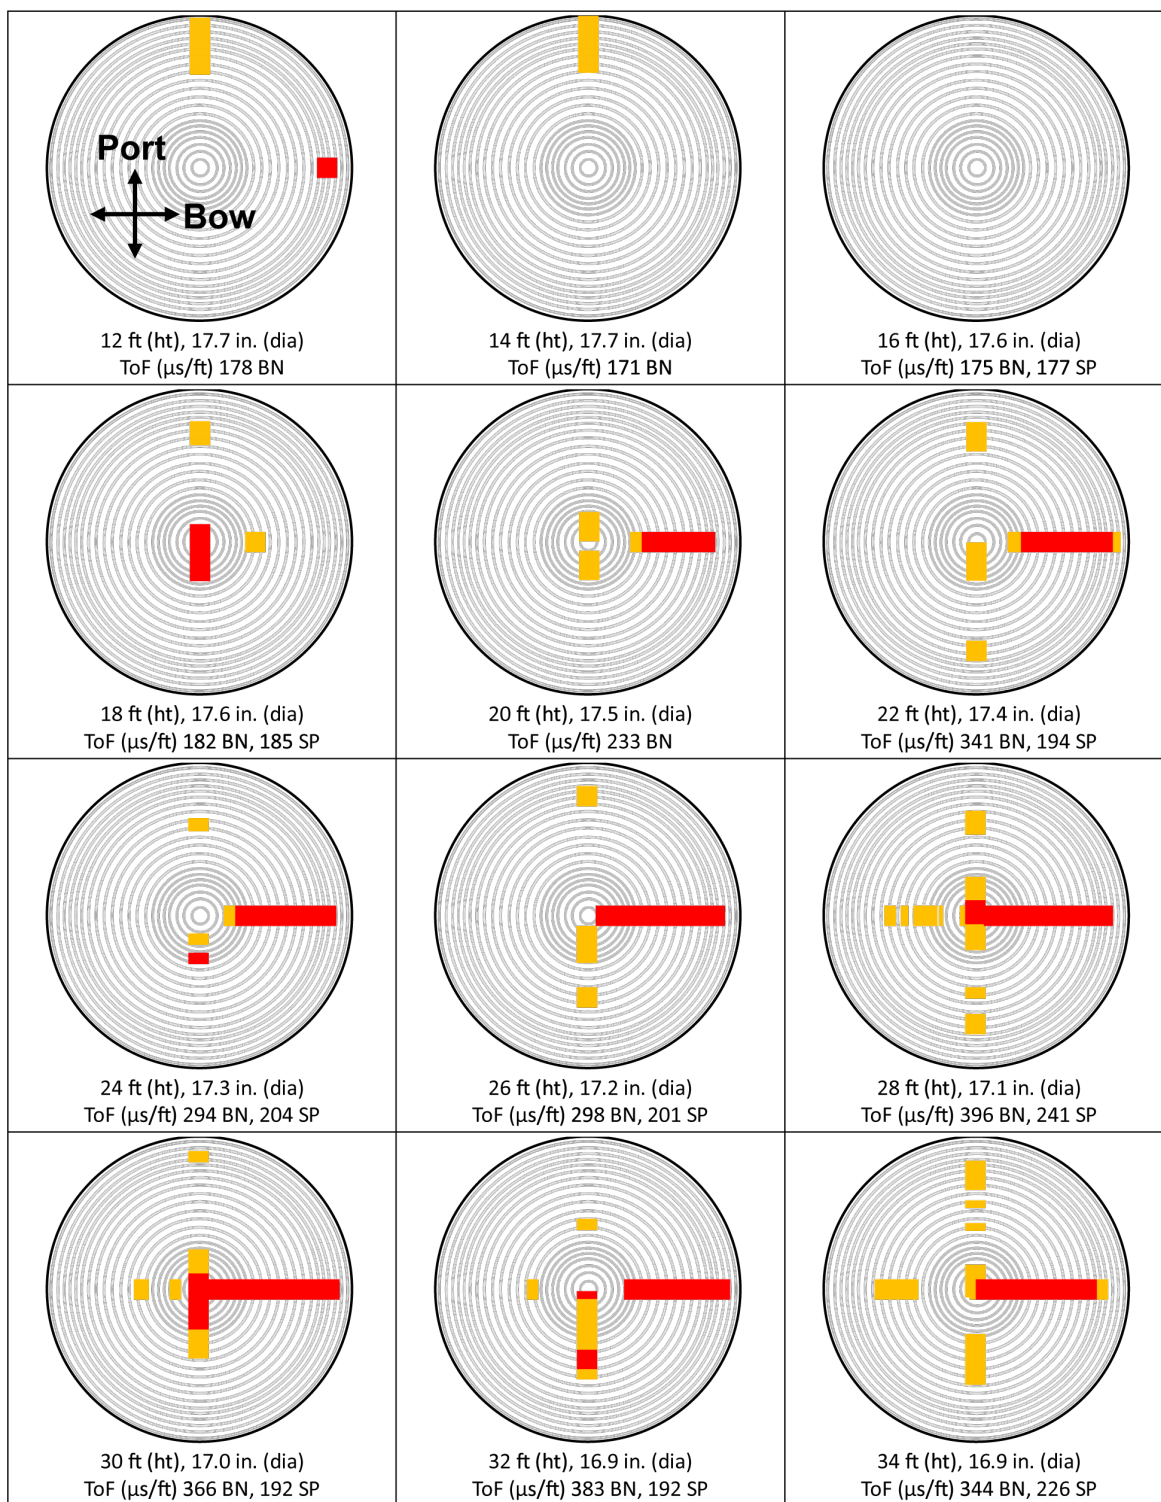
The resistance drilling results were then compared to the time of flight measurements. Figures 5A and 5B show conceptualized cross sections of the mast. Areas of decay and suspect wood are shaded in red and yellow, respectively, based on the Coast Guard resistance drilling data. Under each image is the height of the measurement, the diameter of the mast at that location, and the ToF along the bow-to-stern (BN) axis and the starboard-to-port (SP) axis. Note that the height values listed are the distance from the base of the mast. The Coast Guard measured height as the distance from the deck. As a result, the resistance drilling heights shown in this report have values 10 ft higher than those in the Coast Guard’s report. The conversion here is for consistency among the report figures. It is apparent that a region of decayed wood is present in most of the mast height from the centerline of the mast to the edge of the mast facing the bow of the ship. As height increases, the decay extends closer to the outer shell of the mast. There are several areas of suspect wood along the SP axis of the mast, but degradation along the SP axis is noticeably lower than along the BN axis.

**Figure 5a.**—U.S. Coast Guard resistance drilling results of the *Grace Bailey* mast from 12 to 34 ft. Decayed and suspect wood are indicated by red and yellow shading, respectively. Mast diameter (dia), time of flight (ToF) across the bow-to-stern axis (BN) and across the starboard-to-port (SP) axis are given at each height.

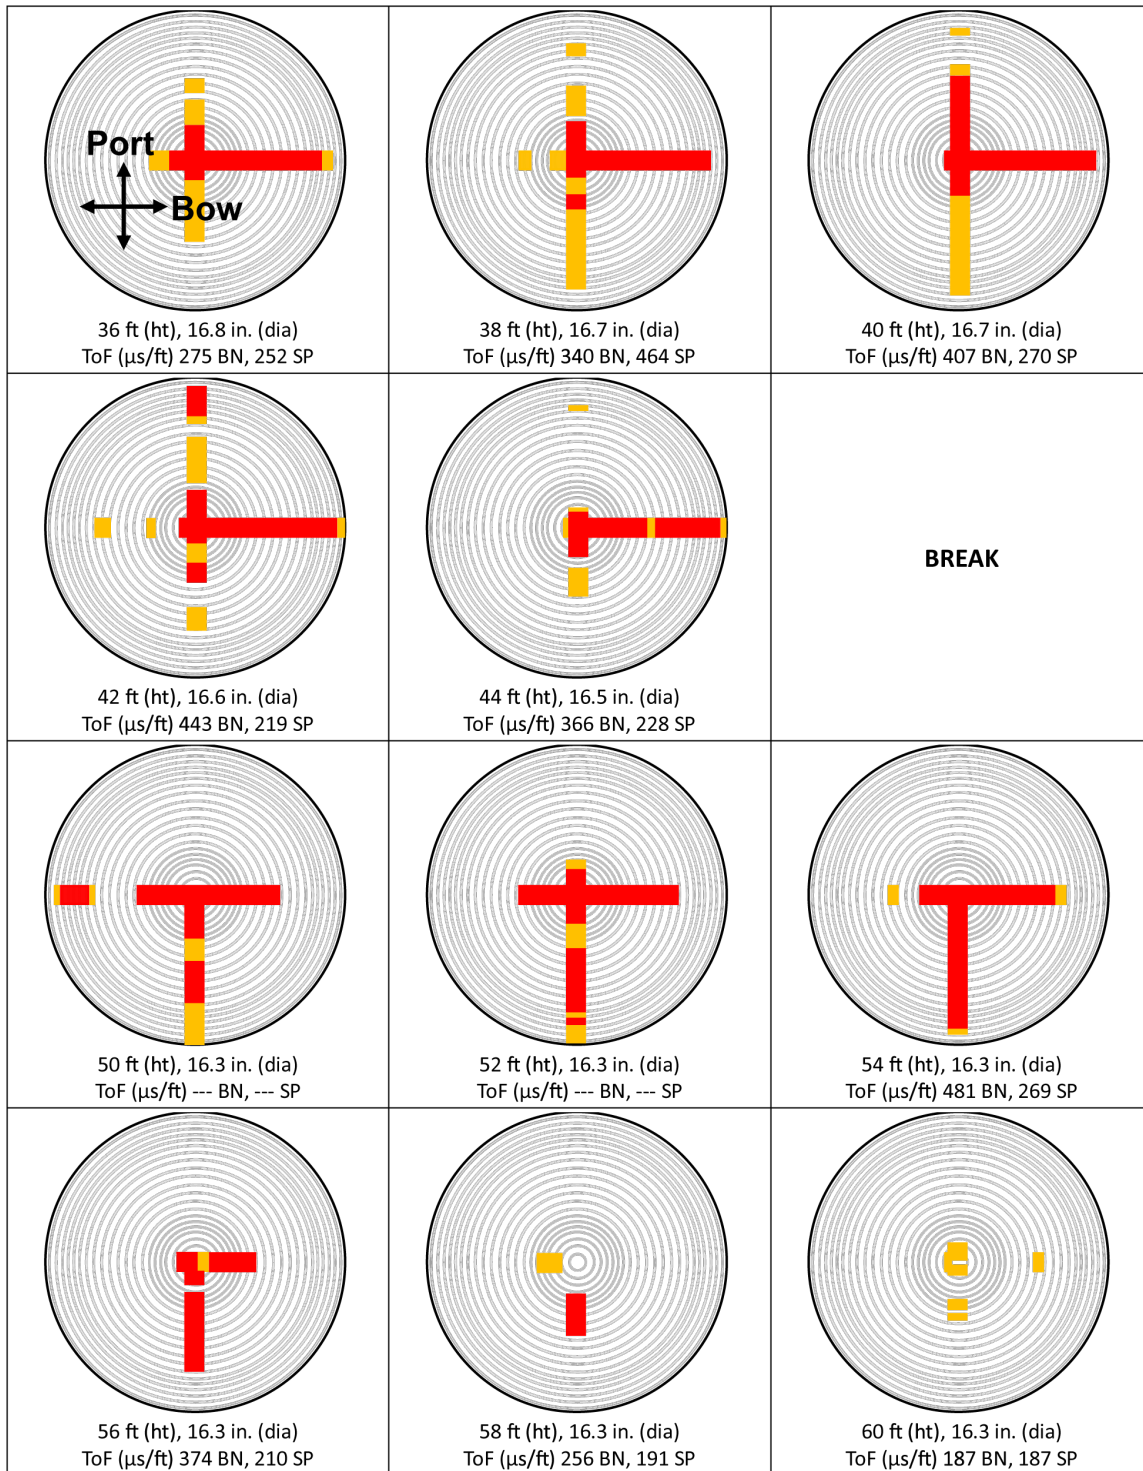
**Figure 5b.**—U.S. Coast Guard resistance drilling results of the *Grace Bailey* mast 36 to 60 ft. The mast broke between 44 and 50 ft. Decayed and suspect wood are indicated by red and yellow shading, respectively. Mast diameter (dia), time of flight (ToF) across the bow-to-stern axis (BN) and across the starboard-to-port (SP) axis are given at each height.

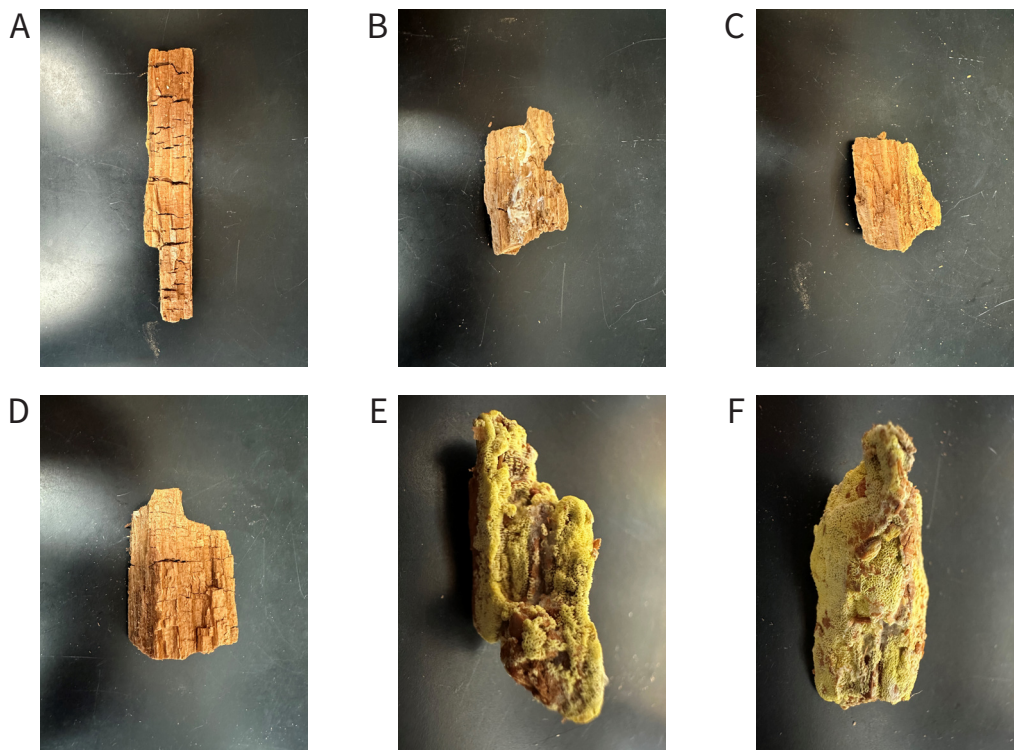
Figure 6 shows six samples of decayed wood collected from different sections of the mast. Figure 6A was collected from the mast at 47 to 48 ft (see Fig. 1F), 6B was collected at 53 ft (see Fig. 1B), 6C was collected at 36 ft (see Fig. 1H), 6D was collected at 28 ft (see Fig. 1I), and 6E and 6F were collected at 43 ft (see Fig. 1G). Brown rot decayed wood is visible in 6A, 6B, 6C, and 6D. An unknown yellow, porous fungus is visible in 6E and 6F.

The initial examination found that the unknown polypore that caused extensive brown rot decay of the mast had a citric yellow pore surface containing small pores. It was hypothesized that the polypore could be *Auriporia* (encrusted cystidia), *Laetiporus* (no clamps), *Wolfiporia* (no clamps), *Anomoporia* (monomitic with no skeletal hyphae), or *Antrodia*. Further examination showed dimitic, generative hyphae with multiple clamps and unbranching, thick-walled skeletal hyphae. *Auriporia* typically has encrusted cystidia (sterile cells viewed under the microscope); however, none were found from the unknown polypore. It was determined that the polypore belonged to the genus *Antrodia* and was likely either *Antrodia xantha*, synonymous to *Daedalea xantha*, (Fr.) A. Roy & A.B. De, or *Antrodia alpina* (Litsch.) Gilb. & Ryvardeen. The Gilbertson and Ryvardeen (1986) key to North American polypores lists the definitive character between the two as number of pores per mm, with 2 to 4 per mm for *Antrodia alpina* and 5 to 7 per mm for *Antrodia xantha*. The unknown specimen had frequent instances of more than 5 pores per mm, and upon comparison with herbarium specimens, the larger pores on *Antrodia alpina* herbarium specimens (two available and examined) were obvious, with frequent instances of 2 pores per mm. In contrast, herbarium specimens of *Antrodia xantha* examined had frequent instances of more than 5 pores per mm, the same range as the unknown specimen. With this information, it is highly likely the polypore that caused the brown rot was *Antrodia xantha*.

**Figure 6.**—Douglas-fir decayed wood samples collected from five locations of the *Grace Bailey* mast showing brown rot and yellow fungal mycelia. A: broken section at 47 to 48 ft; B: upper broken section at 53 ft; C: mast section at 36 ft; D: mast section at 28 ft; E and F: mast section at 43 ft. Forest Service photos by Katie M. Ohno.

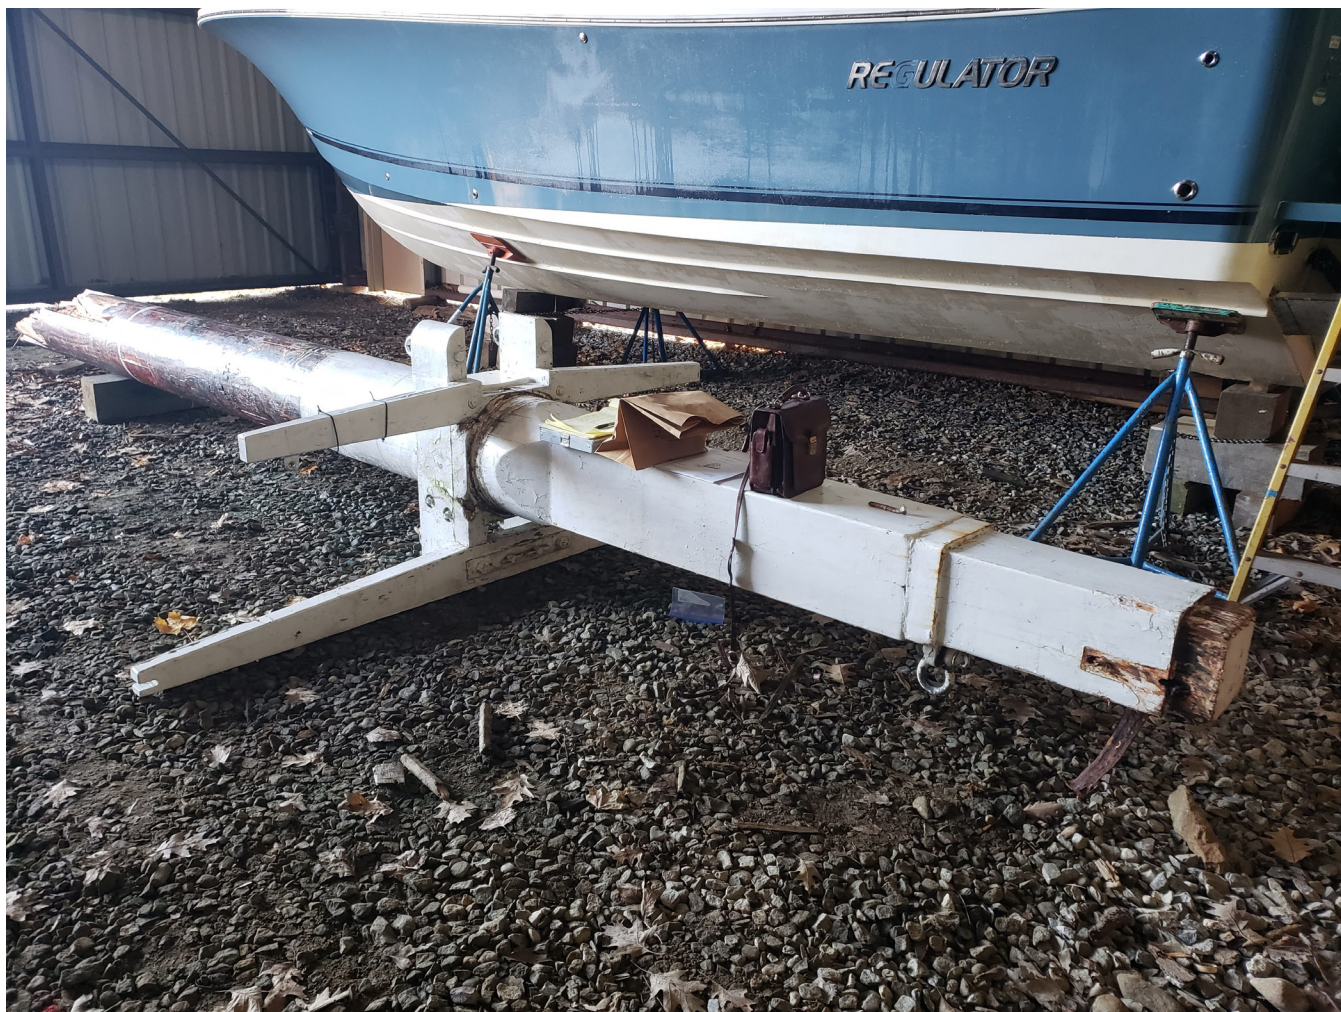
The broken top of the mast is shown in Figure 1A. The fracture surface is shown in Figures 1B through 1F. Evidence of fungal decay is present as the white coloration in Figures 1B, 1D, and 1F. Figures 1E and 1F show regions of brash failure (i.e., a sudden, brittle break with little or no splitting) and cubical fracturing (i.e., a crack pattern in which the wood breaks into cube-like blocks). Both are evidence of fungal decay in wood.

**Figure 1A.**—Broken top of the *Grace Bailey* mast. Forest Service photo by Xiping Wang.

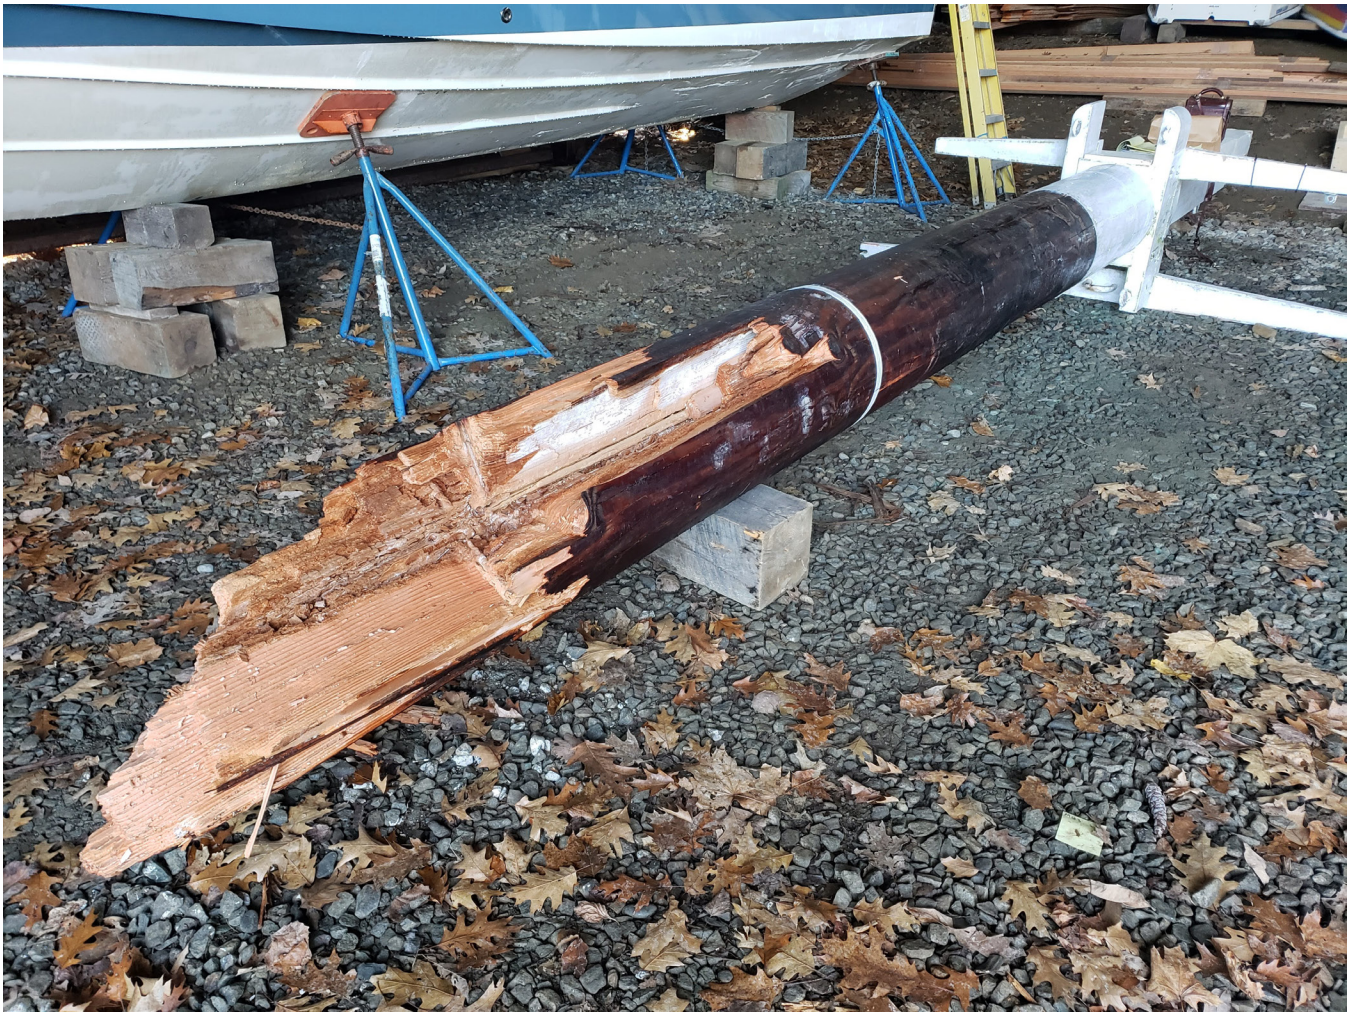
**Figure 1B.**—Fracture surface of the *Grace Bailey* mast (upper portion). Forest Service photo by Xiping Wang.

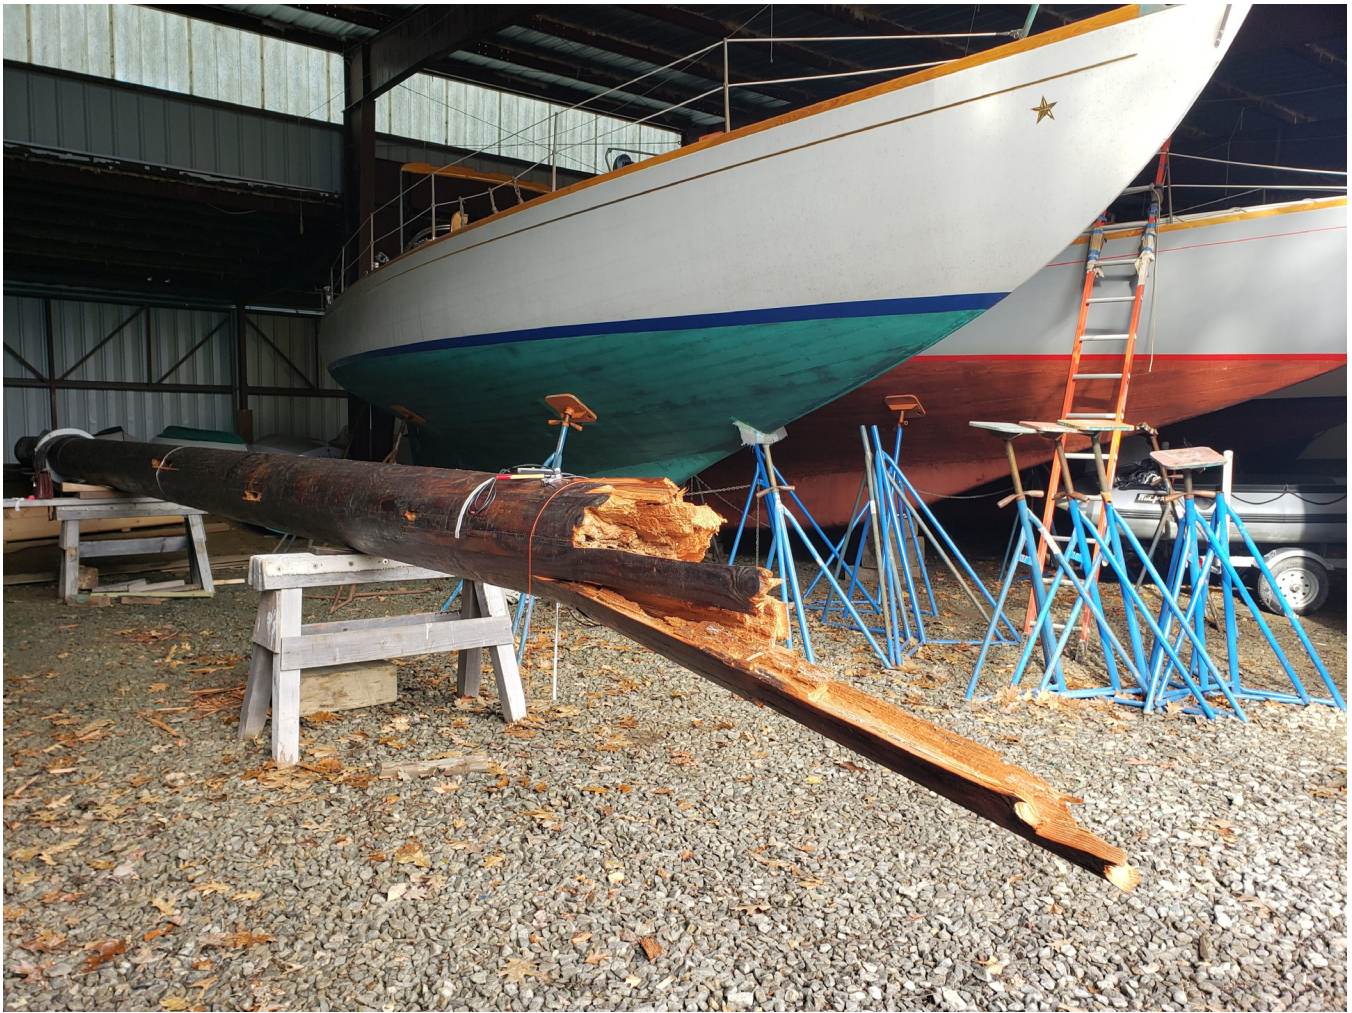
**Figure 1C.**—Fracture of the *Grace Bailey* mast (lower portion). Forest Service photo by Xiping Wang.

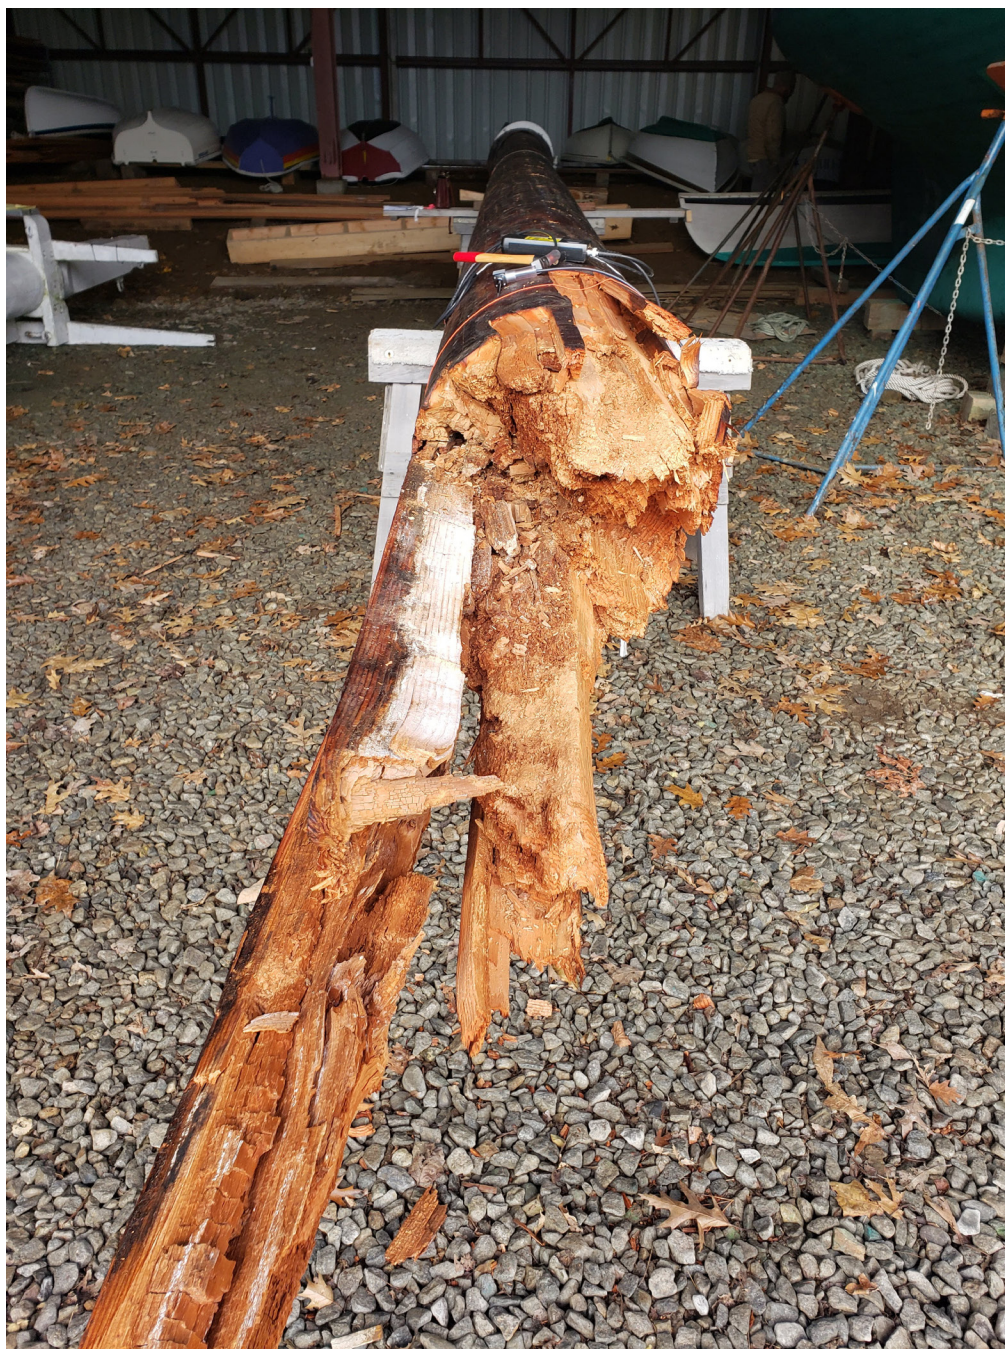
**Figure 1D.**—Fracture surface of the *Grace Bailey* mast (upper portion). Forest Service photo by Xiping Wang.

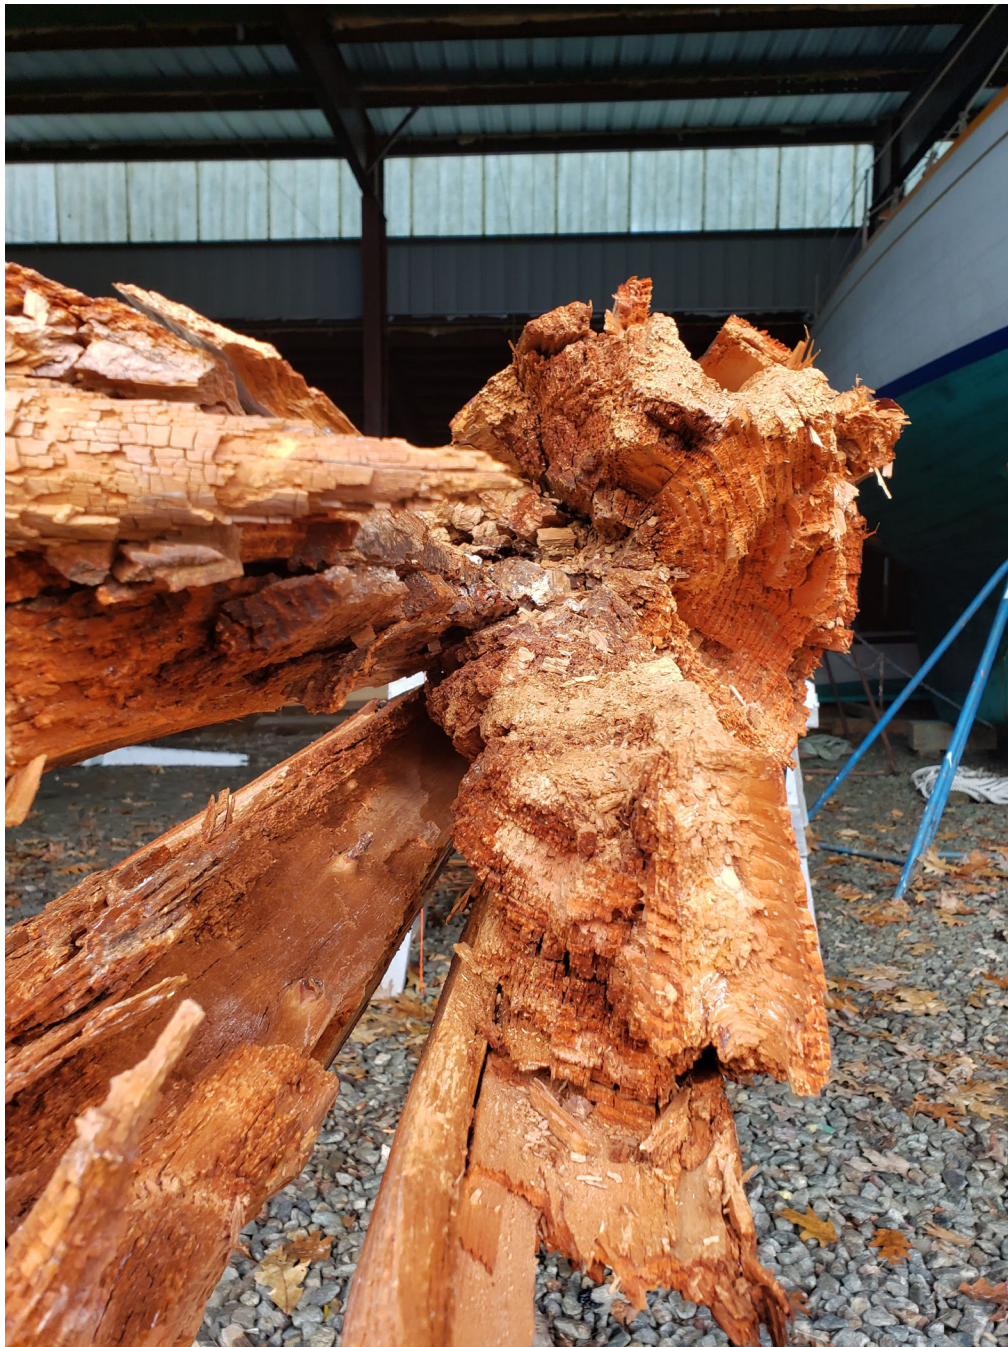
**Figure 1E.**—Close up of fractured cross section of the *Grace Bailey* mast. Forest Service photo by Xiping Wang.

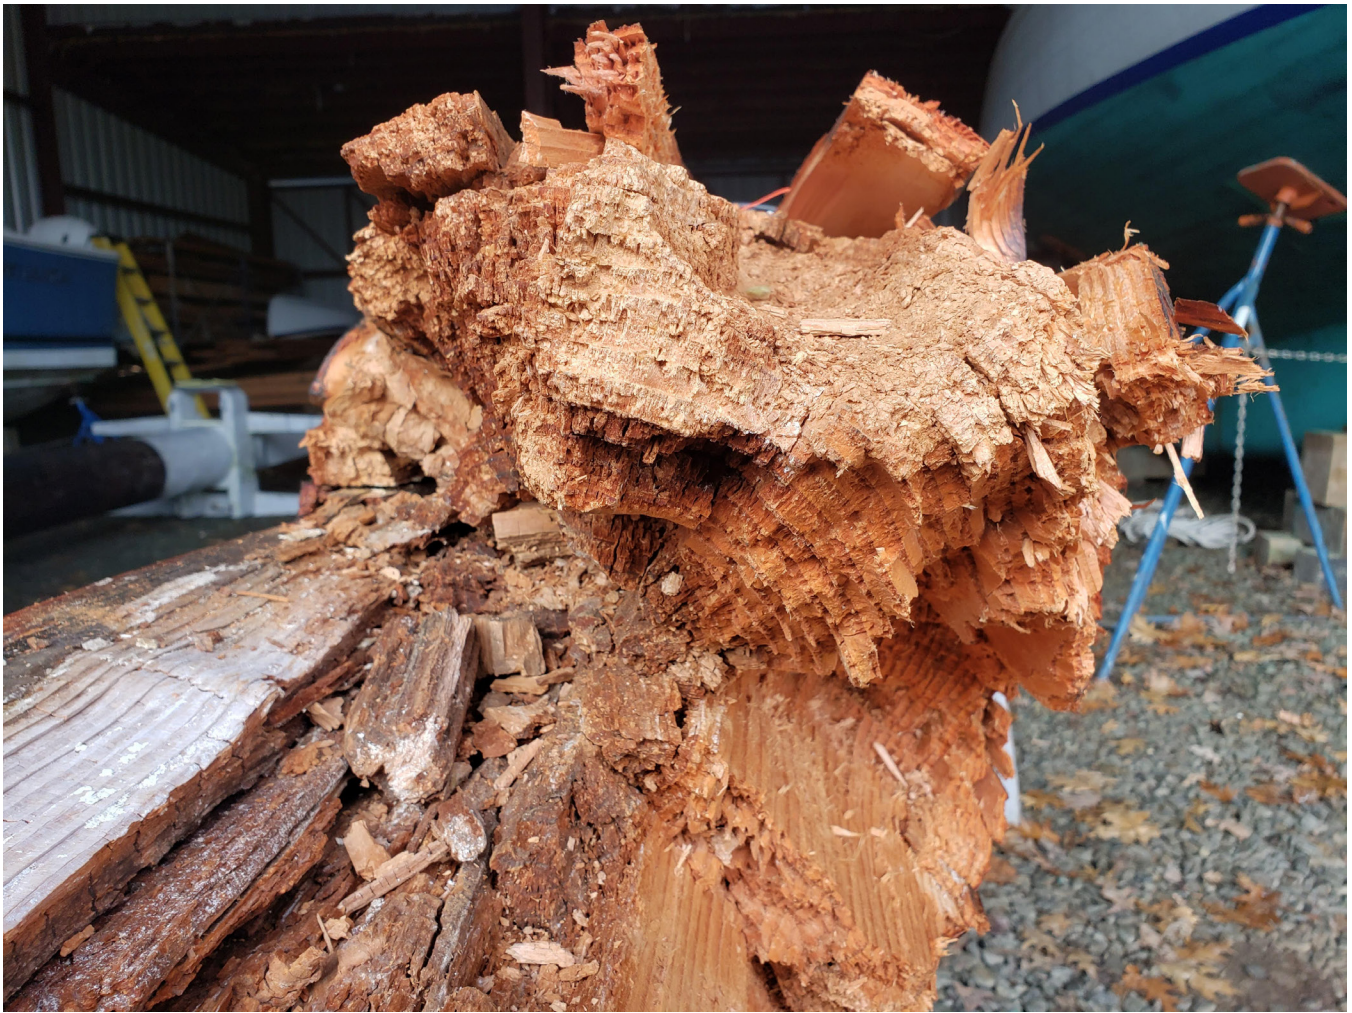
**Figure 1F.**—Close up of fractured cross section of the *Grace Bailey* mast. Forest Service photo by Xiping Wang.

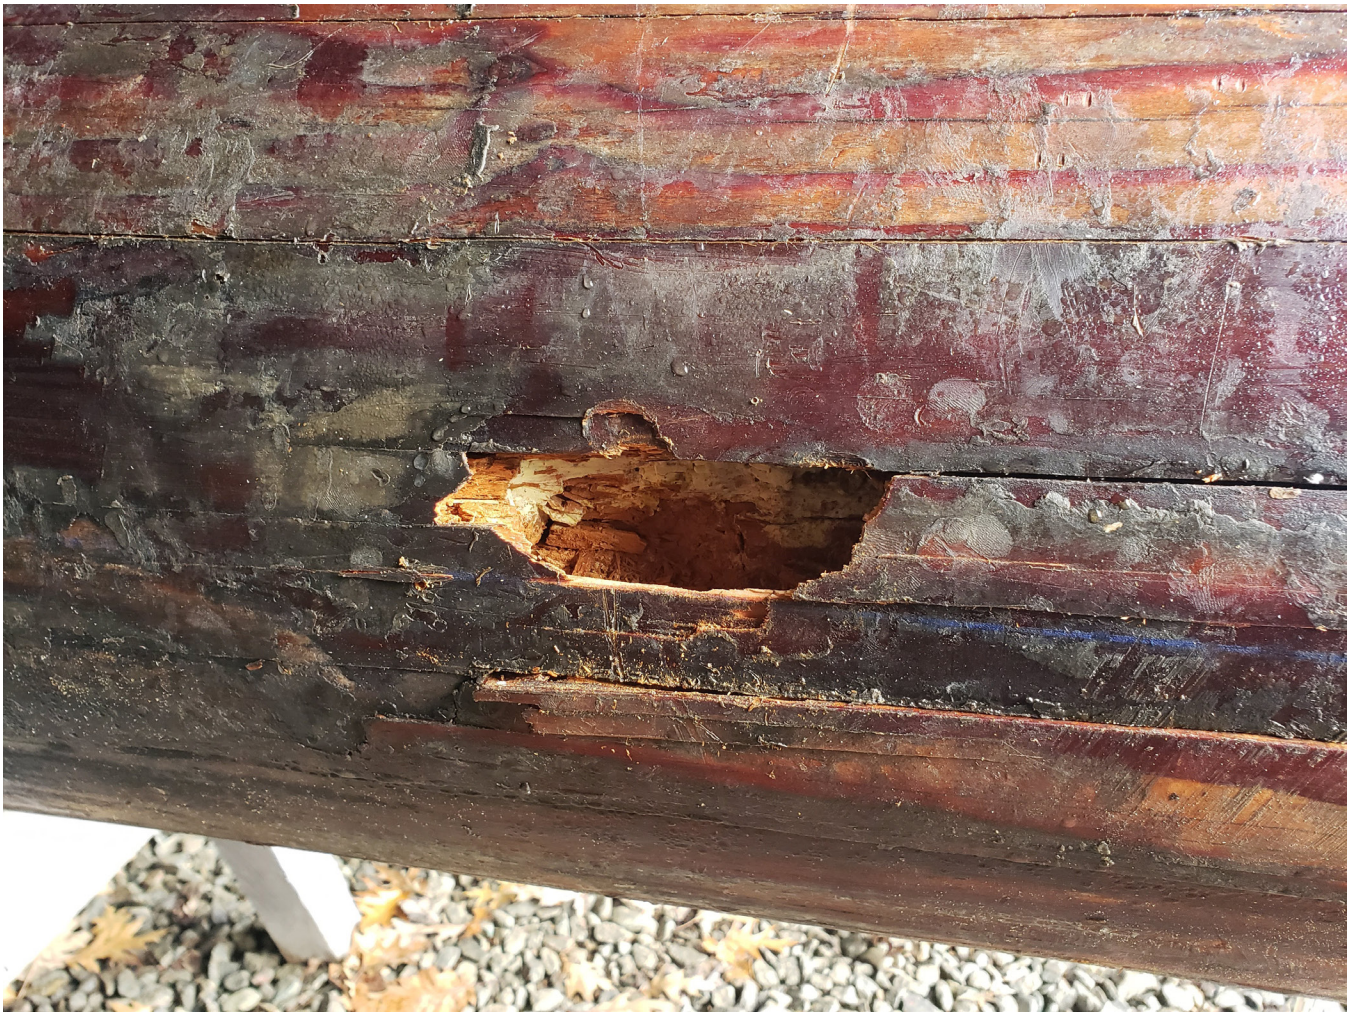
Figures 1G, 1H, and 1I show inspection holes created prior to the FPL inspection. The holes allowed access to the interior of the mast, where extensive internal decay was observed. Fungal decay, evidence of brash failed wood, and cubical wood remnants were visible in the three locations of the inspection holes.

**Figure 1G.**—Examination hole in the *Grace Bailey* mast (at approximately 39 ft) created prior to Forest Products Laboratory inspection and revealing internal decay. Forest Service photo by Xiping Wang.

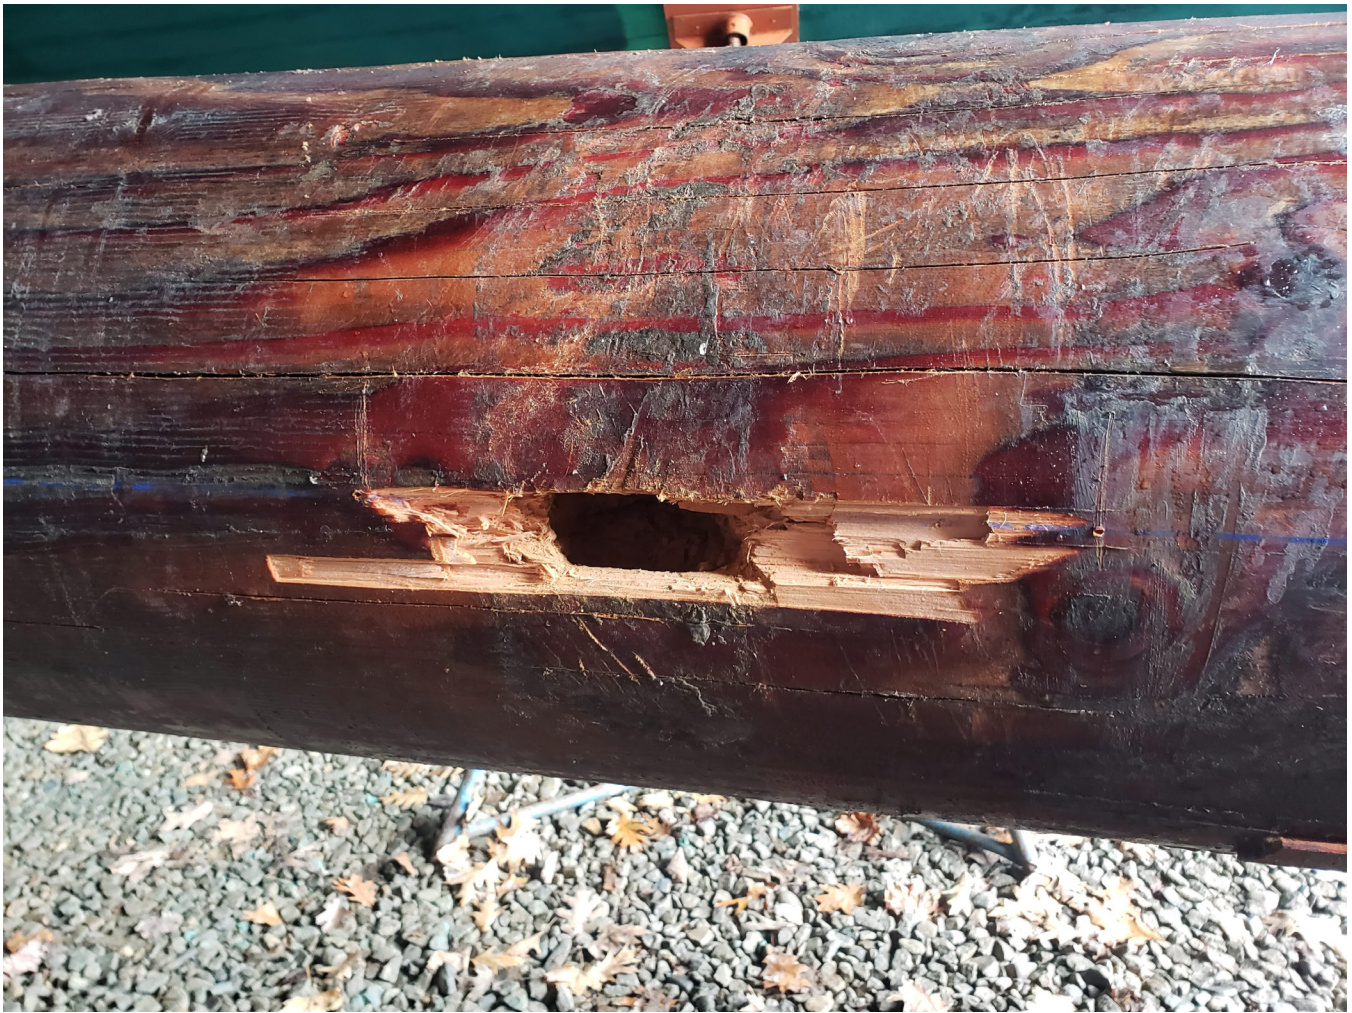
**Figure 1H.**—Examination hole in the *Grace Bailey* mast (at approximately 34 ft) created prior to Forest Products Laboratory inspection and revealing internal decay. Forest Service photo by Xiping Wang.
