Forest Products Laboratory | General Technical Report FPL-GTR-308 | February 2026

# Condition Assessment of the Wooden Mast of Historic Schooner *Grace Bailey*

On October 9, 2023, the main mast of the historic schooner *Grace Bailey* unexpectedly snapped at about two-thirds of its height and fell onto the deck, killing one passenger and injuring three others. The United States Coast Guard promptly initiated a formal investigation into the cause of the mast's sudden failure. At the request of the Coast Guard, the U.S. Department of Agriculture, Forest Service, Forest Products Laboratory (FPL) conducted an on-site evaluation of the broken mast on December 19, 2023. The inspection used nondestructive testing methods and included visual analysis, stress wave scanning, resistance micro-drilling, and fungal identification at FPL. Severe decay was identified from stress wave transmission measurements taken between 26 and 56 ft above the mast base in the bow-to-stern axis. Suspect wood ranged from 20 to 26 ft and from 56 to 58 ft along the same axis. Along the starboard-to-port axis, suspect wood ranged from 24 to 56 ft, with decay at 37 to 38 ft and severe decay at 45 ft. Results from f

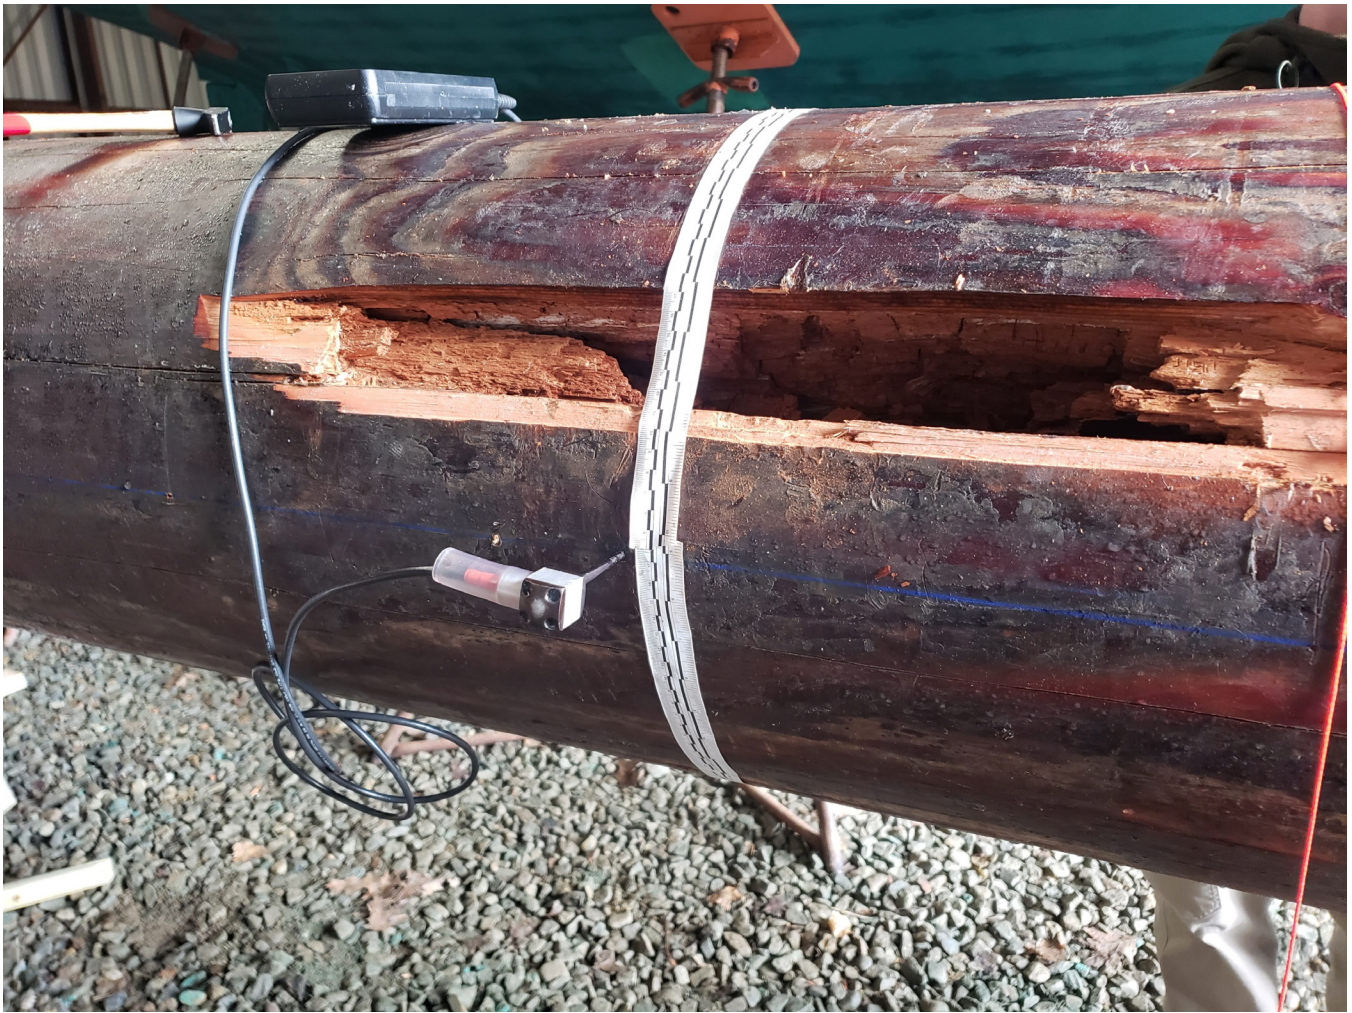
Figures 1G, 1H, and 1I show inspection holes created prior to the FPL inspection. The holes allowed access to the interior of the mast, where extensive internal decay was observed. Fungal decay, evidence of brash failed wood, and cubical wood remnants were visible in the three locations of the inspection holes.

**Figure 11.**—Opening in the *Grace Bailey* mast (at approximately 25 ft) created prior to Forest Products Laboratory inspection and revealing internal decay. Forest Service photo by Xiping Wang.

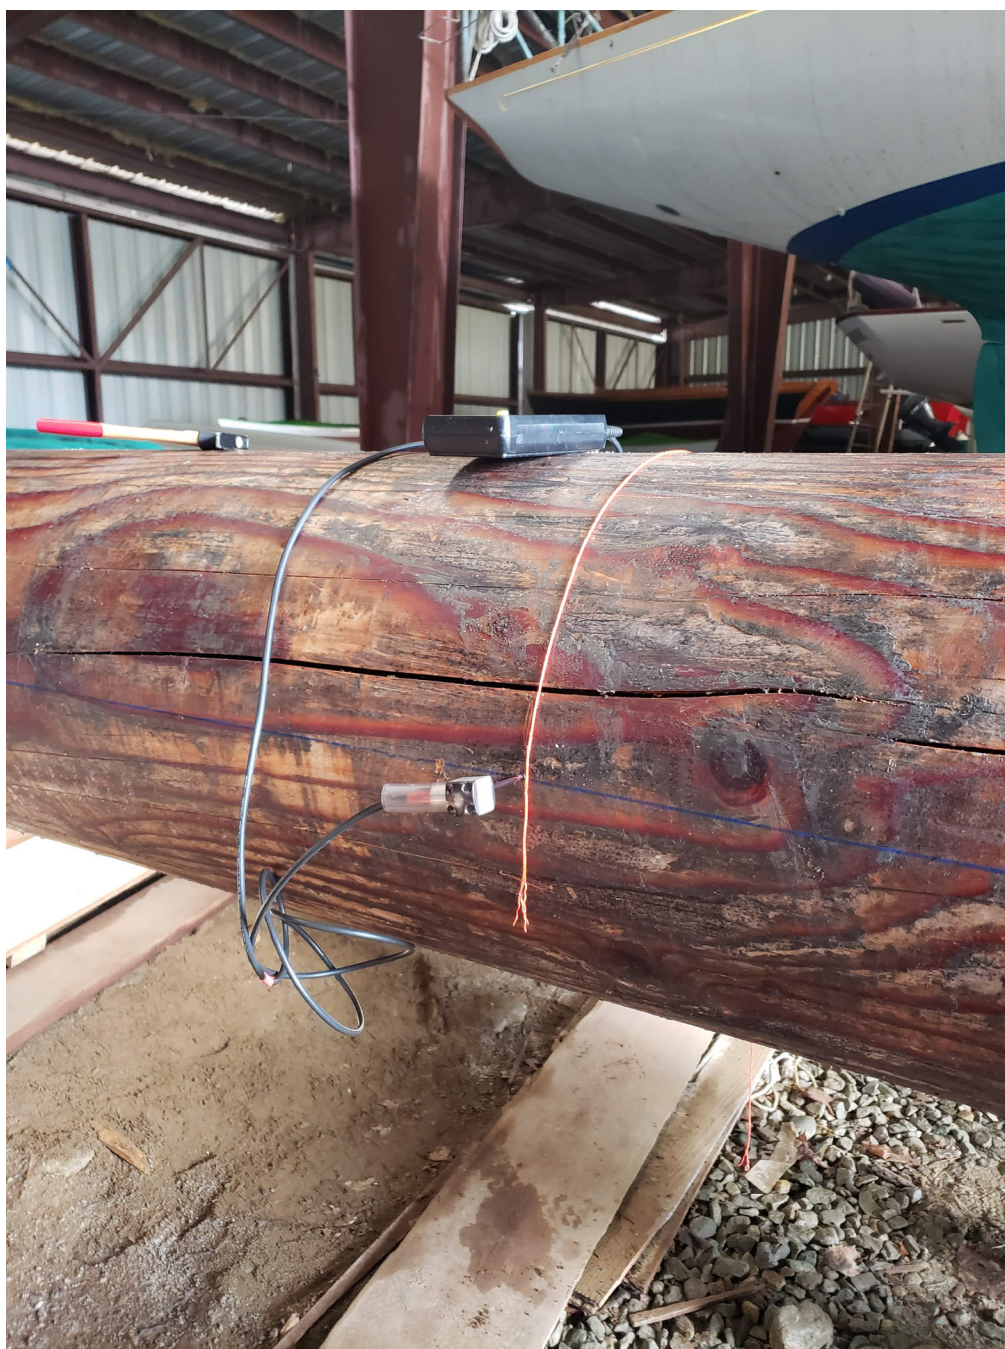
Figure 1J shows the first evidence of suspect wood at approximately 21 ft from the base of the mast, which is in the middle of the scarf joint from the 2014 scarf repair. Figure 1K shows the mast at deck height in visually sound condition. Figure 1L shows the mast area 5 ft above the base where localized surface deterioration is visible.

**Figure 1J.**—Stress wave transmission test performed on the *Grace Bailey* mast at 21 ft detecting possible internal decay. Forest Service photo by Xiping Wang.

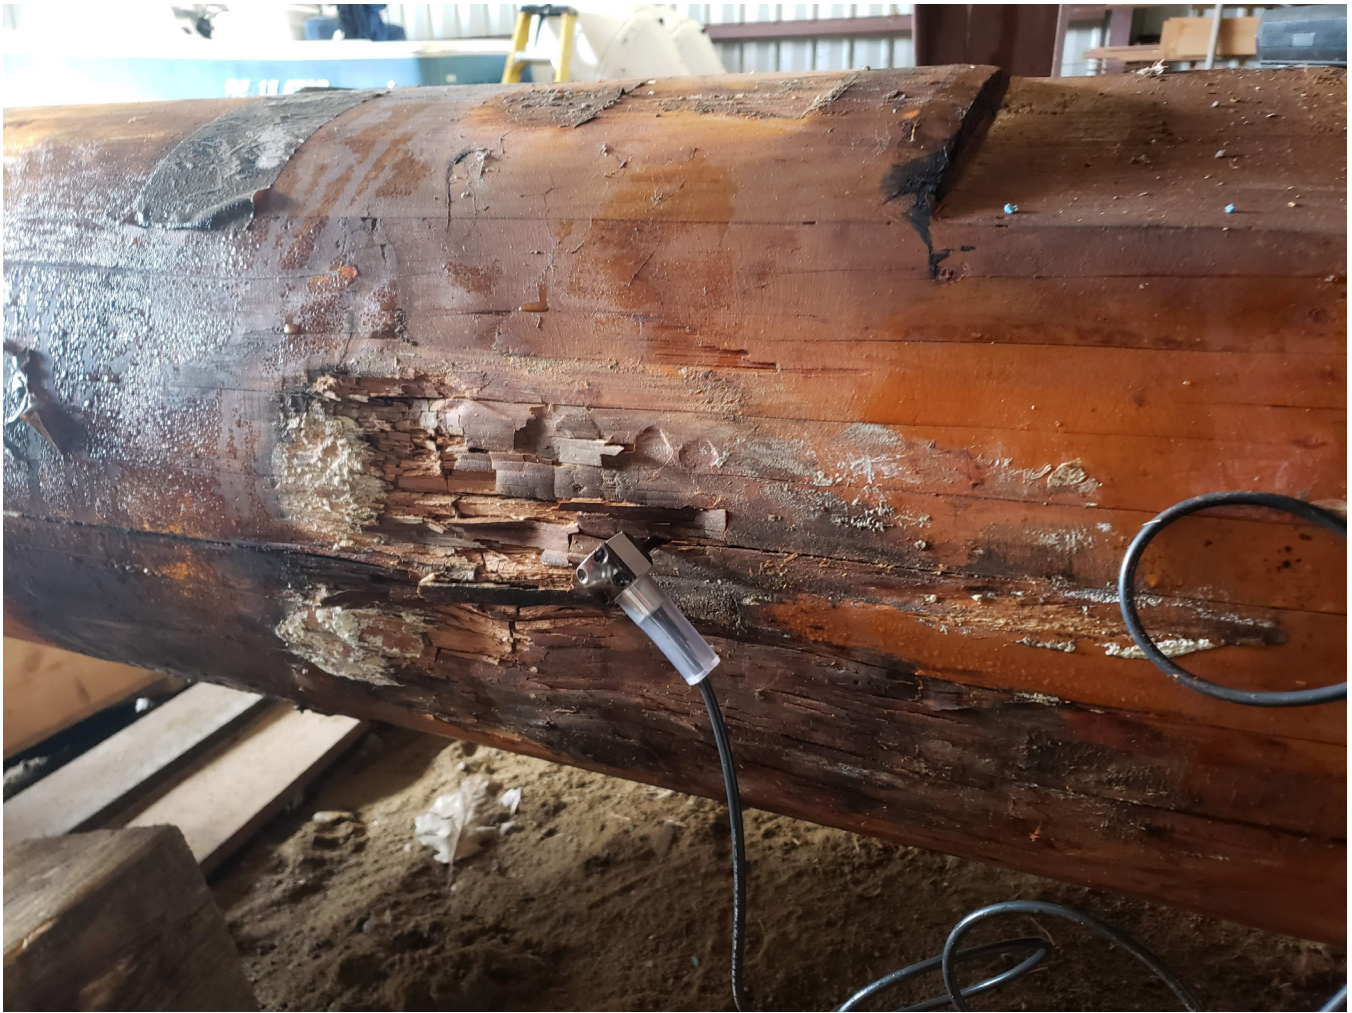
**Figure 1L.**—Surface deterioration observed on the *Grace Bailey* mast at 5 ft. Forest Service photo by Xiping Wang.
