## Paintability of Two Hawaii-Grown Woods . . .

### First Progress Report

R. SIDNEY BOONE

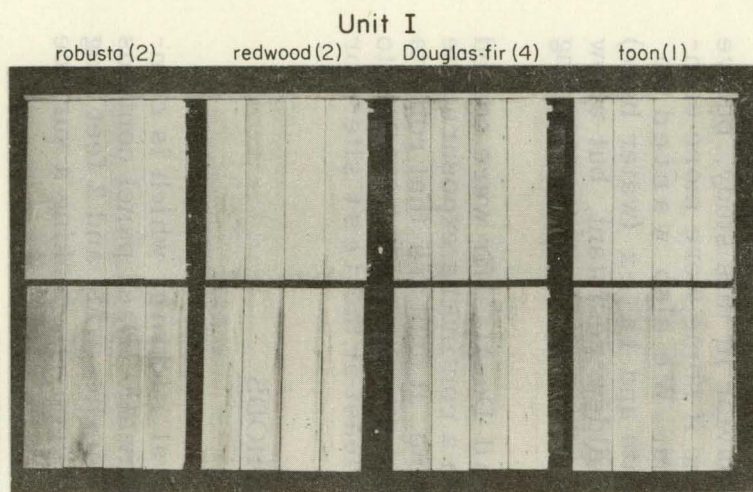
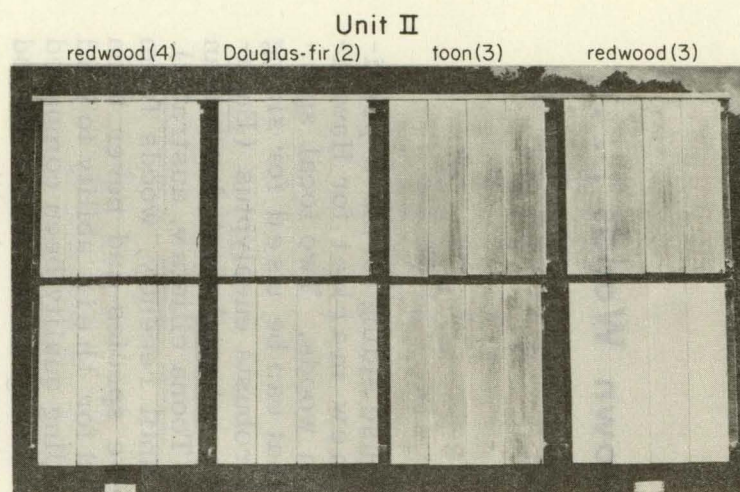
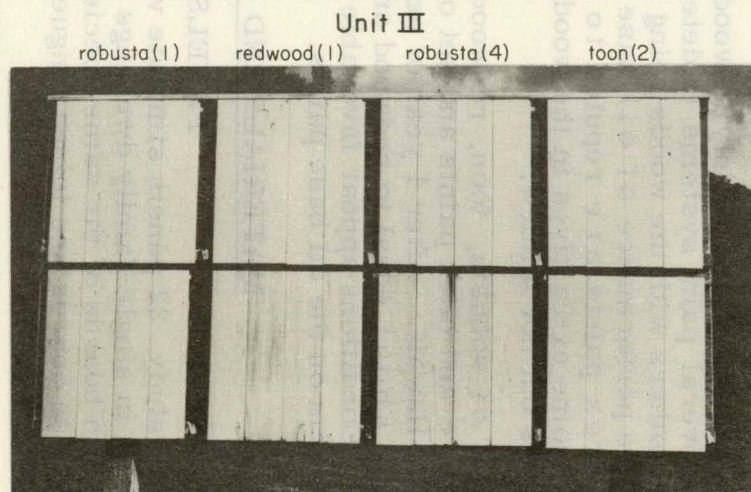
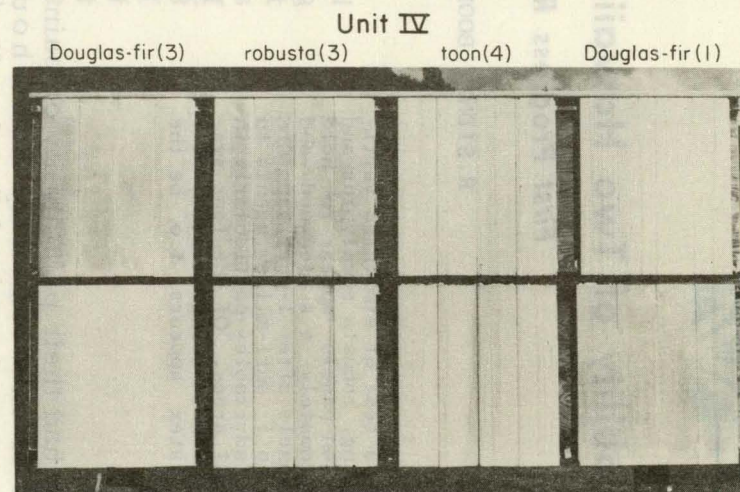
Figure 1. --Appearance of panels in the four test units after 1 year of exposure, November 1965. Each panel is identified by species, and by treatment as follows: (1) three coats of oil base paint; (2) three coats of latex paint; (3) one coat of oil base, two coats of latex; (4) two coats of oil base.

The difference in appearance of the panels (fig. 1) is due to the difference in paint systems--not the wood. The panels can be classed in three broad categories: (a) uniformly white; (b) spots or streaks of mildew; (c) uniformly gray.

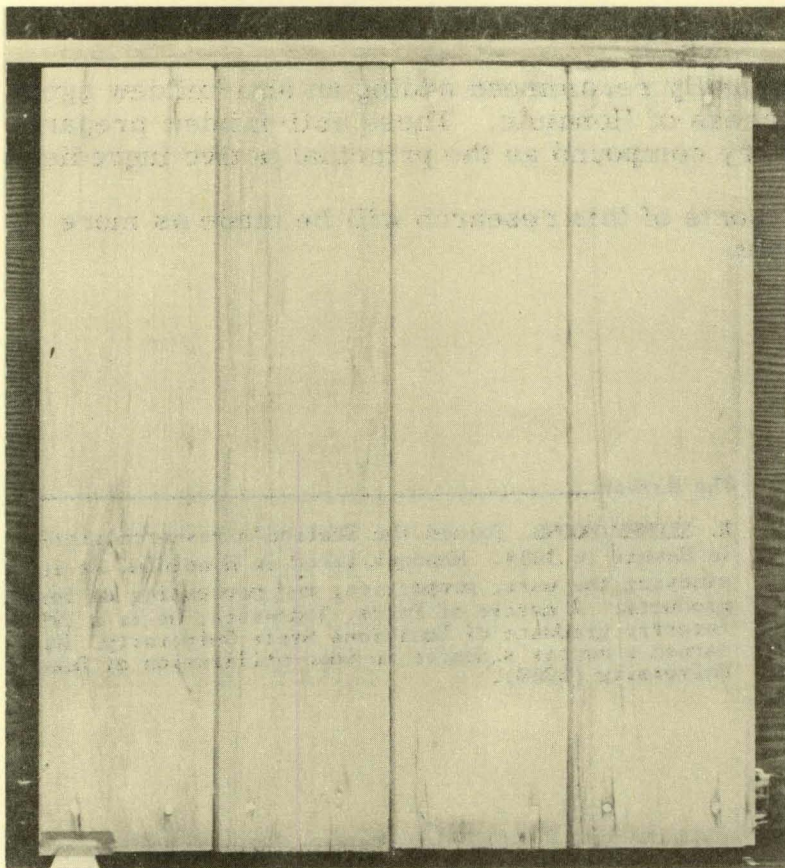
Panels that are uniformly white were painted with three coats of exterior latex. Except for some bleed-through of extractives on the redwood panels (fig. 2), this paint system looks the best among the four used in the study after 1 year of exposure.

Figure 2.--Three coats of latex on redwood, after 1-year's exposure.

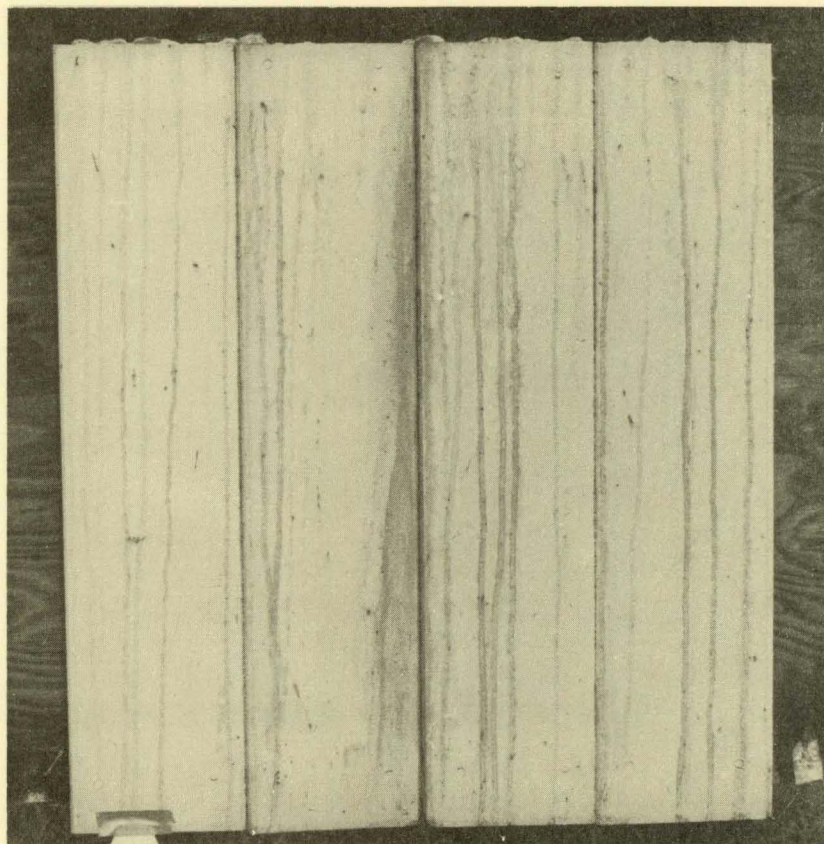
Panels that show spots or streaks of mildew were painted with one prime coat of oil base paint and two coats of oil base white exterior (fig. 3), or with one prime coat of oil base paint and one coat of oil base white exterior. The streaks are avenues of water runoff, which favor the development of the mildew. This streaking appears only on these two paint systems.

After the 6-month inspection, the discoloration of the paint systems using oil base paints was identified as a green algae on the paint surface with a sooty mold growing on the algae.<sup>3</sup> After the 1-year inspection, we again consulted Dr. E. E. Trujillo for a more extensive examination of the discoloring agent. He identified them as four genera of sooty molds: Fumago sp., Fusicladium sp., Pullularia sp., and Hormiscium sp. No green algae was found at this inspection.

Figure 3.--Panel of toon painted with one prime coat oil base, and one coat of oil base white exterior paint, after 1-year's exposure.

Local paint dealers normally recommend adding an anti-mildew agent to paints used in the wetter areas of Honolulu. These anti-mildew preparations have a copper or mercury compound as the principal active ingredient.
