## RESEARCH NOTE NC-186

### DOES CANOEING INCREASE STREAMBANK EROSION?

Edward A. Hansen, *Principal Hydrologist*  
Cadillac, Michigan

**ABSTRACT.**—Describes research on the Pine River in Michigan to determine if large increases in canoeing accelerated streambank erosion. Most erosion was natural but people sliding and camping on streambanks created some erosion. Heavy canoe traffic was not a cause of erosion.

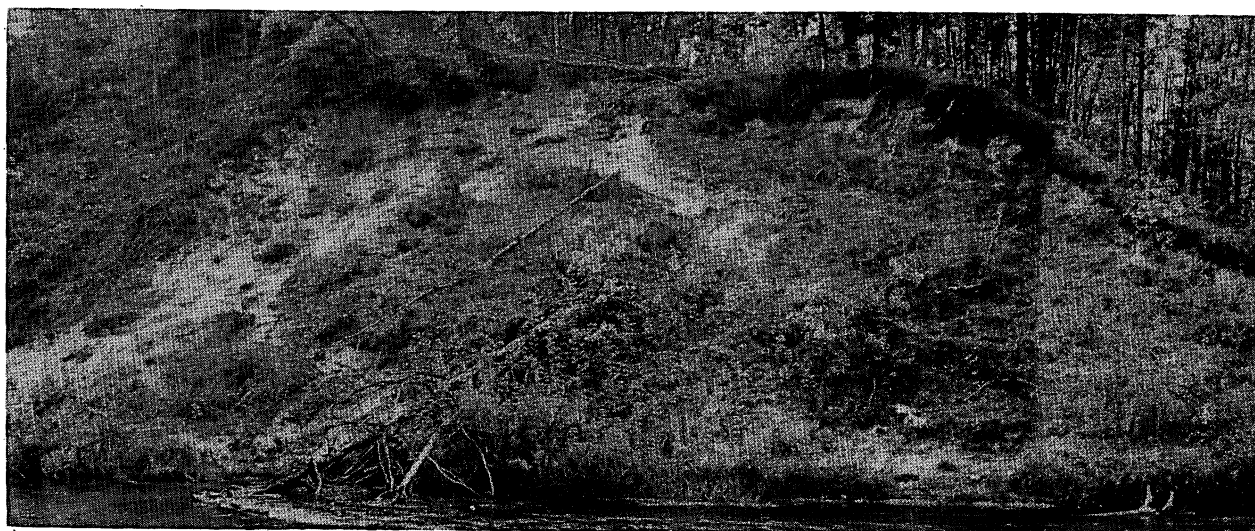
Figure 1.--Natural revegetation of an eroding bank. More than a quarter million people canoed past the bank between the two photo dates. No effort was made to stabilize the bank. Top photo taken in August 1967; botton photo taken in September 1973.

The banks were revegetating naturally (table 2). This conclusion is admittedly based on subjective judgment. However, the vegetation changes were usually striking enough that there was little doubt about the overall trend (fig. 1). Only a few banks lost vegetation and in those cases the changes were relatively minor.

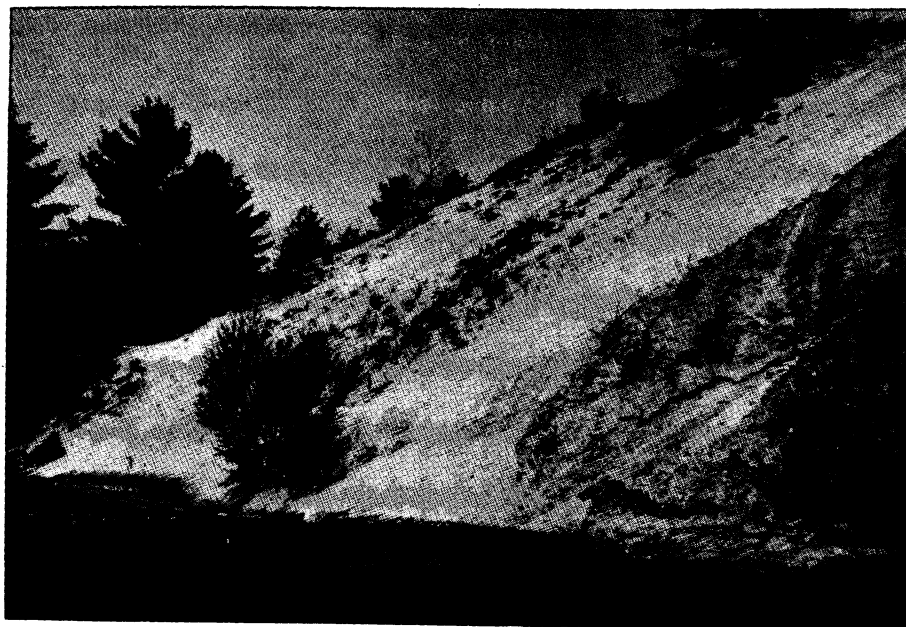
Figure 2.--A few steep banks are used as "sand slides" by canoeists, campers, and other stream visitors.

Two canoeing-associated activities do tend to increase streambank erosion: sliding down steep sand banks (Taube 1967), and the upsurge of "wilderness" camping. Sliding is limited to relatively few banks (about five on the Pine). Several of these banks near campgrounds are probably also

used for sliding by noncanoeists (fig. 2). Camping has depleted streambank vegetation at landing points (fig. 3). These campsites are usually on low flood plains and erosion of the devegetated banks appears minimal.
