by James H. Patric

# Soil-Water Relations of Shallow Forested Soils During Flash Floods in West Virginia

**FOREST SERVICE RESEARCH PAPER NE-469  
1981**

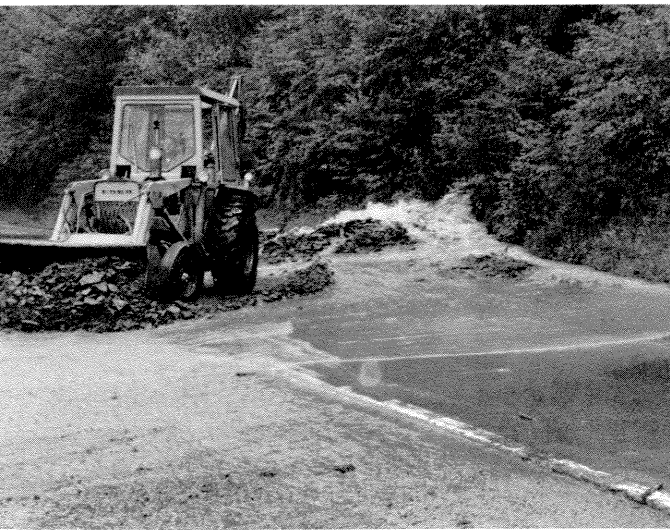
**Figure 2.—Highway workers were pressed to keep Route 38 open to traffic as debris poured from this unnamed draw near St. George. At this elevation (1,700 feet) tree foliage had almost fully emerged.**

Debris at the mouths of Wolf Run (Fig. 15), Jonathan Run (Fig. 16), and an unnamed hollow near St. George (Fig. 2) had been deposited in discrete, easily measured piles. Tonnage of these piles was estimated by multiplying their volume in cubic yards by 1.4, a factor recommended as realistic by a local stone and gravel company.

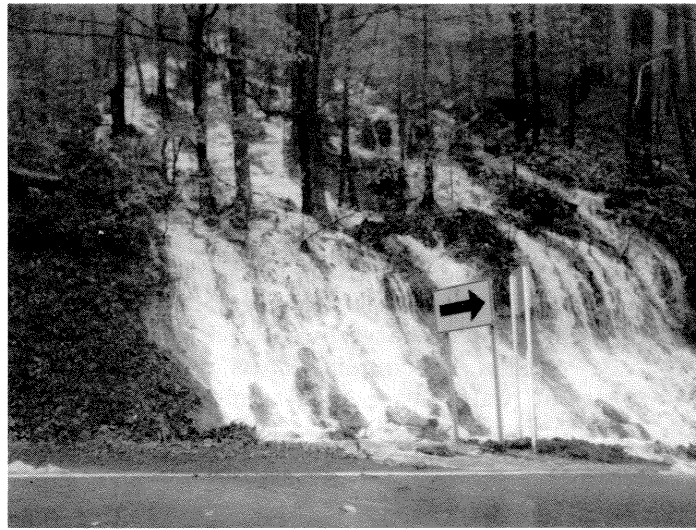
**Figure 3.—Stormflow far exceeded the capacity of this ephemeral flow channel on Route 219. At this elevation (2,800 feet) tree foliage had only begun to emerge. Note small stones being washed along the road pavement.**

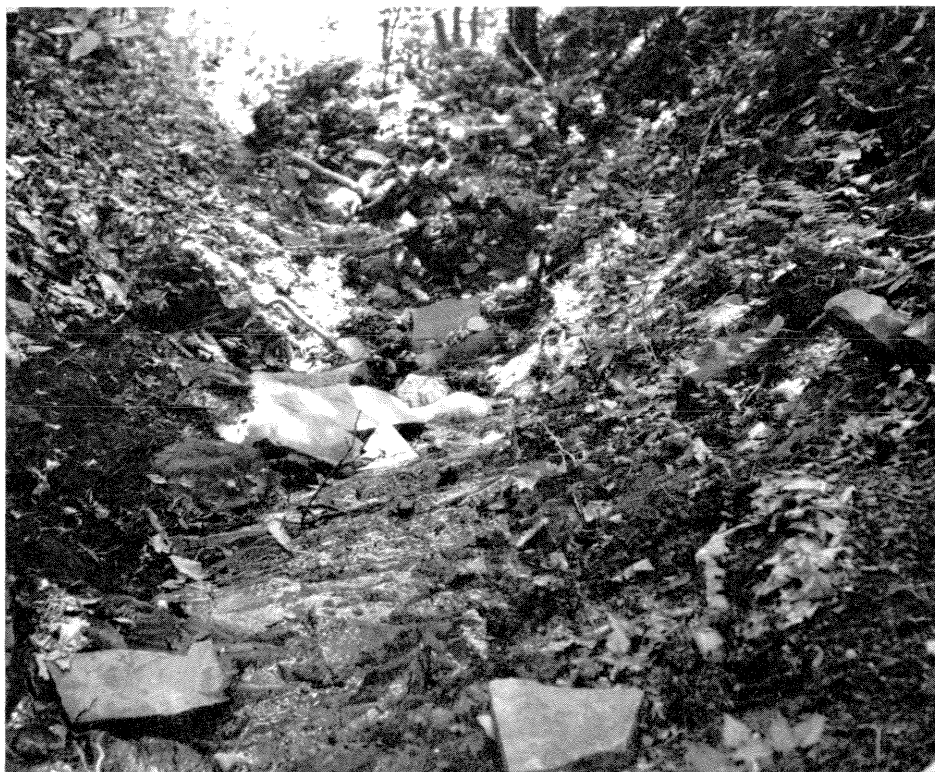
**Figure 6.—The channel of the V-shaped basin, about 50 feet above Route 38, looking downslope. The freshly scoured bedrock is partly covered with sandstone fragments too large to be carried farther downslope. Note the scant cover of litter on channel sides. It is not possible to convey the steepness of this channel in photographs.**

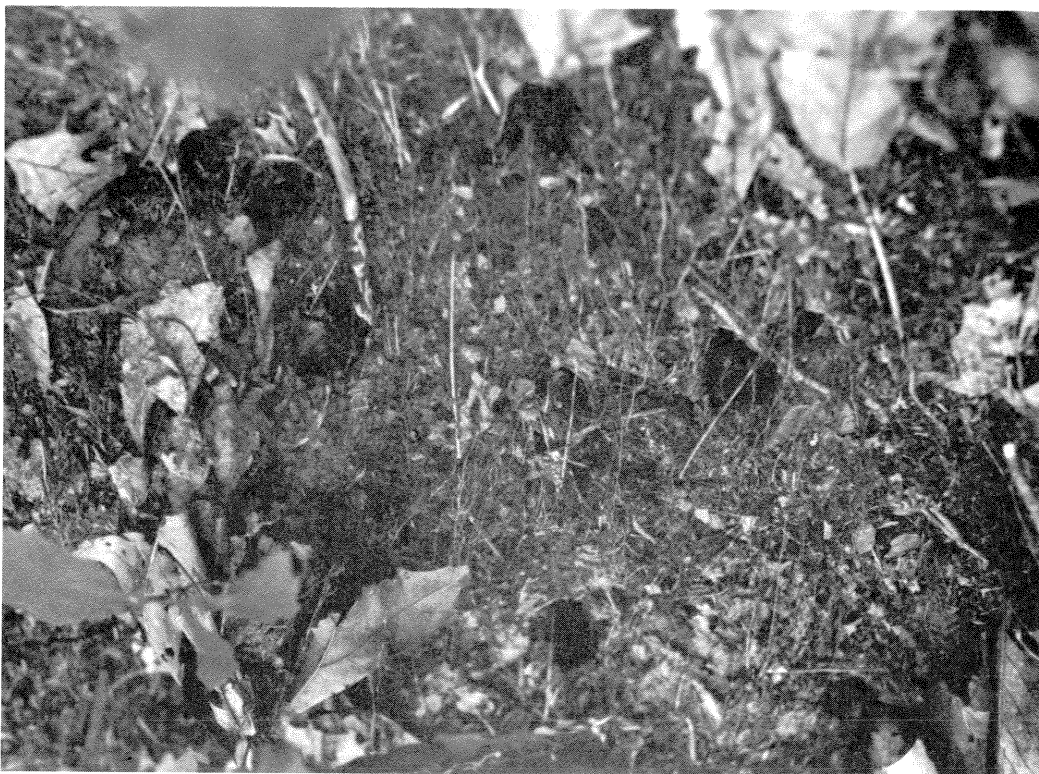
**Figure 7.—This photographic field is about 1 square foot and shows nine piping cavities.**

L and H layers (Fig. 7) suggested piping during the storm. Extending a few to several inches upslope between the organic and mineral soil horizons, were cavities 1/2 to 1 inch in diameter—probably animal burrows, which were found wherever overland flow had swept away the litter.

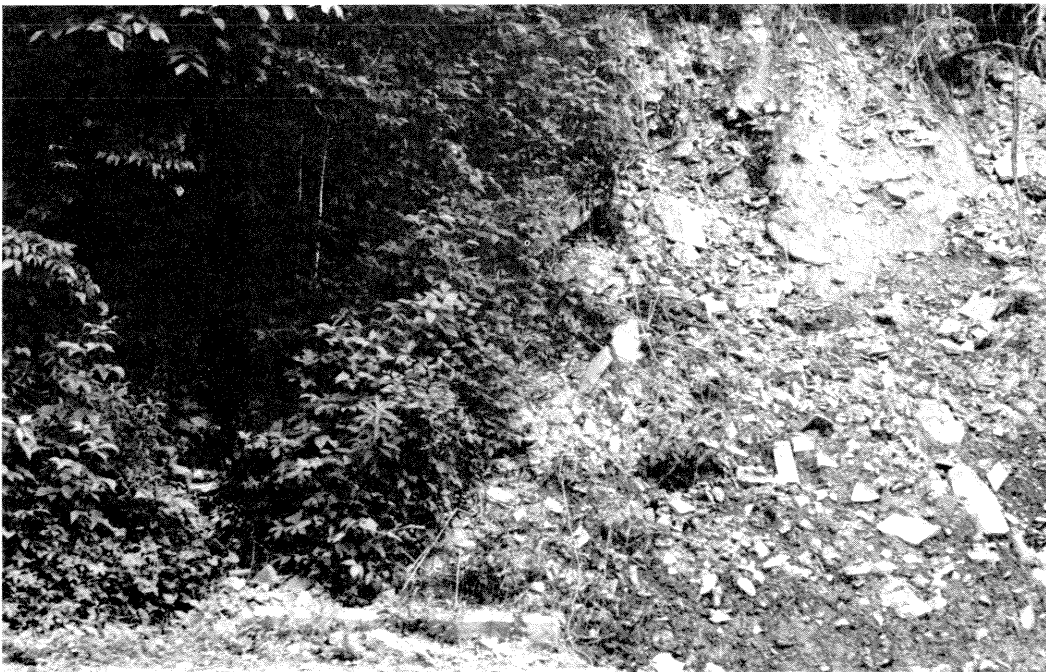
reinfiltrated within short distances downslope. The 18-inch culvert under Route 72 had carried the entire stormflow without plugging (Fig. 8).

**Figure 8.—Outlet of the gently concave drainage. The culvert headwall is visible at the lower center of the picture.**

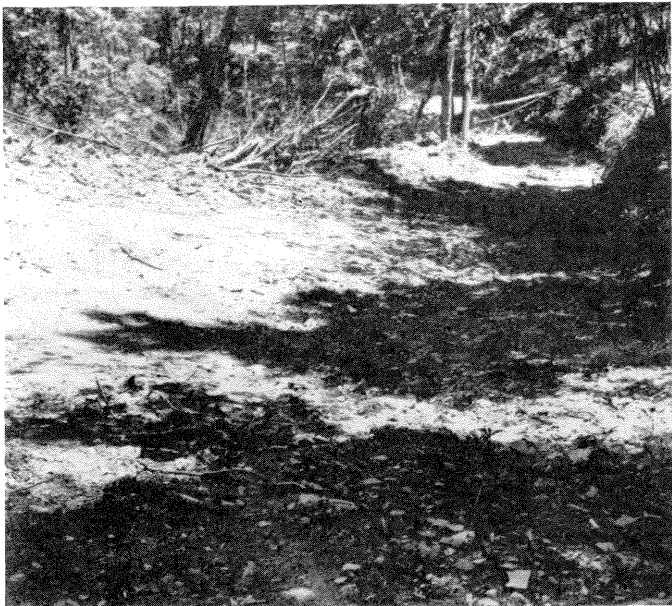
landing (Fig. 9) or from any logging road. Most of the finer soil particles probably had washed away during the previous winter. In any case, an existing erosion pavement of small stones and woody detritus had prevented serious soil loss during the storm of May 24.

**Figure 9.—View across a log landing, downslope along a logging road with an 8-percent grade. This road had not been regraded after the storm and presented no obstacle to safe driving.**

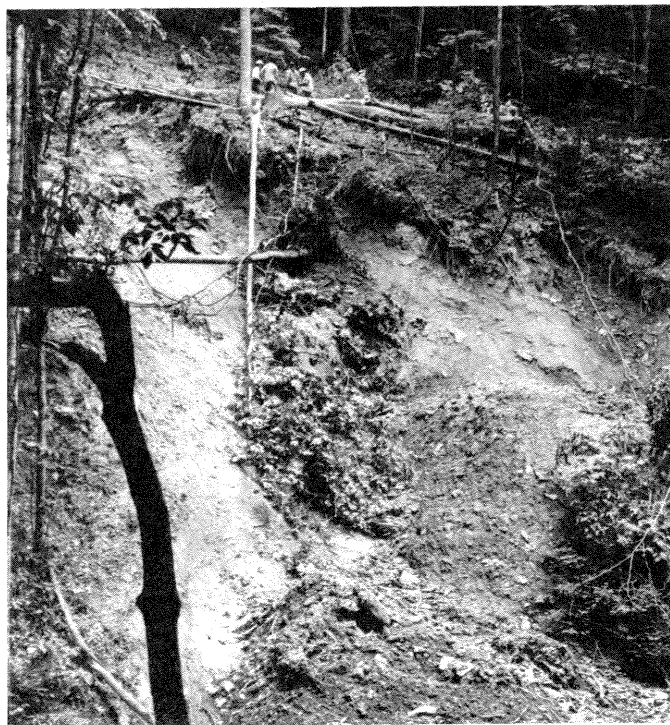
Slope failures above roads and streams were common, but only one landslide (Fig. 10) was found on the storm track. It was on a 58-percent slope between Routes 38 and 72. Almost 100 feet wide and perhaps twice as long, it dumped nearly 1,500 cubic yards of debris into Clover Run. Monongahela National Forest personnel believe that road

**Figure 10.—Landslide on the Right Fork of Clover Run. The lightest colored surfaces are bedrock. For scale, note workmen at the top of the photograph.**

construction caused this landslide. Loss of slope support from bank undercutting by Clover Run seems as likely a cause. Upstream a short distance, another landslide of similar size had occurred long before the forest was roaded.

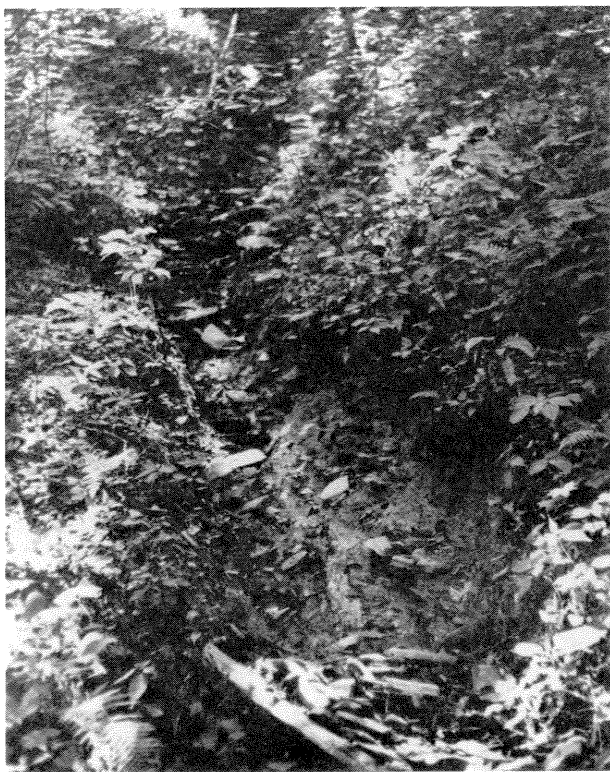
Heavy rain caused stream channels to extend far upslope, often into land showing no previous overland flow (Fig. 11). Here, the

**Figure 11.—Overland flow on shallow Dekalb soil cut this channel on a 40 percent slope where no channel had existed.**

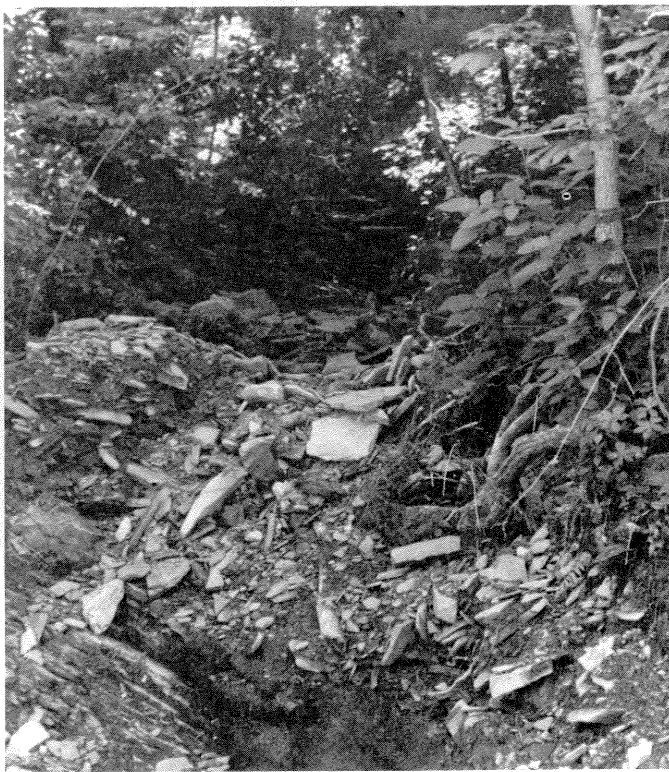
erosive action probably was like that described for the V-shaped basin. Scour was severe, too, in small headwater hollows (Fig. 12), the origin of mere trickles during ordinary wet weather. Bank undercutting was ubiquitous, with several slope failures per mile common along perennially flowing, first-order headwater streams (Fig. 13). Huge stormflows had widened and deepened the second- and third-order stream channels (Fig. 14). Debris from all of these upstream

**Figure 12.—This ephemeral channel near Route 38 was scoured to bedrock and greatly widened.**

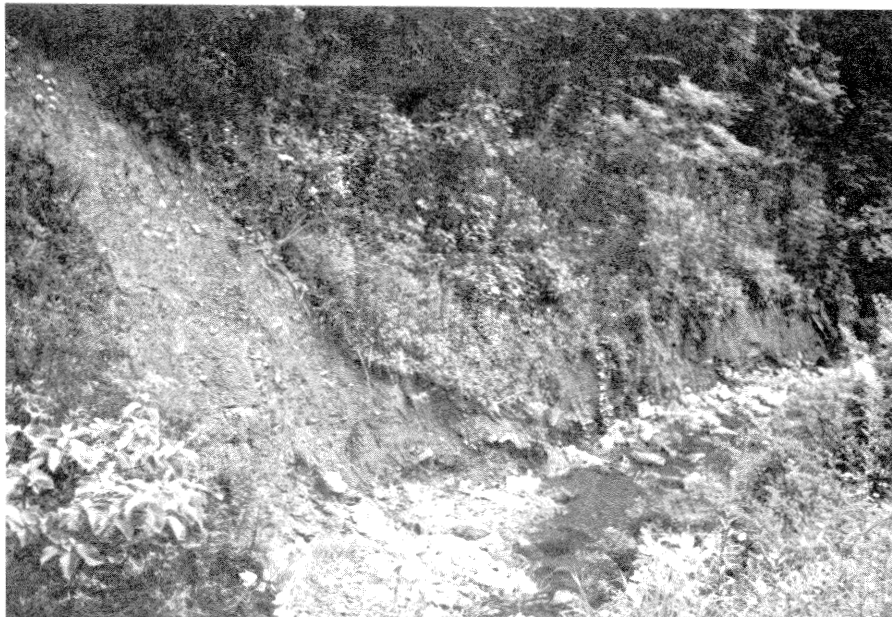
**Figure 13.—Water had flowed at least 4 feet deep far up the headwaters of Clover Run. Several slipouts of this size or larger occurred per mile along its streambanks.**

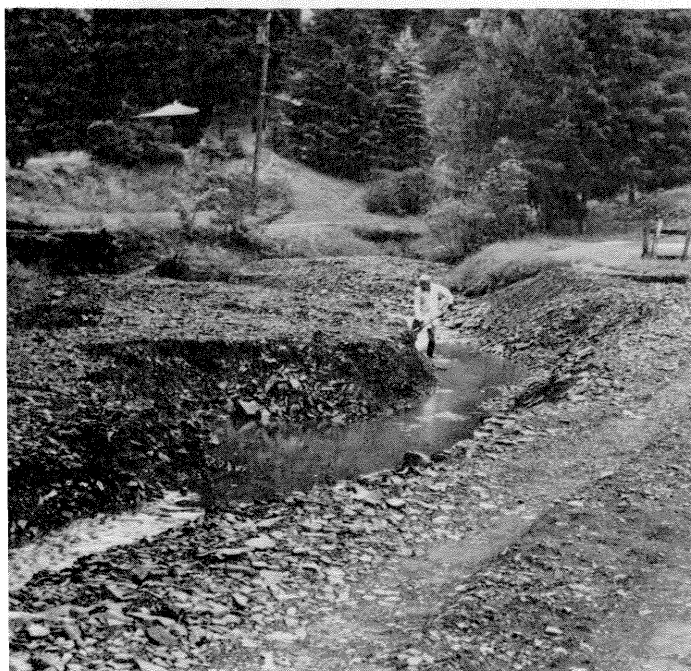
sources was deposited downstream where channels widened and flattened (Fig. 15), or where tributaries joined larger streams (Fig. 16).

**Figure 15.—Huge amounts of gravel were deposited near Wolf Run's confluence with the Cheat River. Note road pavement swept away.**

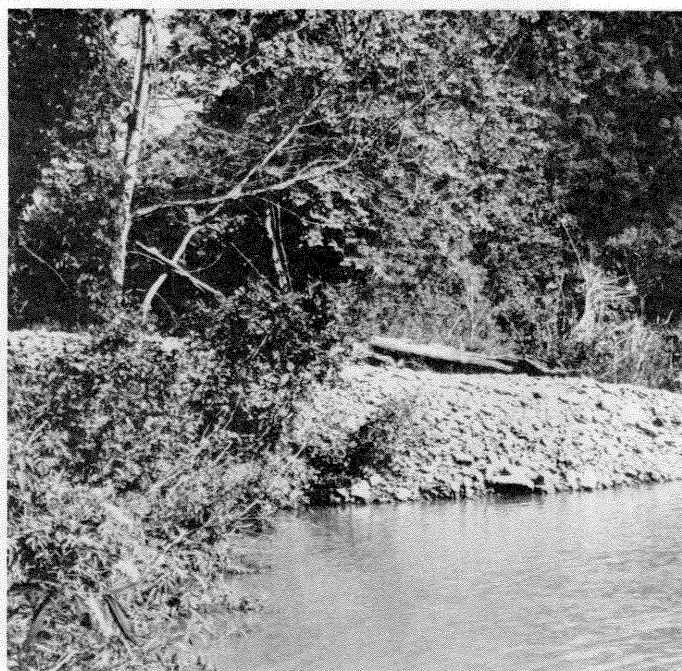
**Figure 16.—Debris from Jonathan Run at its confluence with the Cheat River. The largest object found in this deposit, a concrete block of about 2 cubic feet, indicated the carrying power of the flash-flood waters.**

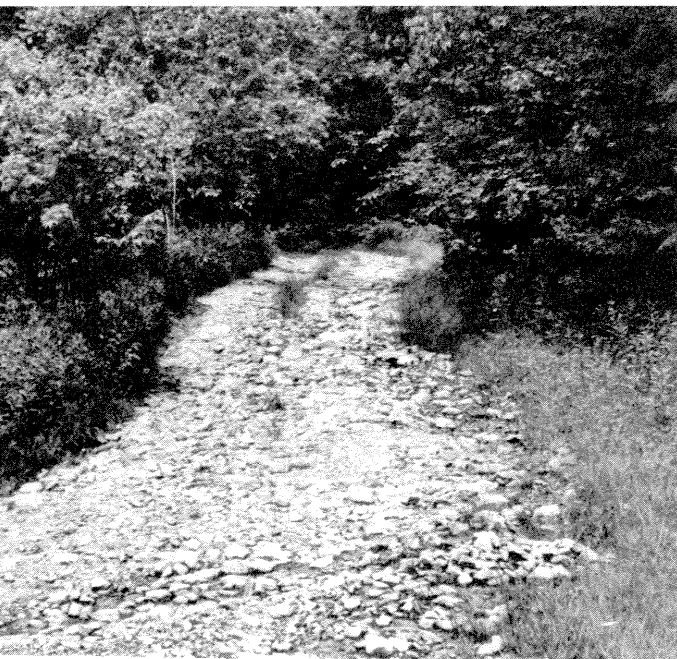
Given the flatter topography of this plateau, there was no high-velocity overland flow and associated erosion on the forest floor. Only the stream channels eroded severely, often as severely as channels in the St. George vicinity. Here too, erosion damage to logging roads was minimal (Fig. 17 and 18). Most of these roads had been little used

**Figure 17.—Erosion pavement on a logging road with an 8-percent grade near Canyon Rim Road, Blackwater Falls Park. This was the most severely eroded road found and most of the soil loss probably occurred before the storm of May 24.**

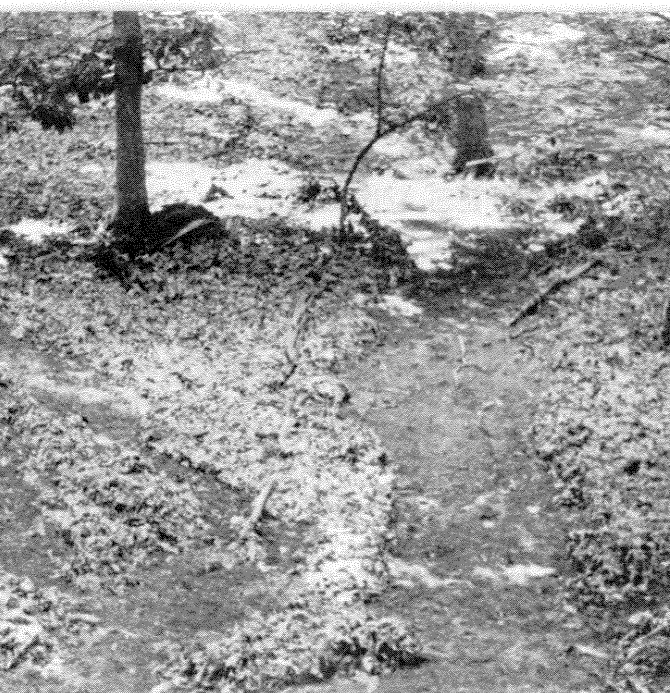
**Figure 19.**—Overland flow paths on grazed woodland. The largest path is 3 to 4 feet wide, litter ridges on each side about 1 foot high. The H layer was not disrupted and mineral soil was not exposed.

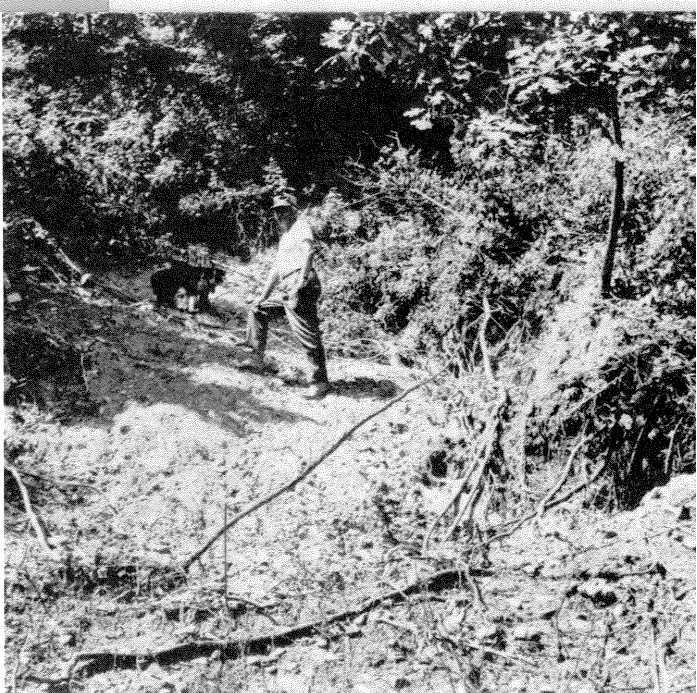
North of the Ewing residence, a debris avalanche (Fig. 20) had occurred on a 55-percent slope in grazed woodland. The avalanche scar was about 20 feet wide, 50 feet long, and 2 feet deep to bedrock. The debris slid about 700 feet to the base of a 40- to 45-percent slope. It must have flowed as a semiliquid mass because grass and small trees were bent over but not uprooted by its passage. Five smaller (200 to 300 square feet) landslips were found close to the base of a 40-percent grassy slope nearby.

**Figure 20.**—About 70 cubic yards of soil and rock were dislodged from this debris avalanche scar.

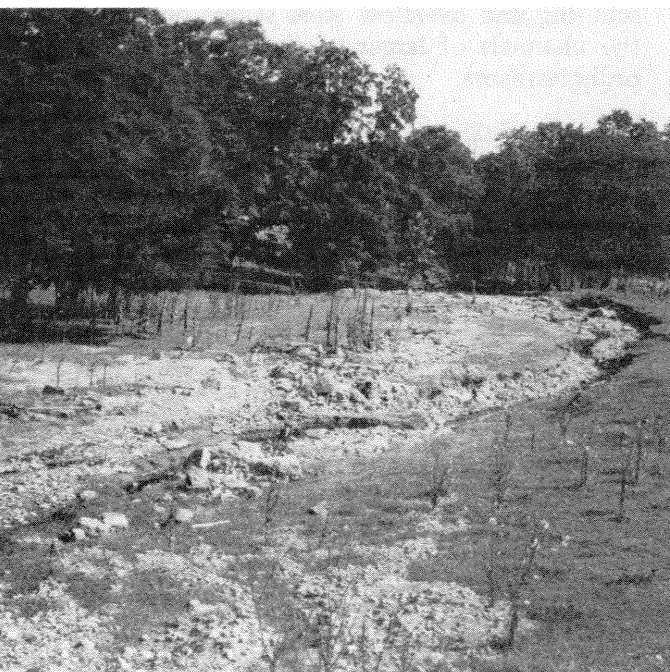
Johnson's Run gives a first impression of severe channel scour (Fig. 21). Debris strewn about the channel area is nearly all sandstone but this watershed is underlain with calcareous shale. Most of the debris came from Buchanan soil, a sandstone-derived series to the east that overlies the shale. The road east of Johnson's Run cuts into this sandstone and had been rebuilt several times, most recently since the storm of August 5 (Fig. 22). Several large gullies on 30 to 40 percent slopes have

**Figure 21.**—The main channel of Johnson's Run, downstream from the outlets of gullies caused by road drainage.

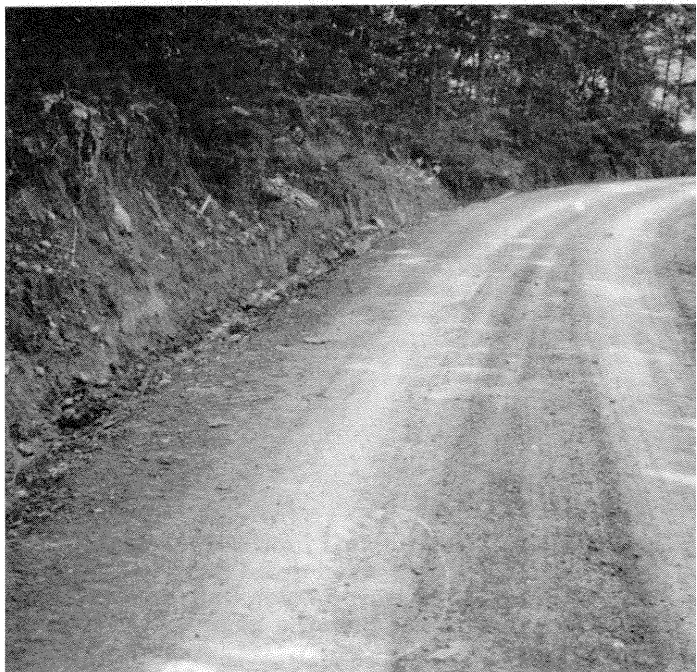
**Figure 22.**—These road banks are 8 feet high, the ditches 2 feet deep, the traveled road surface 24 feet wide. The roadbed is on sandstone bedrock at a grade of 9 percent. The road was completely washed out by the flash flood.

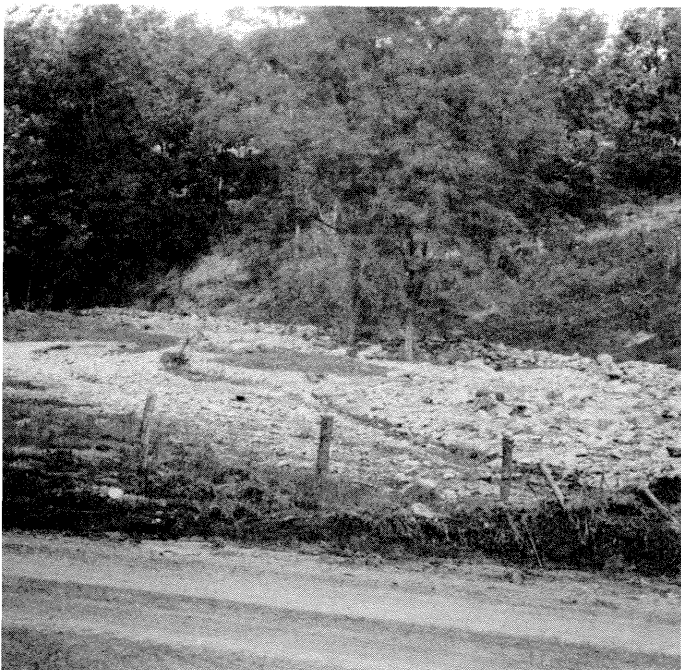
carried road debris into Johnson's Run for years (Fig. 23). Surely, this road and its associated gullies are the sources of sandstone debris strewn about the stream channel. The streambed of Johnson's Run had scoured to its shale bedrock but there had been only minor loss of soil and organic matter from its tributary channels.

**Figure 23.—Tons of debris from the road shown in Figure 22 poured down this 35-percent pastured slope. Johnson Run is about 200 yards downslope from the fence.**

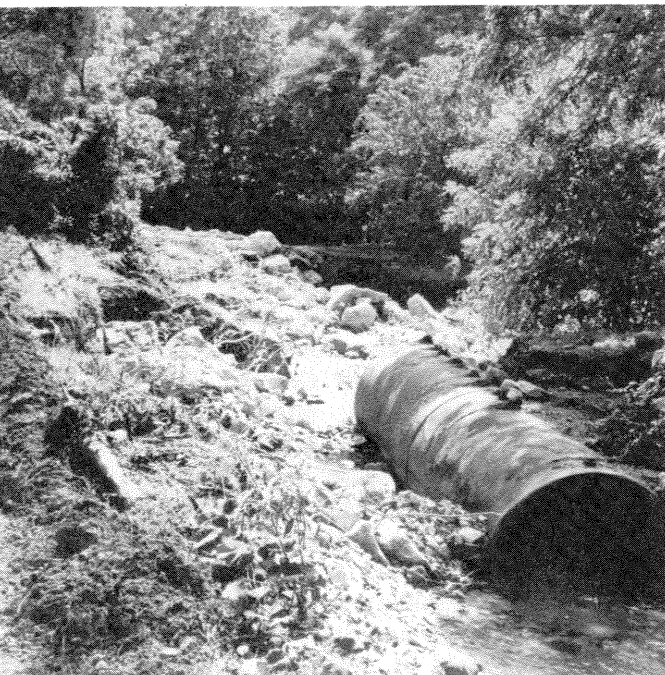
Flash-flooding had similar effects in May and August with respect to infiltration, woodland grazing, and logging roads. Channel overflow and scour in large, perennial streams were similar, too (Fig. 24). Only in the tiny, ephemerally flowing, first-order channels was there contrasting behavior. Most of these had carried damaging freshet flows in May and were deeply eroded; in August, flows and erosion were negligible in all of them (Fig. 25).

**Figure 24.—**This 4-foot culvert had provided access to a small farm on the right. Dumplin' Run washed away the newly repaired gravel road on the left.

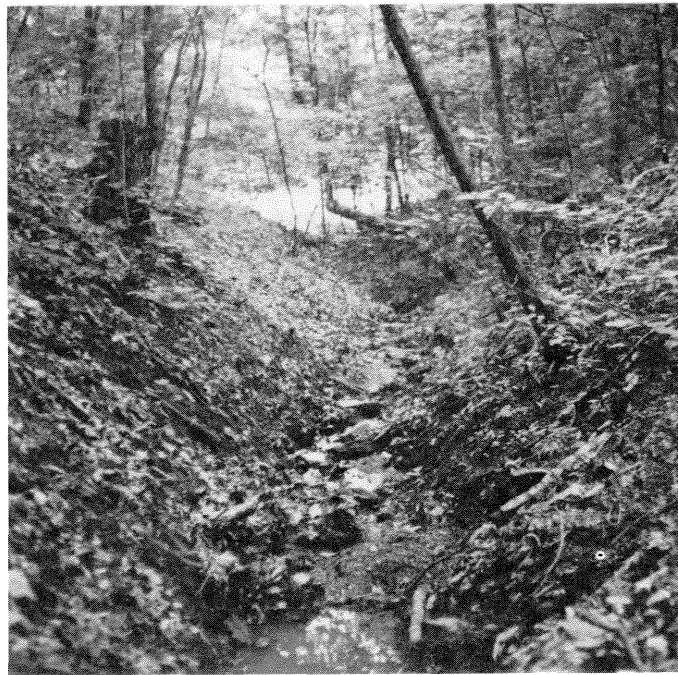
**Figure 25.—**This tributary of Dumplin' Run has a channel gradient of 25 percent. Litter was flushed out but there had been no heavier scour. There was no evidence of overland flow on the 70-percent channel banks.
