Research Paper  
NE-501

# Erosion on Very Stony Forest Soil During Phenomenal Rain in Webster County, West Virginia

J. H. Patric  
W. E. Kidd, Jr.

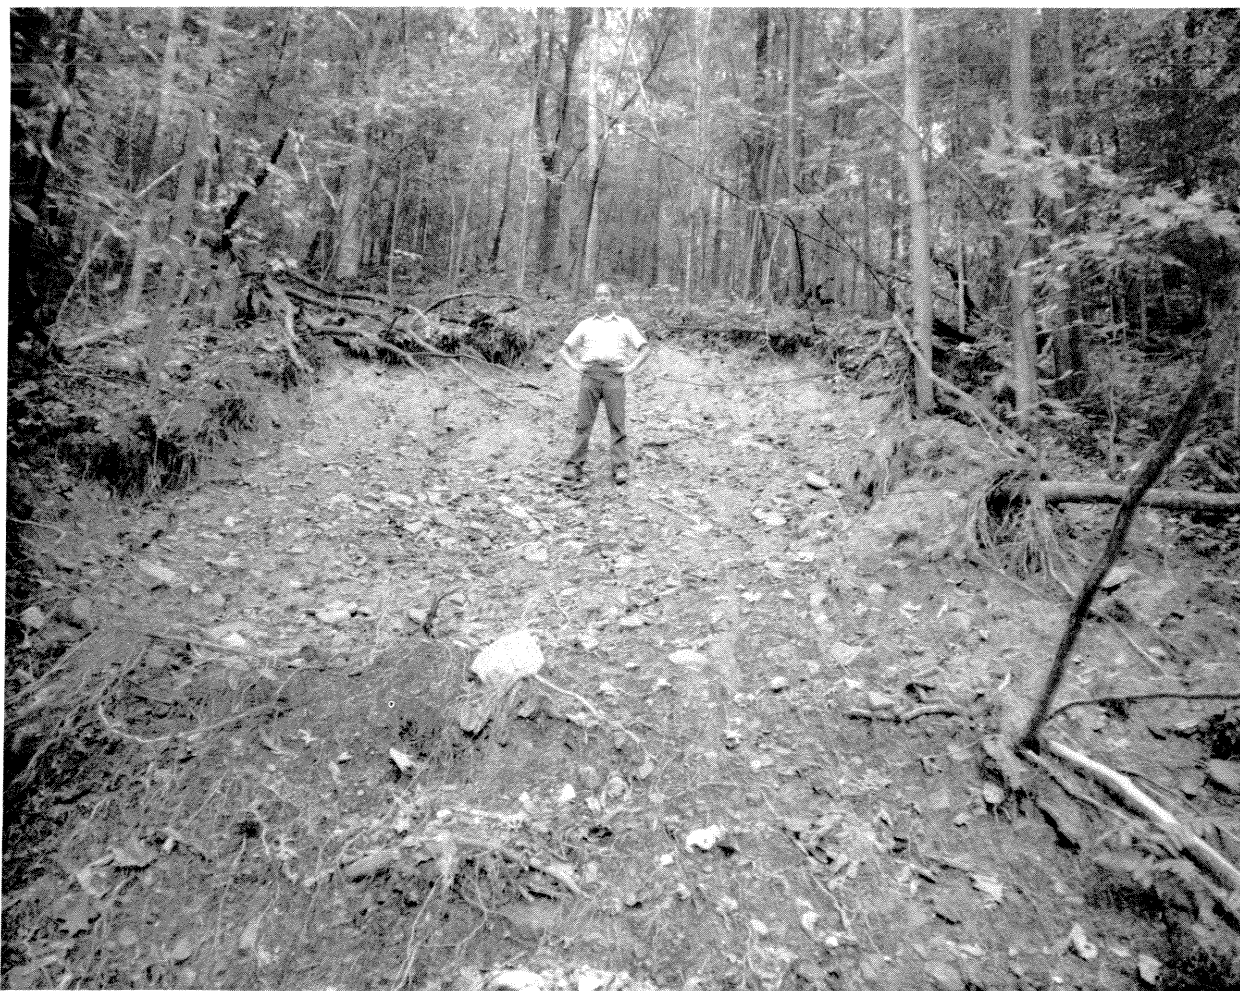
Figure 2.—This small debris avalanche originated where the man is standing, then came to rest as a block about 150 feet downslope.

At least a dozen small debris avalanches were found on the fraction of the flash-flooded area exam-

ined. All were on slopes steeper than 50 percent, originating as oval-shaped slip-outs about 2 feet deep and perhaps 20 to 30 feet across. Two were in pasture, one in a white pine plantation, and the balance in hardwood forest. Debris slid as a block from most of the slip-outs, moving downslope from a few to many feet (Fig. 2). Debris from others must have moved downslope as a viscous mass to the nearest waterway, leaving little evidence of passage over the forest floor except a coating of mud and a speckling of small, flat stones. The debris avalanches are regarded as a form of

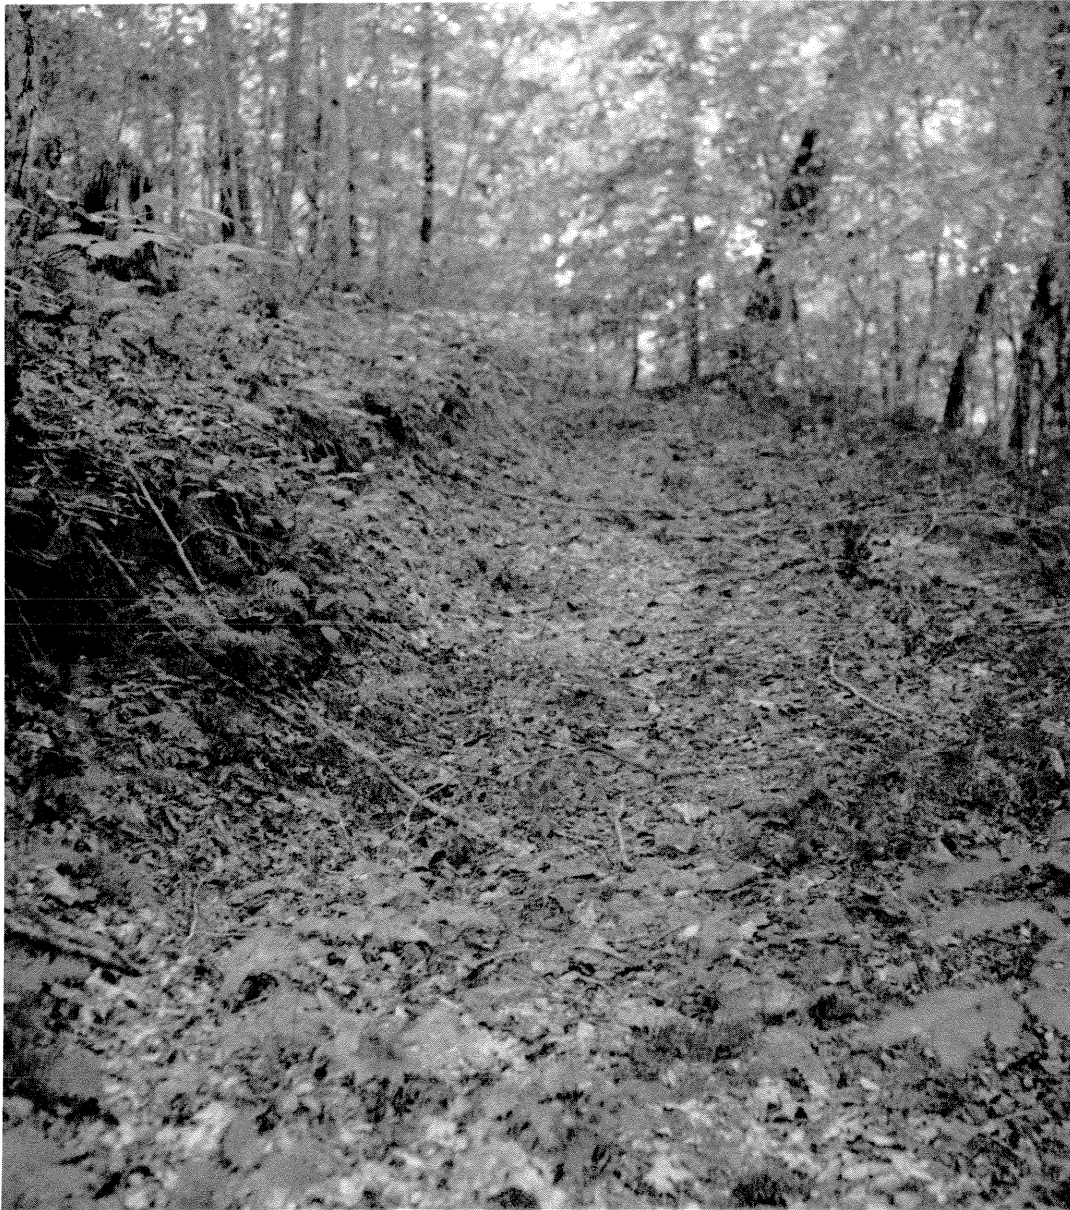
Figure 4.—This logging road, on an 8 percent grade, showed no sign of erosion after the storm of July 15 and 16.

ways were covered completely with litter (Fig. 4); steeply sloping (>30 percent) roads had little or no litter cover. The cover ranged from complete to absent between these extremes of slope.

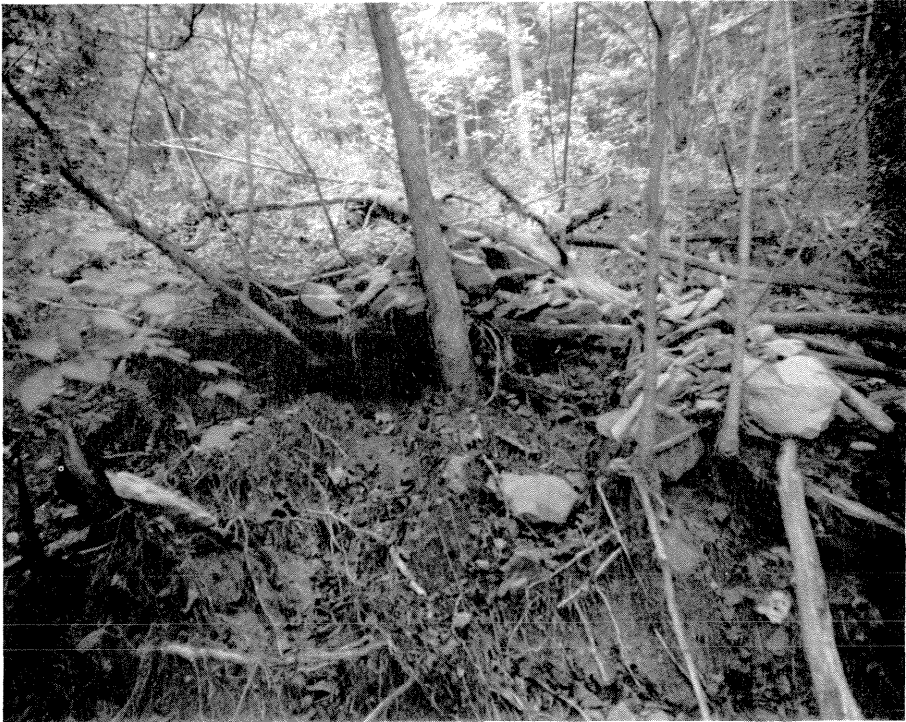
Figure 7.—Tons of rock and soil were trapped below the breakout point. Overland flow also swept large amounts of litter and soil from inundated parts of this slope.

out at that point, about 1,200 feet upslope from Holly River. Tons of rock were dumped along the 60 percent slope immediately below the breakout point (Fig. 7) though the stormflow also swept away some litter, soil, and small stones from that slope. The net effect, in terms of eroded material actually reaching the Holly River, can only be guessed. But even on so steep a slope, a considerable volume of soil and rock was deposited before it reached the river. This is, of course, the function of a filter strip, but the volume of stormflow vastly exceeded any absorptive capacity of the forest floor, largely nullifying much of its filter-strip function. We estimate that about one-third of the eroded material was deposited between the breakout point and the stream, and that the remainder (380 tons) was swept into the Holly River.

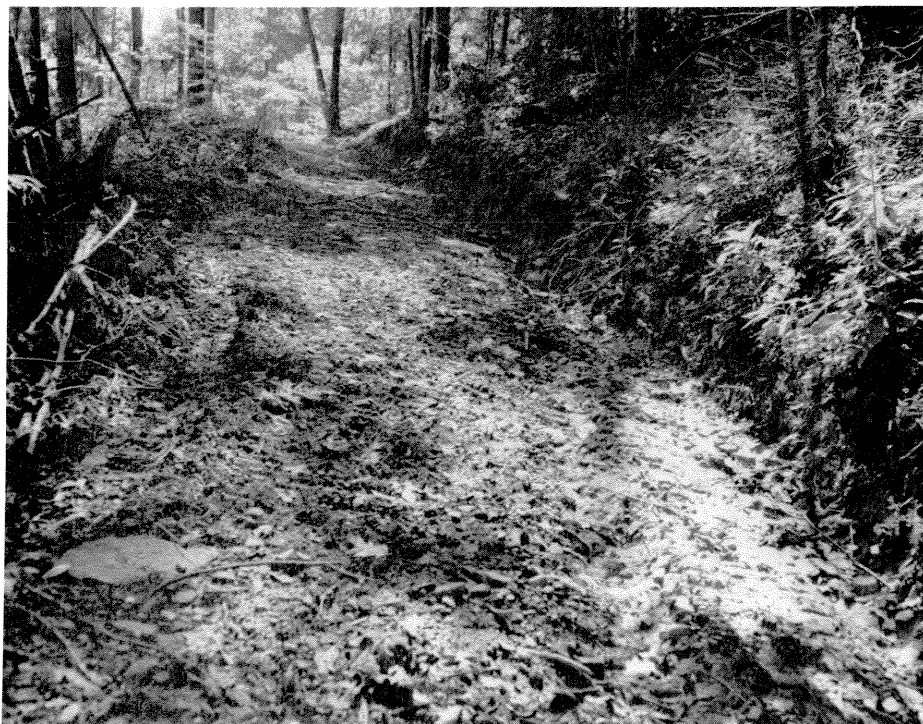
Figure 9.—This road suffered little or no erosion even though it was insloped and on a 15 percent grade.

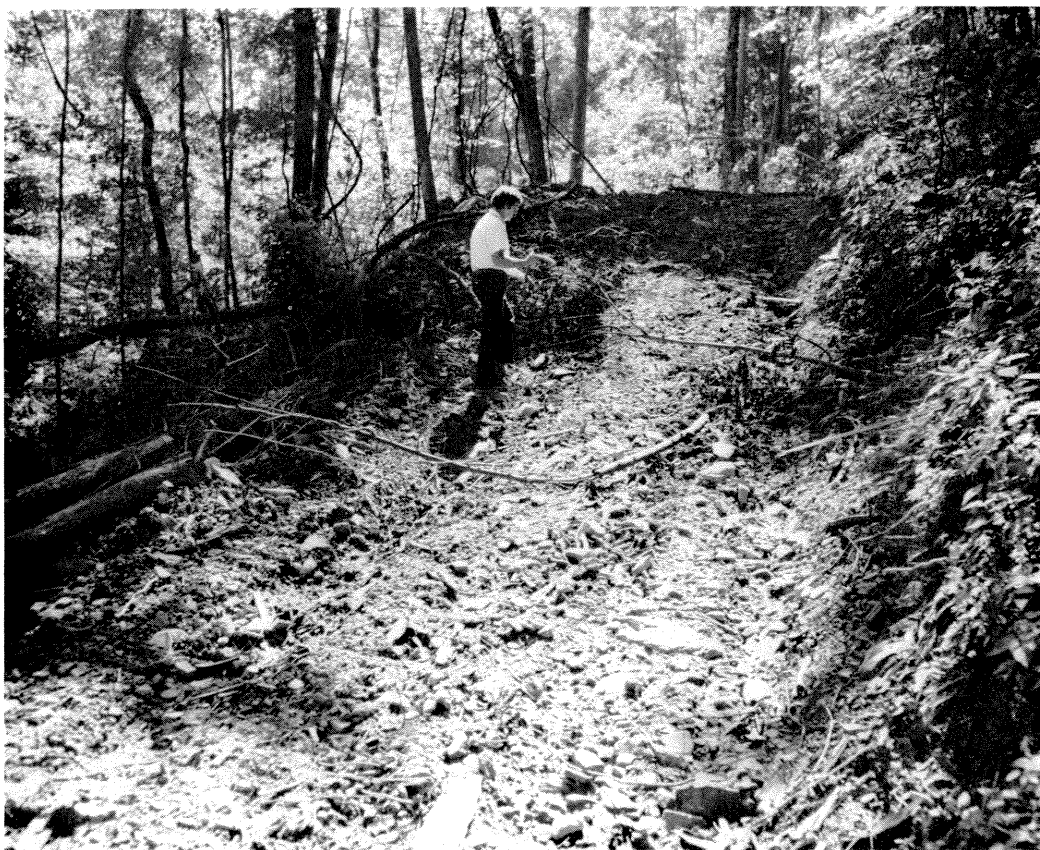
Figure 10.—The most severely eroded segment of the main haulroad, Bruffy property.

- One hundred sixteen tons of soil eroded from that portion of the main haulroad (650 feet; grade: 21 to 27 percent) extending upslope from the landing. Here, too, the evidence suggests that only sand-size or smaller particles (about two-thirds or 78 tons) contributed to sediment loading in Holly River.
