# **Pendulum Impact Tests of Wooden and Steel Highway Guardrail Posts**

USDA FOREST SERVICE RESEARCH PAPER NE-311  
1974

Impact strength characteristics of southern pine, red oak, and steel highway guardrail posts were evaluated in destructive impact testing with a 4,000-pound pendulum at the Southwest Research Institute. Effects were recorded with high-speed motion-picture equipment. Comparisons were based on reactions to the point of major post failure. Major comparisons of 6x6-inch and 6x8-inch red oak and southern pine posts with W6x8.5 and S3x5.7 steel posts showed wooden posts to be equal or superior to steel. The basis for wooden-post specifications should be the amount of knot-associated grain distortion in the middle third of the tension face of the posts. Acceptable posts are those with no single knot in the middle third of the tension face that disorients the grain for more than one-third the width of the face.

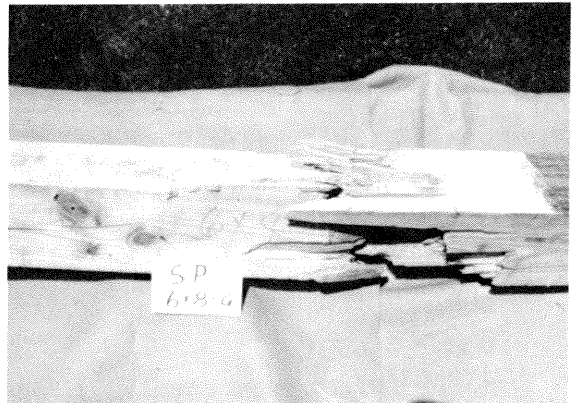
SP 68G. Three knots were located 4 to 6 inches above the clamp on the tension face. No knot disoriented the grain for more than one-third the width of the tension face. Post impact strength: above average for the SP 68 series.

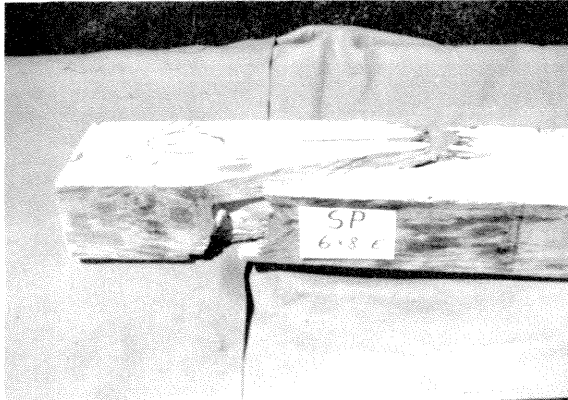
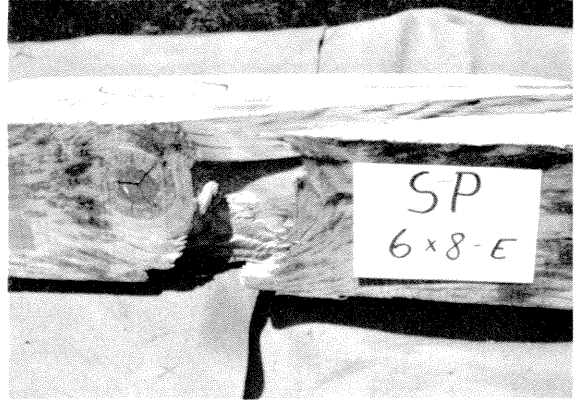
SP 68E (two views, above): a 1½-inch knot located about 11 inches above the clamp on the tension face disoriented the grain across the entire 6-inch width of the face. Other knots from the same cluster on front and compression faces had no effect on strength. Post impact strength: far below average for the SP 68 series.

Posts 68E and D, though slightly low in percentage of summerwood and specific gravity, performed poorly because of knot-associated grain distortion. SP 68E (fig. 7) had a 1½-inch knot about 11 inches above the clamp that disoriented the grain across the entire 6-inch width of the tension face. Failure beginning immediately below this knot was clearly visible in the high-speed motion pictures. Other knots from the same cluster on the other faces had no effect.

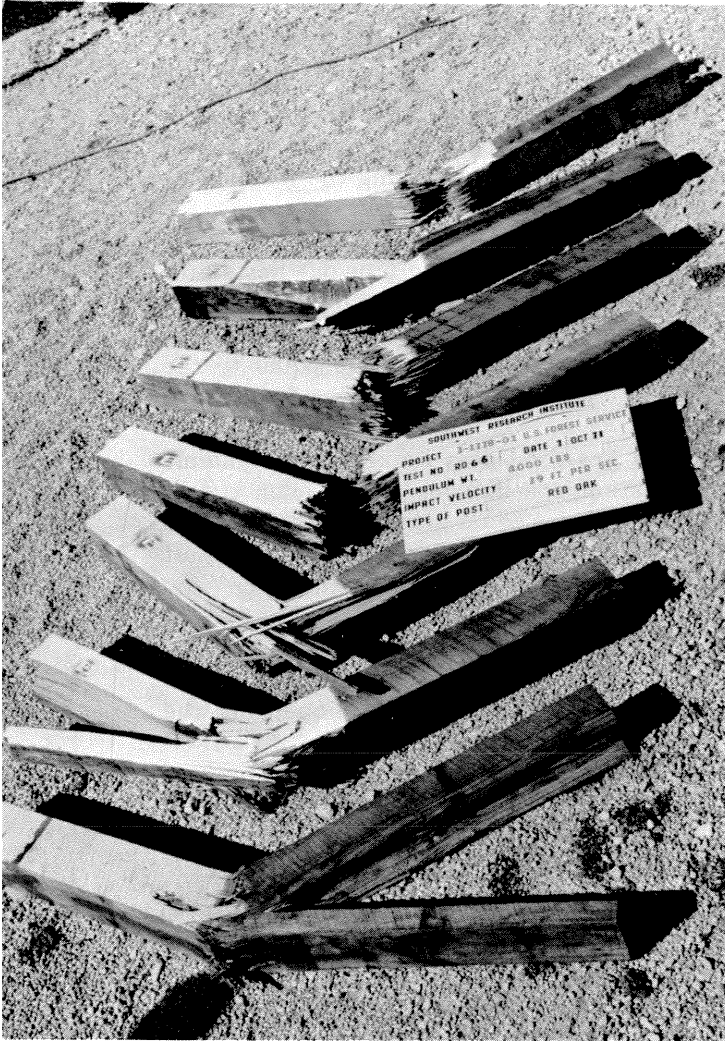
Figure 11.—Examples of wooden posts after impact testing.

Considering these factors, we found that wooden posts have characteristics that are equal or superior to those of comparable steel posts. The No. 1 SR 6x6 southern pine posts were directly comparable to the S3x5.7 steel posts. The red oak 6x6 posts (fig. 11) and the southern pine 6x8 No. 1 SR posts were, overall, slightly superior to the W6x8.5 steel posts. The red oak 6x8 posts and the No. 1 Dense SR creosote-treated southern pine posts were considerably superior to the W6x8.5 steel posts (fig. 12).

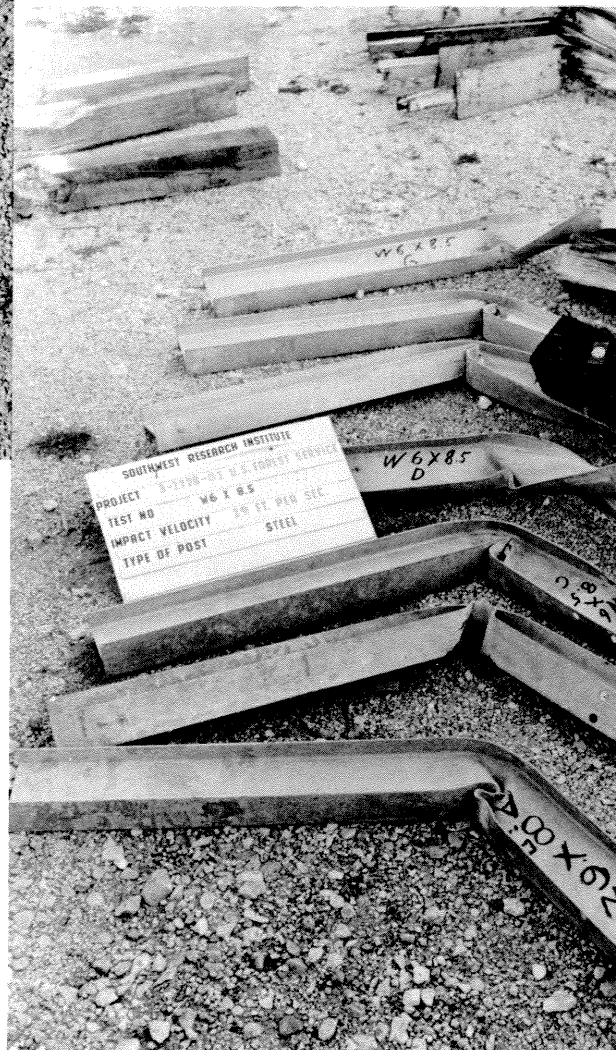
Figure 12.—Examples of steel posts after impact testing.
