**By R. Sam Williams**  
**USDA Forest Service Forest**  
**Products Laboratory**

# Don't get (sun) burned

**Exposing exterior wood to the weather prior to painting contributes to finish failure**

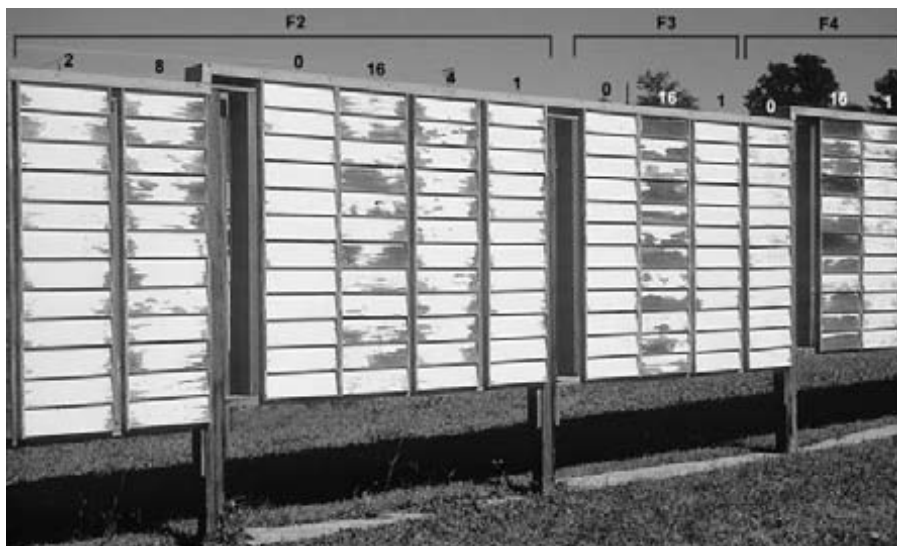
**Figure 2 (Above):** Panels exposed at the Forest Products Laboratory field site 15 km west of Madison, WI (F2, WRP/alkyd/latex; F3, alkyd/latex; F4, latex/latex).

All finishes were commercial formulations. For each preweathering period (0, 1, 2, 4, 8, and 16 weeks), 12 boards (four panels of three boards per panel) were exposed outdoors for 20 years (Figure 2).
