# Restoration of Soldier Spring: an isolated habitat for native Apache trout

Jonathan W. Long<sup>1</sup>, B. Mae  
Burnette<sup>2</sup>, Alvin L. Medina<sup>1</sup>, and  
Joshua L. Parker<sup>2</sup>

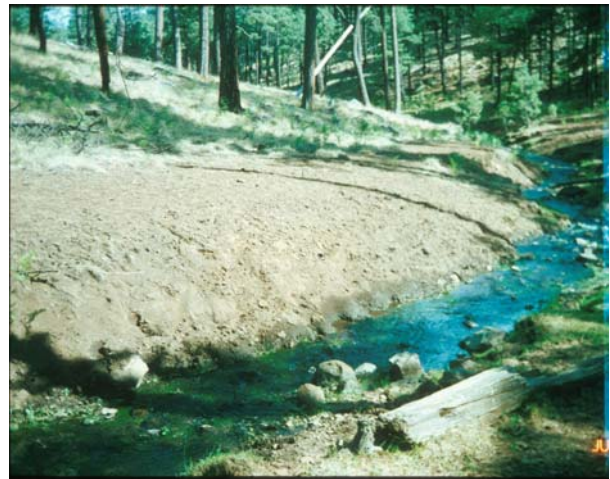
**Figure 1:** View downstream from the spring, June 1996, prior to treatment, revealing the bare streambanks that were common along reach.

Field surveys from 1995 to 1997 revealed that the channel was actively downcutting (Fig. 1). The streambanks lacked native wetland plants and were trampled by ungulates (horses, cattle, and elk). We found remnants of log structures, demonstrating an earlier, unsuccessful attempt to enhance or stabilize the stream. New restoration efforts began in 1998 with support from a number of tribal, federal, and school organizations. By 2004 (Fig. 2), we are able to evaluate the numerous gains that have been achieved at this restoration site.

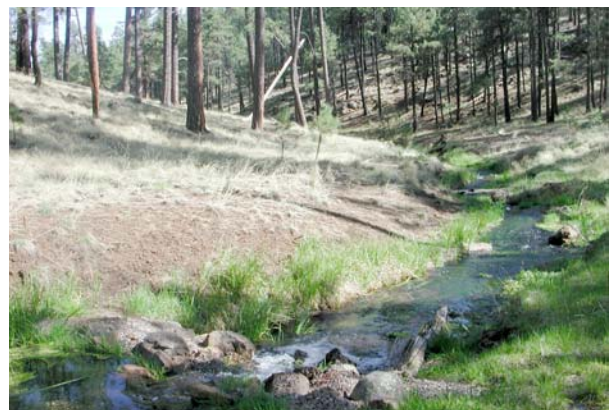
**Figure 2:** View downstream from the spring, May 2004, six years after the initial treatment, showing one of the riffle formations and the increase in streamside vegetation.

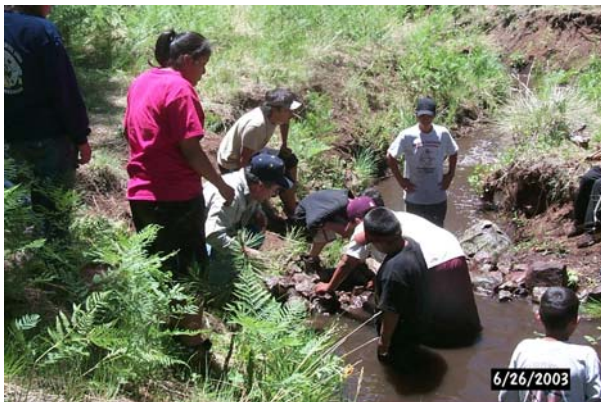
**Figure 3:** Participants at the White Mountain Apache Tribe’s summer youth camp helped to build riffle formations by hand using rocks from adjacent side-slopes.

To arrest the downcutting, we needed to include a structural intervention as part of the comprehensive treatment of the site. Rather than relying on wood as in earlier efforts, we used rock and gravel “riffle formations” that recreate the natural grade control features of a step-pool system (Medina & Long 2004). These formations were built by hand using rocks from the adjacent slopes (Fig. 3) and gravels imported to the site using wheelbarrows. In addition to providing grade control, these rock riffle formations rearmor the streambed to improve substrate quality for the trout. We also recognized the need for in-stream and shoreline herbaceous vegetation to stabilize banks, to provide habitat for aquatic organisms, and to knit the grade control features into the banks. Therefore, we integrated sedge transplants with our riffle formations to stimulate recovery of stabilizing vegetation. Because ungulate grazing was reducing streambank stability and vegetation development, we excluded ungulates by erecting a large, solar-powered electric fence around the site.

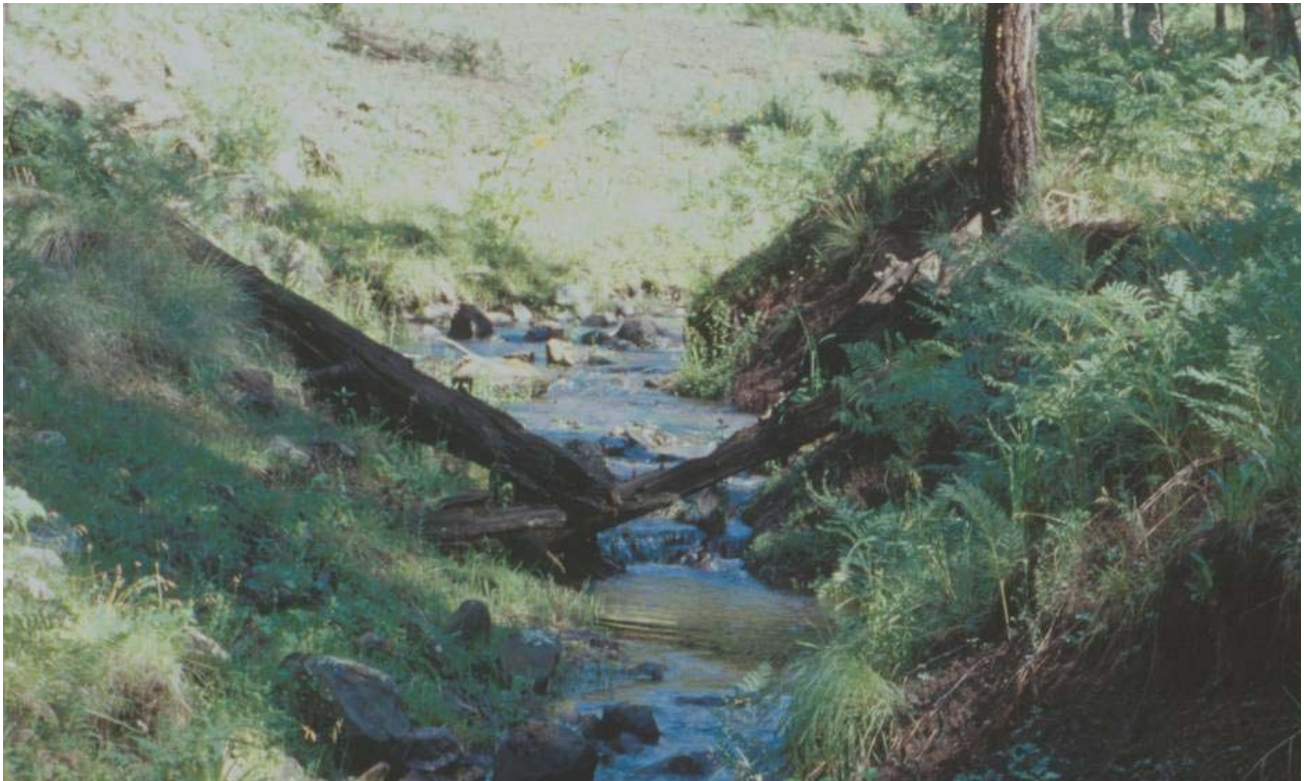
**Figure 4:** View of Soldier Creek before placement of riffle formation, June 1998. The logs in the channel were remnants of a failed grade control structure dating to the 1980s.

Figures 4 and 5 depict a typical incised reach before and after treatment with a riffle formation. Due to the protective fencing, transplanting, and raising of the water level along the stream, streamside vegetation growth was vigorous. Transplanted sedges bound to the streambed and banks within the first year, and these plants have begun to climb higher along the edges of the banks (Fig. 2). The formations have become interwoven with aquatic vegetation, including extensive beds of water buttercup (*Ranunculus aquatilis*), mannagrass (*Glyceria* spp.), and sedges (*Carex* spp.). Dense growth of the aquatic plants in the channel has concentrated flow (Fig. 6), thereby helping to cleanse fines from the gravel substrates.

The treatments achieved the primary objective of arresting channel degradation and reforming riffle features. The riffle formations mimic naturally formed gravel bars, which serve to transform a high energy-laden flow into a more tranquil one through changes in bed forms, bed armoring and longitudinal profile (Heede 1986). Log steps and gravel bars both provide grade control in natural streams, but log steps are less flexible structures (Heede 1985). For example, logs often induce lateral erosion because small streams cannot reposition them efficiently, log steps can destabilize the channel once they rot out, and logs do not provide a rooting medium for aquatic plants until they are so rotted that they no longer perform a structural function (Fig. 4 shows a typical failed log structure).

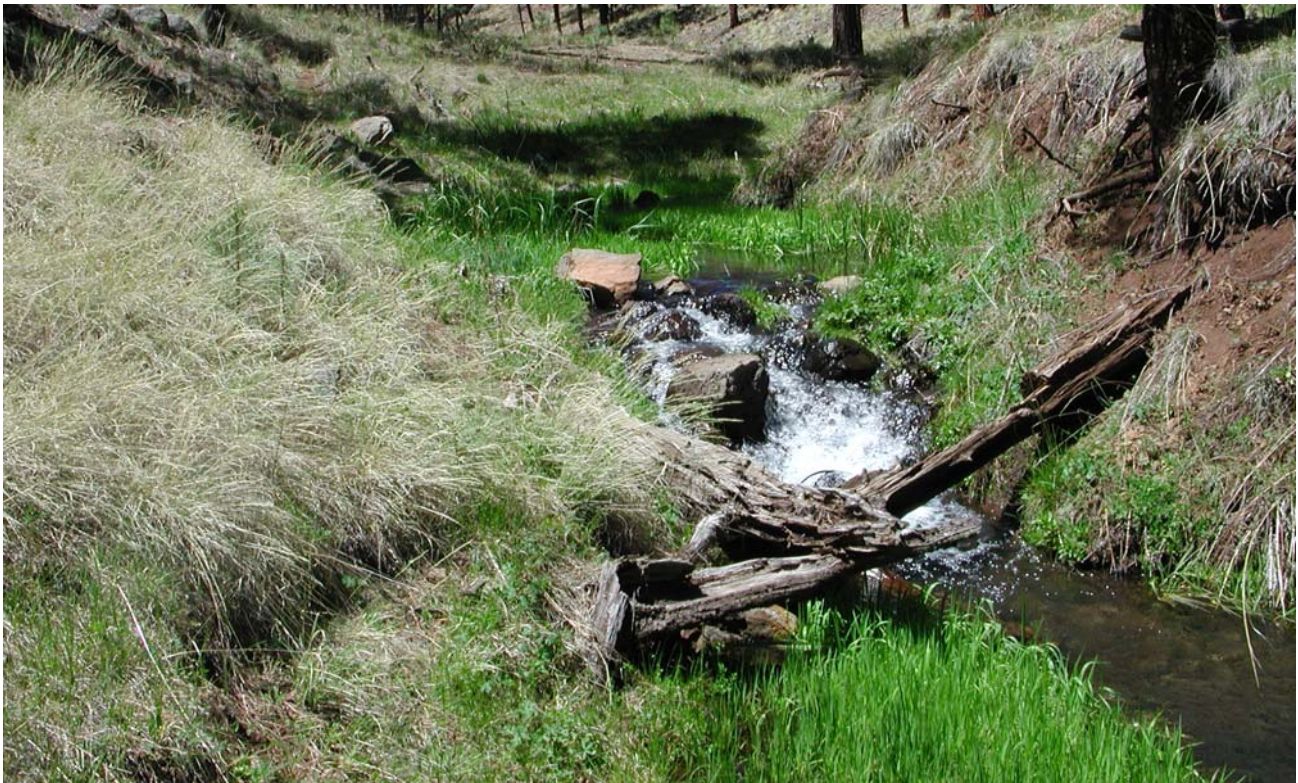
**Figure 5:** View of Soldier Creek after treatment, May 2004. The photo reveals growth of aquatic grasses above, below, and along the formation.

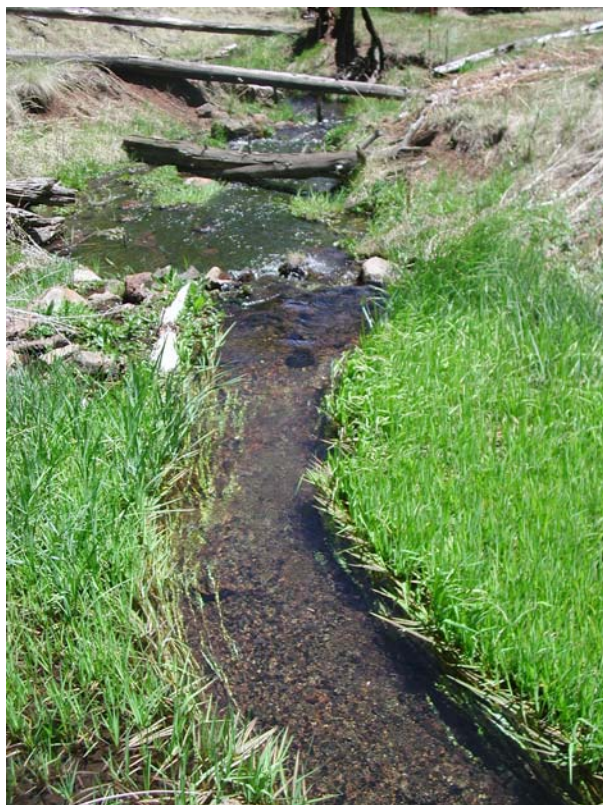
**Figure 6:** View downstream at a riffle formation, showing the dense growth of mannagrass (right) and Nebraska sedge (left), which confines flows and in turn keeps the gravel substrate clean (center).
