## Quaternary Geology and Geomorphology of the Lower Deschutes River Canyon, Oregon

The morphology of the Deschutes River canyon downstream of the Pelton-Round Butte dam complex is the product of the regional geologic history, the composition of the geologic units that compose the valley walls, and Quaternary processes and events. Geologic units within the valley walls and regional deformation patterns control overall valley morphology. Valley bottom morphology is mostly the result of Quaternary events. These include several large landslides, which have caused retreat of the canyon rims but have also constricted the valley bottom with immense volumes of debris. In at least two instances (as at Whitehorse Rapids), landslides blocked the channel, resulting in ponding, breaching of landslide dams, and downstream floods. Large floods from other mechanisms have also formed many valley-bottom features along the lower Deschutes River. A large Pleistocene lahar resulting from a *circa* 0.07 Ma eruption of Mount Jefferson left bouldery deposits along the valley margins for most of the canyon length. The 15,000-12,700 <sup>14</sup>C yr BP Missoula floods backflooded *up* the Deschutes River

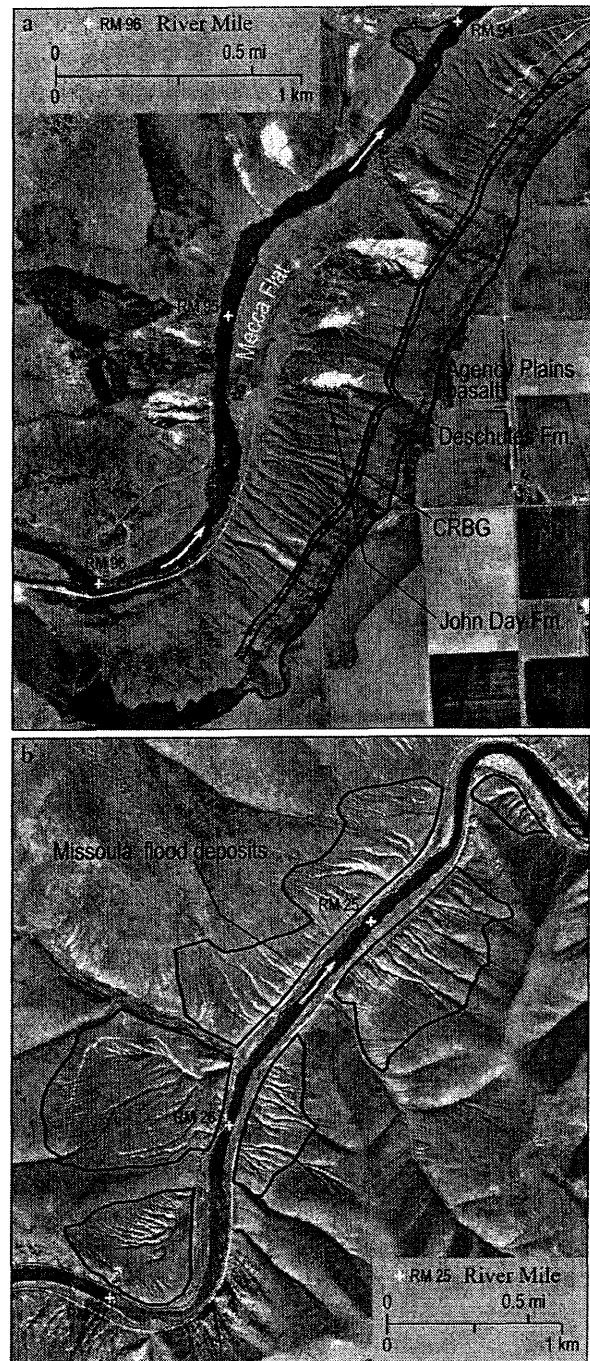
**Figure 10.** Vertical aerial photographs (1995, Portland General Electric) of gullies and rills. (a) Large gullies and rills in the John Day Formation near Mecca Flat at RM 95. CRBG is Columbia River Basalt Group. (b) Rills developed in Missoula flood sediment near RM 25. Missoula flood sediment mantles valley slopes developed in Columbia River Basalt Group.

**Missoula floods.** The late Pleistocene Missoula floods resulted from cataclysmic releases of ice-dammed Glacial Lake Missoula [Bretz, 1969], sending 60 to 90 large floods [Atwater, 1986] down the Columbia River between 15 and 12.7 ka [Waitt 1980, 1985; Atwater, 1986]. In the Columbia River valley at the confluence of the Deschutes River, the maximum stage of the largest Missoula flood was about 300 m above sea level or about 250 m deep [O'Connor and Waitt, 1995]. If maintained at steady state, this water would have back-flooded the Deschutes River valley as far upstream as RM 60. Silt, clay, and sand carried in suspension by these floods mantles the valley slopes adjacent to the Deschutes River to an elevation of 275 m above sea level and as far upstream as RM 45 (Figures 3 and 12). Erosion of these fine-grained deposits has been a continuing source of sediment to the lowermost 60 km of the lower Deschutes River (Figure 10b).

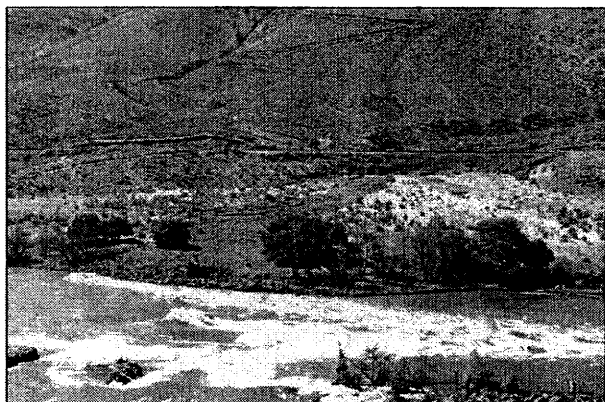
**Figure 15.** View north of the tributary fan at RM 7.8, where a July 1995 debris flow transported bouldery gravel into the Deschutes River channel, forming 'Washout Rapids.' Culverts under railroad have diameters of 4 m. June 2, 1998 photograph by J. E. O'Connor.

they are local sources of readily-mobilized coarse-grained sediment. According to Steve Pribyl (Oregon Dept. of Fish and Wildlife, oral communication, 1998), the fan emanating from the Harris Canyon tributary (RM 12) has repeatedly encroached into the Deschutes River channel over the last decade, only to be trimmed back several times by large mainstem flows. Just downstream, the apex of Harris Island has accumulated angular basalt gravel and cobbles that likely derive from the Harris Canyon fan. *Curran and O'Connor* [this volume] more fully discuss locations, sizes, and distribution of tributary fans.
