# **SLOPE STABILITY PROBLEMS ASSOCIATED WITH TIMBER HARVESTING IN MOUNTAINOUS REGIONS OF THE WESTERN UNITED STATES**

D. N. SWANSTON

PACIFIC NORTHWEST FOREST AND RANGE EXPERIMENT STATION  
U.S. DEPARTMENT OF AGRICULTURE      FOREST SERVICE  
PORTLAND, OREGON

This paper was presented at the "Symposium on Forest Operations in Mountainous Regions, " in Krasnodar, U. S. S. R., August 30–September 11, 1971.

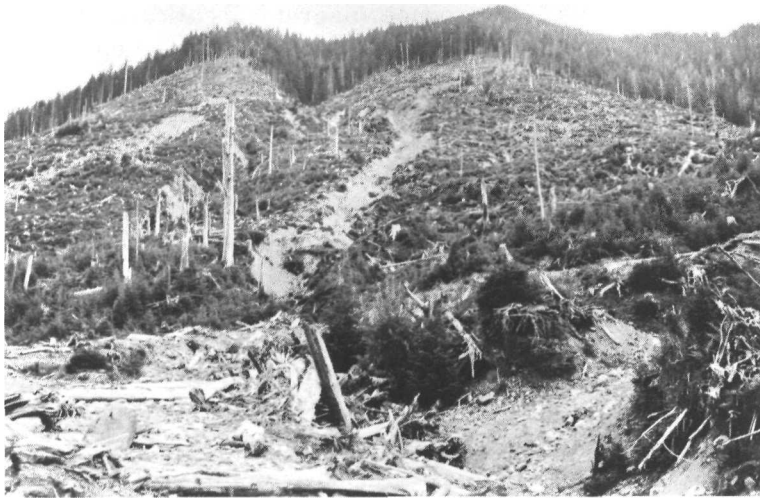
Figure 2-a. Debris avalanche, debris flow combination on a recently logged, till-covered slope. Failure occurred during a period of high intensity rainfall in a zone of concentrated subsurface drainage. The sliding material was weathered till less than 1.0 meter thick overlying compacted unweathered till. The slope angle is about  $34^{\circ}$  (75 percent grade). Note scouring of the avalanche path below spoon-shaped **zone** of initial failure and flow development at slope base.

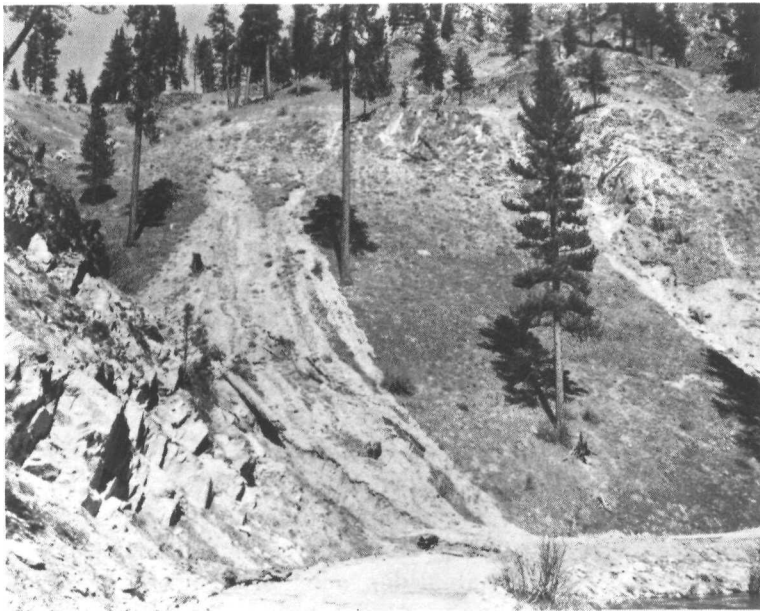
Figure 2-b. Debris avalanches along the South Fork of the Salmon River, Idaho. These failures occurred in a shallow granitic soil following saturation during a high intensity rainstorm. The soil is a lithosol less than 0.3 meter thick. The slope is in excess of  $31^{\circ}$  (70 percent grade).

In Idaho, Megahan (see footnote 1) reports about 90 percent of the soil mass movements which occurred along the South **Fork** of the Salmon River during a storm in April 1965 (a total of 89 events) resulting from soil failures along the logging road right-of-way. Most open-slope failures occurred in shallow granitic soils on slopes in excess of 50 percent. Again, the greatest number of these resulted from road fill failures followed by failures resulting from obstructed road drainage (fig. 6).

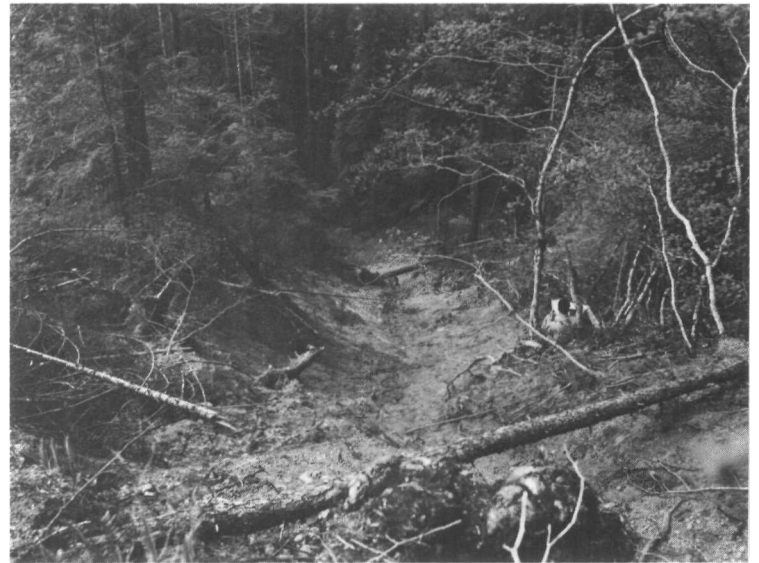
*Figure 3-b. Channel scour event in undisturbed timber on the H. J. Andrews Experimental Forest, Oregon. This event occurred as a result of failure near the head of the drainage.*

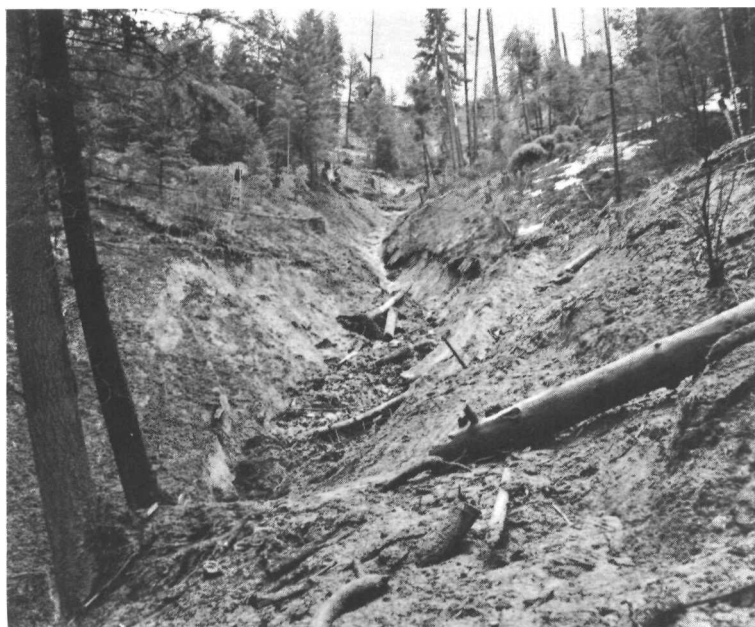
*Figure 3-c. Debris torrent developed in an intermittent stream channel along the South Fork of the Salmon River in Idaho. Initial failure occurred in road fill near the ridgetop.*

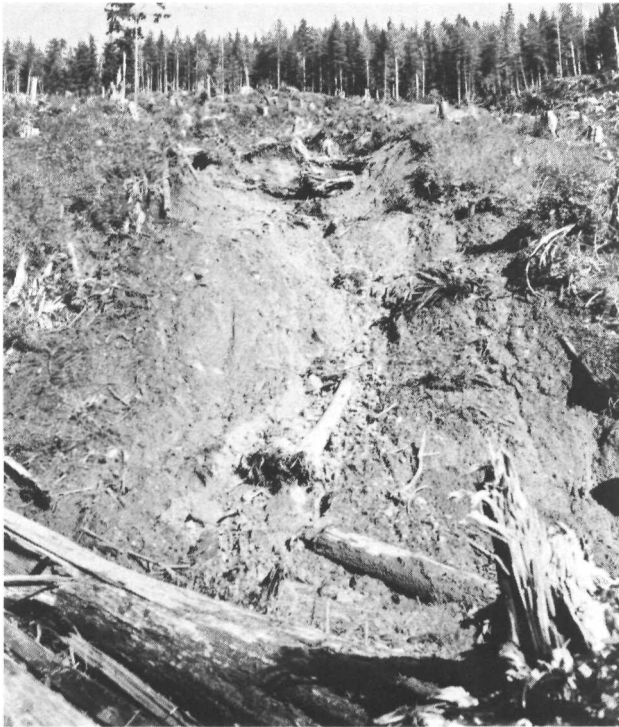
Figure 4. Examples of natural slumps and earthflows.  
a) Massive slump and earthflow in a weathered till bank near Hollis, Prince of Wales Island, Alaska. Depth of weathering approximately 4 feet. Slope approximately  $15^{\circ}$  (34 percent grade).

The second group includes deep seated soil creep, slumps, and earthflows. These three entities are closely related in terms of their occurrence and genetic process (fig. 4).

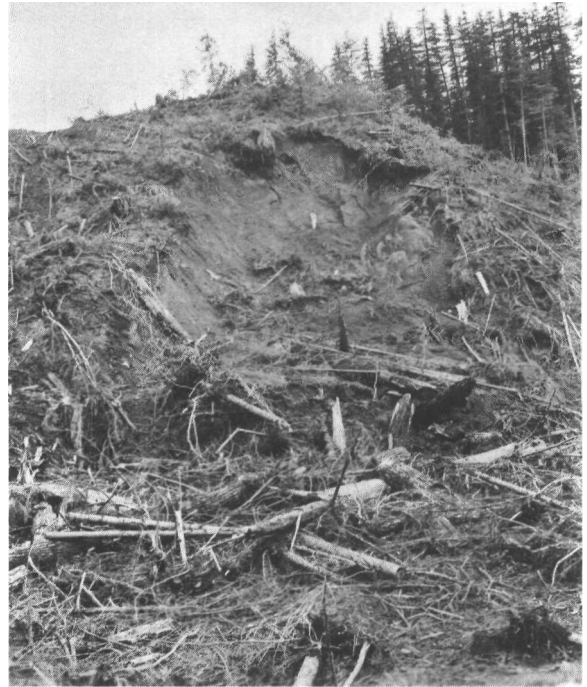
Figure 4-b. Massive earthflow in a recently logged area on the west flank of the Cascades. Depth of soil not available, but failure occurred in relatively deeply weathered pyroclastic materials.

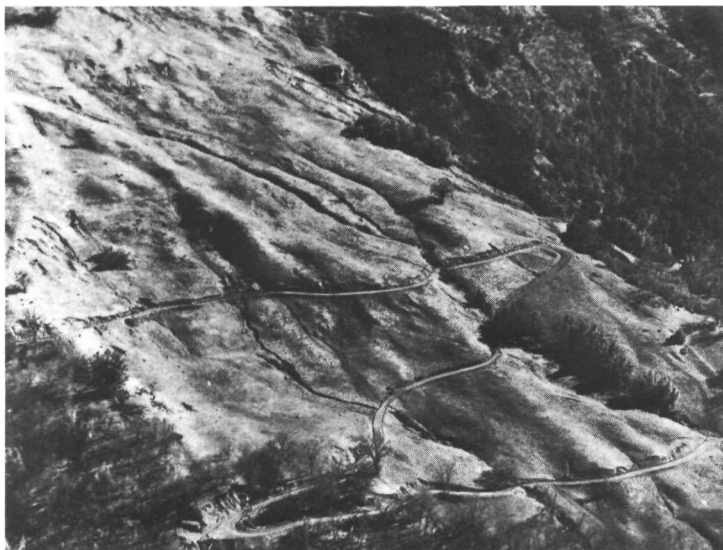
Figure 4-c. Massive slope failure in the northern California Coast Ranges. The failure has resulted from creep and progressive failure in a deeply weathered series of greywackes, shales, bedded cherts, and limestone lenses of Cretaceous Age.

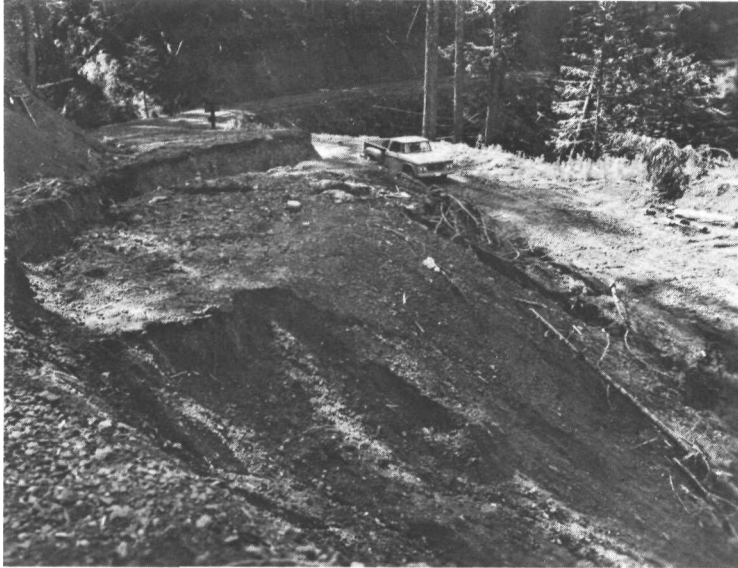
Figure 6. Examples of mass soil movements resulting from failure along a road right-of-way,  
a) Road fill failure in the Cascade Range of Oregon. Failure resulted from plugged side drainages and resultant saturation of the road prism.

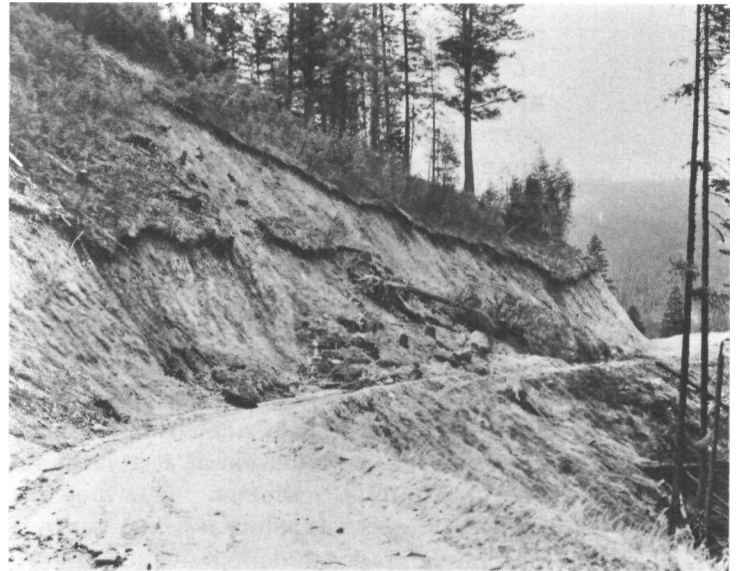
Figure 6b. Backslope failure along a logging road in the Salmon River Mountains of Idaho. Failure resulted from undercutting of the slope toe.

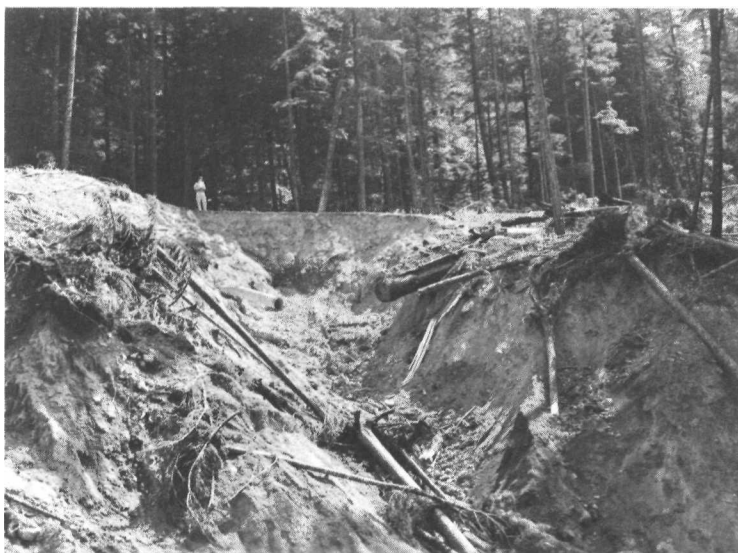
Figure 6c. Failure due to inadequate road drainage in the Cascade Range of Oregon.
